Blistology

Treating And Preventing Hull Blisters

Story And Photography By STEVE C. D'ANTONIO

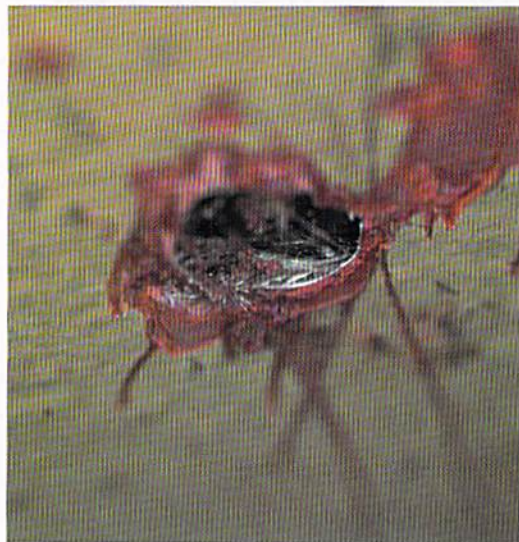
Opposite page: Anatomy of a blister. The dome of this blister has been dislodged by the first pass of a peeler, revealing the delaminated section beneath. Above: This blister's dome has been broken, revealing the short glass strands that are probably part of either chopper gun-applied reinforcement or chopped-strand mat. Many fiberglass experts believe that these short strands provide a path for water ingress into the laminate.

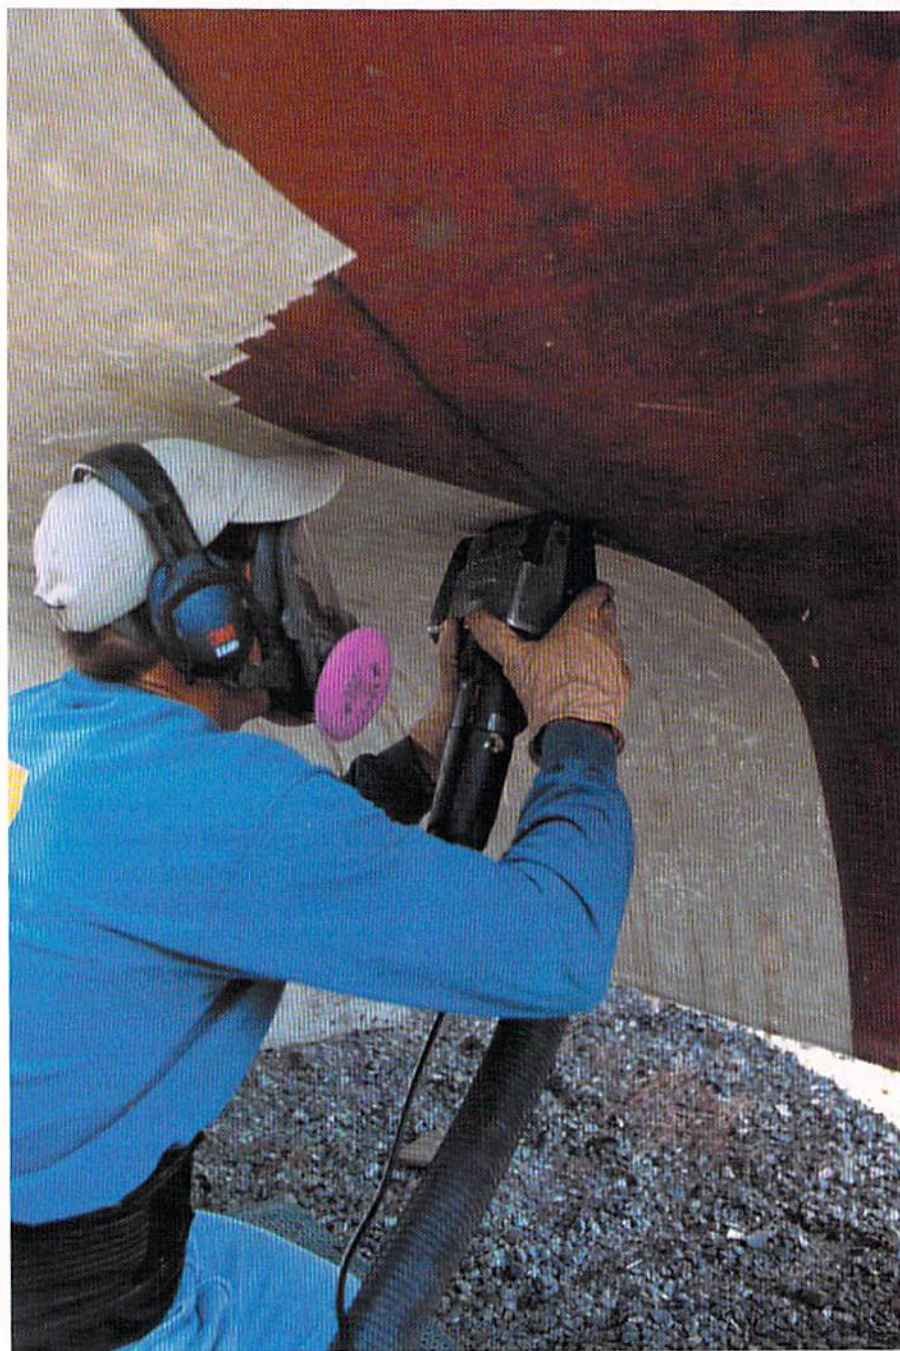
One step in the process of ensuring that blisters will not reoccur involves removing the "wet" or affected laminate. The most efficient and least invasive way of doing this involves using a planer-like tool, known as a peeler.

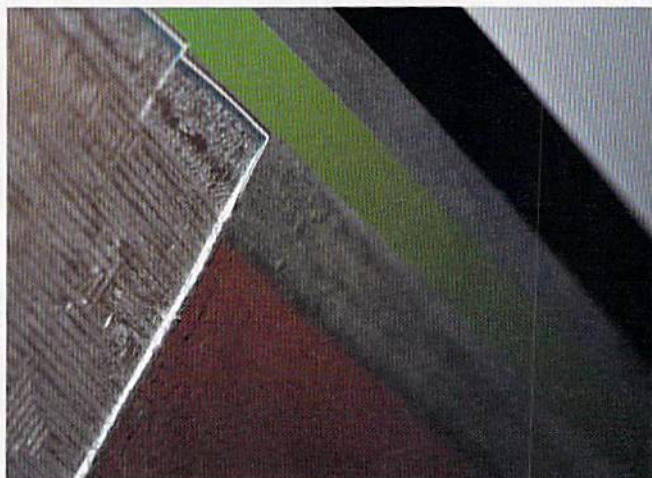
The final, and clearly destructive, test involves using a hole-saw to drill out a 1-inch core sample from the hull in one or more locations. (Because repair of a resulting

hole can be expensive, a seacock can be installed to fill the hole, whether or not osmosis repairs are undertaken.) This drilled-out core provides a 1-inch sample, or “coupon,” of the bottom that can then be sent to a laboratory that specializes in this type of analysis. The presence of moisture can be confirmed, laminate ply by laminate ply.

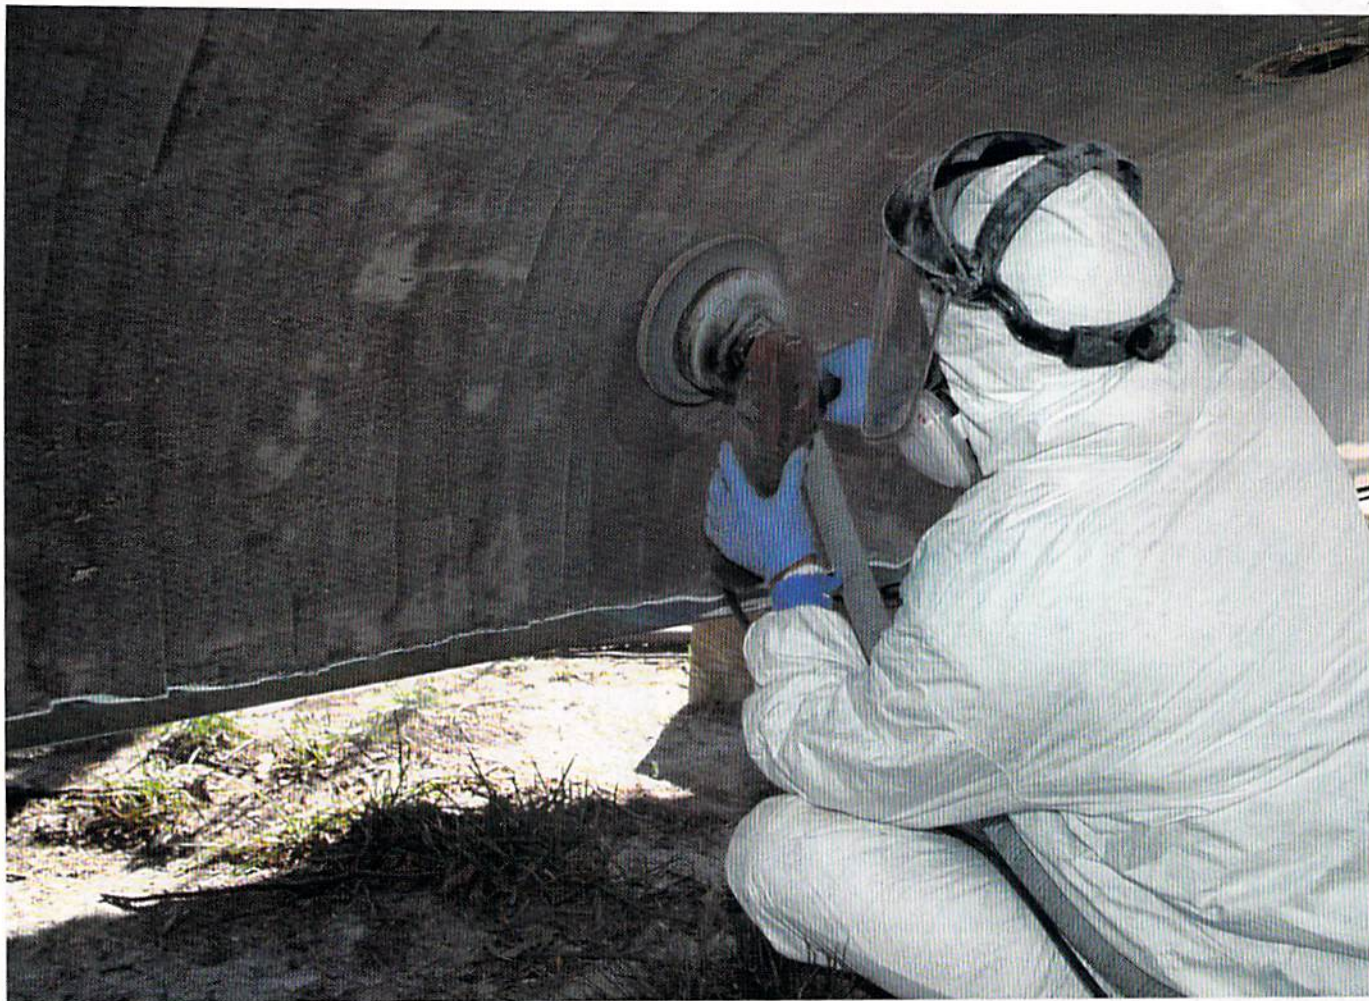
While the peeler removes the bulk of the affected laminate, the surface must still be dressed using a grinder. In the hands of an experienced professional, a grinder is a useful tool. The uninitiated, however, can quickly cause more harm than good if this tool is used incorrectly.

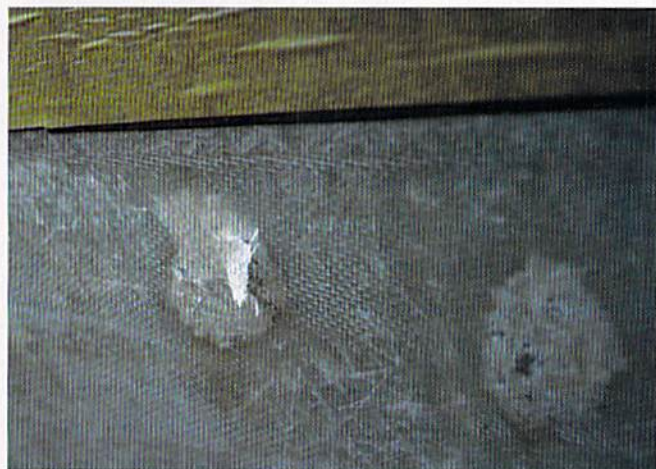
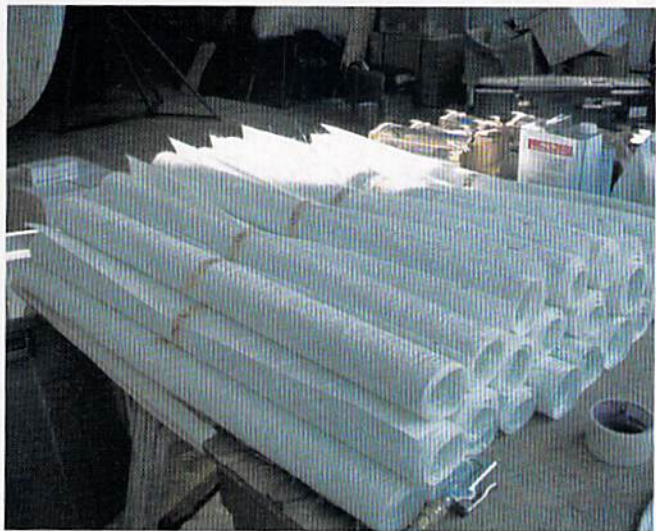
Top: After the first pass, one can clearly see that the blisters on this boat extend deep into the laminate. In this case, two passes with the peeler will be required in order to remove all the affected fiberglass. Above: Precut rolls of new fiberglass reinforcement ready to be applied to a recently peeled hull. Because the application is essentially carried out upside down, it is important that the applicator do as much premeasuring and cutting of the fabric as possible.

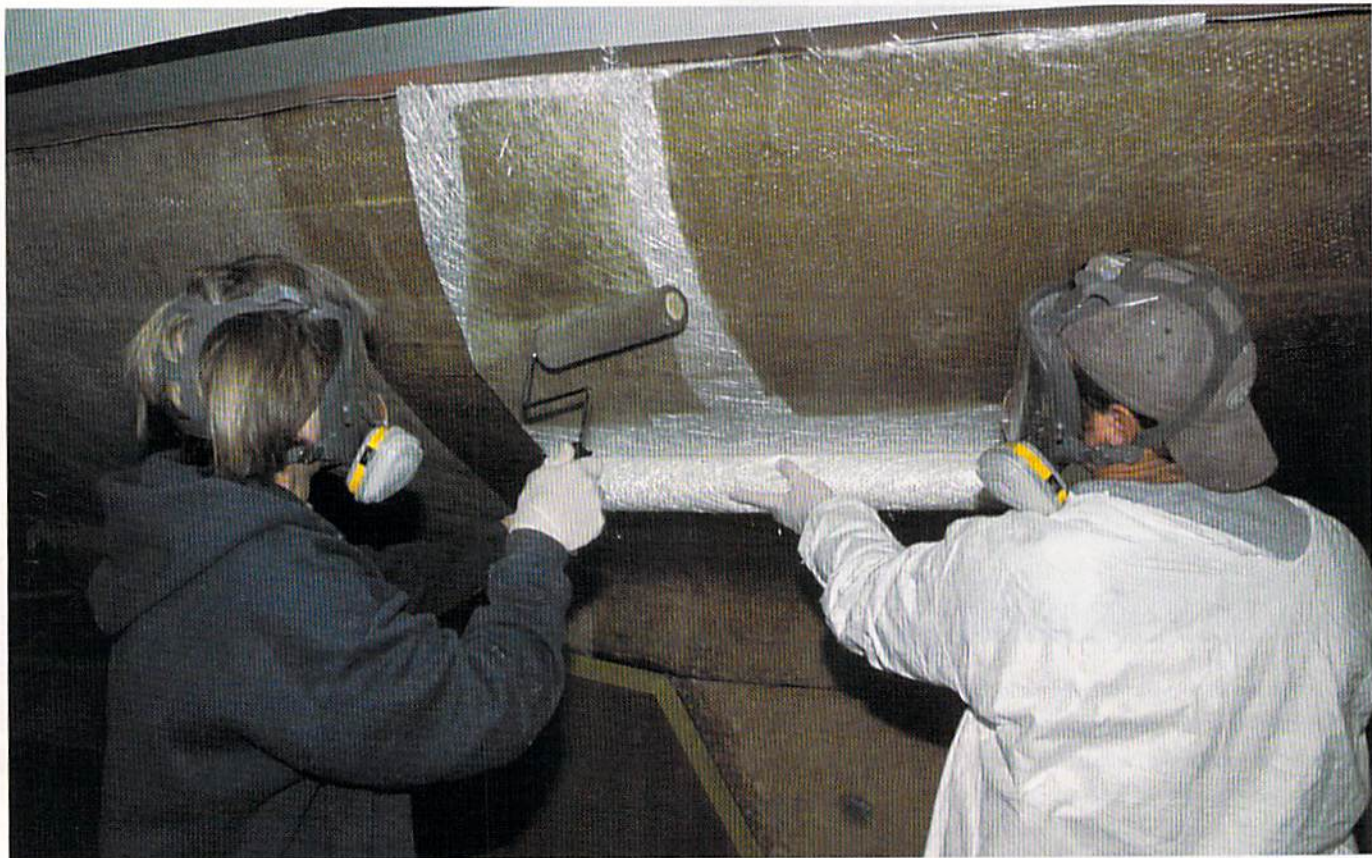
While a skilled pro can make it look easy, the relamination process is often difficult at best, requiring fiberglass technicians to essentially apply resin-soaked fiberglass reinforcement while working upside down.

After the hull has been peeled and properly prepared, a relaminating process using VE resin must use a minimum of two laminate layers—a minimum of 1/10 of an inch of laminate. This depth of applied material ensures that an appropriate exothermic reaction or heating, which is necessary for the resin's molecular chains to properly interlink, takes place. Ideally, the laminate that is removed should be exactly duplicated, once again to the previously stated minimums. Any FRP material that is removed must always be replaced. Although it is tempting to add a little more, chances are good that the naval architect who designed your boat knew what he or she was doing. The laminate schedule for the original construction was appropriate, and, therefore, is worthy of duplication. For the same reason,

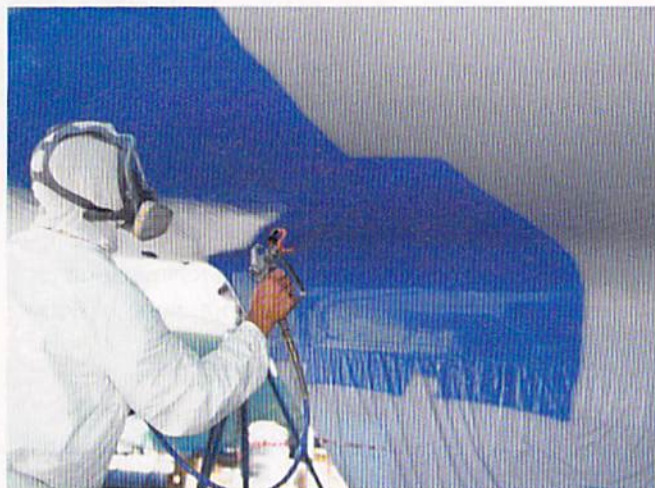
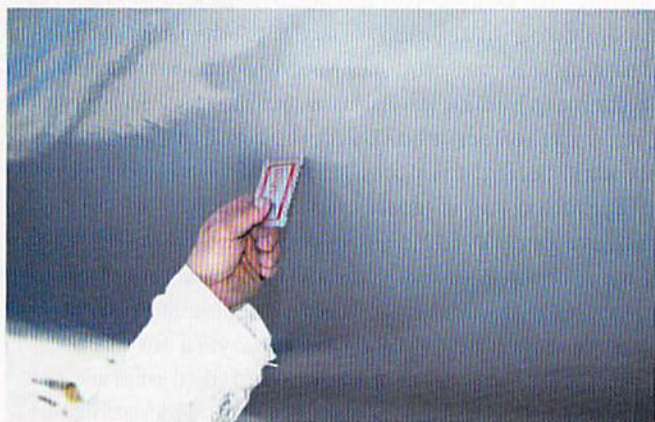
Top: Applying an epoxy barrier coat and then bottom paint using an airless sprayer ensures good coverage of both of these coatings, as well as an exceptionally smooth finish. Middle: The key to the proper performance of an epoxy barrier coat is its thickness. Here, a coating technician measures the millage of a coating as it's applied. Above: An epoxy barrier coat offers a formidable deterrent to water penetration. This can and should be used on all new vessels, as well as those that have undergone a proper blister repair.

The final step, and what may be termed the suspenders of a belt-and-suspenders approach, is the application of an epoxy barrier coat over the relaminated hull. My preference is for a high-solids, epoxy-based coating that comes with a warranty backed by a reputable manufacturer of marine products. Resist the temptation to use products for which manufacturers make incredible or fantastic claims. Instead, go with a proven performer who has a long-term track record of standing behind their product.

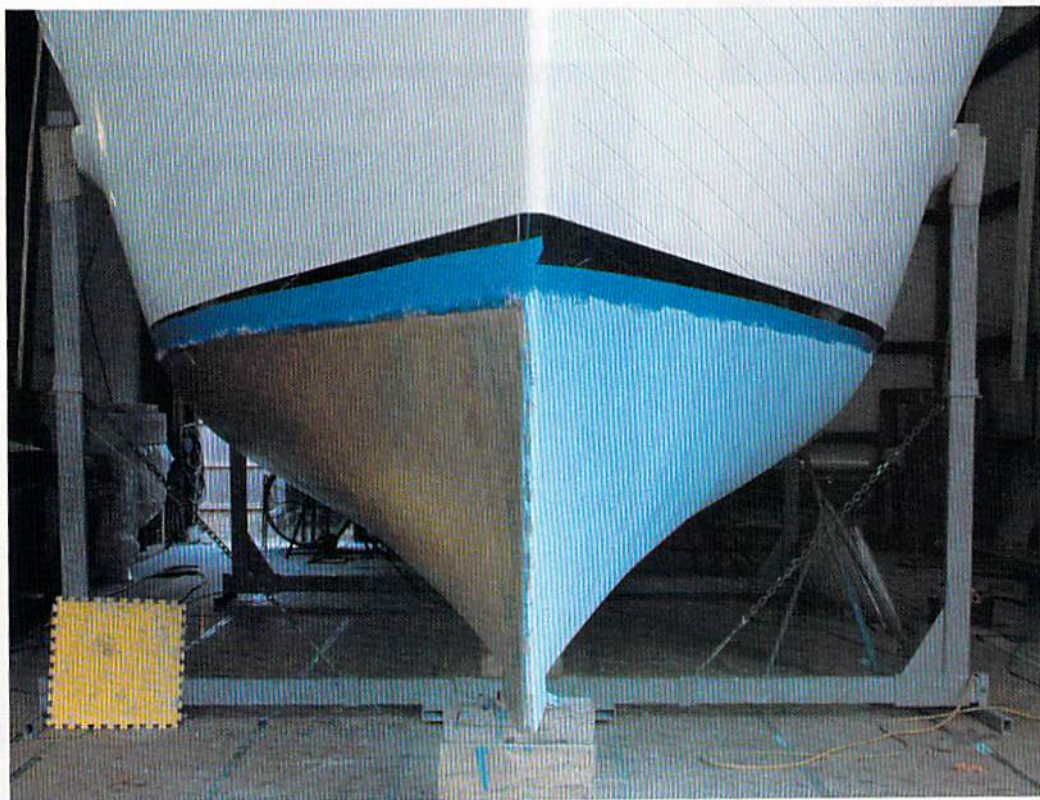
This trawler has had her bottom peeled and relaminated. The blue material seen on the port side is a vinylester fairing compound that improves sandability of the vinylester resin, which makes for an exceptionally smooth bottom. Also, notice the "bottom-free" stands, which support the vessel while the work is being done without interfering with the lamination.
