# Corrosion Evasion: Part 2

Corrosion risks in stainless steel and aluminum.

TEXT AND PHOTOGRAPHS BY STEVE D'ANTONIO

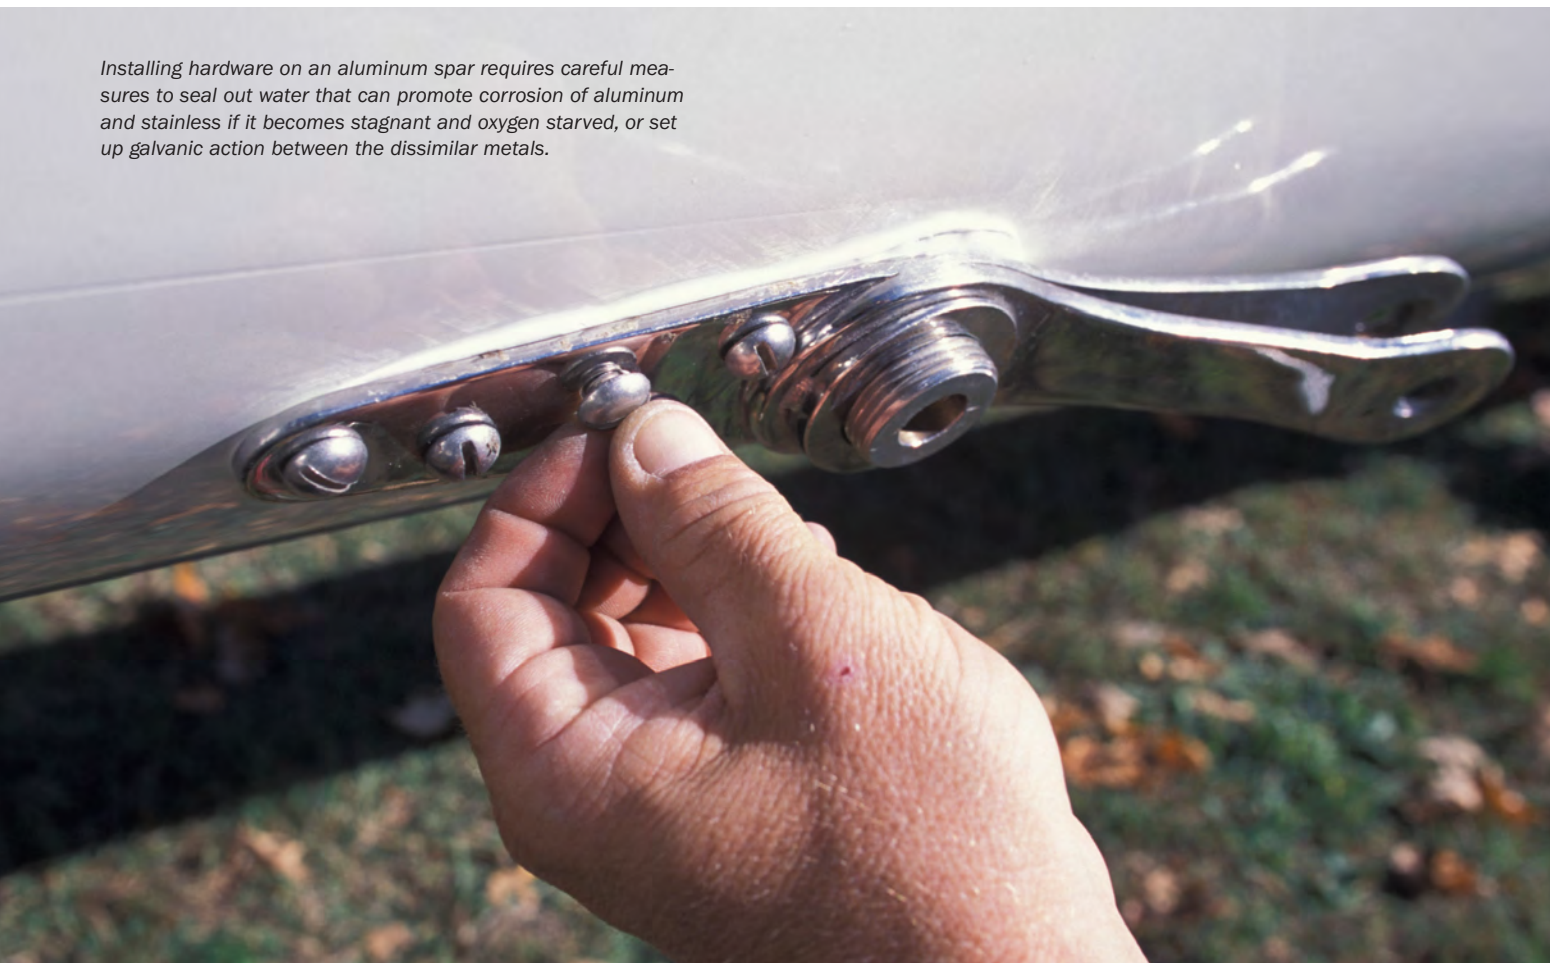
Installing hardware on an aluminum spar requires careful measures to seal out water that can promote corrosion of aluminum and stainless if it becomes stagnant and oxygen starved, or set up galvanic action between the dissimilar metals.

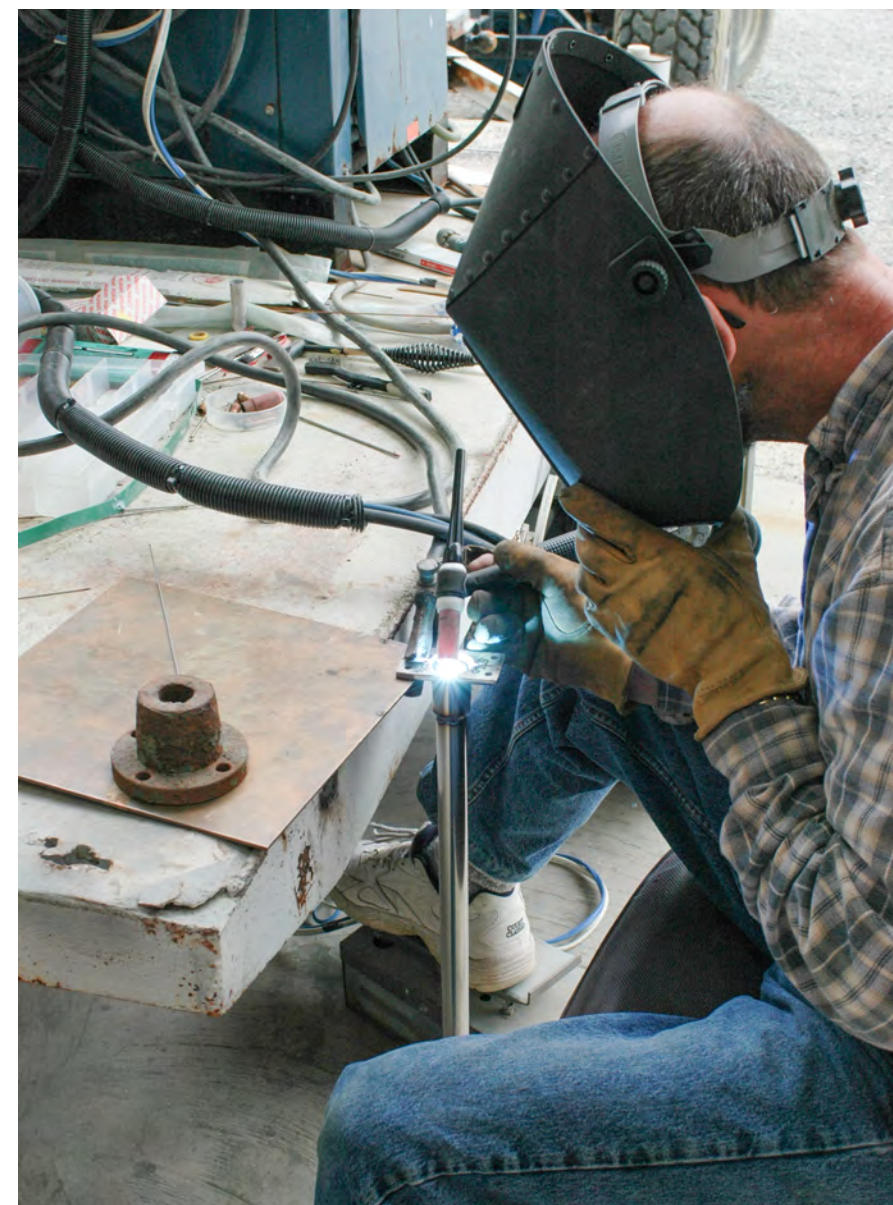
To prevent carbide precipitation, and the corrosion it can facilitate, stainless steel that is to be welded must be of the low-carbon variety, typically identified by an L suffix, such as 304L or 316L.

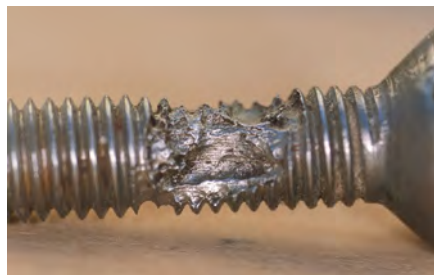
**Top**—Where stagnant water is in persistent contact with a stainless fastener, pitting and crevice corrosion will set in. **Bottom**—Crevice corrosion can manifest as "worm holes" even in shaft-grade stainless steel where bearings and stuffing boxes keep oxygenated water from circulating.

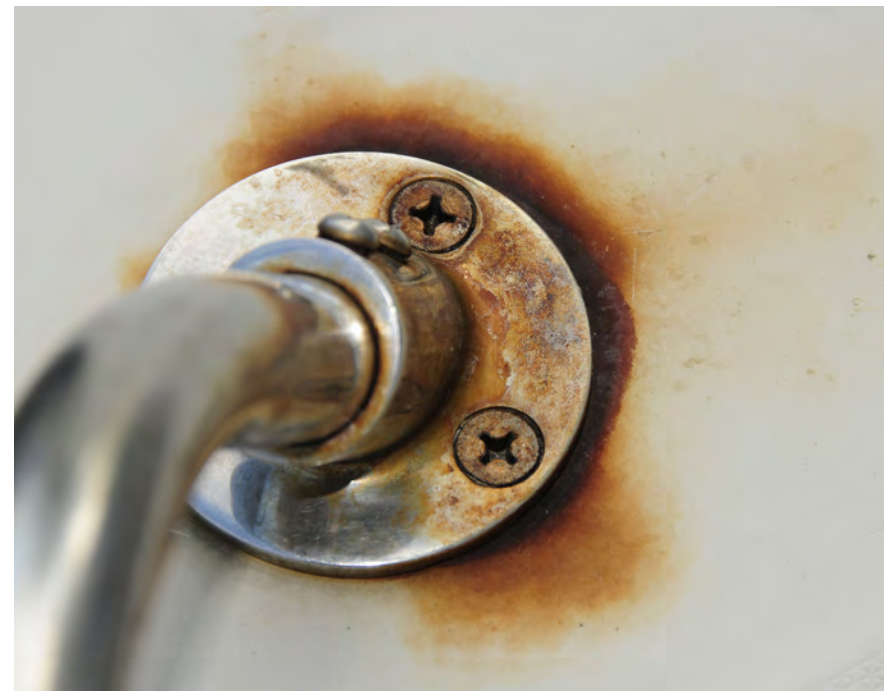
Deck hardware and fittings in 304 stainless steel are particularly vulnerable to "tea staining," where water can stagnate around fasteners and flanges. Cleaning and rebedding hardware is the best solution.

The solution for this problem involves hardware removal, thorough cleaning, dewaxing/degreasing with solvent, and fully bedding the reinstalled hardware in sealant. That means applying bedding compound not only to the areas where fasteners pass through the hardware but to the entire faying surface of a cleat, port light trim ring, grab rail flange, chock, or any other hardware. The bedding compound should squeeze out around the entire perimeter to create a watertight seal and exclude water that could migrate beneath the hardware base. Water exclusion is the key to preventing staining.

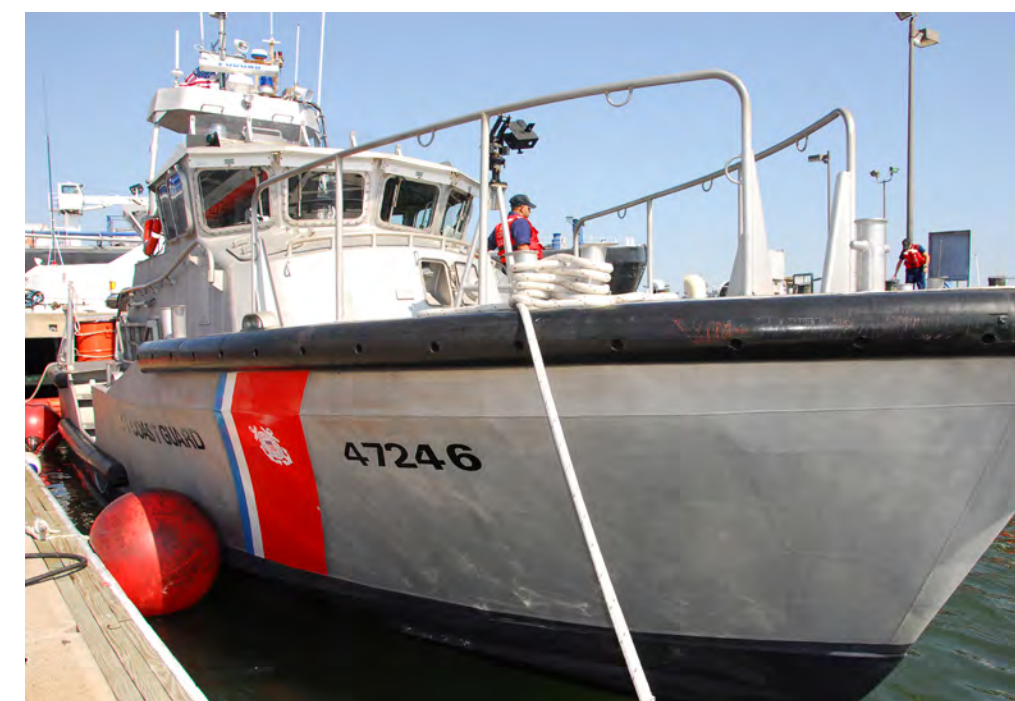
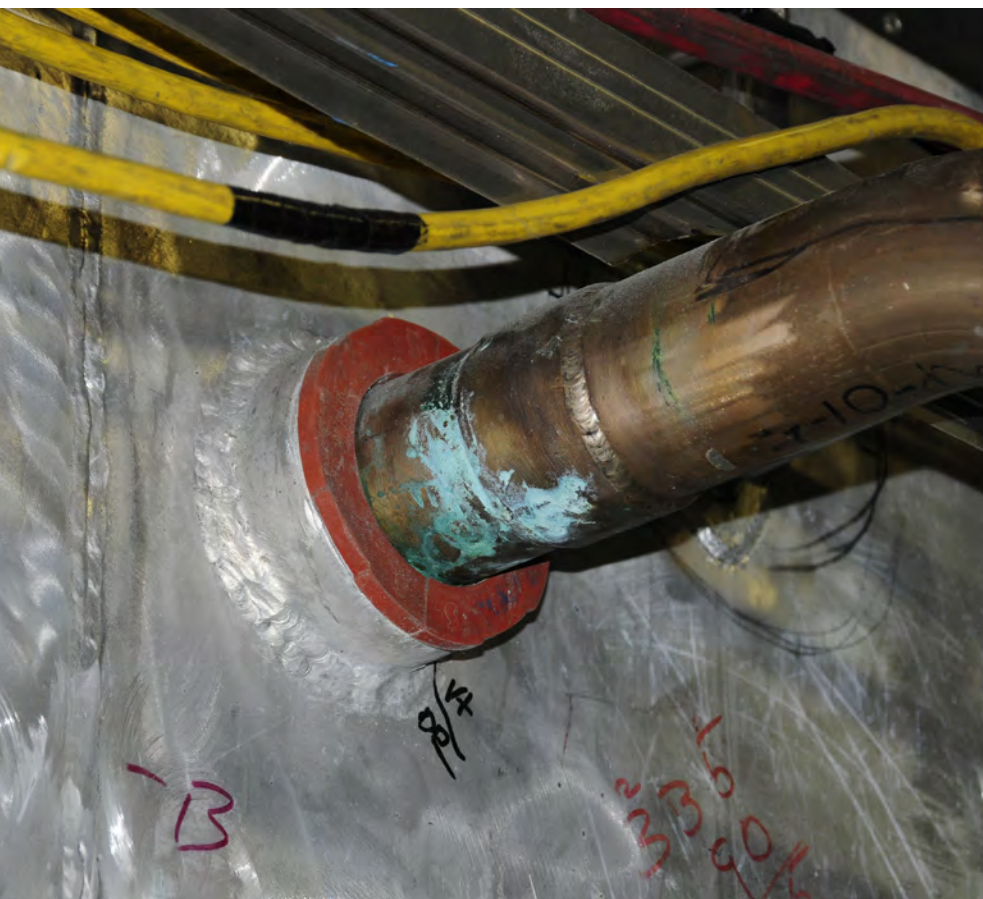
*Aluminum and copper-based alloys don't mix. Where they must be part of an onboard system or structure, it's vital that they be isolated from one another by a nonmetallic bushing or sleeve.*

Copper and copper alloys, including brass and bronze, are located further from aluminum in the series, and are therefore far more harmful; they are considered entirely incompatible with aluminum. A bronze pump, for instance, mounted directly to an aluminum base plate, is a serious corrosion faux pas.

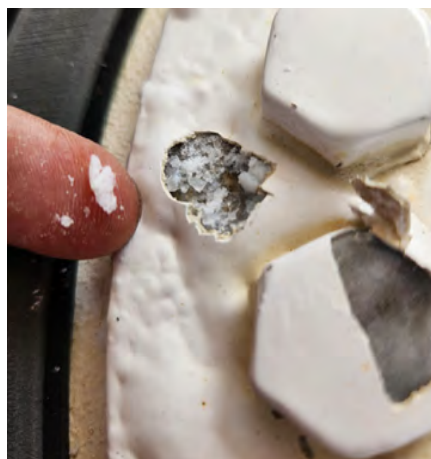
*At breaches in the paint, water held against the underlying aluminum causes corrosion-forming aluminum hydroxide, a white byproduct.*

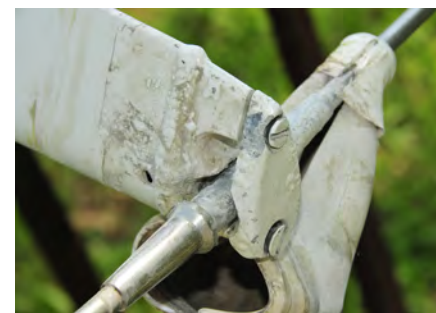
*Aluminum sailing rig hardware kept in a moist environment under the rubber spreader boots is particularly vulnerable to corrosion.*

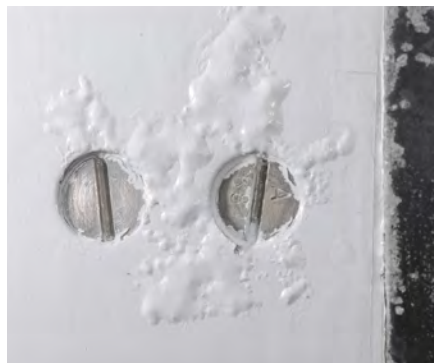
Minute flaws in coatings around fastener penetrations are common initiation points for corrosion of painted aluminum components.

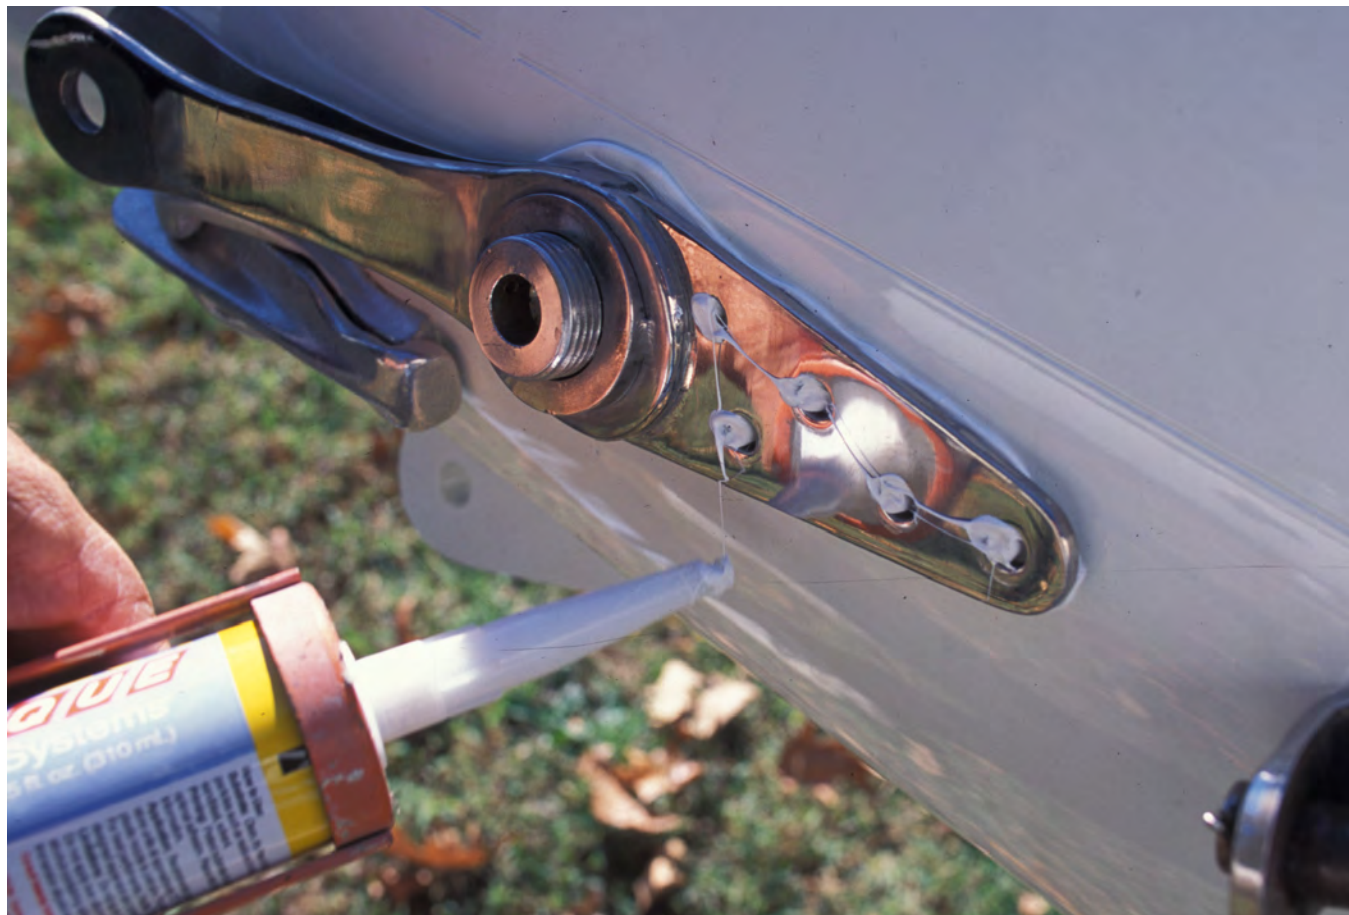
After cleaning painted spar and mounted component surfaces, bedding hardware and fasteners in durable sealant minimizes the risk of paint failure and metal corrosion.

Service yards and boat operators must be vigilant, and any paint abrasion, compromise, or failure should be coated with a resilient, pliable sealant to prevent water intrusion. Specifically, around hardware installations, after both surfaces are dewaxed/degreased using a solvent such as mineral spirits, all hardware should be liberally bedded using a sealant. These measures render the paint "wound" inert by keeping water out.
