July 2025 Newsletter – Risers and Siphon-Breaks

Photo Essay: The Perils of an Unvented Loop

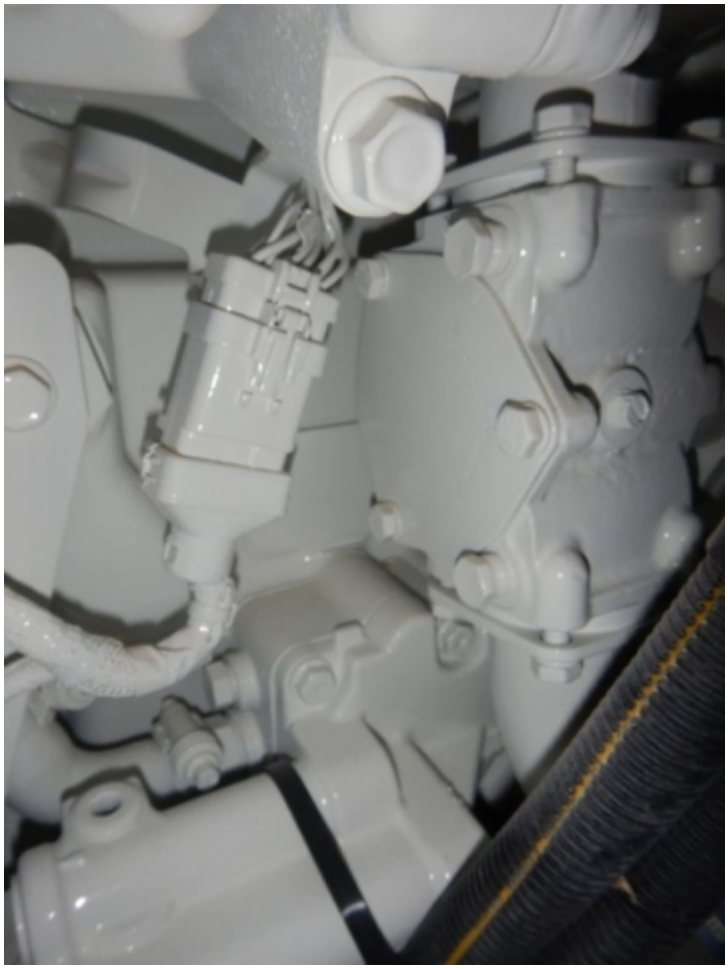
Raw water pump cam screw failures

I’ve now encountered three such failures of the screw that secures the pump’s cam in about the last 12 months, and I have heard about others, all on low hour engines. When this occurs, the pump stops pumping and a stream of water squirts from the hole left by the broken screw. One of those shown here occurred on a vessel that is less than a year old, in the other case the engine had less than 300 hrs. (a wing engine on a trawler).

Thus far I have only seen this on Sherwood pumps.

In my opinion, under normal conditions this screw should never break, it is not under much of a load. I have taken this up with Sherwood/Pentair in an attempt to determine the cause.

My recommendation is to inspect your screw regularly, although I’m not sure if you would be able to see signs of an impending failure; have a replacement cam and screw on hand, and potentially change yours preemptively (cams should be replaced about every third impeller change, or if wear/corrosion is evident). If you opt to change, closely inspect the cam to make sure it is properly seated inside the pump, and be sure to follow the installation instructions, a sample of which are included here (yours may be different, so check based on model number).
