June 2025 Newsletter – Fan Belt Shedding

Photo Essay: Fan Belt Shedding

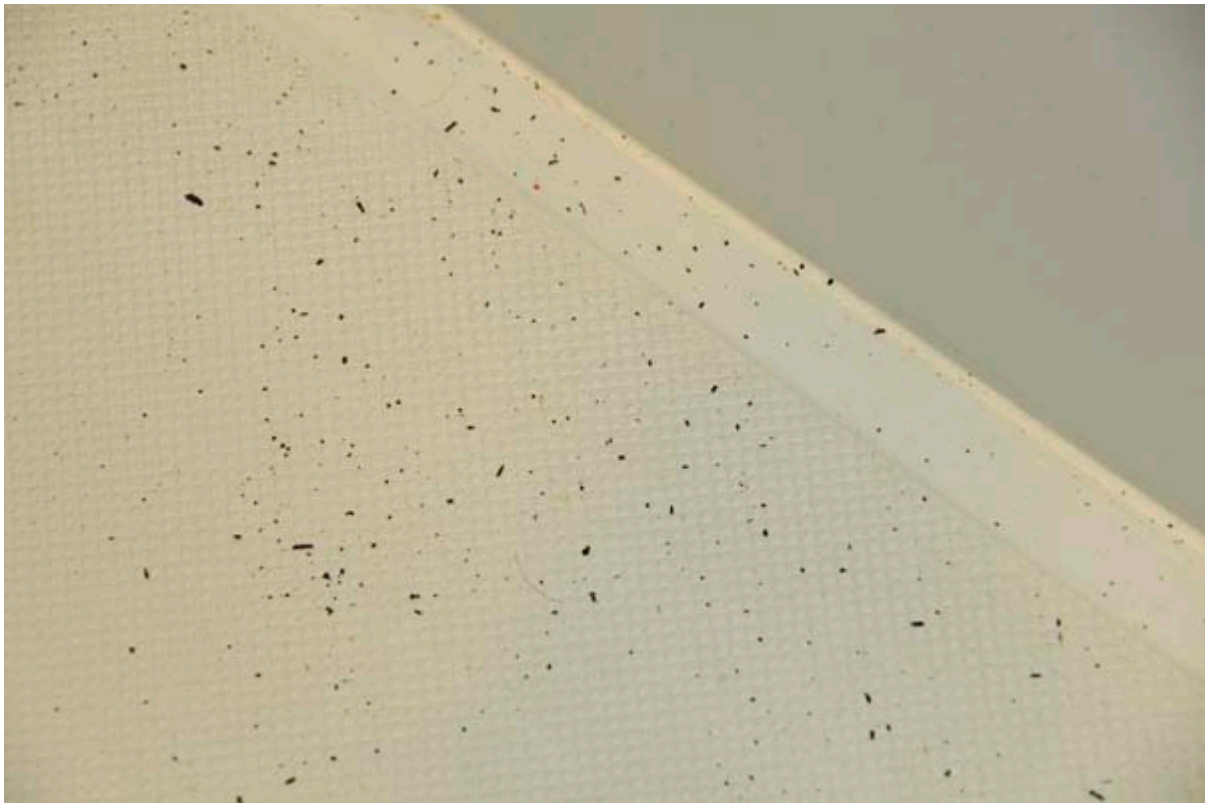
Over-worked or over-loaded serpentine belts, on the other hand, will frequently generate small particles, what are often described as ‘chips’, of belt material. This can occur when the self-tensioning device oscillates, a phenomenon which is

visible, in an effort to compensate for belt over-loading. This phenomenon can also be caused by inadequate “wrap”, i.e., how much of the belt engages the alternator’s pulley If this engagement is too small, the belt is more likely to slip or chatter.

In the attached images, an engine equipped with twin 200-amp, 24-volt alternators, and a large battery bank, is generating these chips. The problem can sometimes be resolved by switching to a heavy duty “emergency vehicle” belt. One belt manufacturer, Gates Industrial Corp., offers just such a belt, which they call a FleetRunner. In other cases, a new tensioner may be needed. However, before any changes are made, the crankshaft, accessory, idler and tensioner pulleys should all be closely inspected for damage, dents, nicks or other anomalies (even excessive paint), any of which can damage the belt, and create chip-like debris. If your belt is generating dust, or chips, if it squeals, or if it has taken on a glazed appearance, don’t ignore these precursors to an impending belt failure.
