# The Ins and Outs of Cored Composite Construction

### Hardware Installation

By Steve D'Antonio  
Copyright July 2013

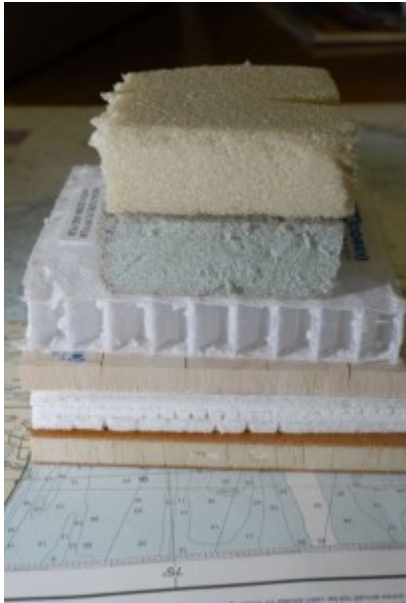
***Core is available in a wide range of materials, from synthetic foam and honeycomb to balsa and plywood.***

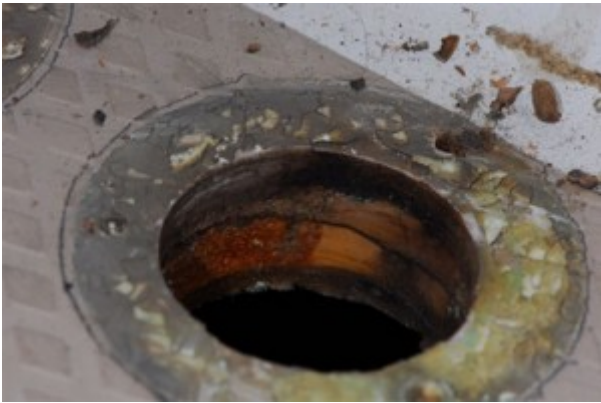
***When core material, wood in this case, is visible at a deck "penetration", such as this fuel fill, the only thing standing between it and water saturation is sealant. Sealant, even by most manufacturers' own admission, has a finite life of no more, and often less, than ten years. And, don't be fooled by the thin coating of resin on this core material, it is far too delicate to prevent water entry and does nothing to prevent water from entering through fastener holes, visible around the perimeter.***

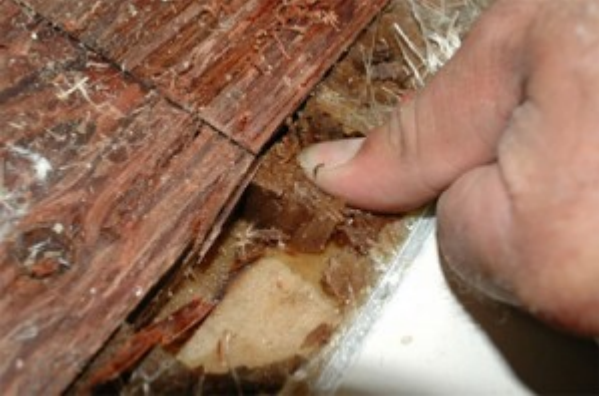
*This flybridge deck has been cored with a mixture of small plywood blocks and end grain balsa, which is both saturated and decaying. While other core materials exist, ones that are less prone to water absorption, the failure is a result of execution rather than material selection; the core was not properly closed out.*

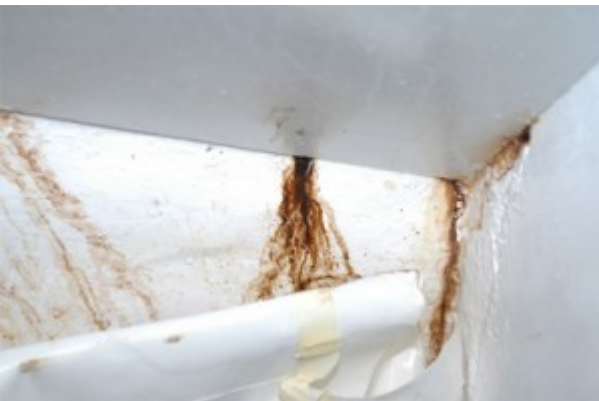
*The telltale brown "coffee stain", it's not a pretty sight and it nearly always bodes poorly for the vessel and its owner. Proper core repairs are nearly always expensive, nearly always more expensive than the preventive measures.*

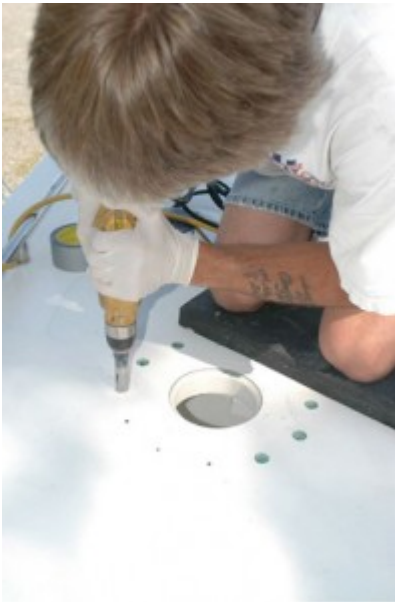
***Drilling oversized holes in a cored composite structure...***

Ideally, when your boat was built the naval architect detailed where each piece of deck or hull hardware would be installed. Knowing this, the builder laminated into these areas either solid fiberglass or special high density core that's designed for this purpose. Then, the folks drilling the holes on the shop floor installed the hardware using the accepted method of measure, drill, apply sealant and install. However, this is often not the case. Naval architects fail to specify, and/or builders fail to install, these special hardware pads during the lamination process, or hardware is added after the design is complete or years after the boat is delivered. In either case, another approach is required. A thumbnail sketch of the preferred procedure follows; it's one you, the builder of your boat, or your boat yard of choice should follow whenever a cored composite structure is penetrated for hardware installation. After the location for the hardware is determined, mark and drill the holes for the fastener to be used. Then, re-drill only the outer skin hole about half again as large as the previous size. For example, a 1/4 (.25)" hole would be re-drilled to 3/8 (.375)". Dig or, "reef" out the core material for a distance of about 1/2 (.50)" around the inside of the hole

using a pick or a bent nail or Allen wrench chucked into a drill (be sure to wear eye protection). Cover the lower hole from inside the cabin, deck or hull with masking tape and then fill the void using epoxy thickened to the consistency of mayonnaise (West System and 406 or 404 filler works well). This is often referred to as backfilling, or as a procedure boat yard folks call it reefing and backfilling. Apply the epoxy slowly using a small brush or syringe to prevent air entrapment. (For especially deep holes, the void may have to be filled in two "pourings". When epoxy cures it creates an exothermic reaction, it releases heat, if that heat is unable to dissipate because the pool of epoxy is too deep, it could overheat, damaging the surrounding fiberglass and/or core, or it may even catch fire.)

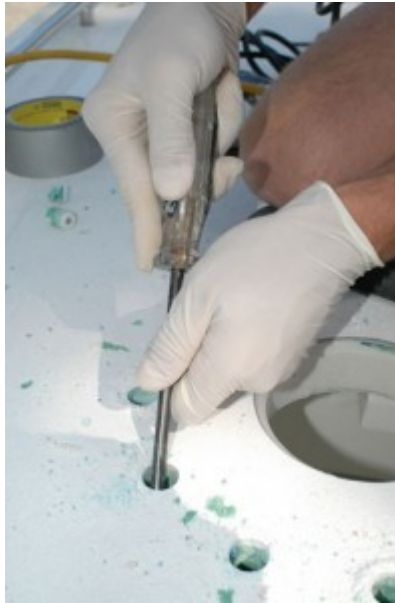
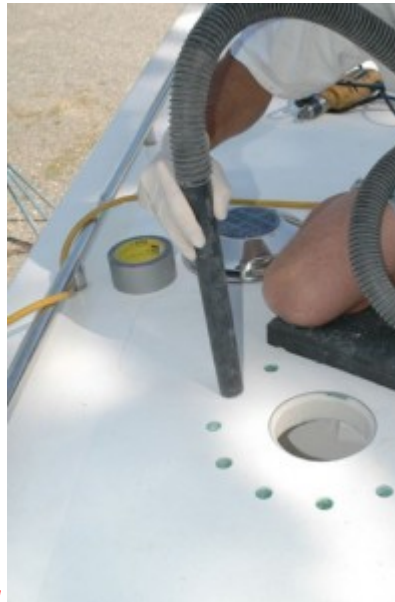
*...reefing out the core material  
the loose core material.*

*Vacuuming out*

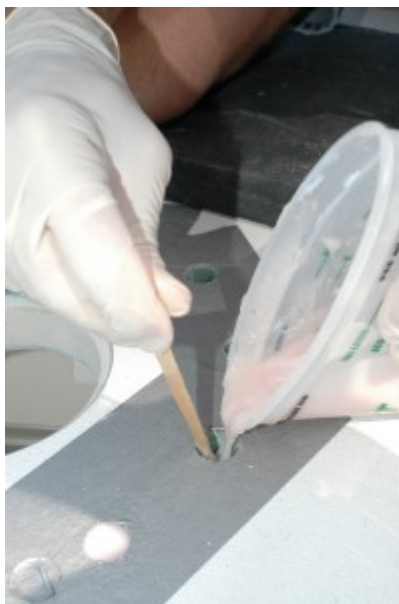
*Filling the holes with thickened epoxy.*

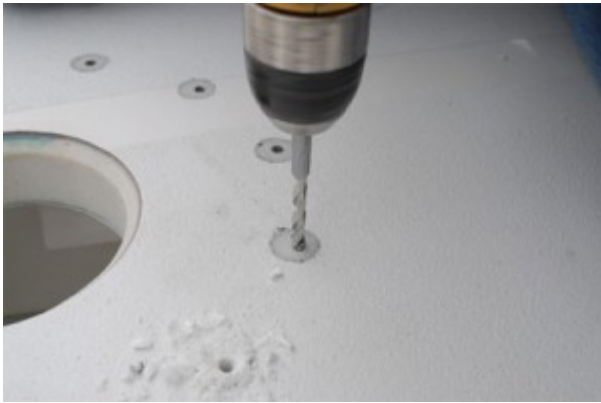
***Re-drilling through the cured***

Once the epoxy has fully cured, re-drill both holes slightly oversized and chamfer the edges of the outer hole to create a land or recess for sealant. A  $\frac{1}{4}$  (.25)" fastener would call for a  $\frac{5}{16}$  (.3125)" hole. Now, wipe the area down with a damp rag to remove amine blush, a water soluble wax that forms on the surface of cured epoxy. Solvent is not necessary for *this* wax and it should not be used. Then, wipe the hardware to be installed *and the fasteners*, as well as fiberglass or gelcoat, with a clean rag moistened with 3M General Purpose Adhesive Cleaner to remove wax, oil and other contaminants.

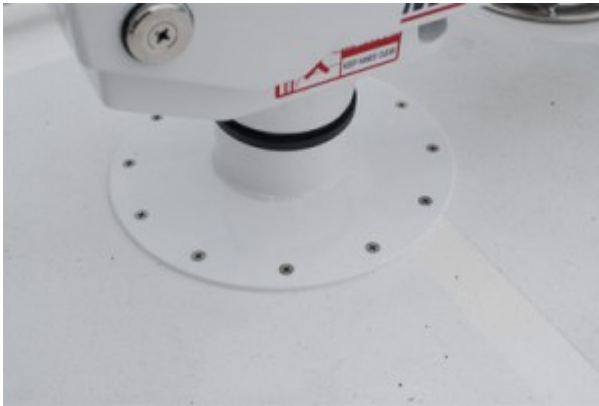
***epoxy. The finished product, this crane has been installed in a manner that precludes water entry into the core. If, when, the bedding fails water may leak past the fasteners or stand pipe, however, it will not enter the core.***

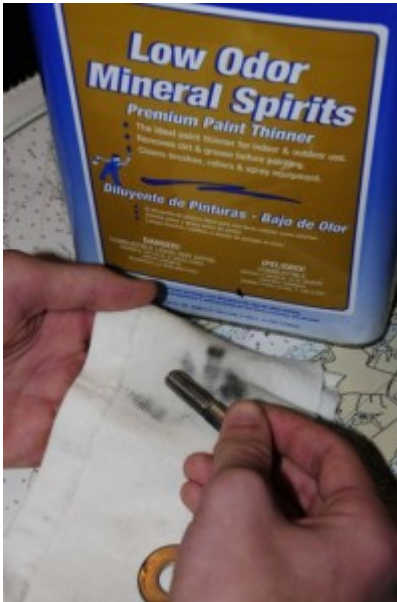
***Degreasing, de-waxing or de-oiling is among the most important preparatory steps for hardware bedding.***

Solvent must be used in this case because these contaminants are not water soluble. Ideally, hardware should not be bedded over non-skid surfaces. In practice, particularly for after-market hardware installations, this may be unavoidable. When it is, every effort should be made to thoroughly clean and free non-skid of dirt, debris and especially wax. Doing so may require the use of a stiff plastic bristle brush and solvent.

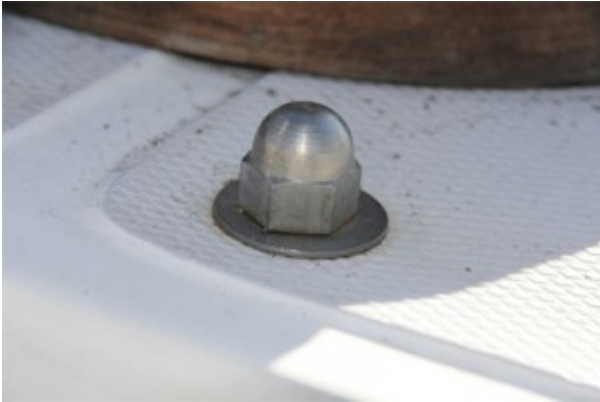
***This through bolt is compressing and crushing the core within this cored composite structure. If the laminate was solid in this area, if high density core material had been used, or if it had been reefed and back-filled, this failure would not have occurred. Make no mistake about it, this structure is now compromised, it is weaker and more prone to water penetration.***

With this approach, you've achieved two ends. One, you've virtually eliminated the possibility of water entry into the core at the fastener penetration. Two, and just as importantly, the epoxy annulus prevents the fastener from crushing the core (a quarter inch fastener can exert over 500 pounds of pressure on the core, four closely spaced fasteners could apply a ton of force). If the fastener crushes the core it will almost certainly lead to water ingress because of the funnel-like depression that's created.

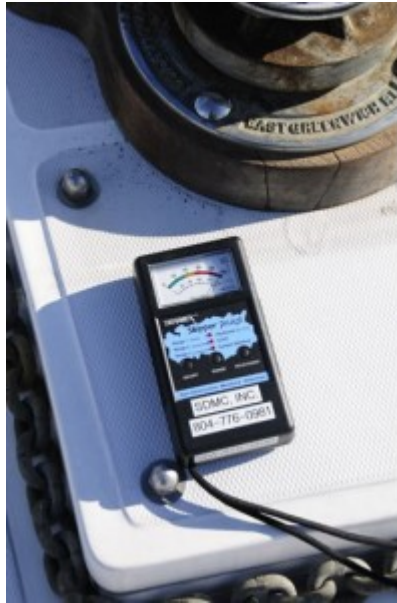
***Water is most likely to penetrate cored structures adjacent to hardware installations, particularly those that are highly stressed.***

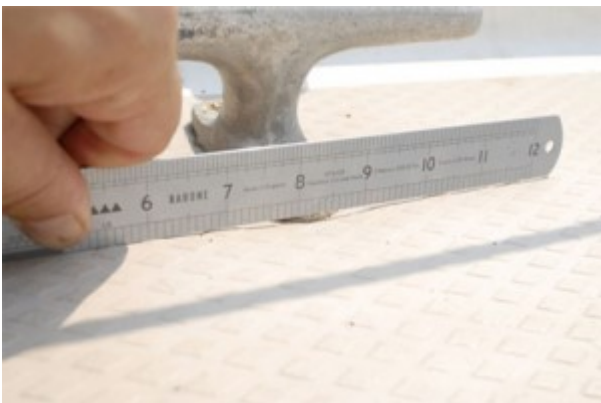
***This cleat is installed in a cored composite deck without the benefit of high density core or reefing and back filling. As a result, the core has been crushed, creating a depression, in which water will accumulate, where it will ultimately find its way into the core.***

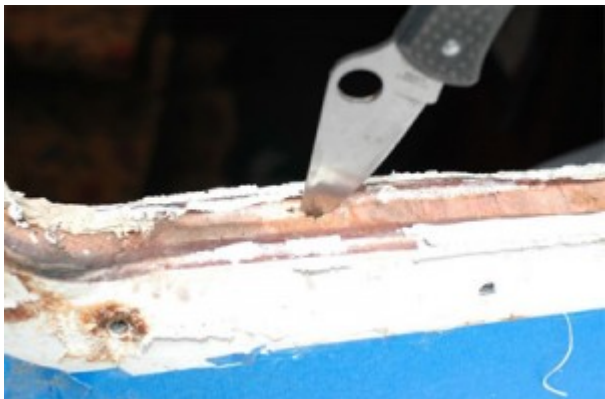
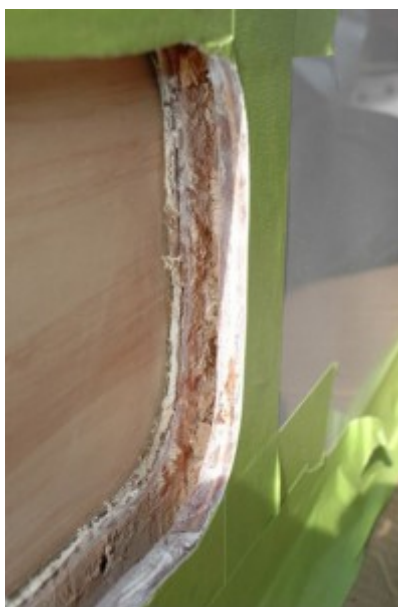
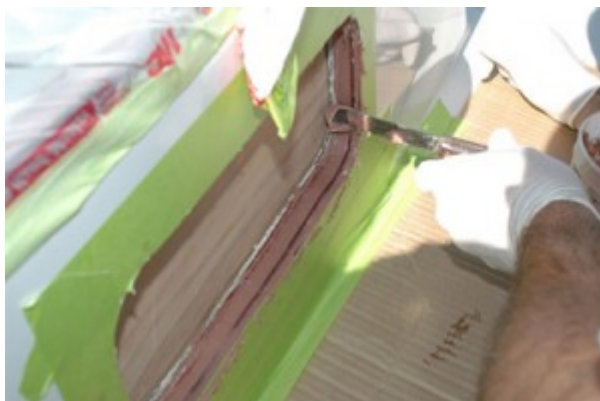
***Whenever a cored composite structure is penetrated, water penetration, and localized crushing, can be avoided by following the closeout procedure. If water does enter in improperly closed out structure, the repair process, depicted in the images above, is as follows...wet and decayed core; reefed out core; epoxy back-filling and cured epoxy filler.***
