# The Ins and Outs of Cored Composite Construction

### Hardware Installation

By Steve D'Antonio  
Copyright July 2013

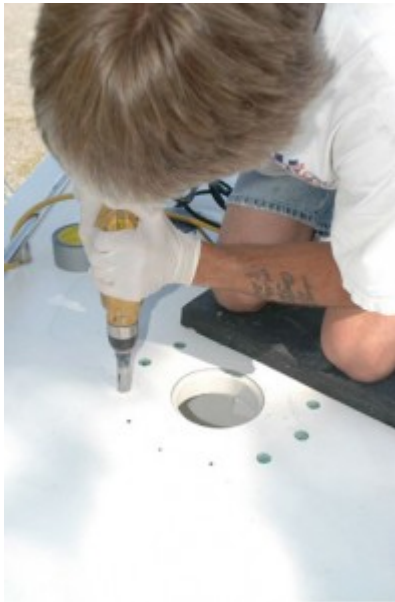
***Drilling oversized holes in a cored composite structure...***

Ideally, when your boat was built the naval architect detailed where each piece of deck or hull hardware would be installed. Knowing this, the builder laminated into these areas either solid fiberglass or special high density core that's designed for this purpose. Then, the folks drilling the holes on the shop floor installed the hardware using the accepted method of measure, drill, apply sealant and install. However, this is often not the case. Naval architects fail to specify, and/or builders fail to install, these special hardware pads during the lamination process, or hardware is added after the design is complete or years after the boat is delivered. In either case, another approach is required. A thumbnail sketch of the preferred procedure follows; it's one you, the builder of your boat, or your boat yard of choice should follow whenever a cored composite structure is penetrated for hardware installation. After the location for the hardware is determined, mark and drill the holes for the fastener to be used. Then, re-drill only the outer skin hole about half again as large as the previous size. For example, a 1/4 (.25)" hole would be re-drilled to 3/8 (.375)". Dig or, "reef" out the core material for a distance of about 1/2 (.50)" around the inside of the hole

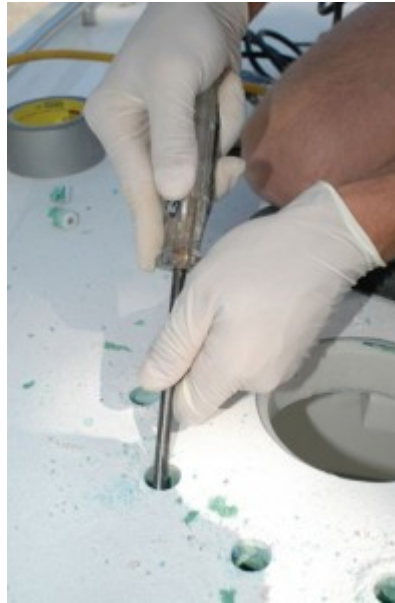
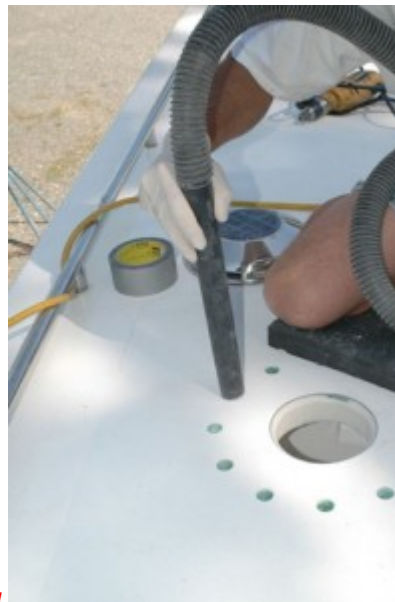
*...reefing out the core material  
the loose core material.*

*Vacuuming out*

using a pick or a bent nail or Allen wrench chucked into a drill (be sure to wear eye protection). Cover the lower hole from inside the cabin, deck or hull with masking tape and then fill the void using epoxy thickened to the consistency of mayonnaise (West System and 406 or 404 filler works well). This is often referred to as backfilling, or as a procedure boat yard folks call it reefing and backfilling. Apply the epoxy slowly using a small brush or syringe to prevent air entrapment. (For especially deep holes, the void may have to be filled in two "pourings". When epoxy cures it creates an exothermic reaction, it releases heat, if that heat is unable to dissipate because the pool of epoxy is too deep, it could overheat, damaging the surrounding fiberglass and/or core, or it may even catch fire.)

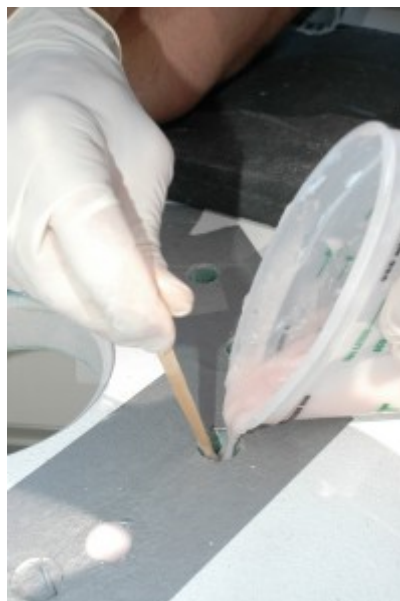
*Filling the holes with thickened epoxy.*

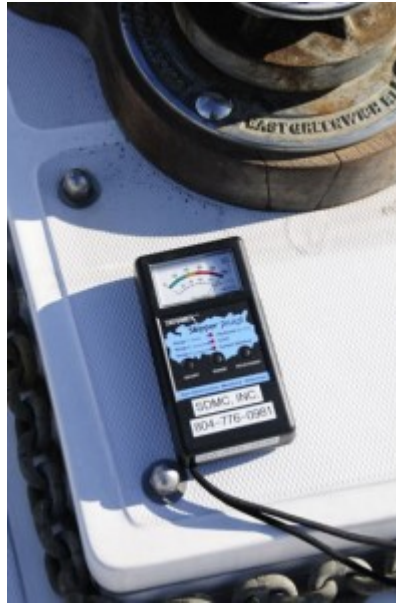
***Water is most likely to penetrate cored structures adjacent to hardware installations, particularly those that are highly stressed.***

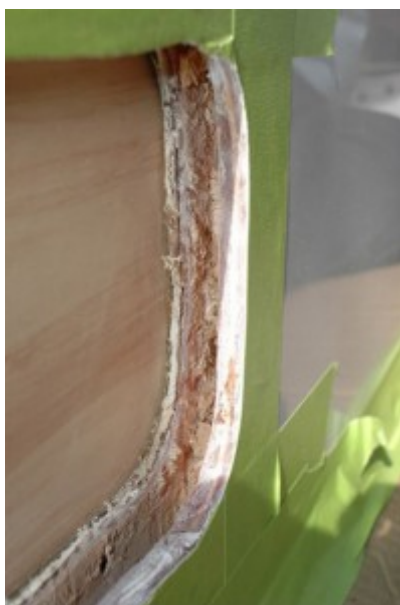
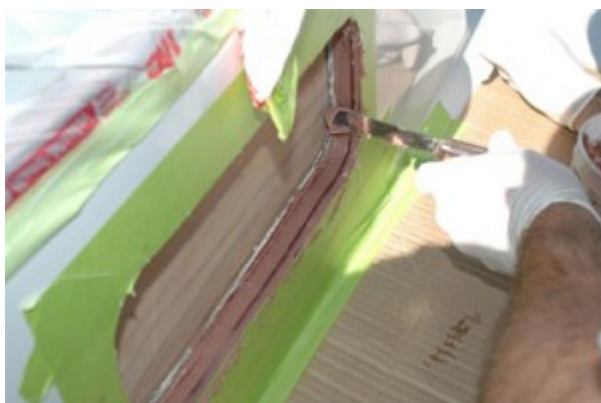
*Whenever a cored composite structure is penetrated, water penetration, and localized crushing, can be avoided by following the closeout procedure. If water does enter in improperly closed out structure, the repair process, depicted in the images above, is as follows...wet and decayed core; reefed out core; epoxy back-filling and cured epoxy filler.*
