# Editorial: Engine Room Fire; Lessons Learned – Feature: Compression and Leak-Down Testing

## Compression and Leak-Down Testing

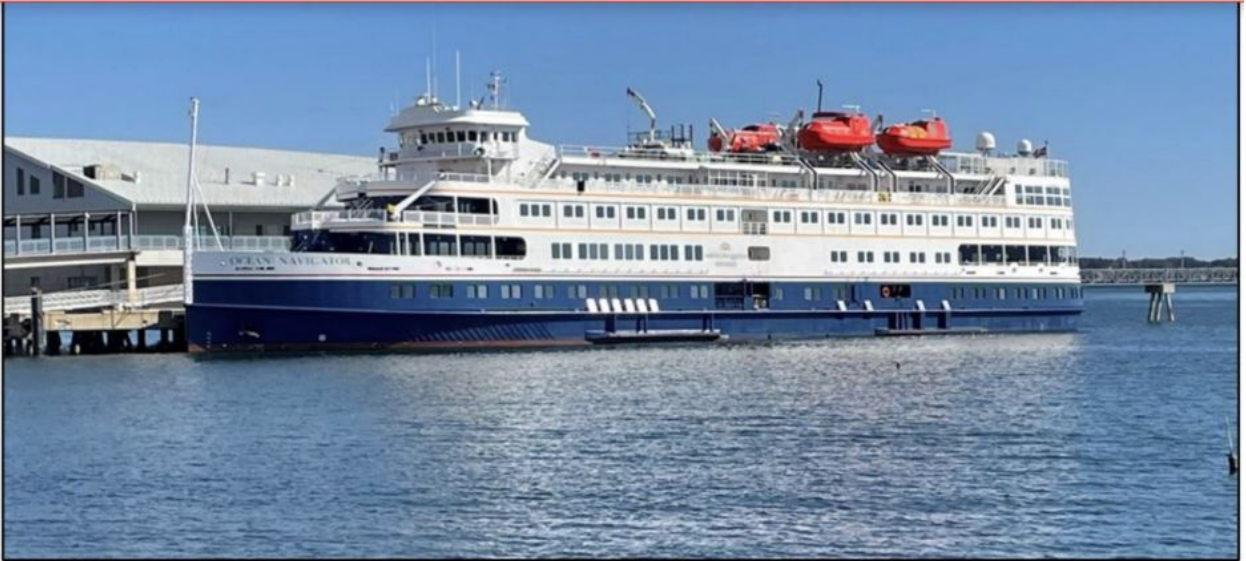
The Ocean Navigator docked in Portland, Maine on October 19, 2023, after the fire. Photo via NTSB

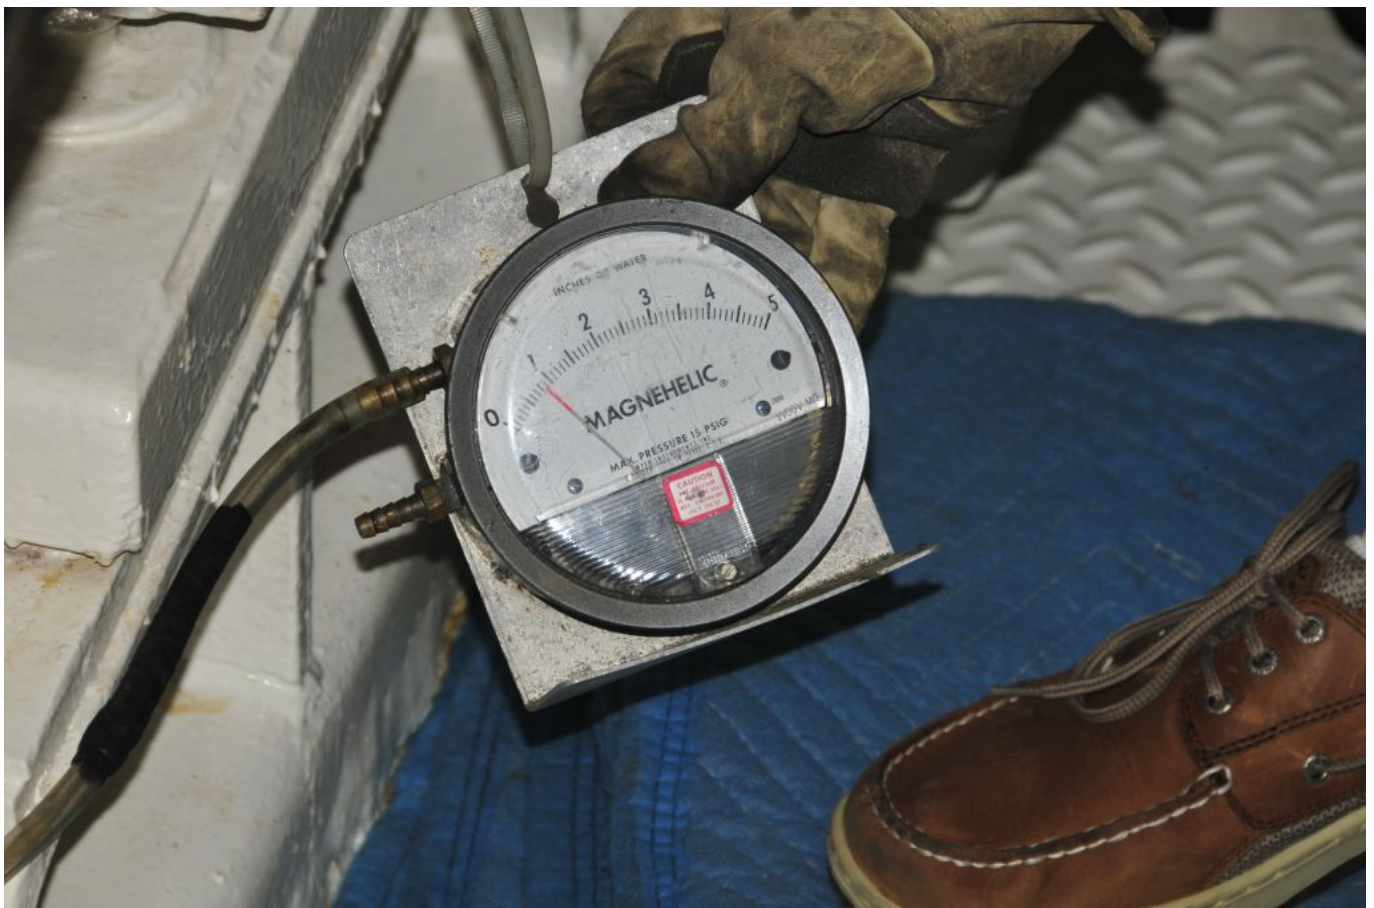
**A manometer is a tool that can be used to measure crankcase pressure, which in turn is an indication of the condition of the engine's piston rings and cylinder walls.**

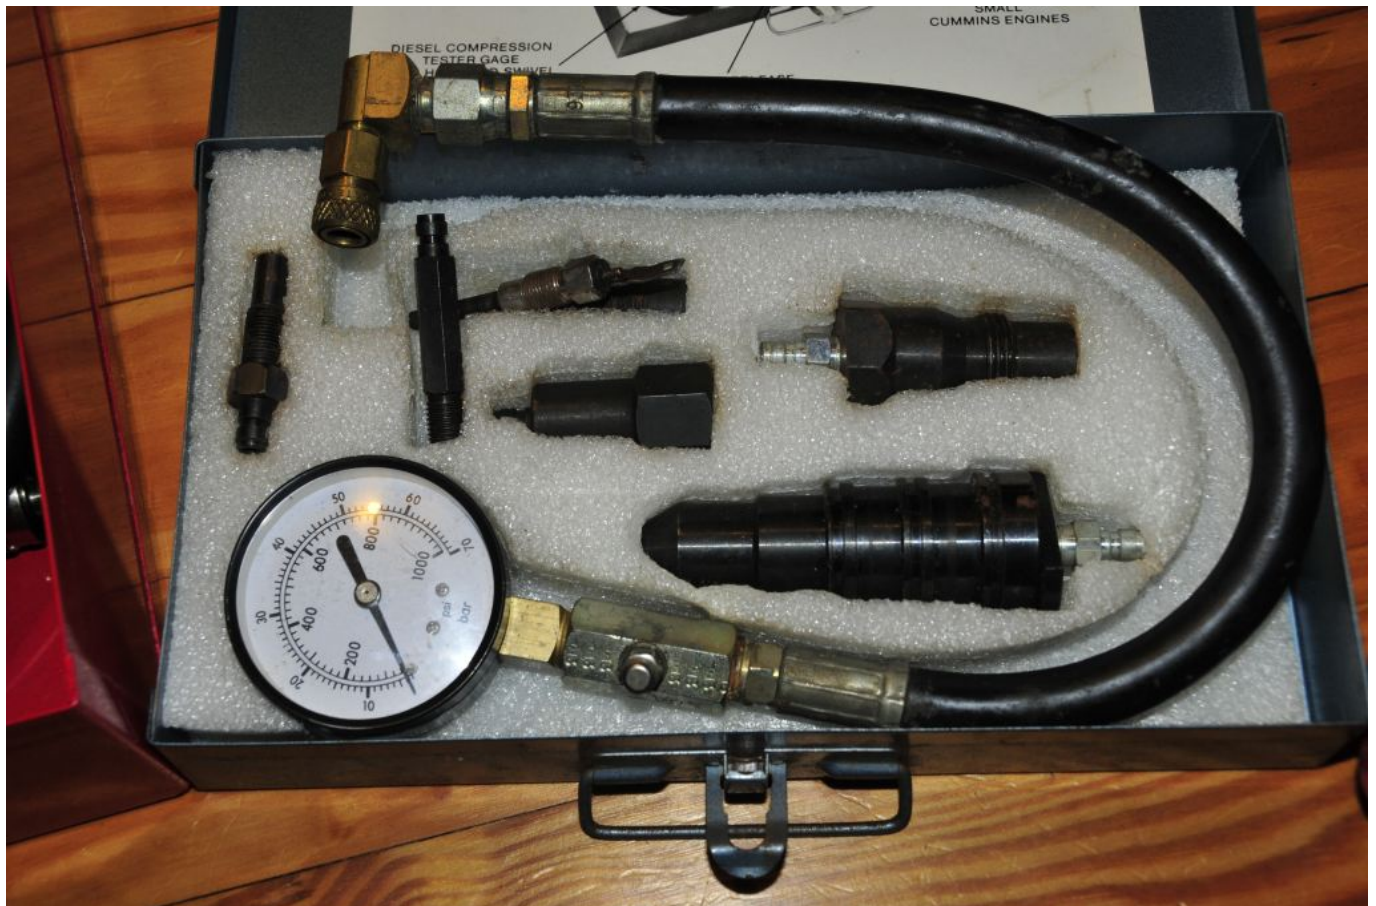
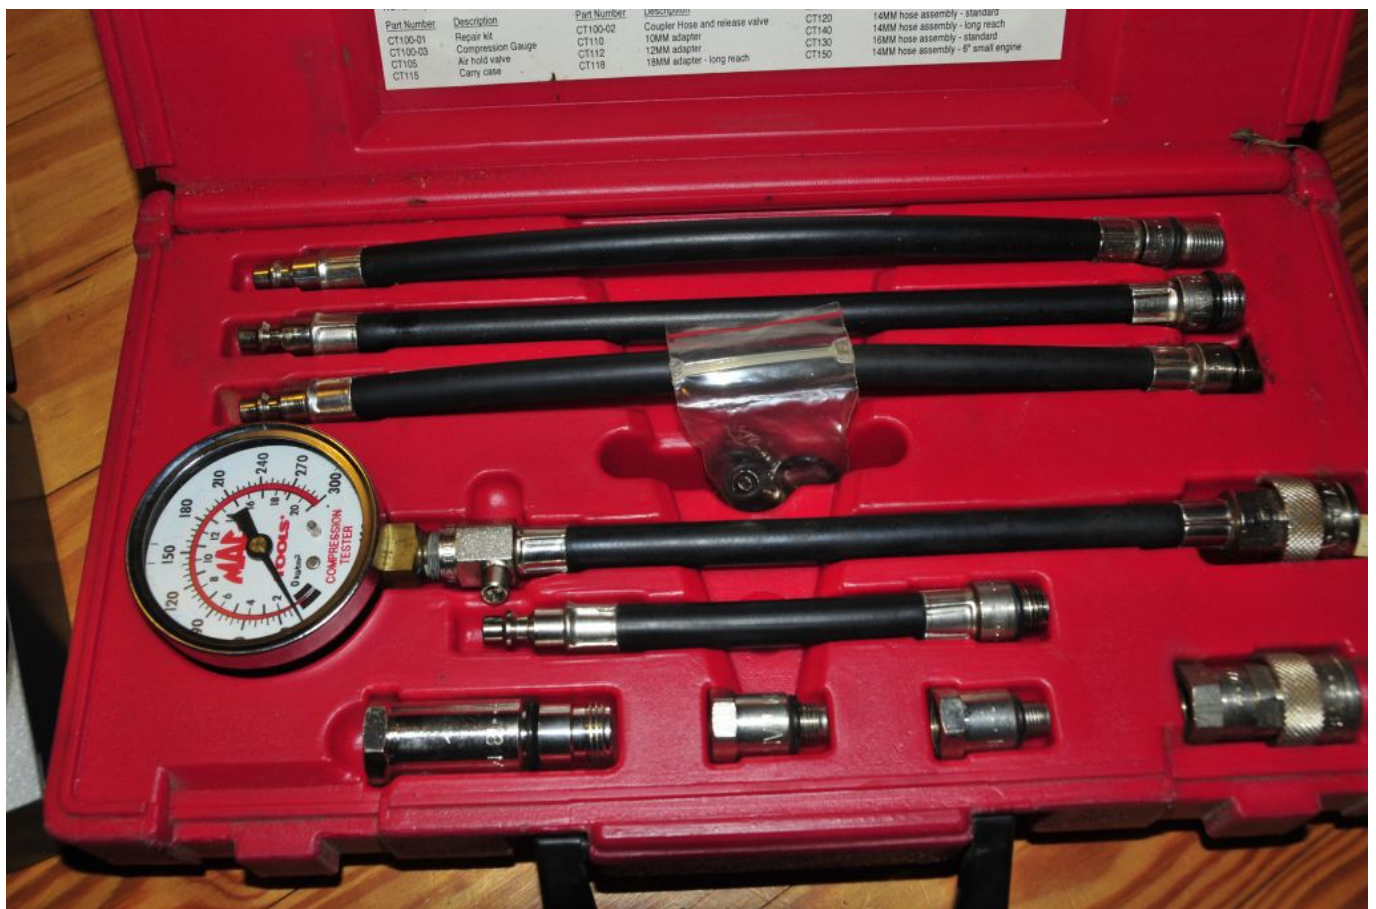
Because the cylinder pressure in a diesel engine is much

higher than a gasoline engine, the tools used to measure compression are different. Here, both diesel (in the gray metal box) and gasoline (in the red plastic box) compression tool kits are shown.

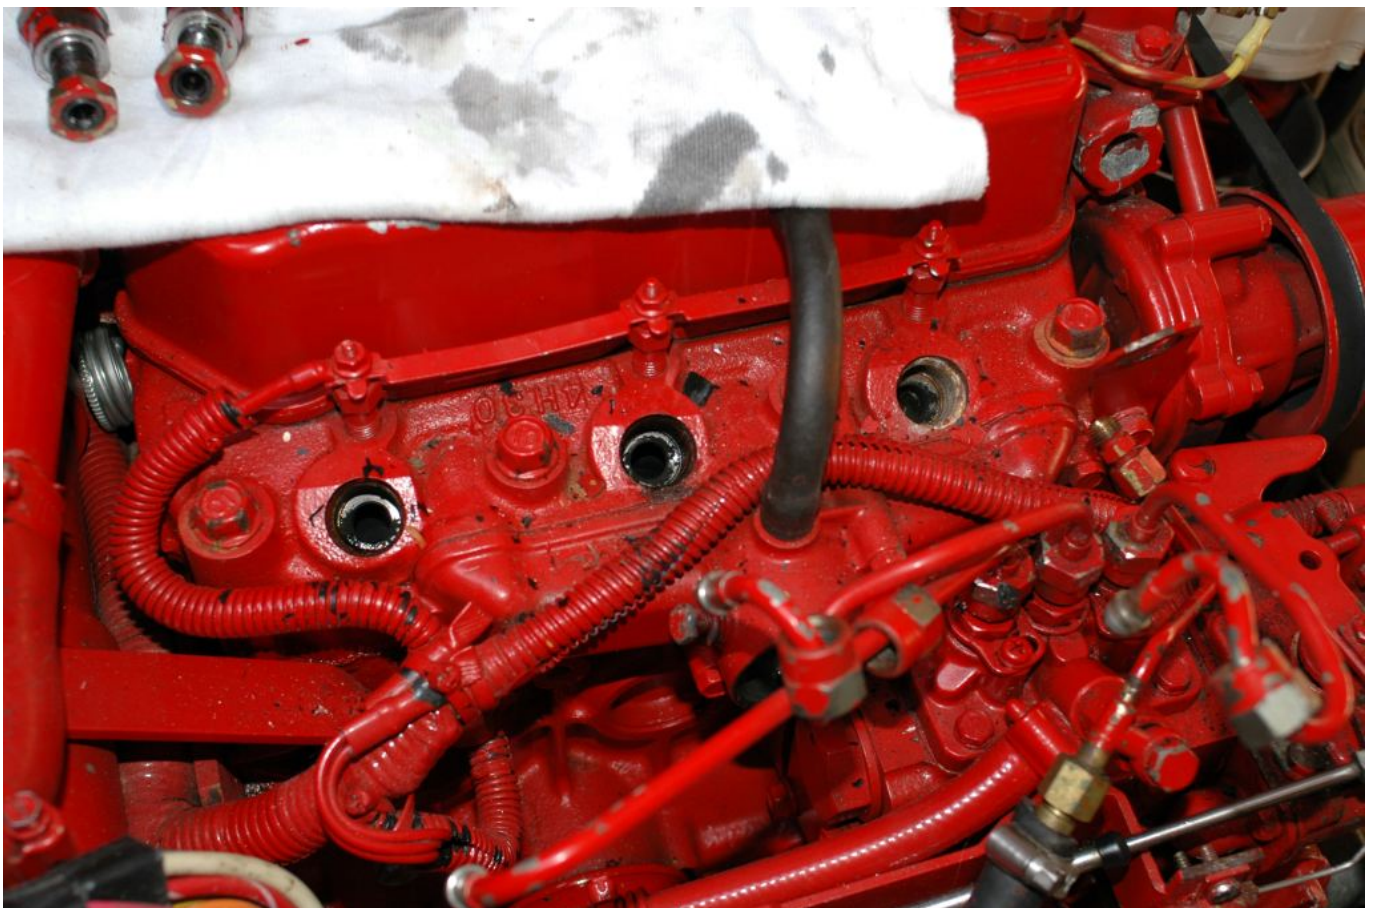
**A compression test requires the removal of injectors (or glow plugs if present) on a diesel engine, and spark plugs on a gasoline engine.**

Testing the compression that is generated in either gasoline or diesel engines is relatively straight forward, and doing so can provide a picture of the condition of the cylinder, piston, rings, exhaust and intake valves. The first and simplest test relies on an aptly-named compression tester. This is inserted into, and in place of, the hole where a spark plug, glow plug or injector would be located. The engine's ignition and fuel system are then disabled to prevent it from starting during the test. Once that's done, the engine is cranked or turned through several revolutions using the starter, and the pressure generated by the piston is recorded by the gauge. The pressure readings are then compared to those provided by the engine manufacturer for a "healthy" engine.

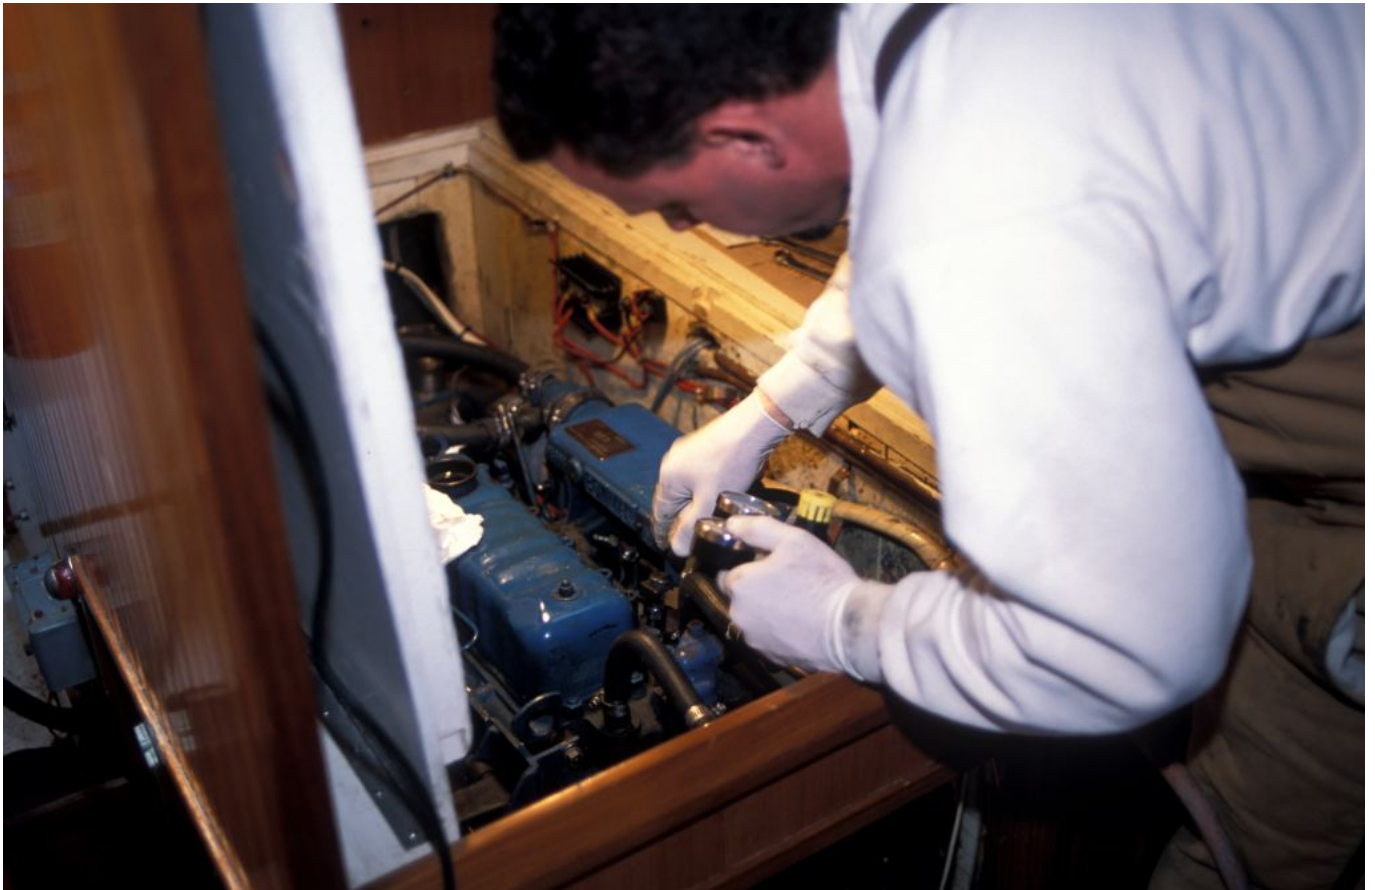
**Differential leak down test tools are used to help narrow down the source of compression leakage. The engine does not need to be turned over for this test, however, a steady source of compressed air is required.**

While the compression test is valuable, it can only provide a pass or fail grade, it's unable to provide details or clues as to where the fault may lie, and how serious it may be. Enter the leak-down tester; this device is similar to the compression tester in that it is plugged into the cylinder via one of the aforementioned ports, however, instead of using the engine's rotation to generate pressure, it utilizes an external compressed air source, typically a shop compressor, which is pumped into the cylinder. The tool is equipped with two gauges, one measuring the pressure of air available to the cylinder and another which measures air pressure maintained within the cylinder (for this reason the tool is sometimes referred to as a differential leak-down tester). The amount of leakage is a direct indication of wear or damage within the cylinder, however, the areas from where the air leaks out of the cylinder can tell a mechanic a great deal about what needs to be done to fix the problem.

Air leaking from the intake or exhaust manifolds indicates worn respective valves or seats, which is comparatively easy to repair in that it only requires cylinder head removal, while air leaking from the crankcase vent often foretells something more ominous, worn or damaged piston rings or scored cylinder walls (leakage at the piston rings, known as blow-by, is a subject that will be covered next month), which in turn requires major disassembly, and a likely engine rebuild or replacement.
