Feature Article: Saving a Drowned Engine – Editorial: Around the World in Two Weeks and Another Portable Lithium-ion battery fire

Around the World in Two Weeks and Another Portable Lithium-ion battery fire

Saving a Drowned Engine

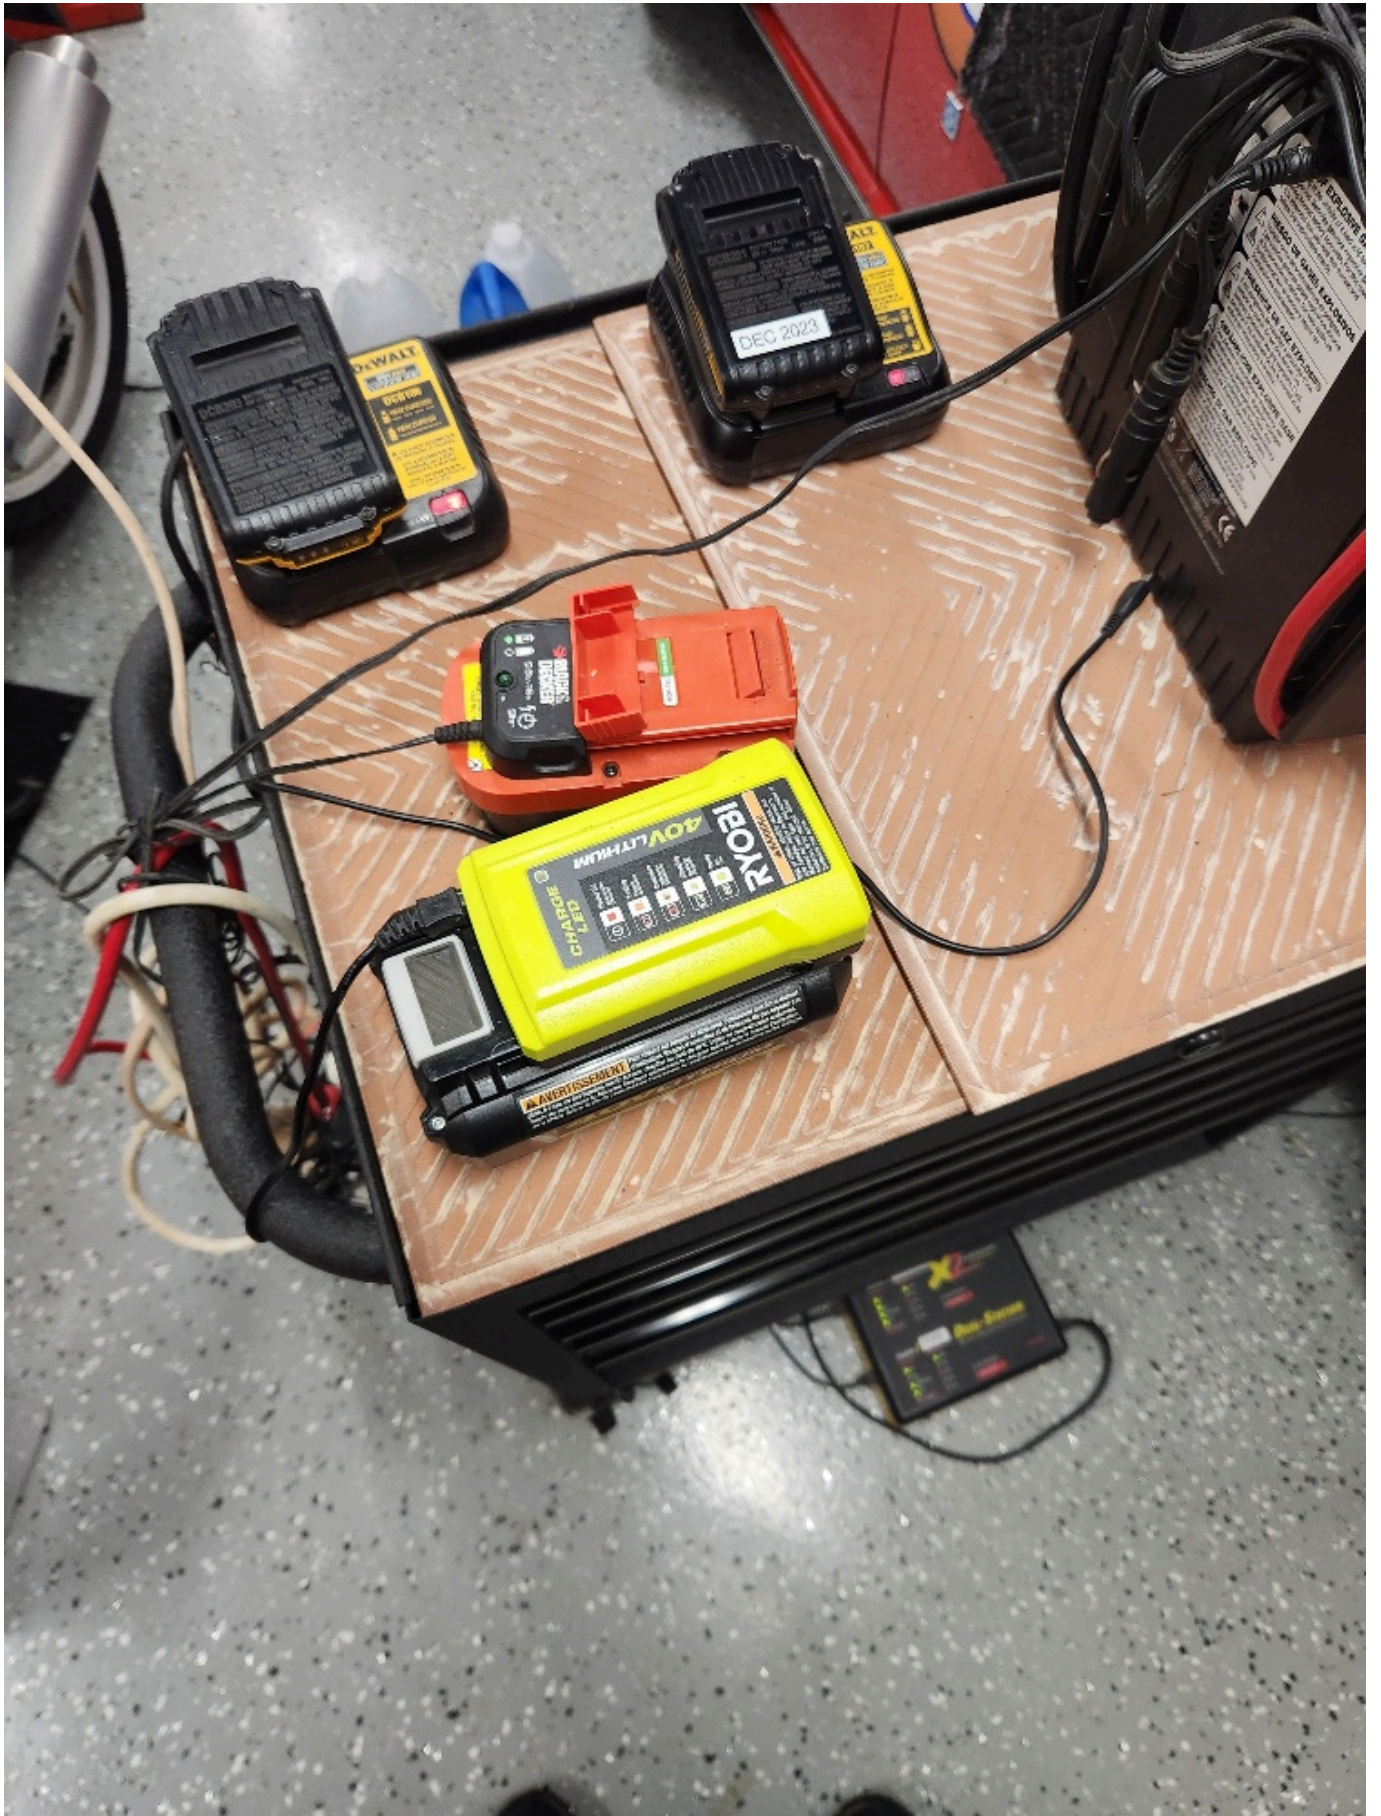
A ceramic top lithium ion battery charging station.

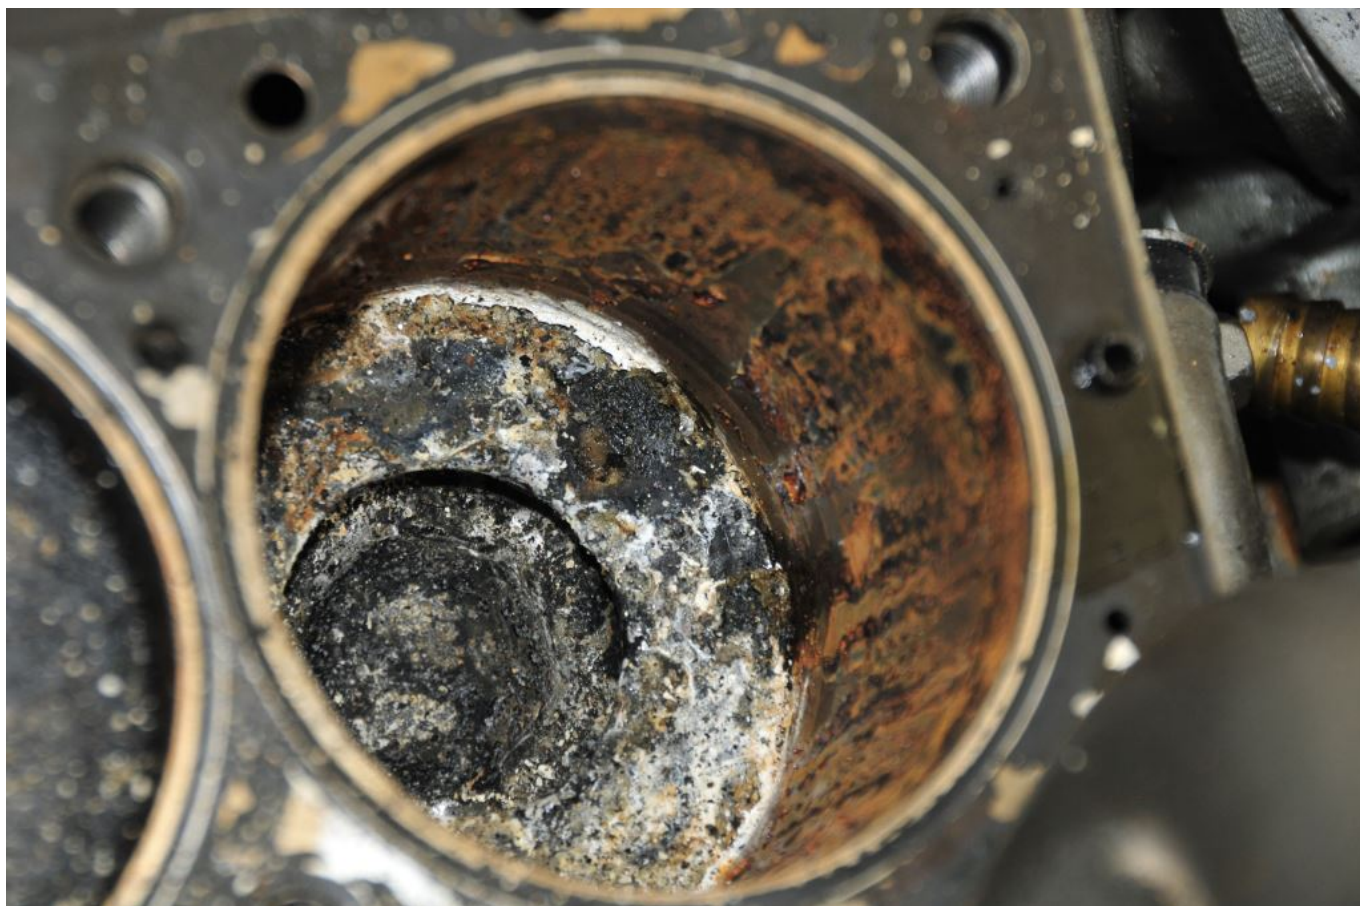
It doesn't take long for corrosion to set in once water enters a combustion chamber.

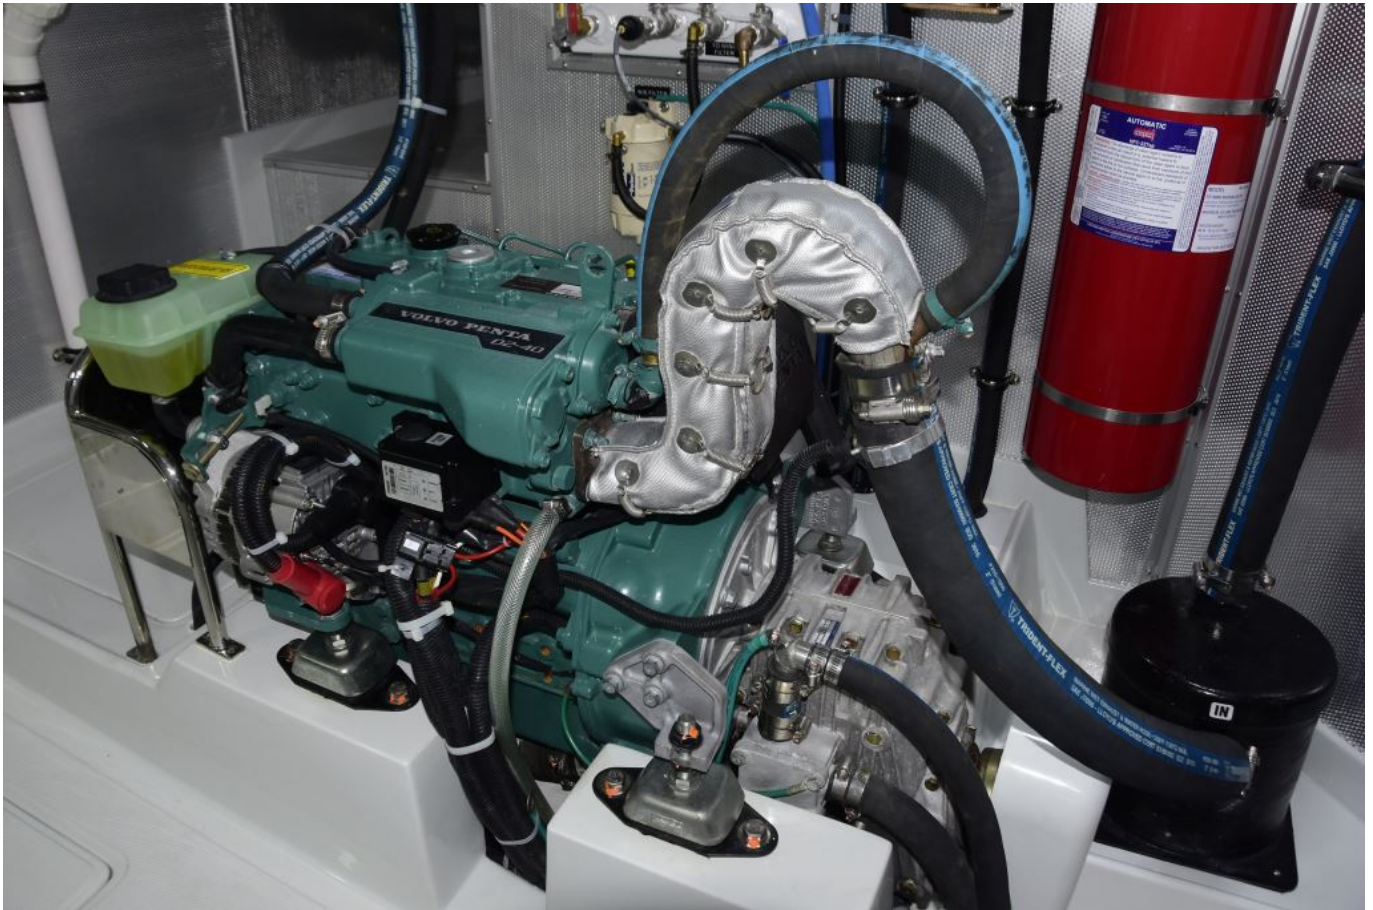
Engines, and gensets, that are located below the waterline, which is both common and normal, where water must be pushed uphill to exit the vessel, are at greater risk of flooding.

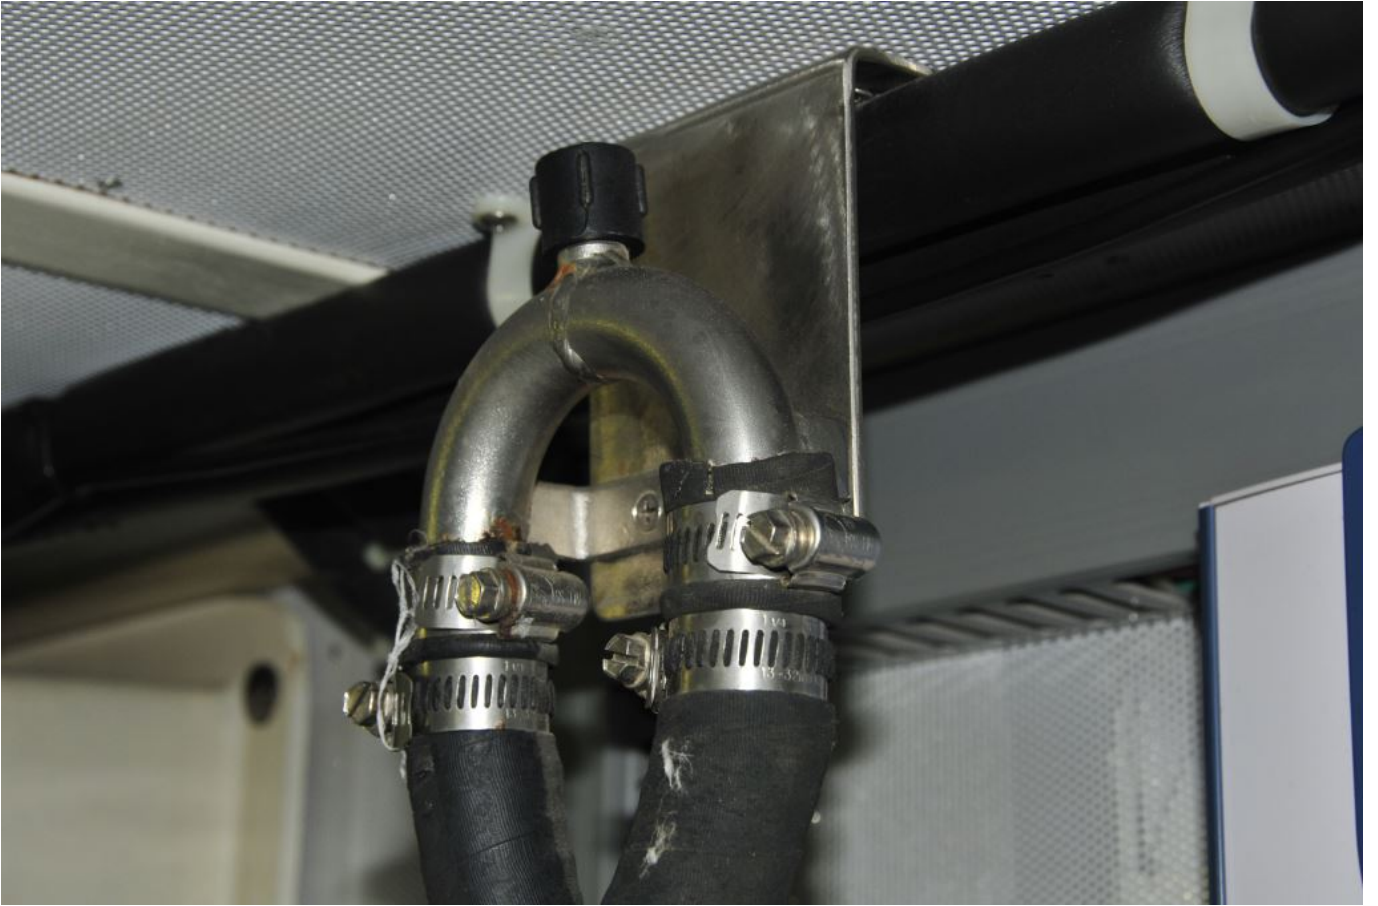
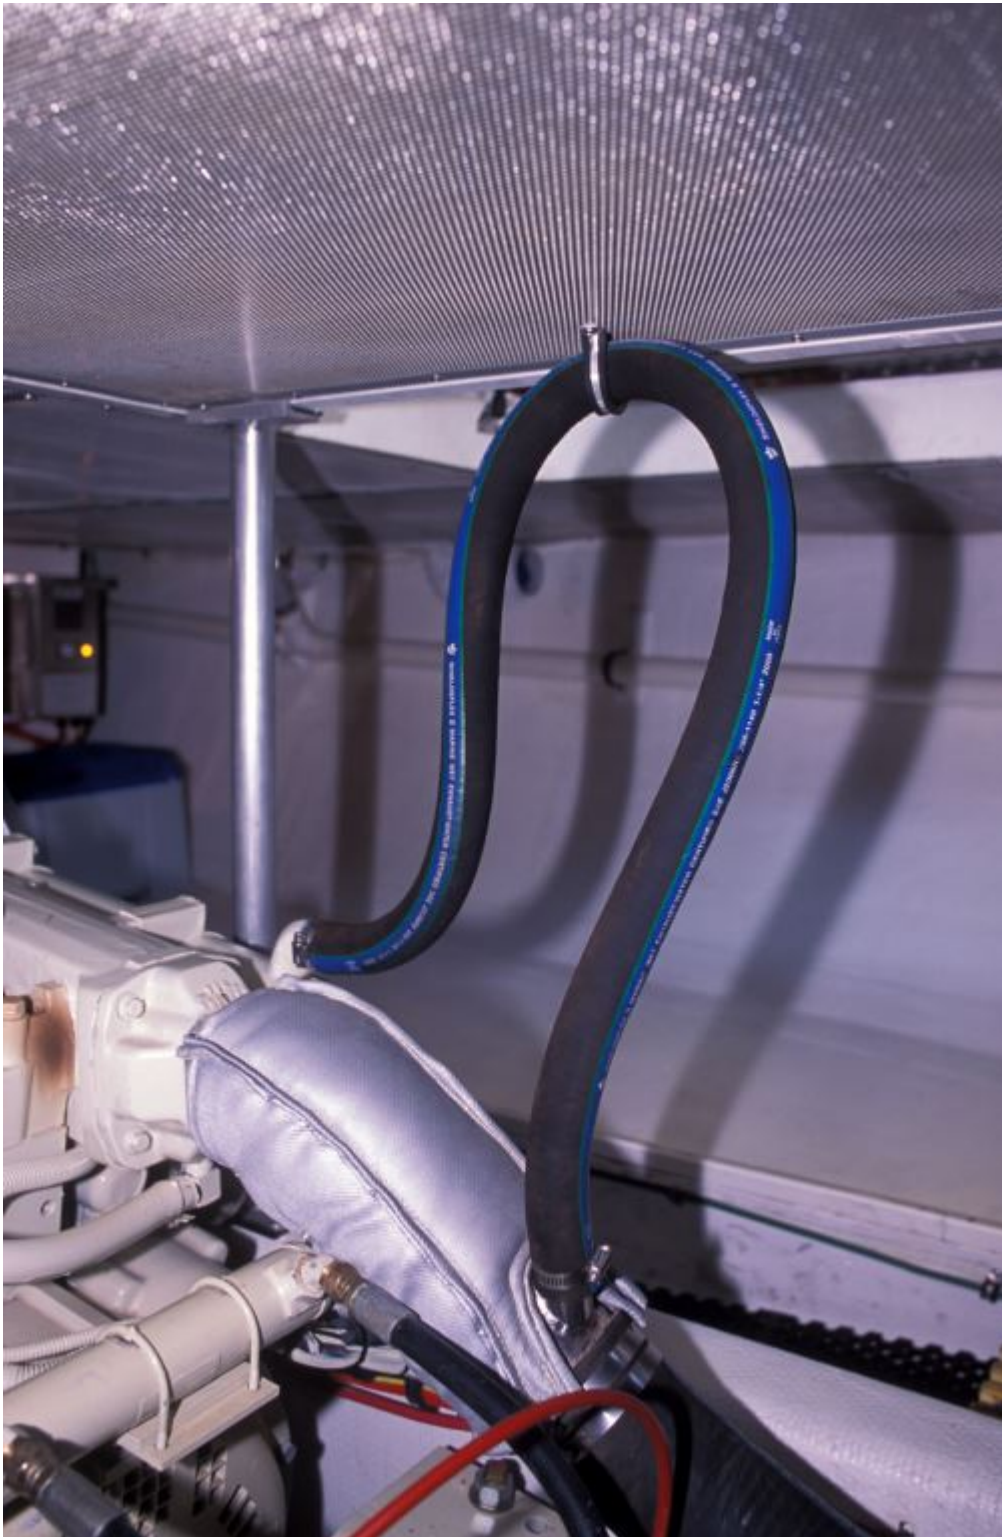
Defective, clogged, improperly installed, or absent anti-siphon valves can lead to engine flooding.

First, the engine is not installed in accordance with the manufacturer's instructions, which are specifically designed to prevent such flooding. Violation of these rules either allows a siphon to develop, which fills the exhaust and then floods the engine's cylinders, or water is pushed in through the exhaust discharge in a following sea, when the engine is idle, and from there through open exhaust valves and into the cylinders. Two, an anti-siphon valve malfunctions.

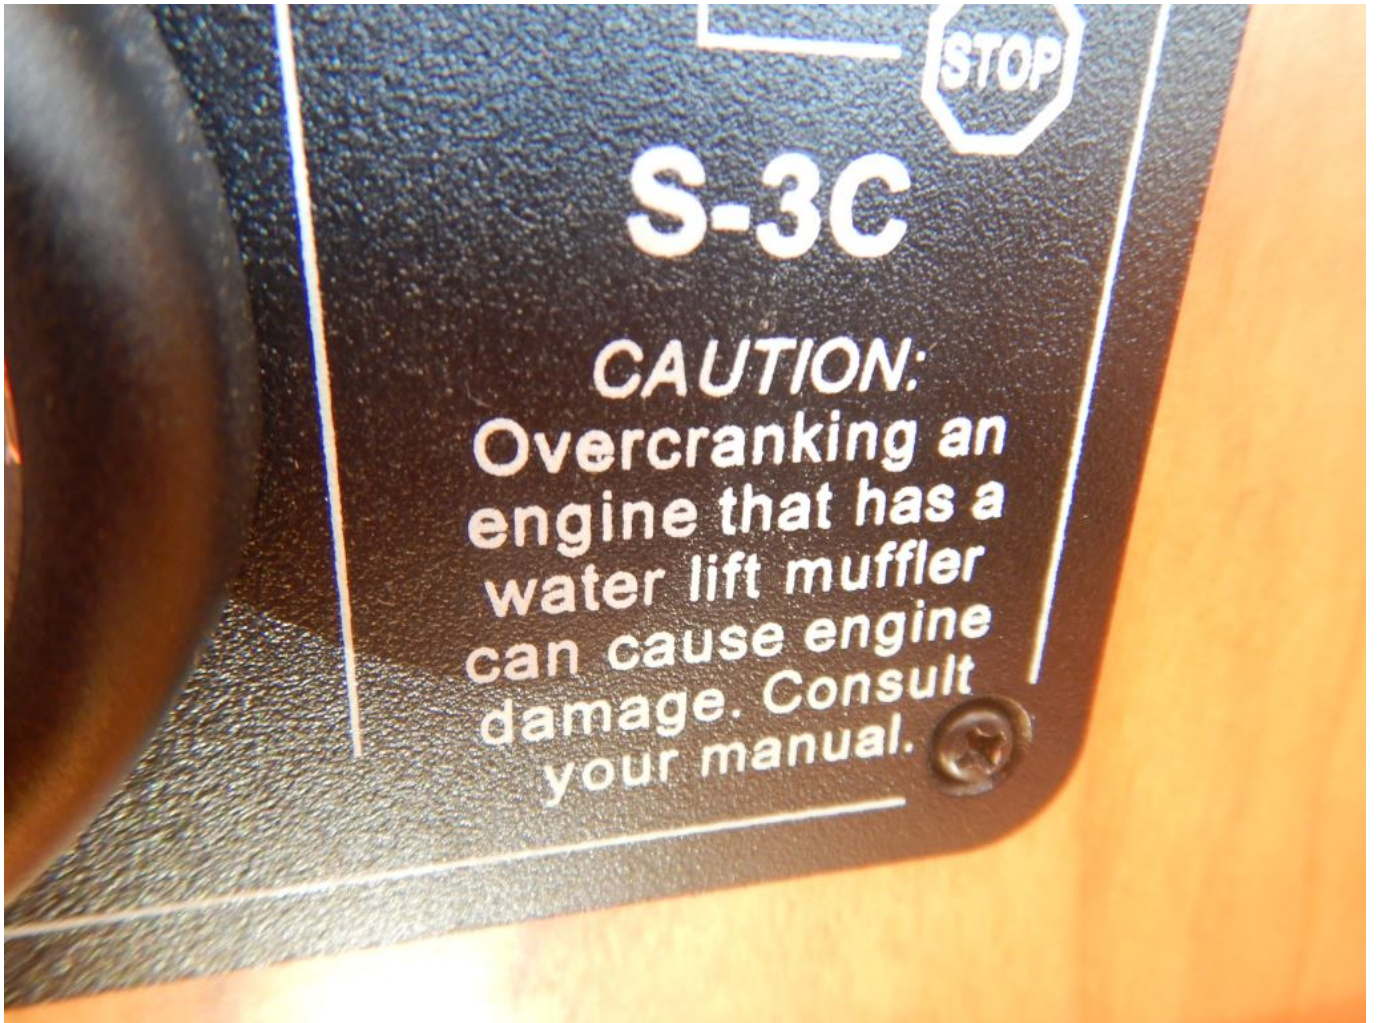
If an engine or genset is cranked excessively, a potentially normal occurrence when bleeding air from a fuel system, even a properly designed exhaust system can experience engine flooding.

Three, the engine is cranked excessively while bleeding the fuel system; with each revolution a small amount of seawater is pumped by the raw water pump into the exhaust system, which eventually overflows back into the engine, and once again

through an open exhaust valve and into a cylinder.

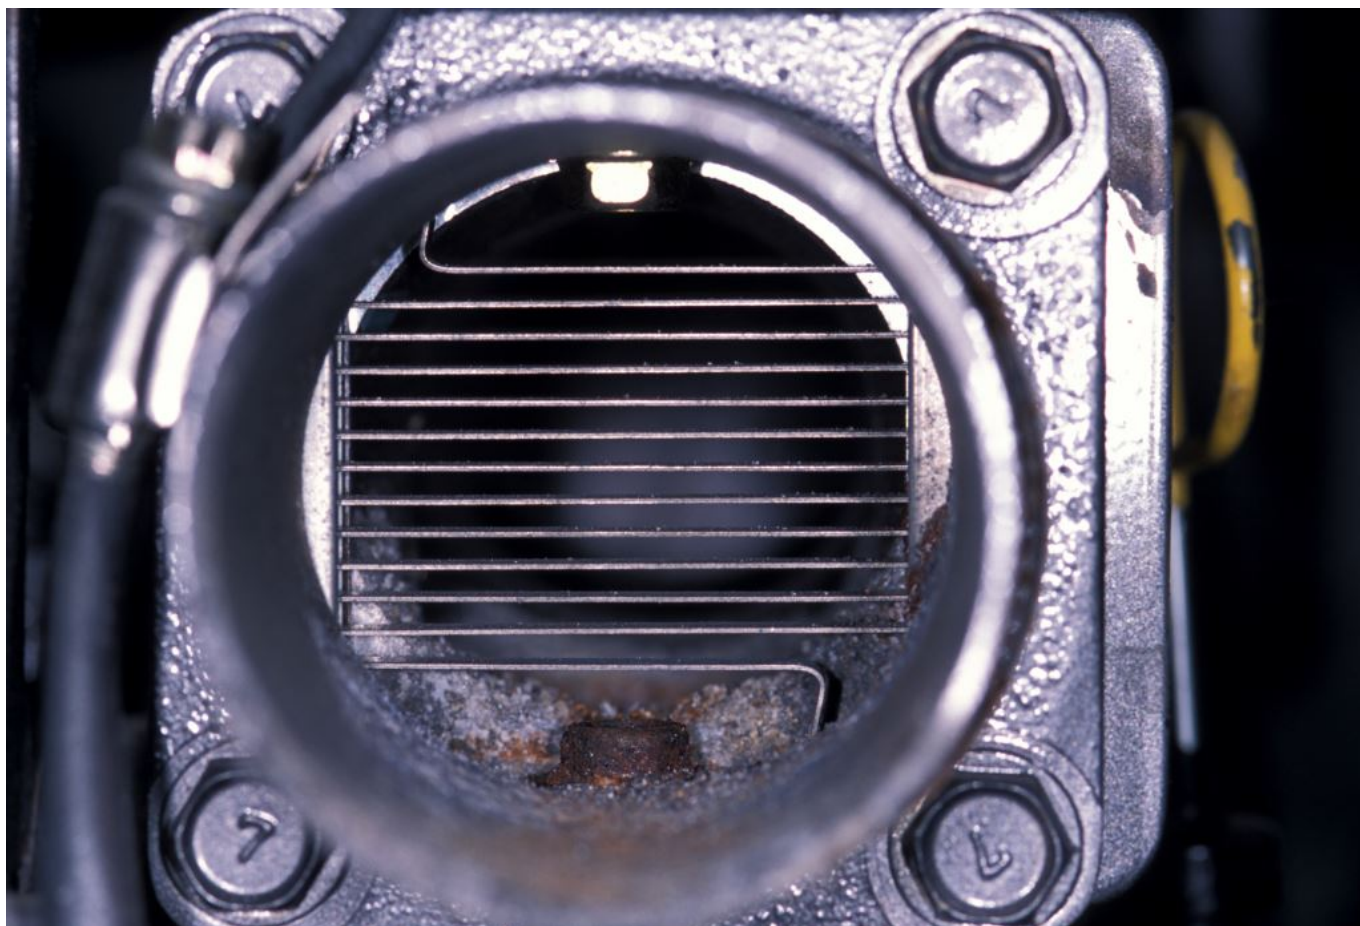
The telltale corrosion and salt accumulation at the bottom of this intake plenum is an indication this engine has experienced a flooding event.

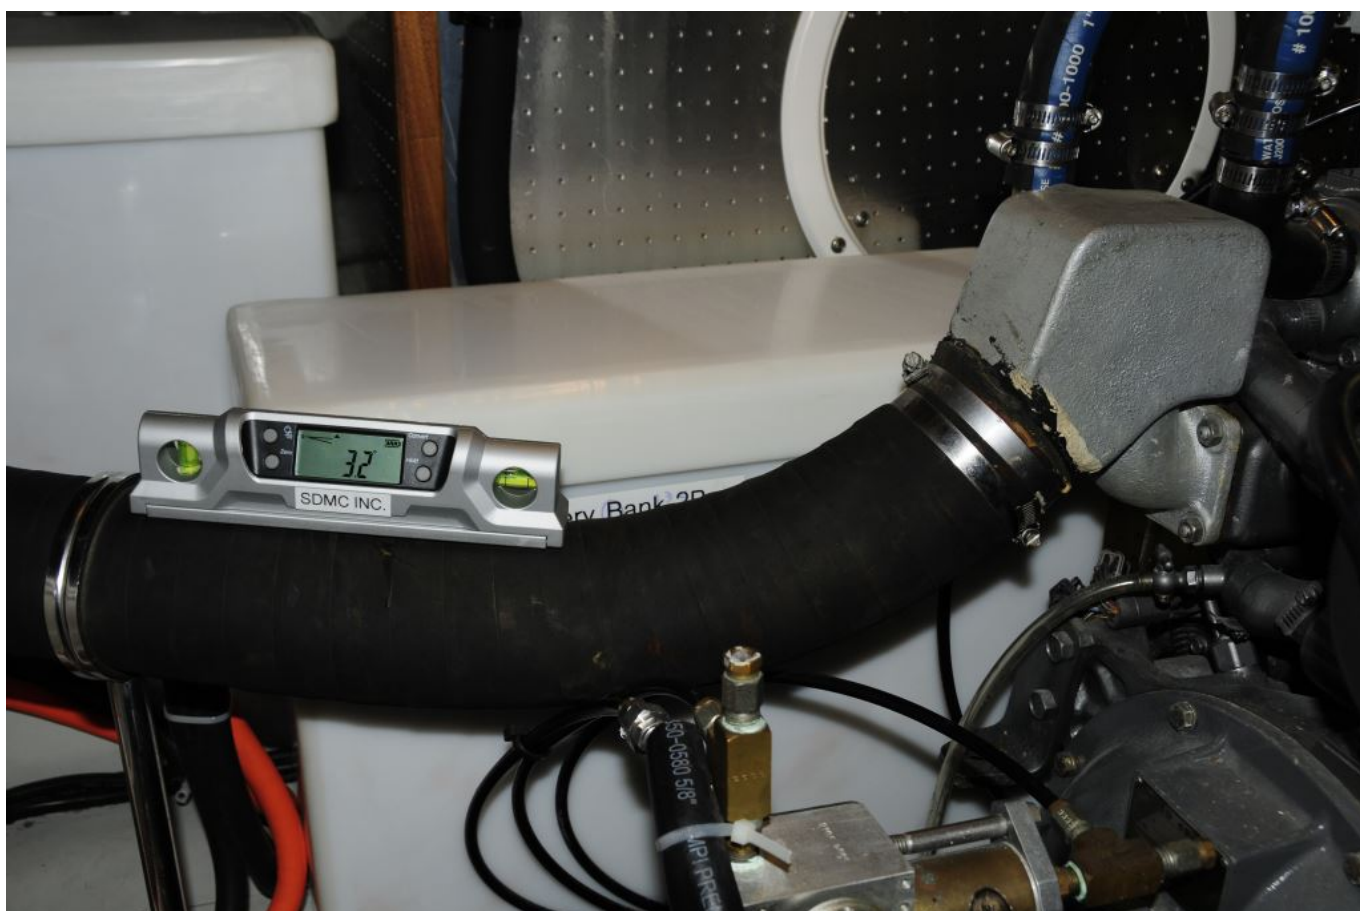
A cardinal sin of exhaust system installation involves trapping water between the mixing elbow and muffler.
