Feature Article: Saving a Drowned Engine — Editorial: Around the World in Two Weeks and Another Portable Lithium-ion battery fire

Saving a Drowned Engine

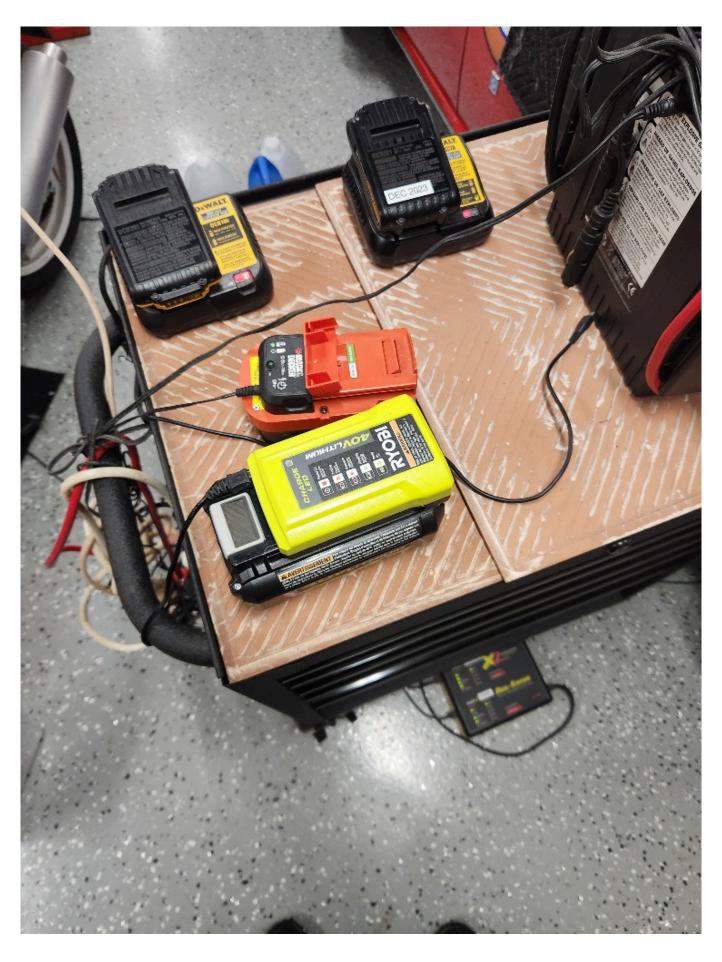
A ceramic top lithium ion battery charging station.

You can read the recently released news release and investigation report here. The bottom line is, onboard (and at home for that matter) portable lithium-ion battery charging requires caution. If a battery is damaged, becomes hot, or is failing to accept a charge normally, it should be properly disposed of, and only batteries and chargers that are UL, or equivalent, certified (the radio and charger that caused this fire was so certified), should be used. The report also recommends against unsupervised charging, however, while that is desirable, I suspect that guidance is unlikely to be followed in the vast majority of afloat and ashore cases. To reiterate, I still recommend all chargers of this sort be placed on fire-proof, ceramic or metallic, surfaces, and again with nearby smoke detection.

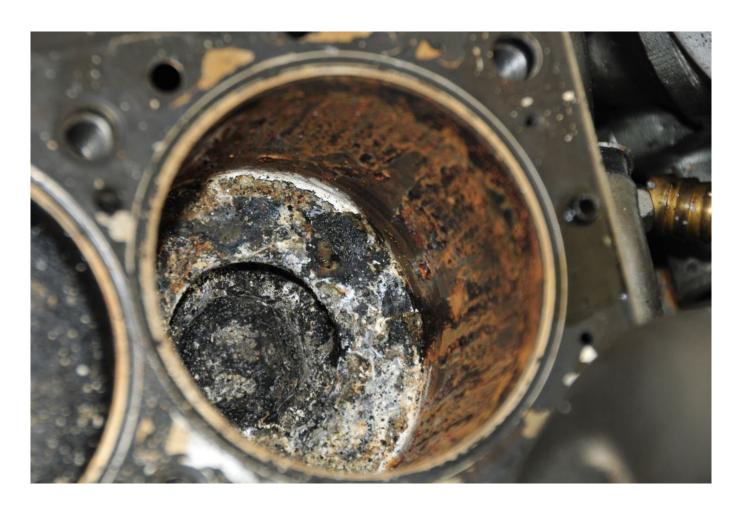
It doesn't take long for corrosion to set in once water enters a combustion chamber.

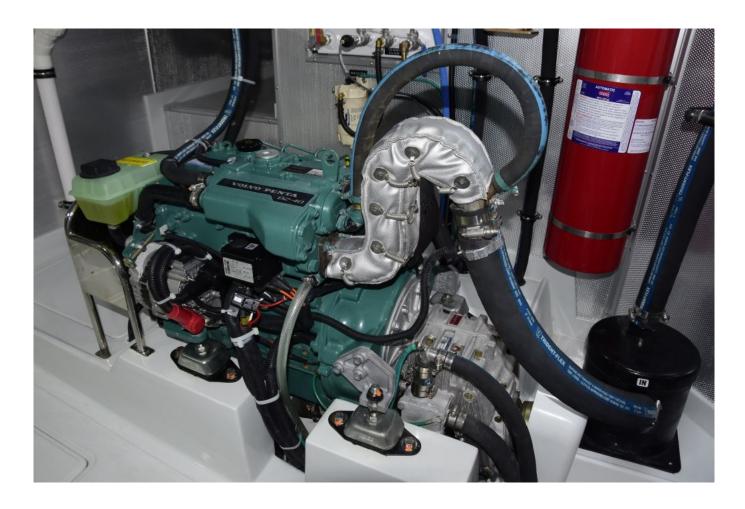
Engines, and gensets, that are located below the waterline, which is both common and normal, where water must be pushed uphill to exit the vessel, are at greater risk of flooding.

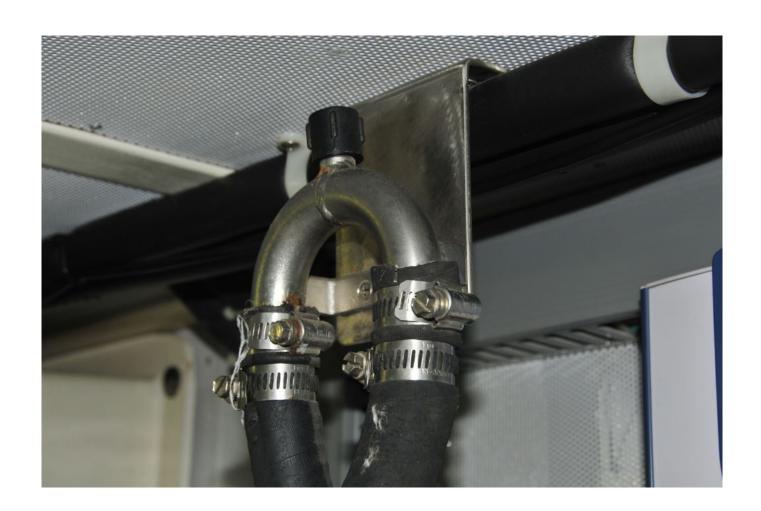
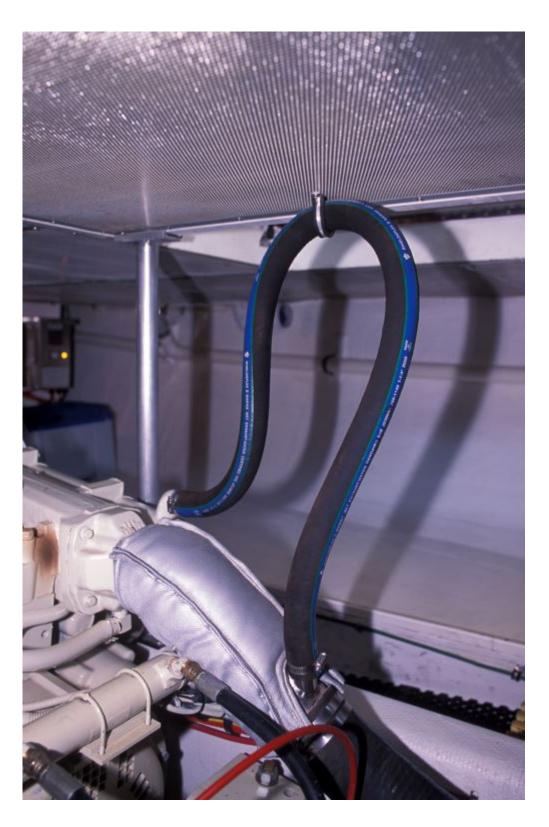
Defective, clogged, improperly installed, or absent antisiphon valves can lead to engine flooding.

First, the engine is not installed in accordance with the manufacturer's instructions, which are specifically designed to prevent such flooding. Violation of these rules either allows a siphon to develop, which fills the exhaust and then floods the engine's cylinders, or water is pushed in through the exhaust discharge in a following sea, when the engine is idle, and from there through open exhaust valves and into the cylinders. Two, an anti-siphon valve malfunctions.

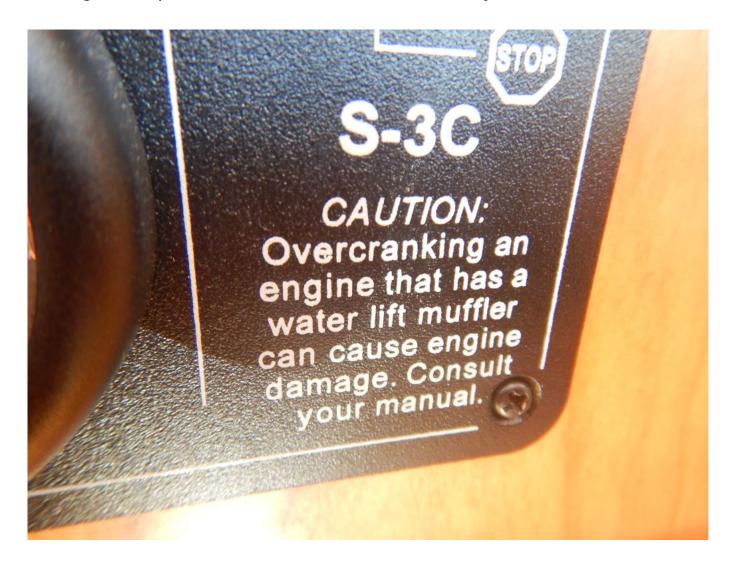
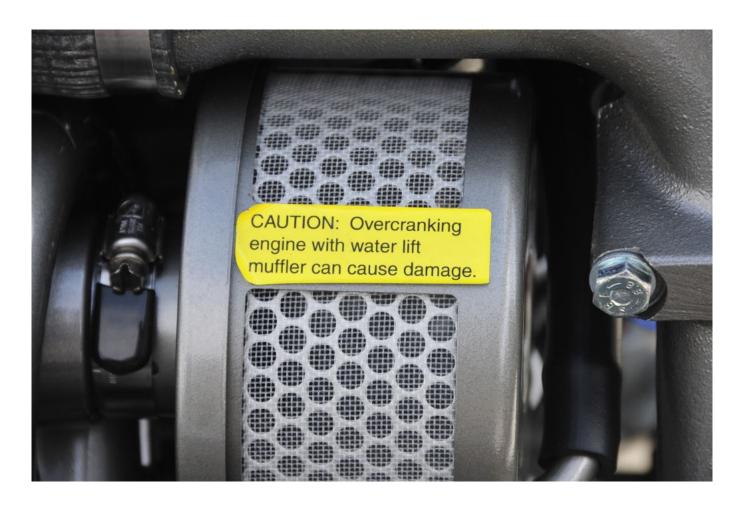
If an engine or genset is cranked excessively, a potentially normal occurrence when bleeding air from a fuel system, even a properly designed exhaust system can experience engine flooding.

Three, the engine is cranked excessively while bleeding the fuel system; with each revolution a small amount of seawater is pumped by the raw water pump into the exhaust system, which eventually overflows back into the engine, and once again

through an open exhaust valve and into a cylinder.

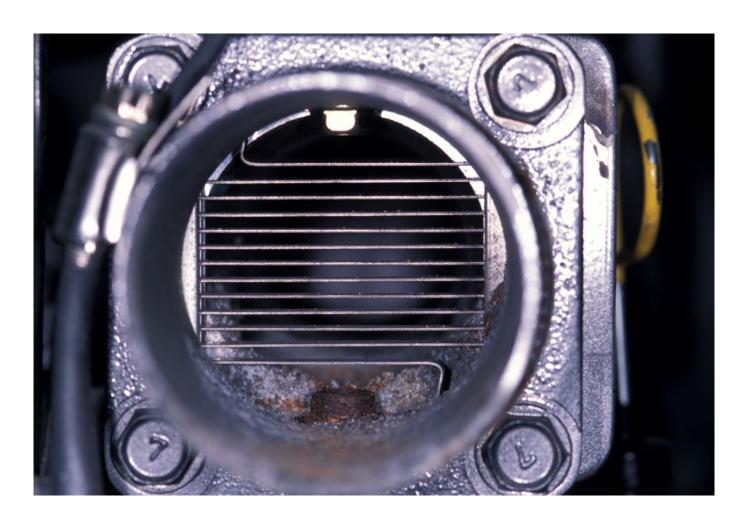
The telltale corrosion and salt accumulation at the bottom of this intake plenum is an indication this engine has experienced a flooding event.

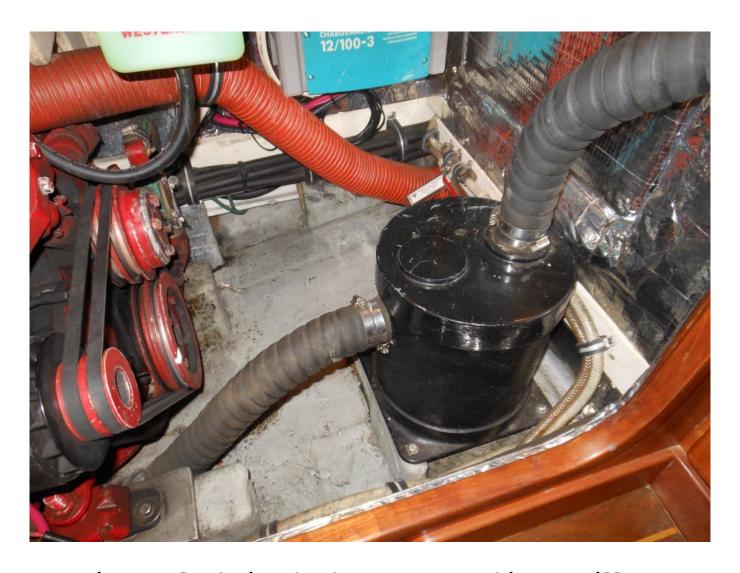
An improperly designed exhaust system, this one will trap water between the mixing elbow and muffler, is one of the leading causes of engine flooding.

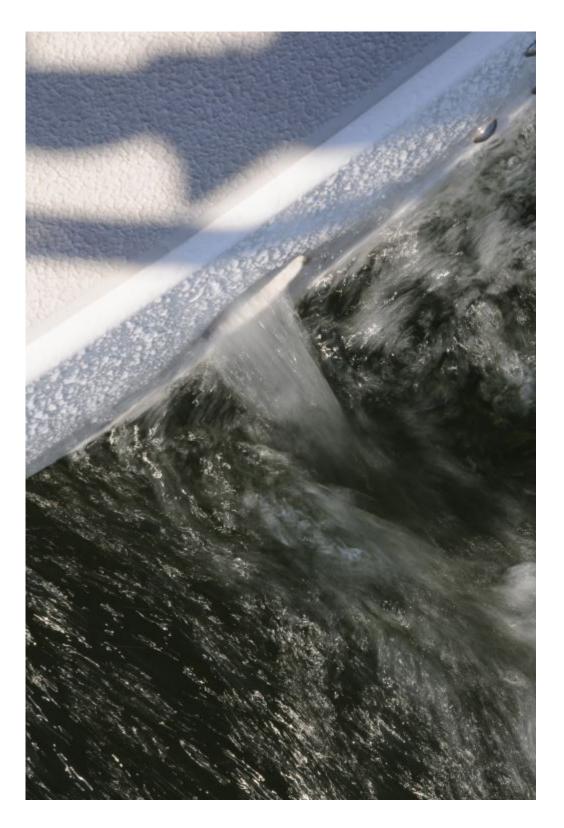
It is possible, especially for sailing vessels, for water to enter the discharge, even in a properly designed exhaust system.

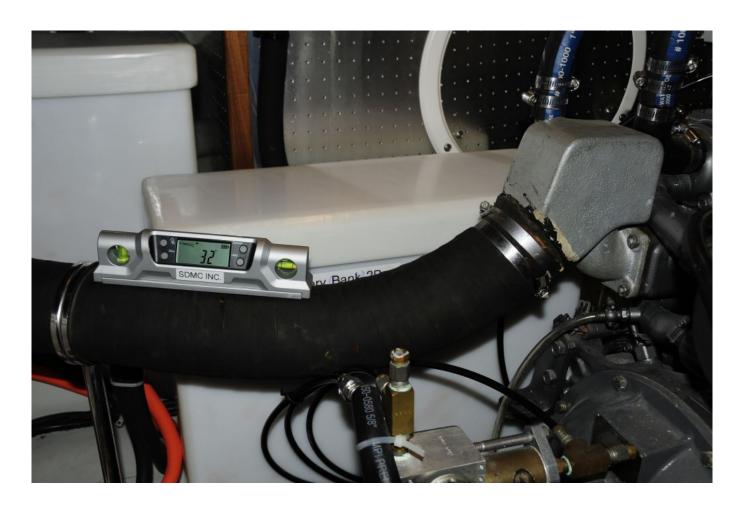
A cardinal sin of exhaust system installation involves trapping water between the mixing elbow and muffler.

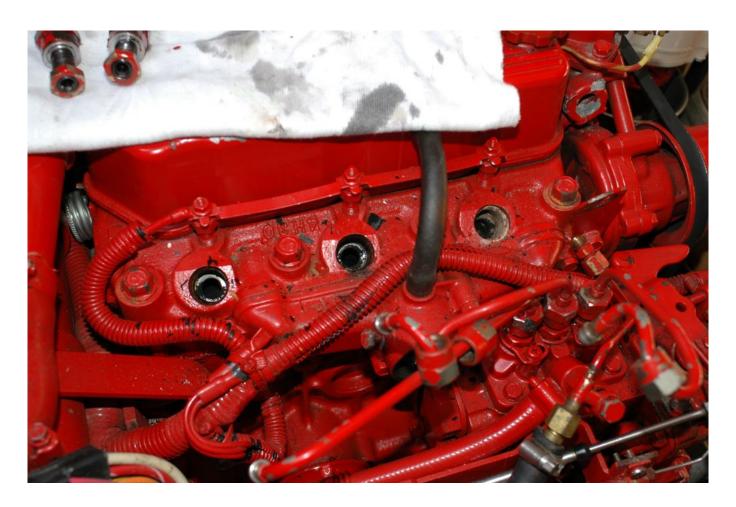
In order to allow water to exit the cylinders, injectors or glow plugs (the latter are usually easier) must be removed before attempting to manually turn over the engine.

- 1. Open or turn off the start battery switch, and turn off the fuel supply.
- 2. Wear safety glasses (I wear safety glasses whenever doing any mechanical work)
- 3. Remove the injectors or, if equipped with glow plugs remove those.

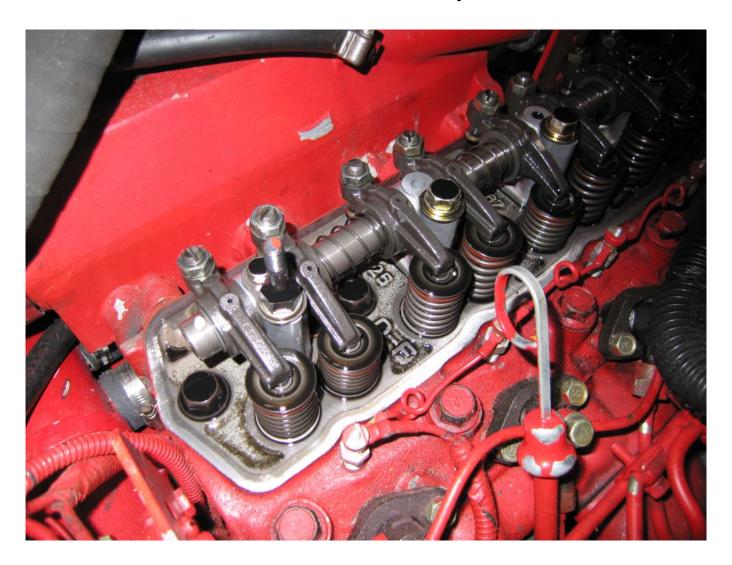
If an engine's valve train components do not move freely, they can be damaged when the engine is rotated.

- 3. Pour a generous quantity of kerosene, light motor oil or automatic transmission fluid over the valve train.
- 4. Using a light plastic head hammer, tap each rocker arm over the valve, and observe whether the valves and rocker arms move freely, or are they seized? If any rocker arms or valves seem sticky, or don't move immediately when tapped, there is a possibility of valve, valve train and piston damage *if the starter is engaged*. At this point, a decision must be made whether to remove the cylinder head.
