Feature Article: Saving a Drowned Engine – Editorial: Around the World in Two Weeks and Another Portable Lithium-ion battery fire

Saving a Drowned Engine

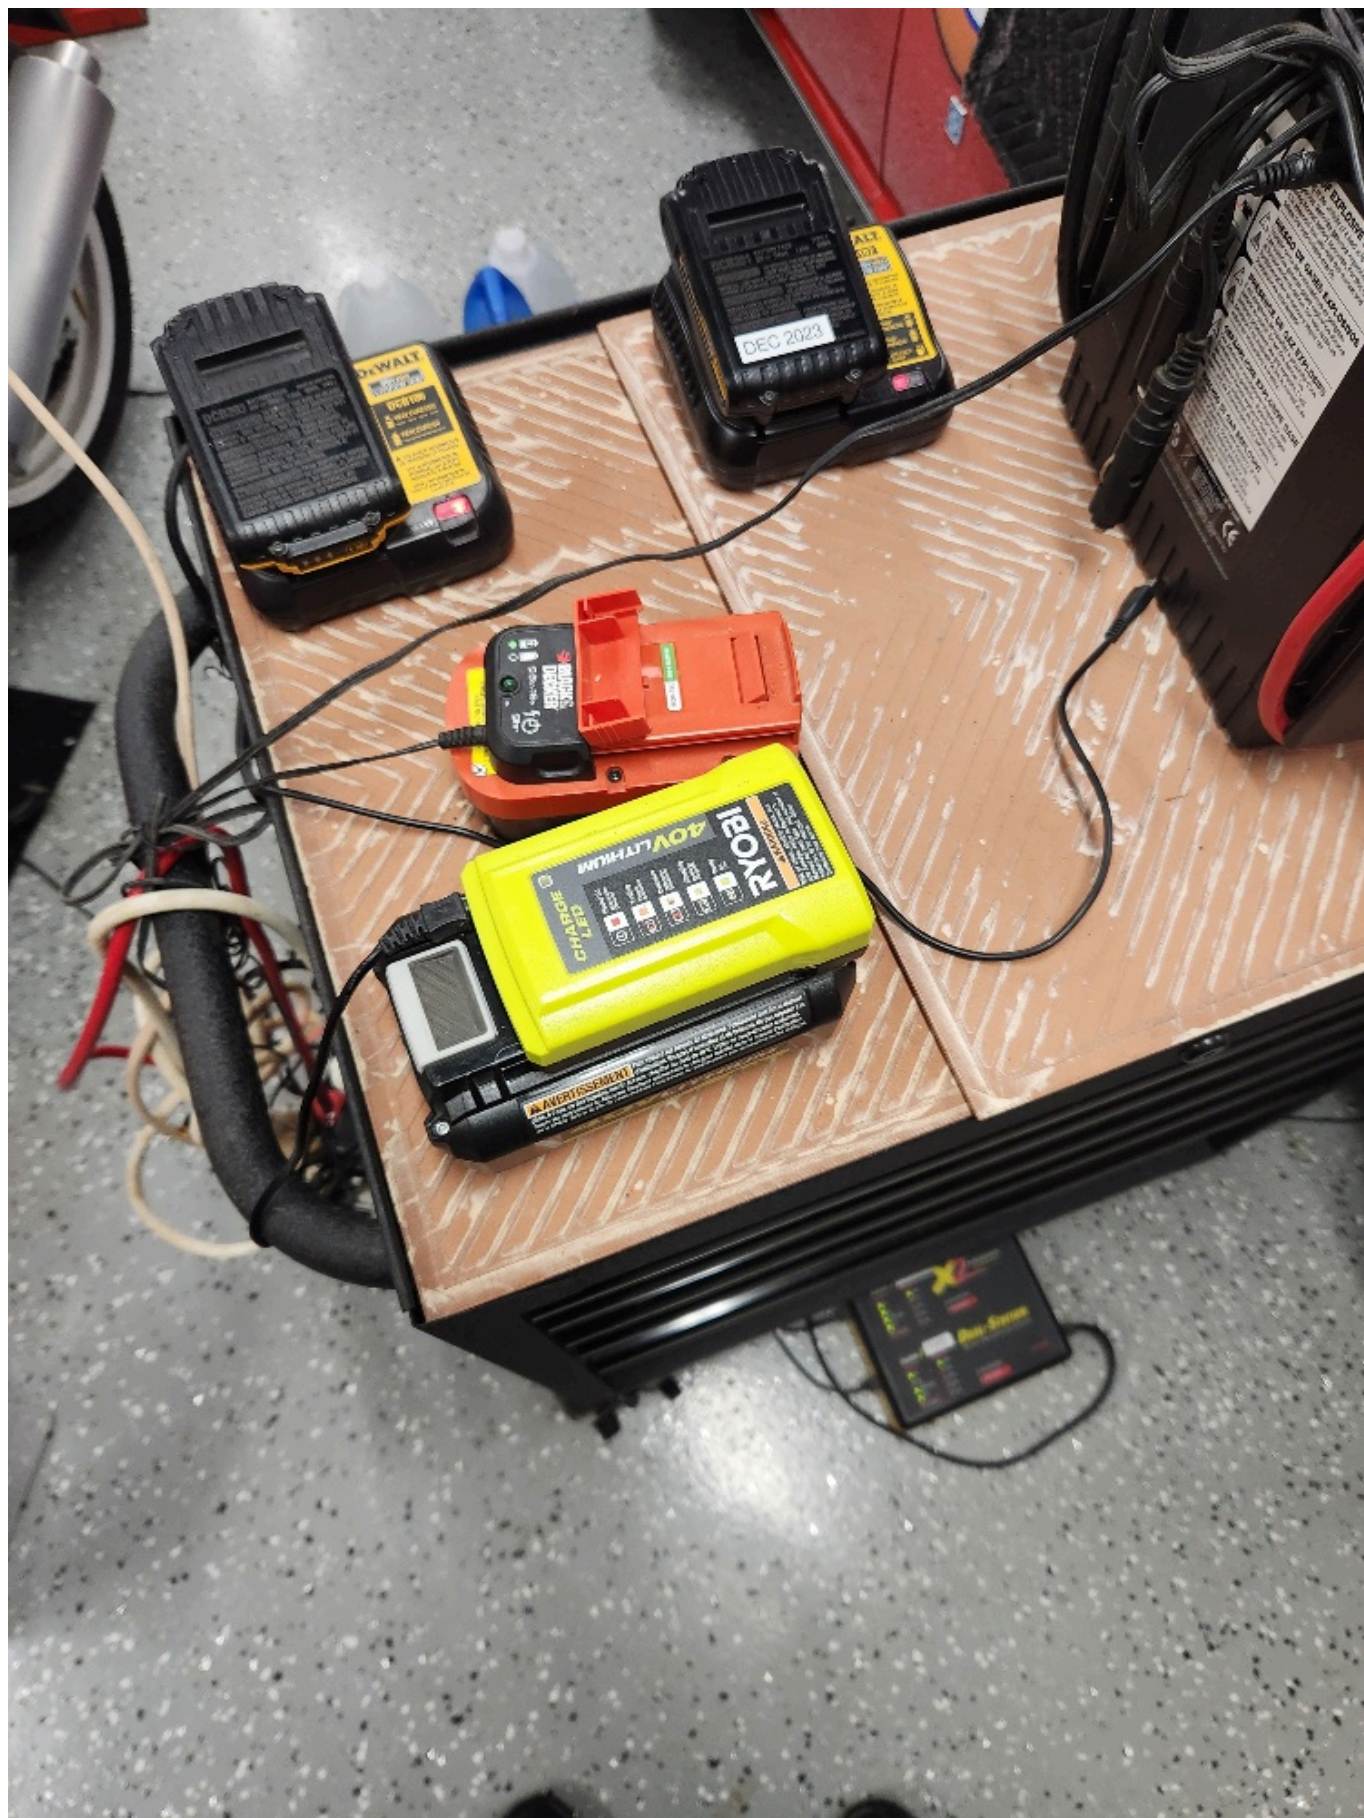
A ceramic top lithium ion battery charging station.

You can read the recently released news release and investigation report [here](#). The bottom line is, onboard (and at home for that matter) portable lithium-ion battery charging requires caution. If a battery is damaged, becomes hot, or is failing to accept a charge normally, it should be properly disposed of, and only batteries and chargers that are UL, or equivalent, certified (the radio and charger that caused this fire was so certified), should be used. The report also recommends against unsupervised charging, however, while that is desirable, I suspect that guidance is unlikely to be followed in the vast majority of afloat and ashore cases. To reiterate, I still recommend all chargers of this sort be placed on fire-proof, ceramic or metallic, surfaces, and again with nearby smoke detection.

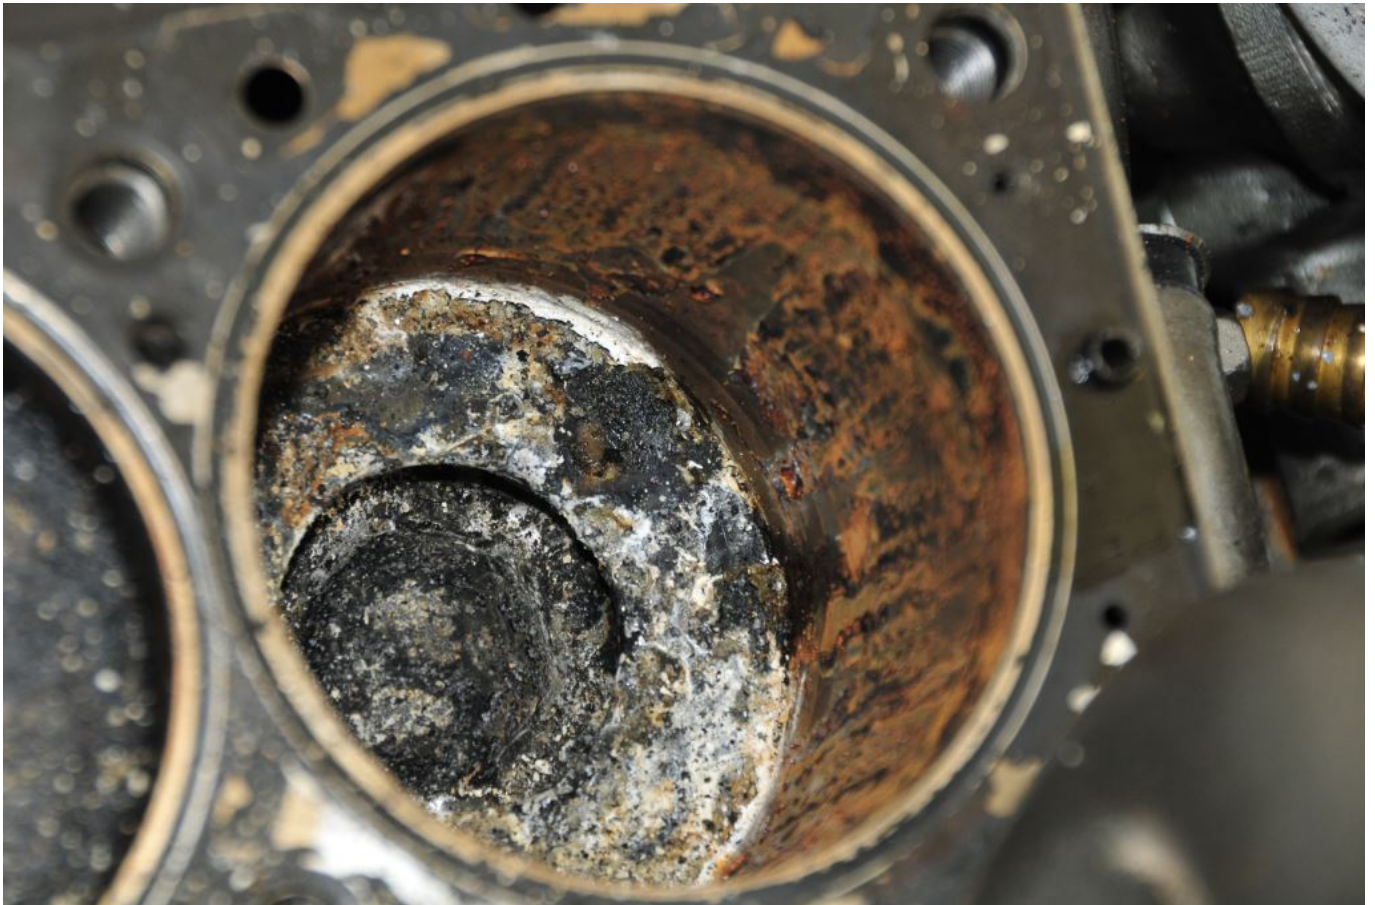
It doesn't take long for corrosion to set in once water enters a combustion chamber.

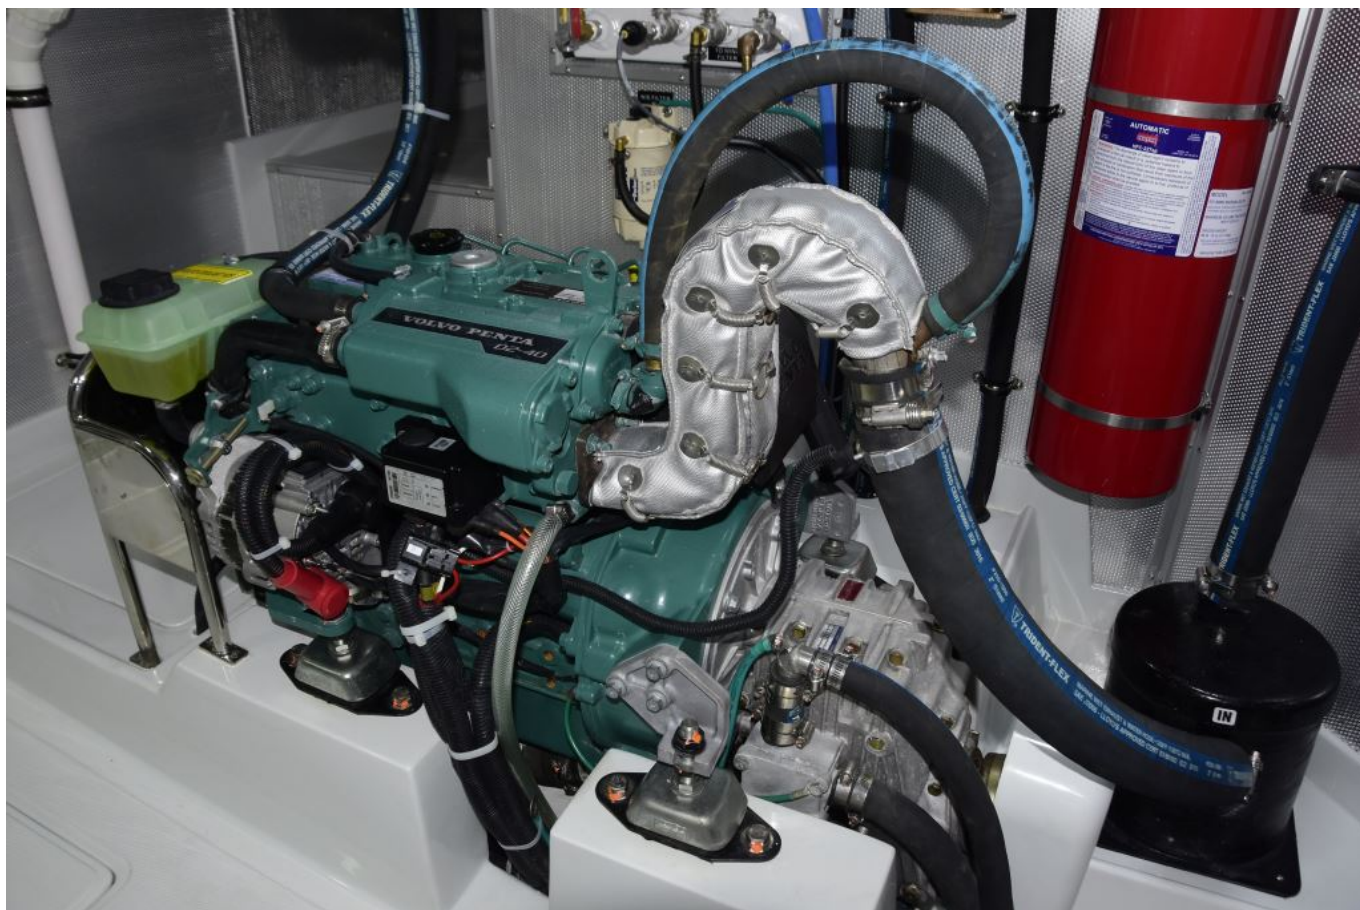
Engines, and gensets, that are located below the waterline, which is both common and normal, where water must be pushed uphill to exit the vessel, are at greater risk of flooding.

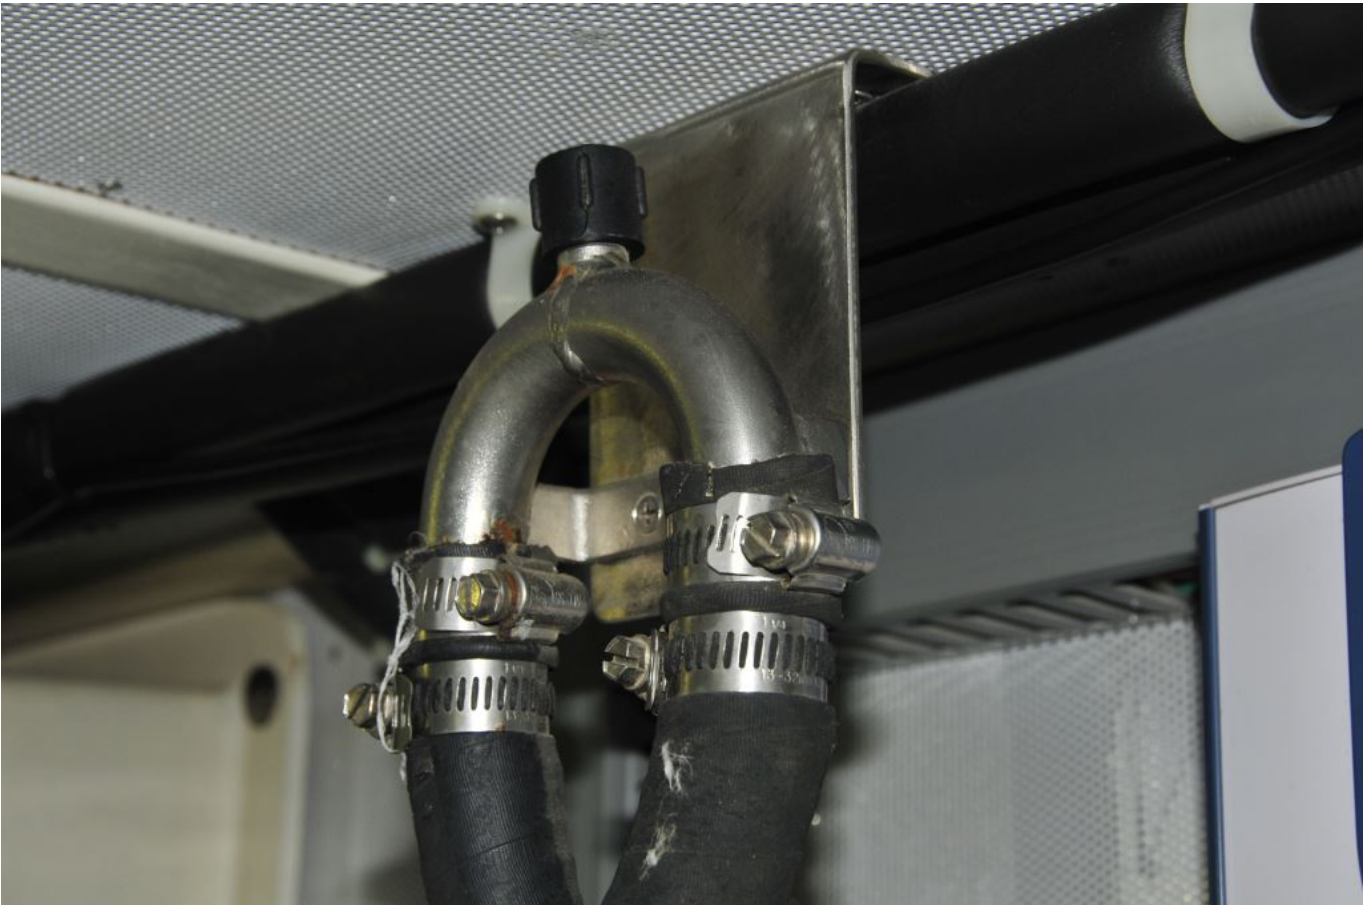
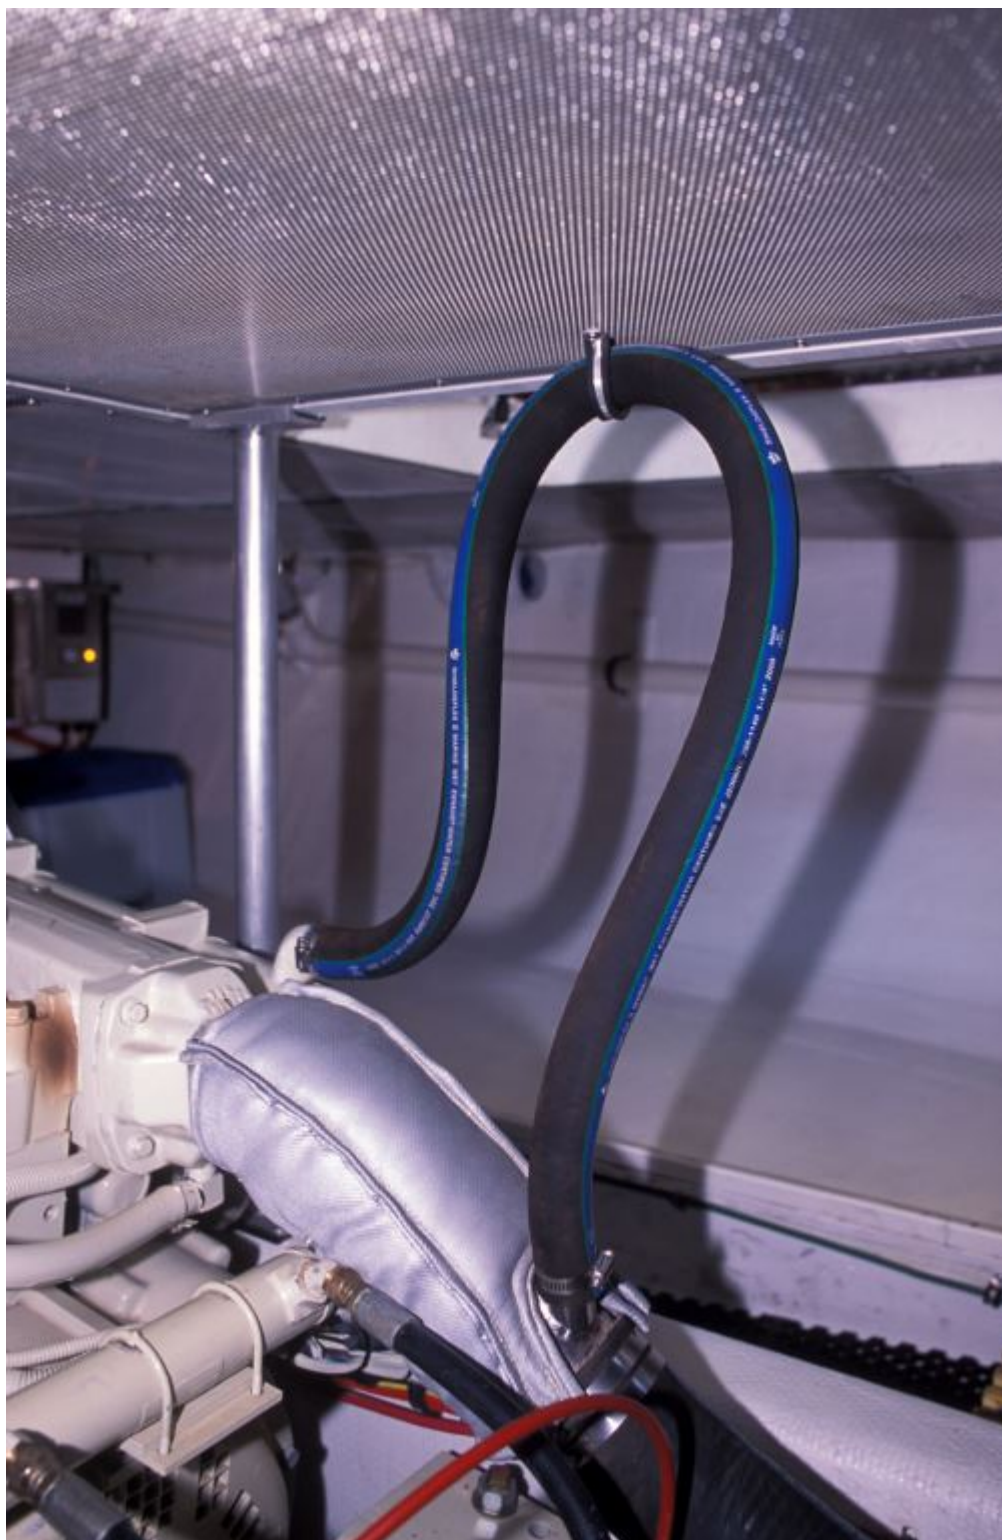
Defective, clogged, improperly installed, or absent anti-siphon valves can lead to engine flooding.

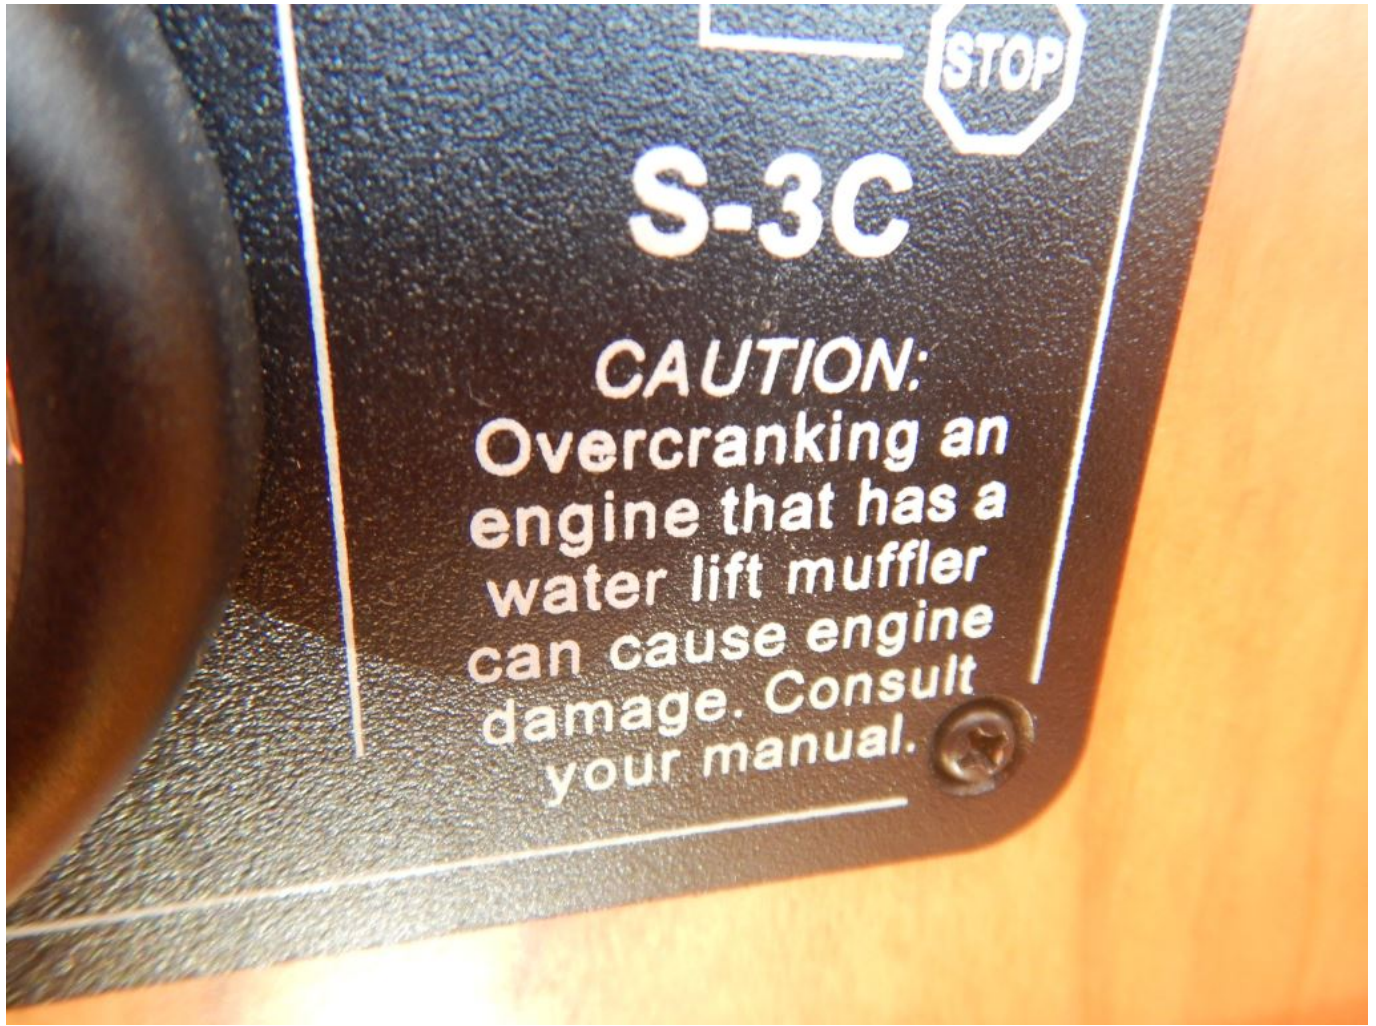
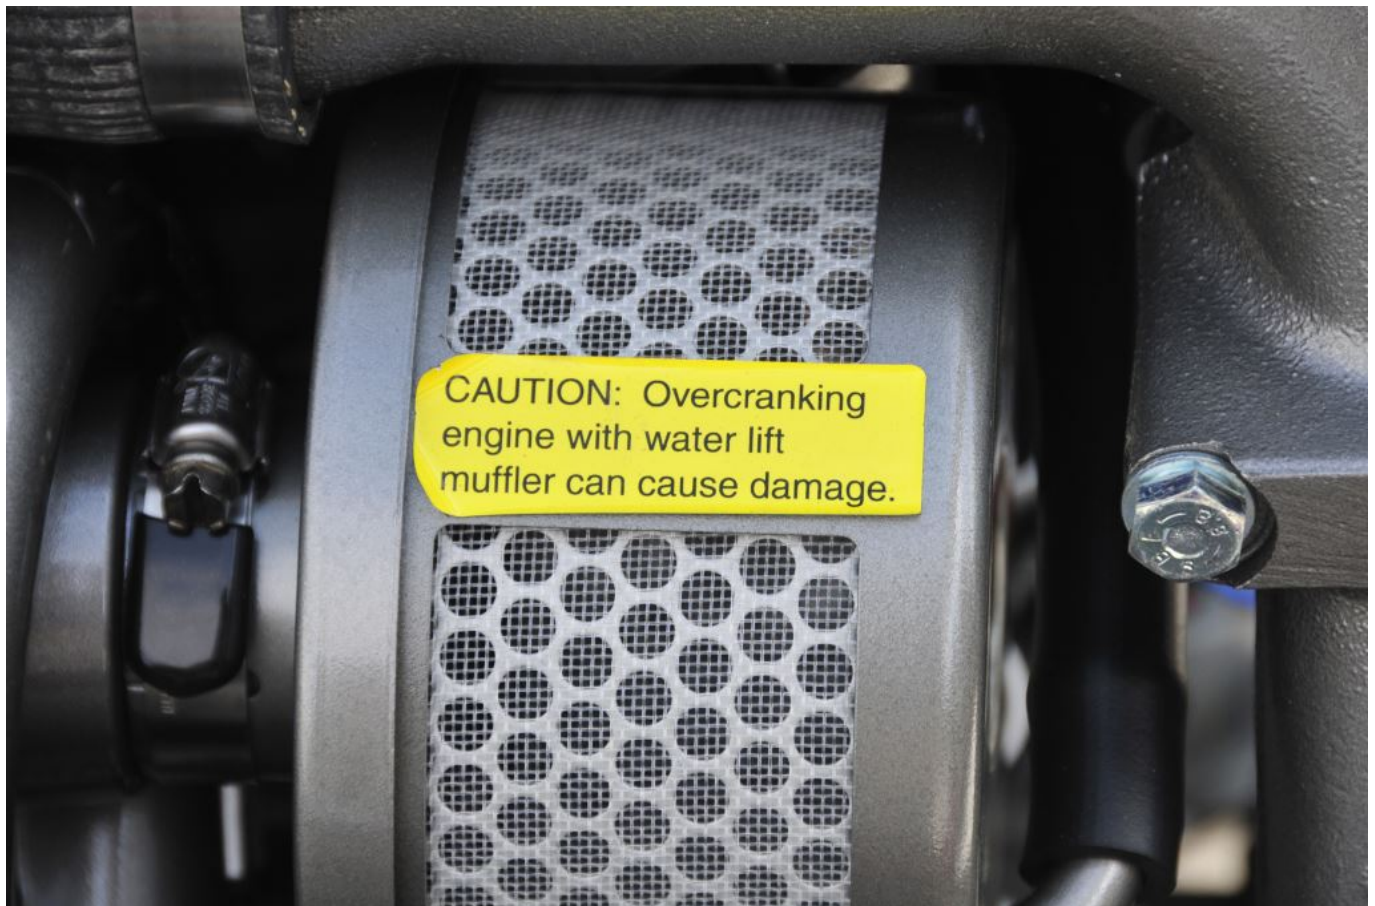
If an engine or genset is cranked excessively, a potentially normal occurrence when bleeding air from a fuel system, even a properly designed exhaust system can experience engine flooding.

Three, the engine is cranked excessively while bleeding the fuel system; with each revolution a small amount of seawater is pumped by the raw water pump into the exhaust system, which eventually overflows back into the engine, and once again

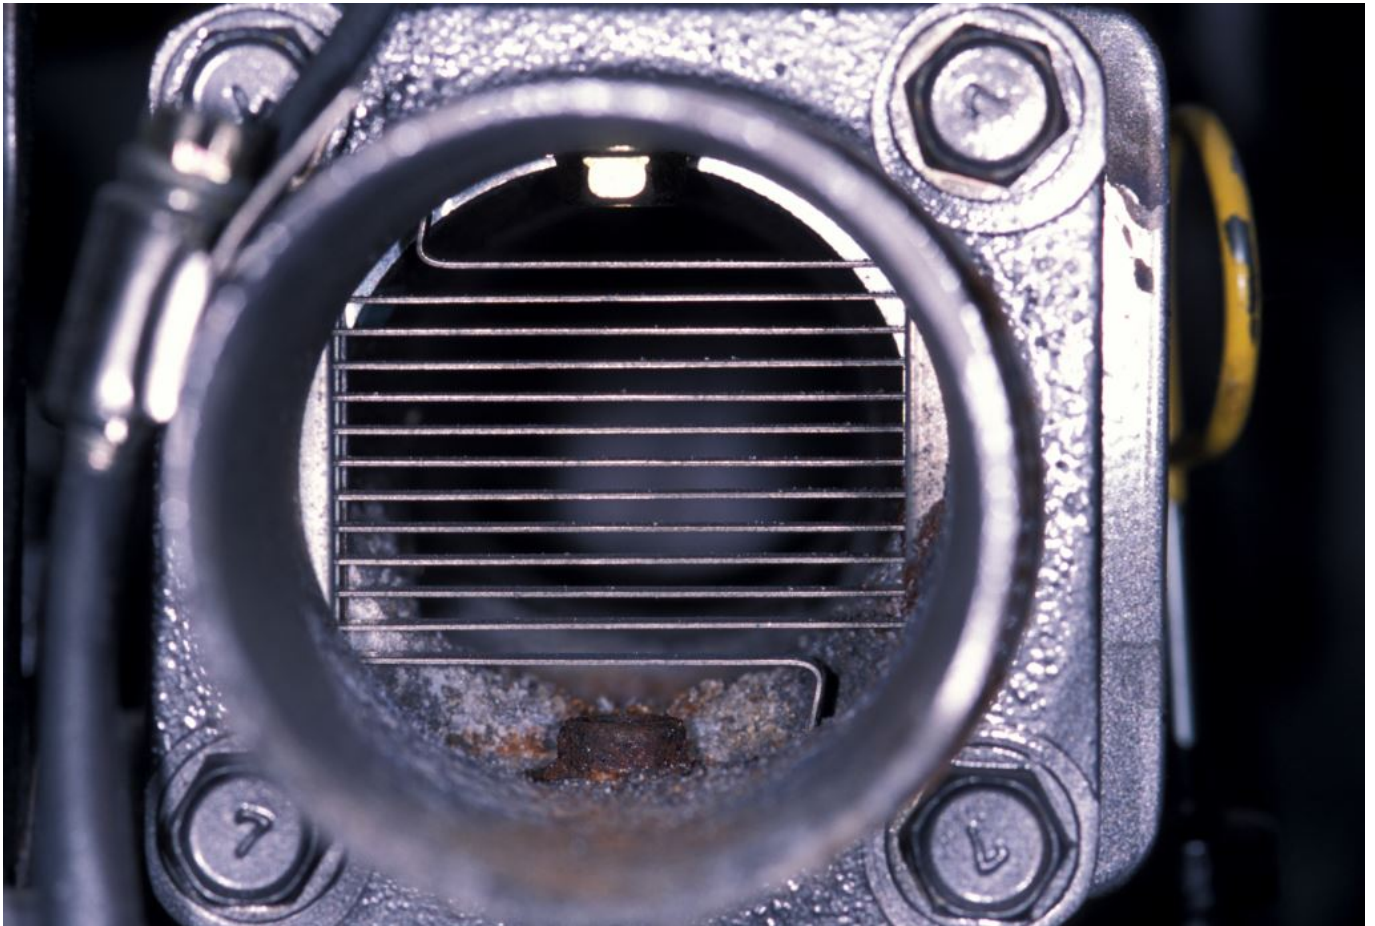
The telltale corrosion and salt accumulation at the bottom of this intake plenum is an indication this engine has experienced a flooding event.

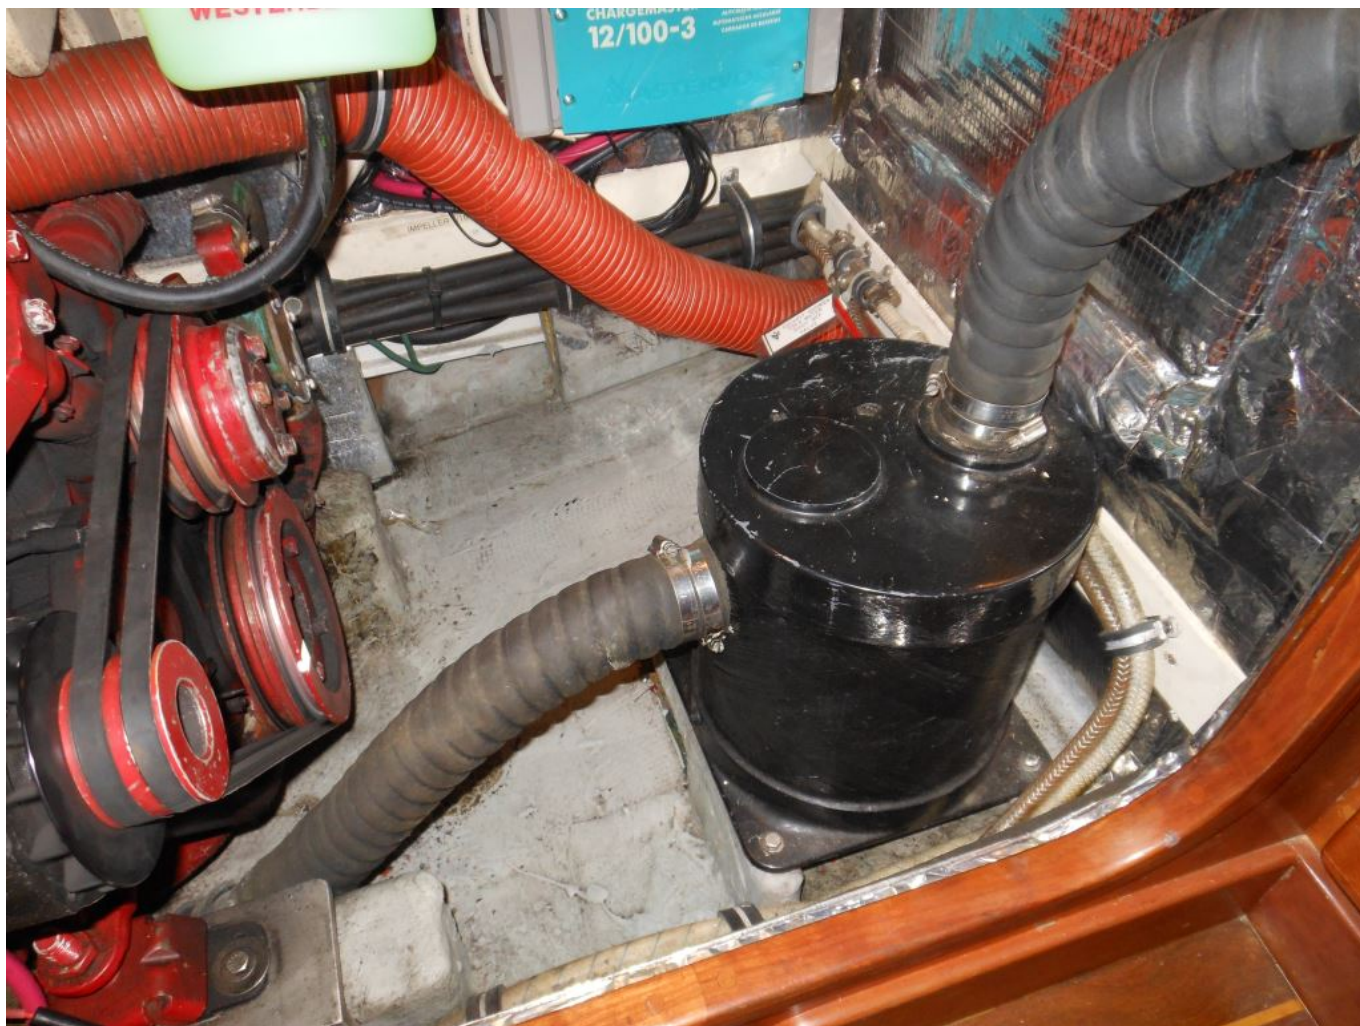
An improperly designed exhaust system, this one will trap water between the mixing elbow and muffler, is one of the leading causes of engine flooding.

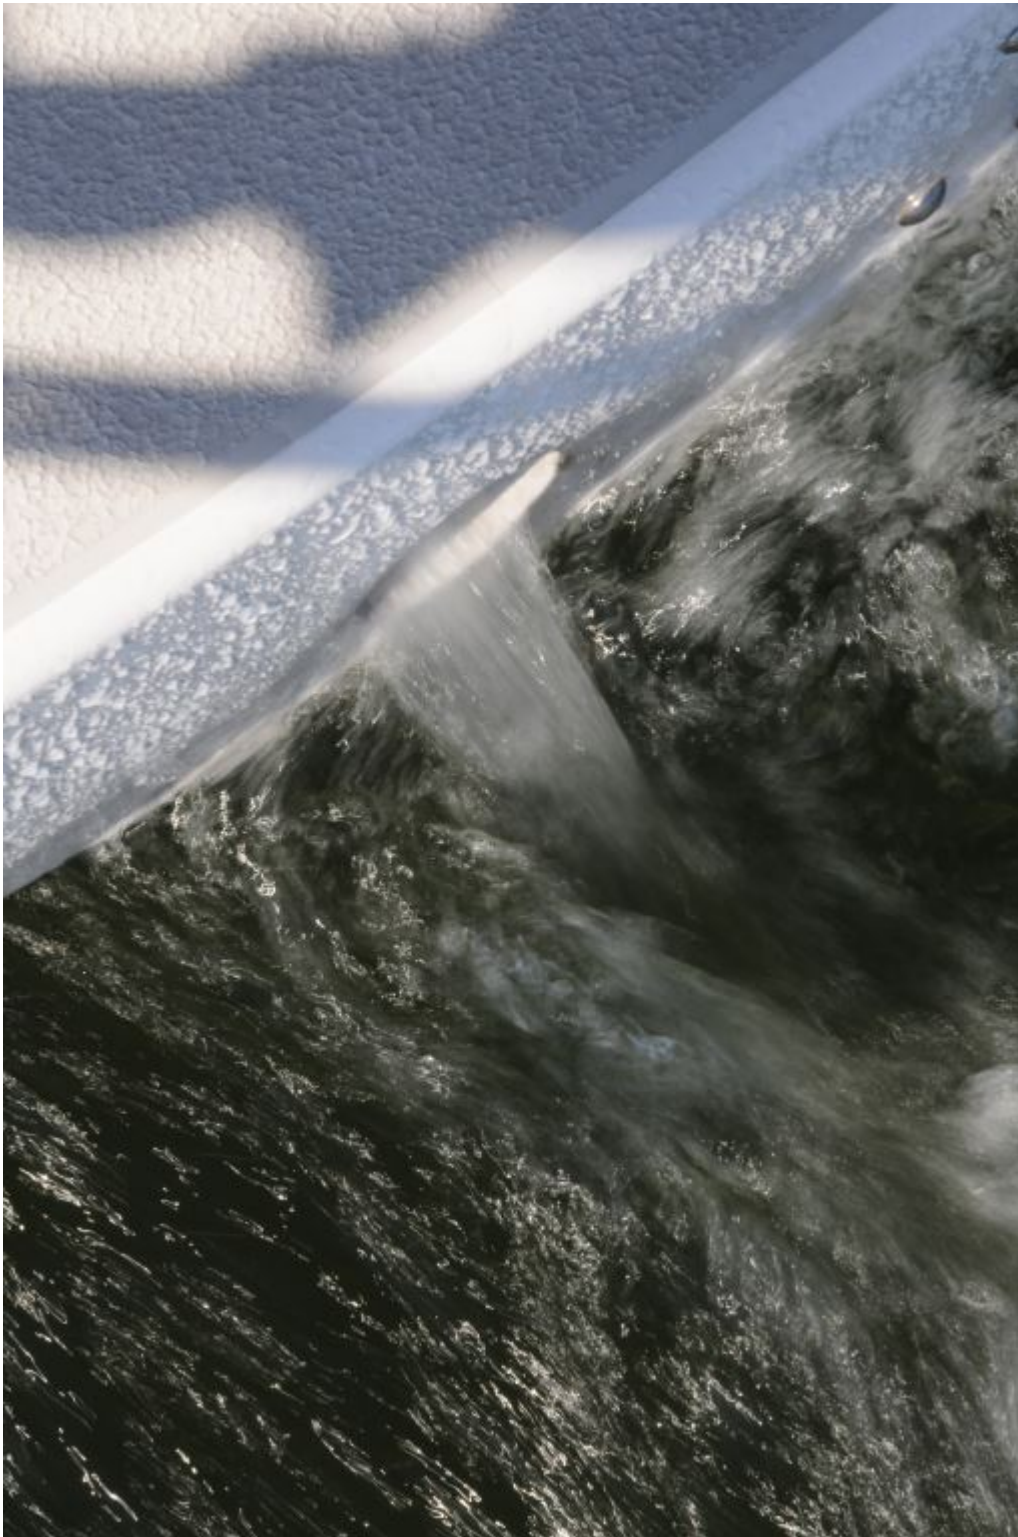
It is possible, especially for sailing vessels, for water to enter the discharge, even in a properly designed exhaust system.

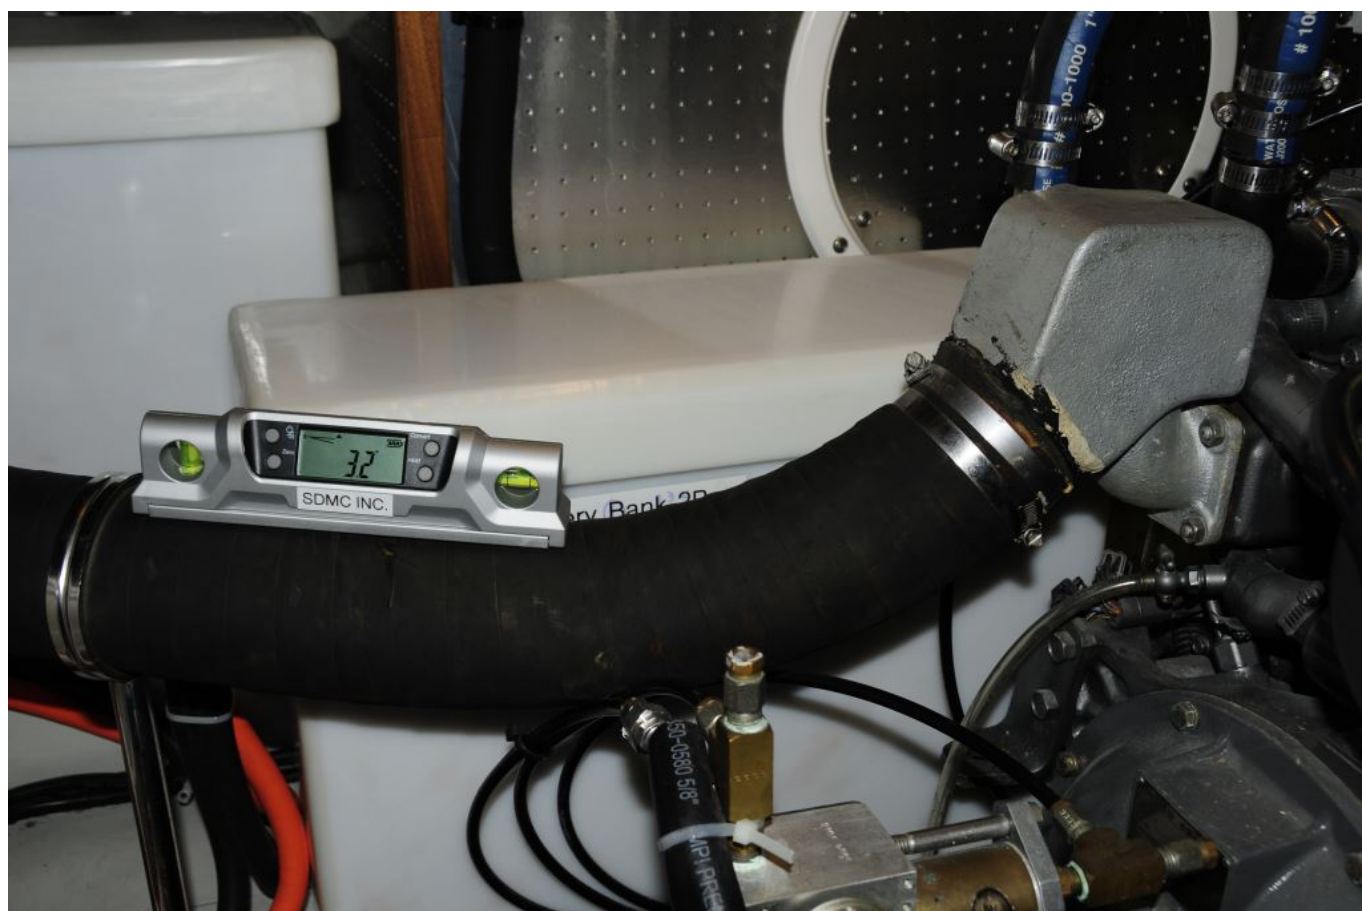
A cardinal sin of exhaust system installation involves trapping water between the mixing elbow and muffler.

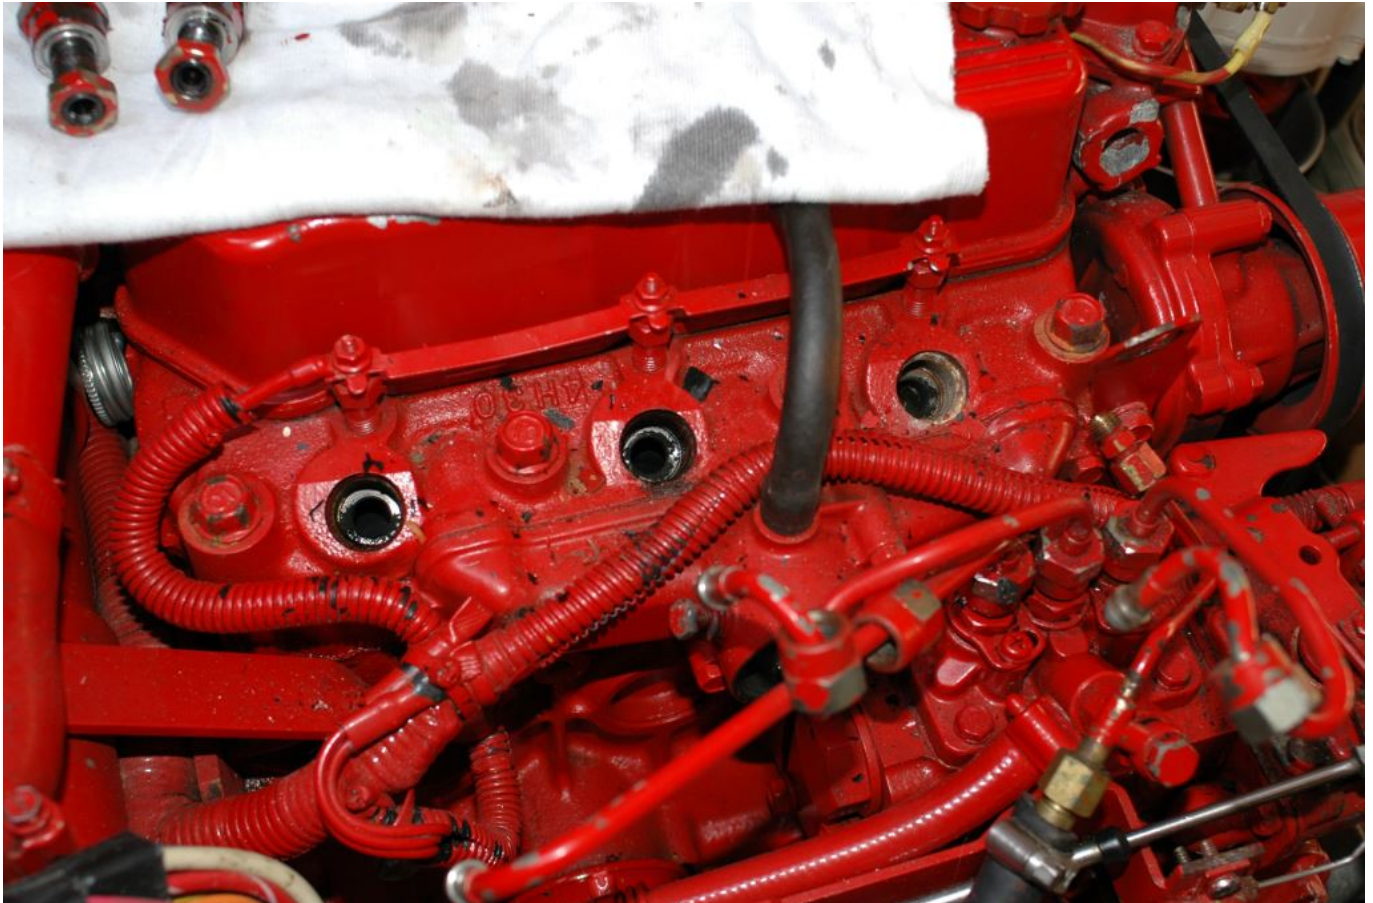
In order to allow water to exit the cylinders, injectors or glow plugs (the latter are usually easier) must be removed before attempting to manually turn over the engine.

1. Open or turn off the start battery switch, and turn off the fuel supply.
2. Wear safety glasses (I wear safety glasses whenever doing any mechanical work)
3. Remove the injectors or, if equipped with glow plugs remove those.

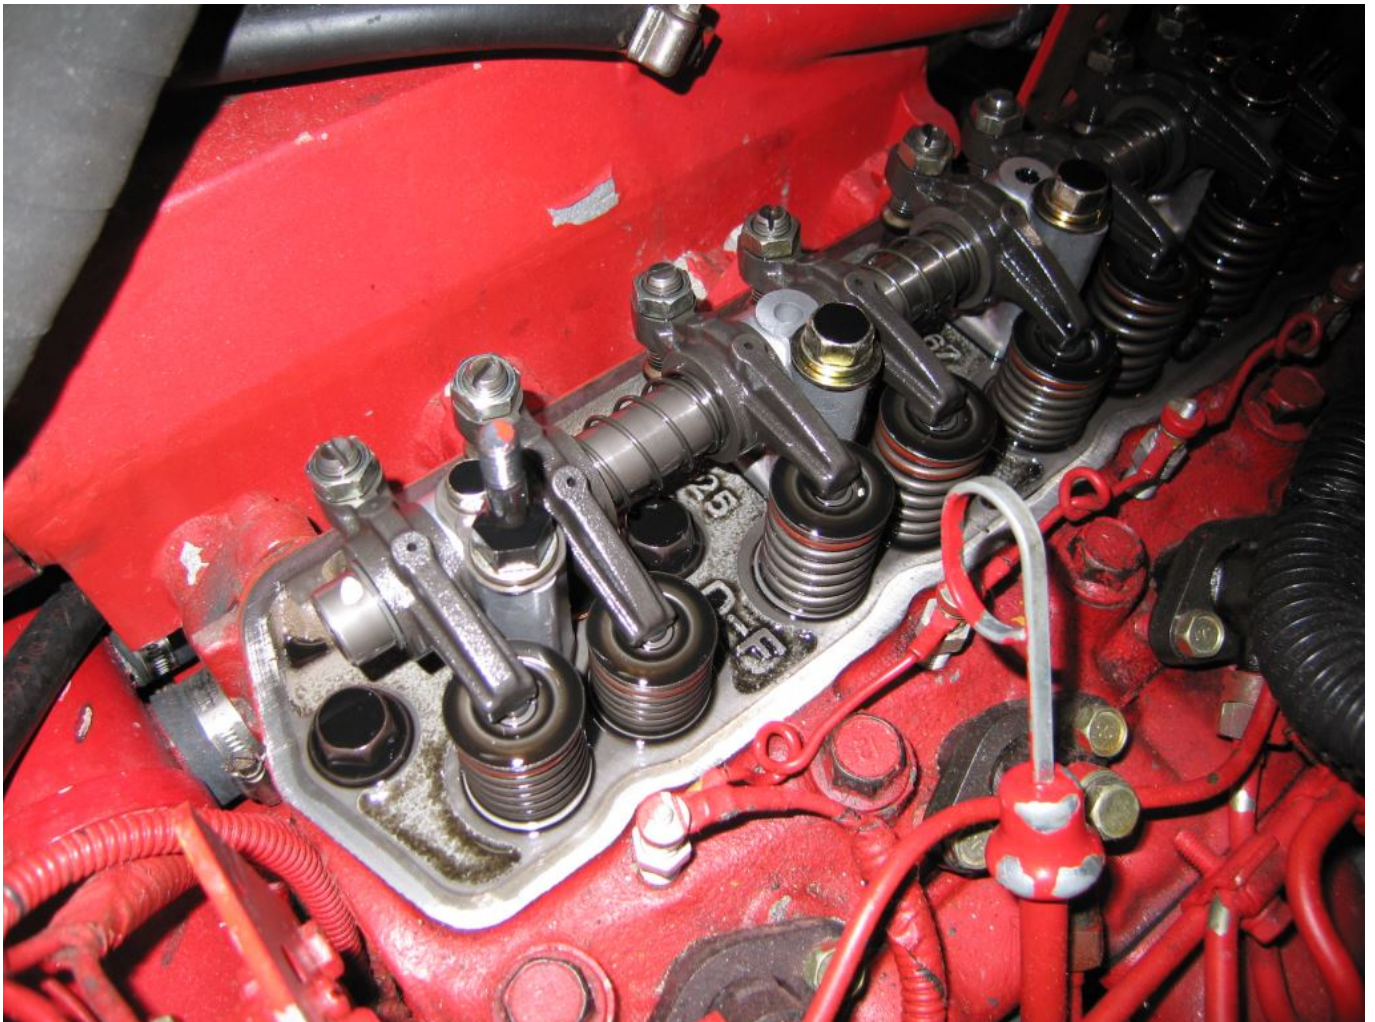
If an engine's valve train components do not move freely, they can be damaged when the engine is rotated.

4. Using a light plastic head hammer, tap each rocker arm over the valve, and observe whether the valves and rocker arms move freely, or are they seized? If any rocker arms or valves seem sticky, or don't move immediately when tapped, there is a possibility of valve, valve train and piston damage *if the starter is engaged*. At this point, a decision must be made whether to remove the cylinder head.
