February 2025 Newsletter – Plumbing Bonding Technique

Photo Essay: Plumbing Bonding Technique

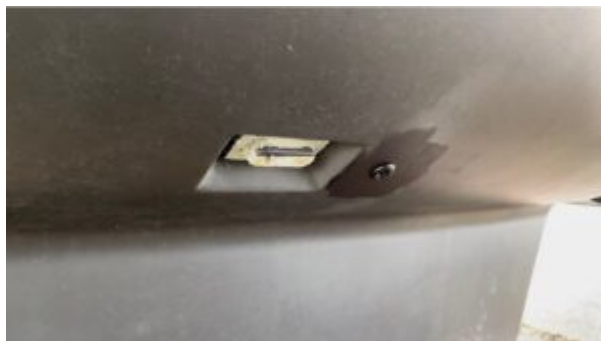
Currently the vessel has two grounds per side as manufactured, plus a larger one on the starboard side. They are only connected to the chainplates on either side of the catamaran.

Can these be used in the system?

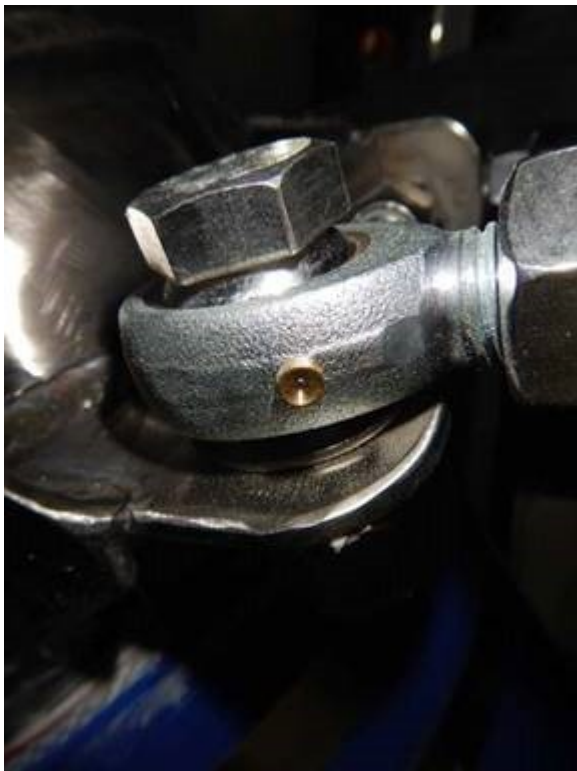
The steering ram end fitting, sometimes called a ball joint rod end, failure is note-worthy for two reasons. First, unless it was removed, I don't see the plastic insert that is often present between the inner ball and the outer cage. If it's missing, there would be considerable slop in the system. The plastic insert is slippery, providing lubrication, which means no grease is required. If none was present from the start, the ball joint would usually be equipped with bronze bushing and a zerk fitting, to allow the injection of grease, or a small hole, which also is used to inject grease with a rubber tip grease gun fitting (those are not common, so these often go ungreased, see the example photo below).

Two, the cage appears to have "sprung", which seems odd, as if it was under tension, or it elongated after the crack occurred. Either way, this is a disconcerting failure. The rust is indicative of crevice corrosion, all that's needed for that to begin is a micro-fracture and seawater. Was it

getting wet? Also, in this design, the fasteners that secures the ball joint to the tiller arm should never wear out; if it is properly tensioned, it becomes one with the center ball, within the cage, so all the movement, and wear, occurs between the inner ball and the cage (or the insert or bushing). If the fastener is allowed to move, it will wear, and this will also cause wear inside the hole through which it passes in the tiller arm. This detail is often lost even on boat builders, who believe the fastener must be left loose to prevent binding.

The second issue is in regard to the ball joint rod end connector between hydraulic cylinder and rudder tiller arm. While underway on autopilot this summer with the Admiral driving, I went into the lazarette and noticed that there was movement between the rudder tiller and the ball joint rod end. A visual inspection of the portion that I could see did not find anything alarming. I guessed the likely reason was wear and tear on the 5/8" bolt that connects the rod end to the tiller and decided to replace it at season's end. When I dismantled the joint, I was surprised to see that the connector was broken clean through around the ball. I have had this boat since 2010 and have never hit anything with the rudder, at least that I am aware of. And surely if I hit something hard enough to break the rod end, I would be aware of it. So, I wonder if it was something other than an impact that broke the rod end? You can see from the [not very good] photo that there is rust on the face of the break. Since this fitting is stainless steel, I wonder if there may have been a crack there from the manufacturer and crevice corrosion did its thing? Or is there a weld there that hardened and eventually failed? Can you speculate on what caused this crack? Maybe this joint is something for all of us to check
