February 2025 Newsletter – Plumbing Bonding Technique

Photo Essay: Plumbing Bonding Technique

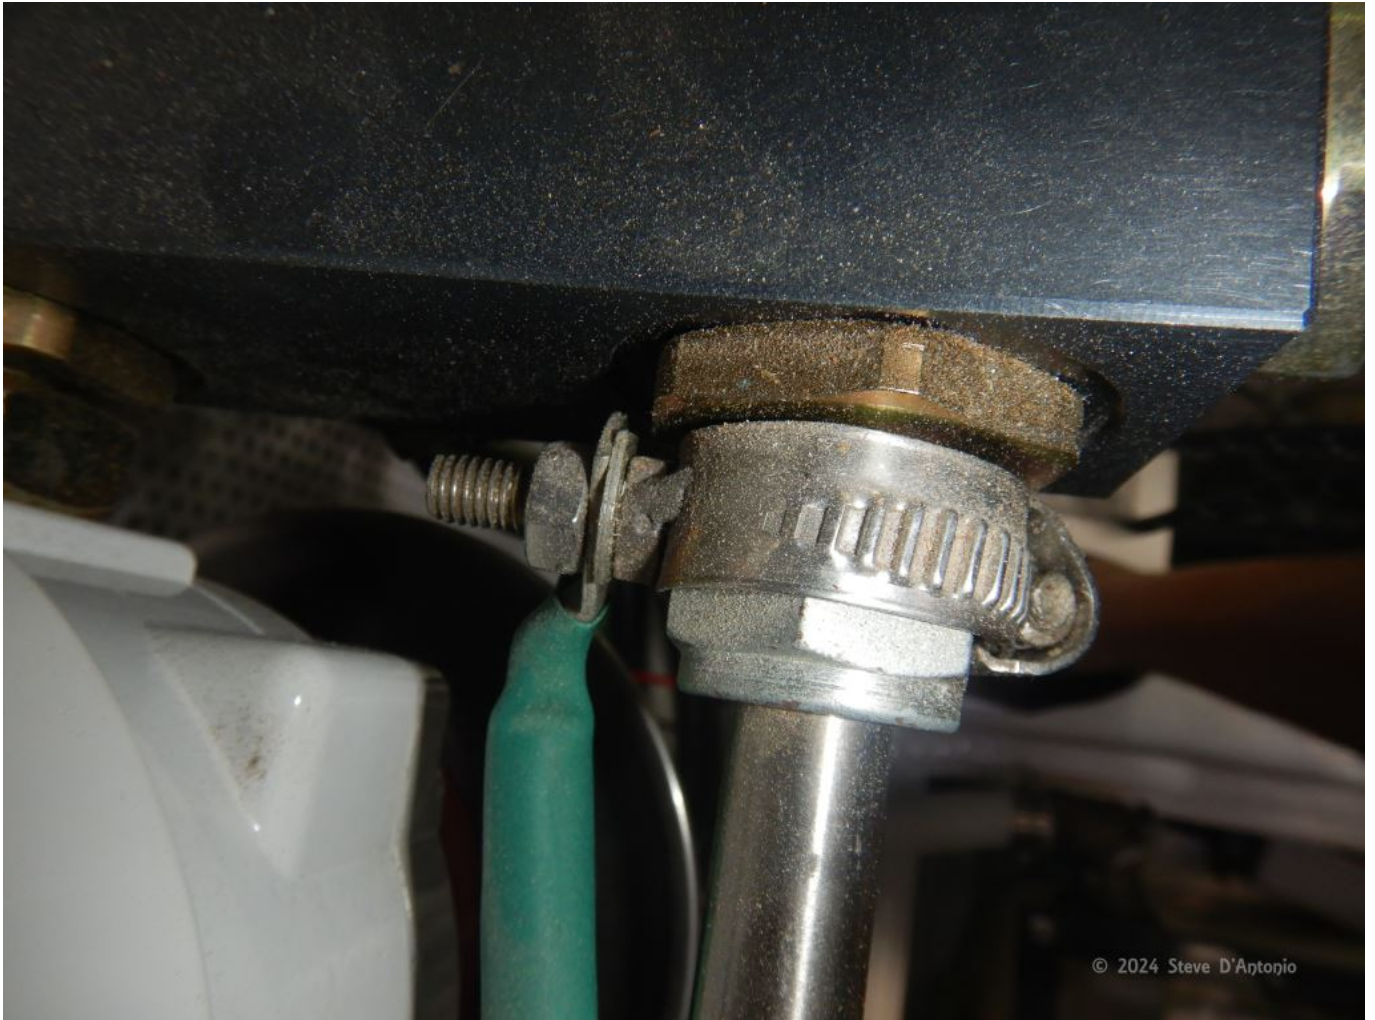
The accompanying image depicts what I believe is the best approach I've encountered yet; a stud that is passed through a hole that has been drilled in a hose clamp. The clamp presses the head of the screw tightly against the plumbing fitting, making good, reliable, and low resistance contact, and a ring terminal is then placed over what is now a stud. In this case the installer has also gone the extra step of welding the fastener to the hose clamp. While that represents a belt and suspenders approach, I don't believe it is necessary to achieve the required low resistance connection with the the bonding or grounding systems.

Many, however, have no fastener or provisions for attachment of wires, and so boat builders and technicians are left to devise a means of reliably making a low resistance (for cathodic or corrosion protection, the maximum allowable resistance between an anode and a protected metal is one ohm) connection to these items. In too many cases this means a section of bare wire attached to a plumbing fitting with a hose clamp. These are prone to corrosion, loosening, and damage to wire strands. An only slightly better scenario involves a ring or barrel terminal retained under a hose clamp.

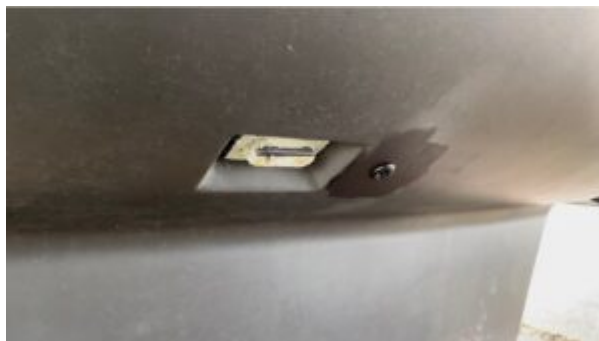
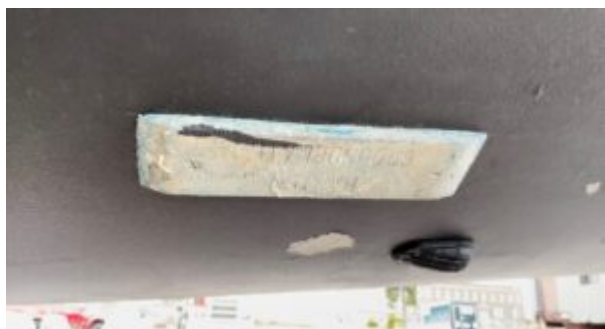
Currently the vessel has two grounds per side as manufactured, plus a larger one on the starboard side. They are only connected to the chainplates on either side of the catamaran.

Can these be used in the system?
