# July 2024 Newsletter – Through Hull Durability

## Photo Essay: Through Hull Durability

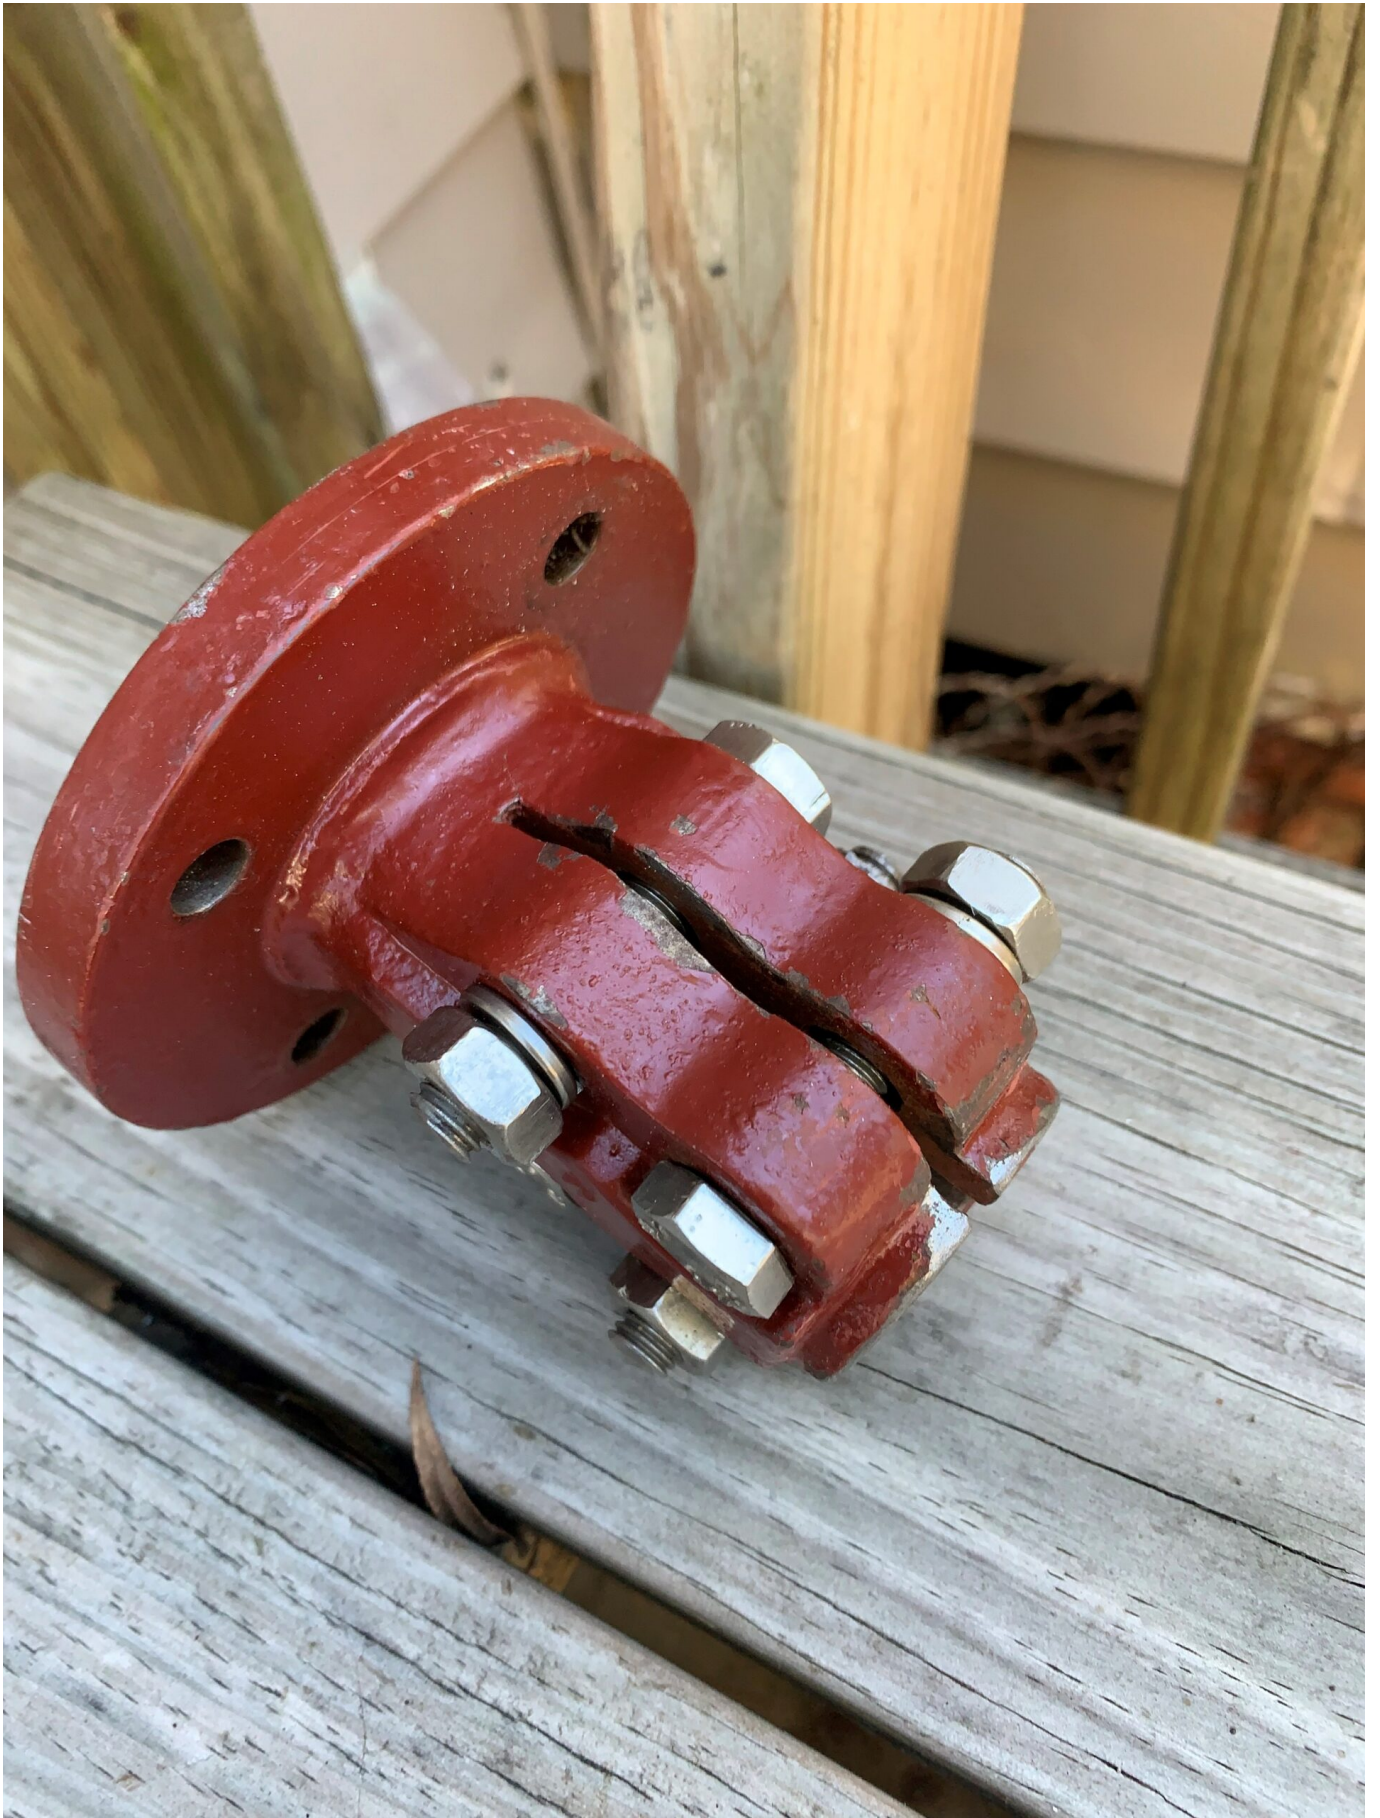
I need to replace my 25mm 54" prop shaft (37 years old, scored in stern tube bearing area), on a 42' sailboat with Beta 50hp. I am buying one from General Propellor, an Aqualoy 22 (only grade they stock in 25mm, fine with me).

If the coupler is okay to keep, bolt holes are 12mm, present SS grade 80 bolts are 10mm. Bolts are inexpensive, assume replace with Gen Prop 7/16 sets. They don't actually say what grade they are, will check.

Given the choice, I prefer a tapered coupling, and especially if you are replacing the shaft, the coupling itself is relatively inexpensive. For all the reasons detailed in this article, tapered couplings offer a host of advantages. Split couplings sometimes forgo keys, however, in those cases they typically use a scallop, clevis, roll or taper pin to retain the shaft. It appears yours has none of these, which would concern me. Again, a tapered coupling eliminates all of these issues. Alternatively, you could use a straight bore coupling, with keyway, which would typically use a set screw for shaft security.

Coupling fasteners should always fill the hole in the coupling (and anywhere for that matter), so these should be replaced with properly sized fasteners. For this application grade 5 mild steel is acceptable, grade 8 would be better. These will require corrosion inhibition.
