Keeping the Keel Attached

Text and Photos By Ralph Naranjo

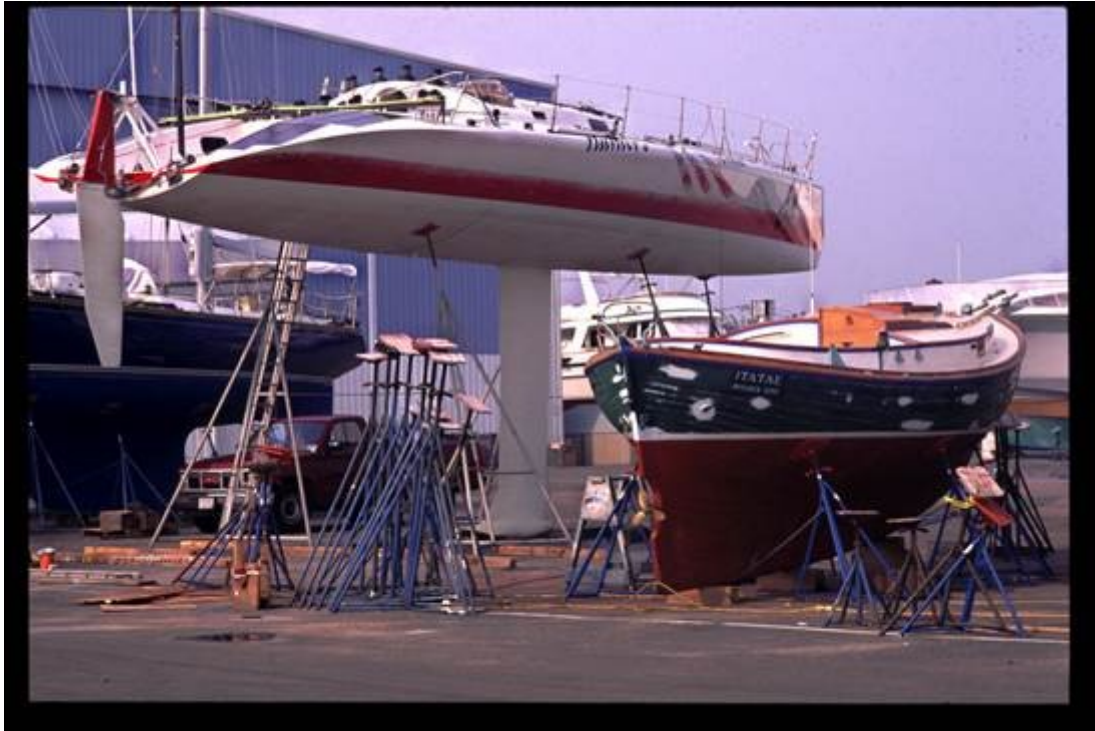
Like bookends of keel design, these two under body extremes reflect how keel loads can be tightly focused or widely dispersed.

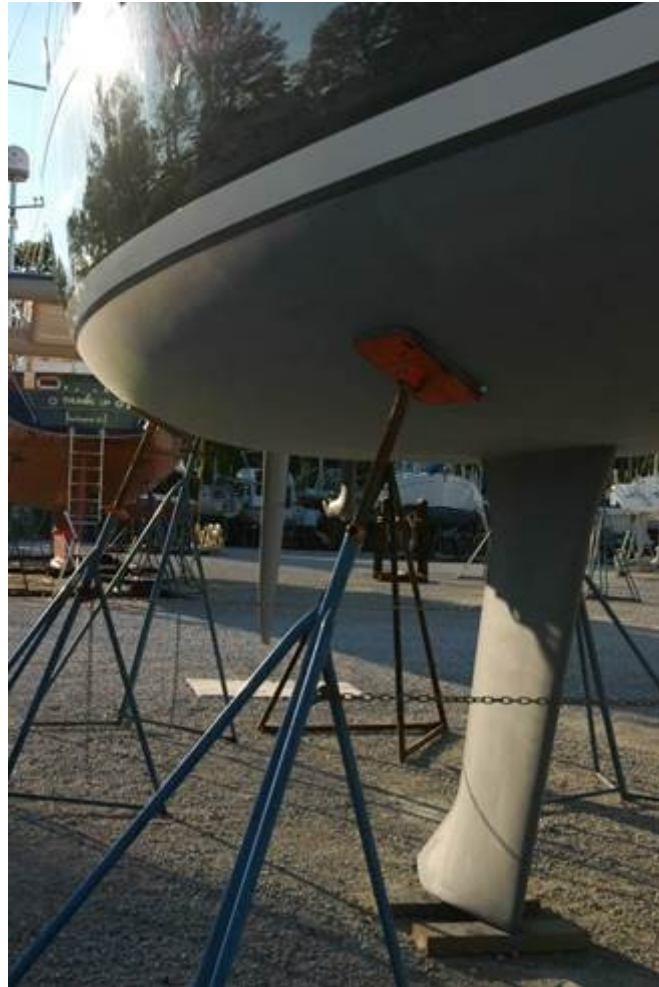
Over the years keel length has been shortened, separate free standing rudders added and ballast lowered. All acceptable traits if the engineering and construction accounts for new stresses and strains.

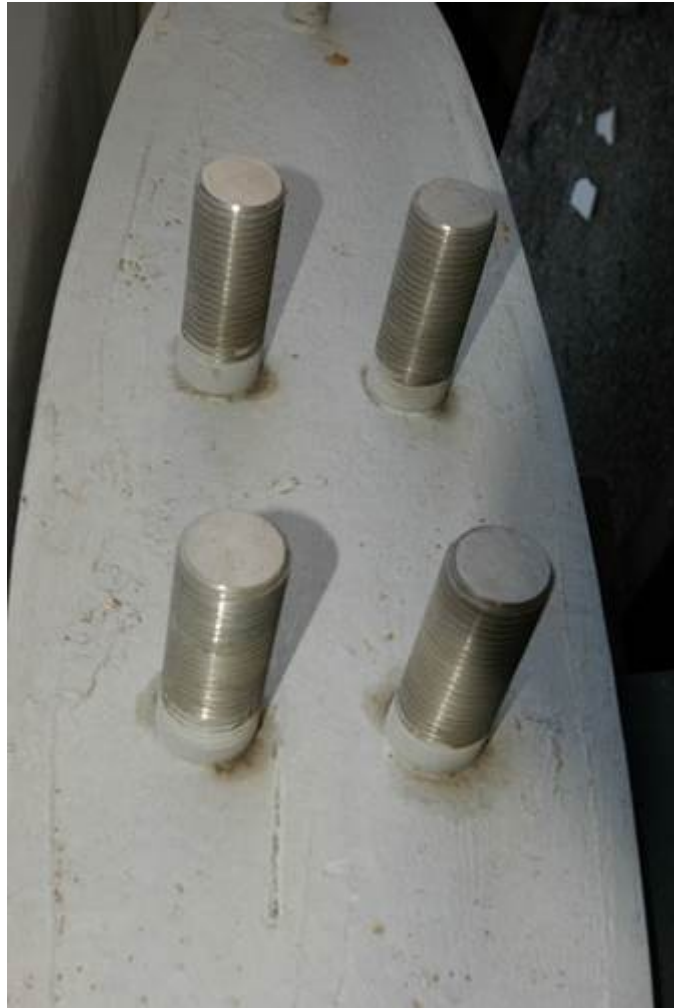
Keel bolts are most often cast into lead keels while iron keels are drilled and tapped to accept a keel bolt. Iron is lower in density and much more corrosion prone than lead, it's a second rate choice as ballast material.

When reattaching, make sure the yard does a “dry” fit to make sure the faying surfaces make complete contact with each other. The keel bolts provide tension but it's the surface to surface contact of the keel and the stub at the garboard seam that carries the load. Using excess seam sealant to make up for imperfections in the mated surface will lead to excess flex with each tack. In some cases a FRP fillet must be made to create the necessary machine fit.

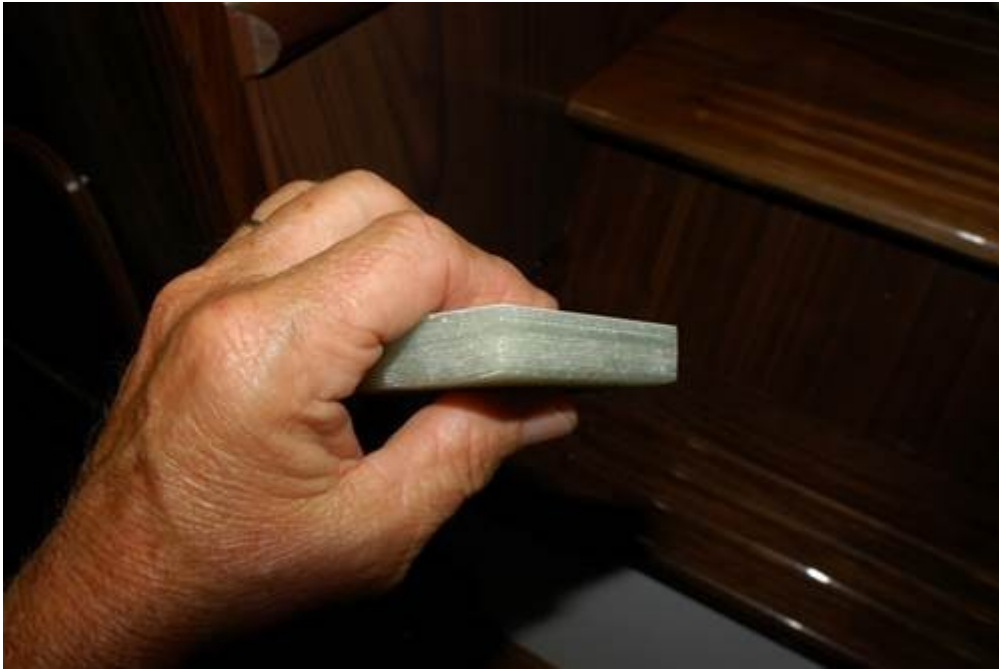
A sample of the solid FRP laminate in the keel stub area of a well-built hull.

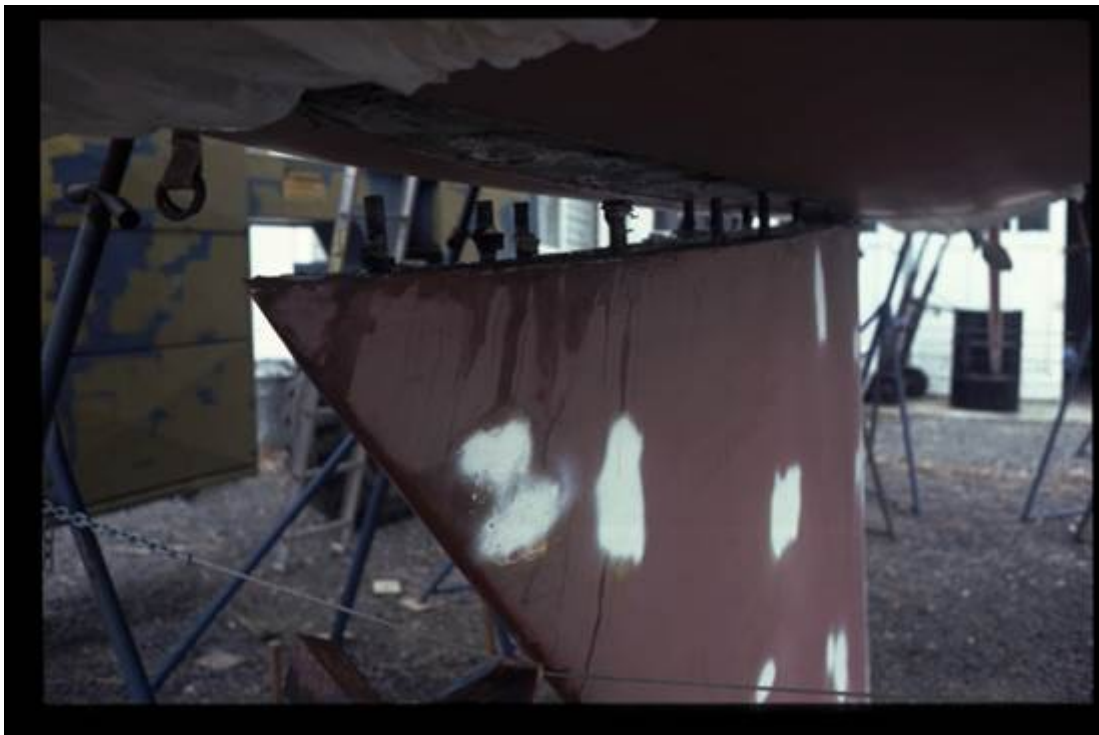
Despite an appropriate number of 316 stainless steel keel bolts, a hard grounding can result in significant hull damage, especially on a more flat bottom hull shape.

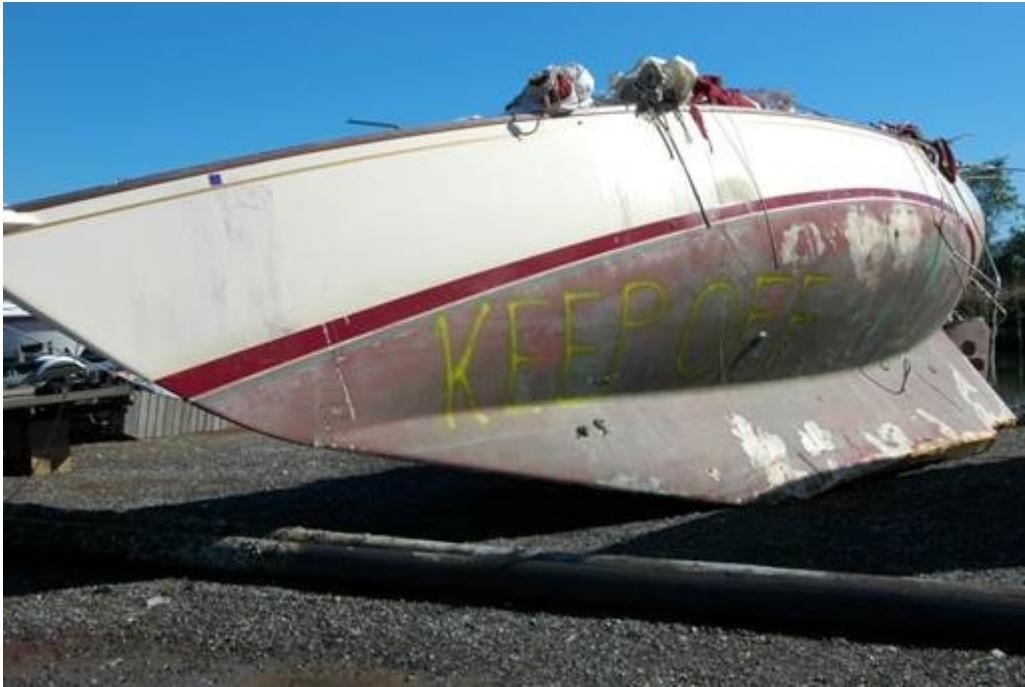
An encapsulated ballast keel on a vessel blown ashore in a storm, note that despite heavy damage the ballast remains intact.

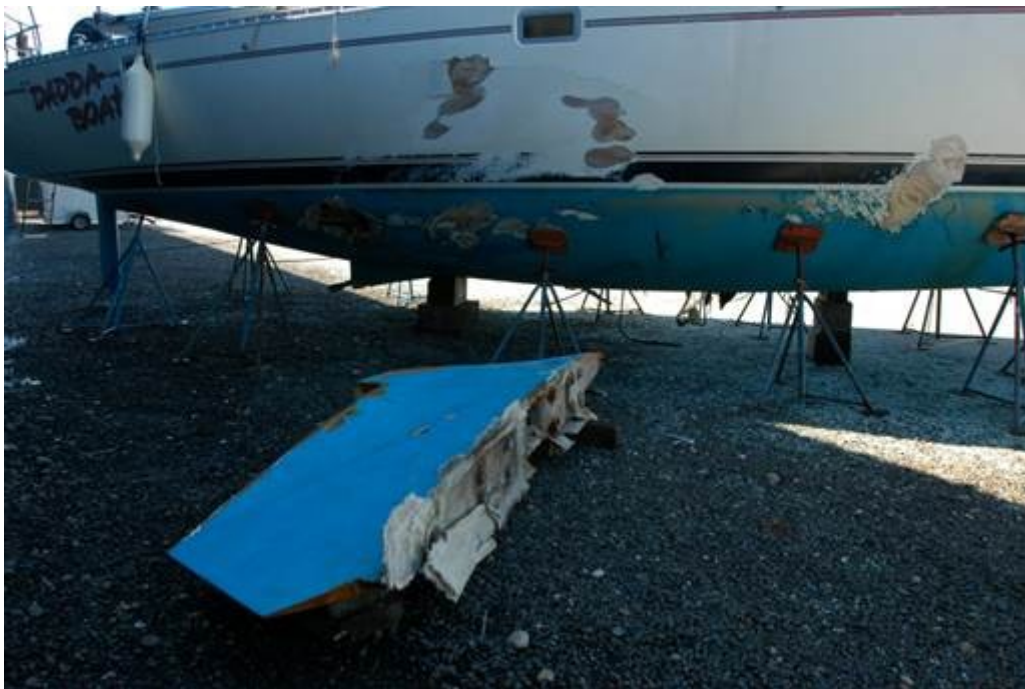
An external ballast keel torn from the hull of a vessel in the same storm, note how thin the bottom laminate happens to be.
