# November 2024 Newsletter Inverter Disconnect

# **Photo Essay: Inverter Disconnect**

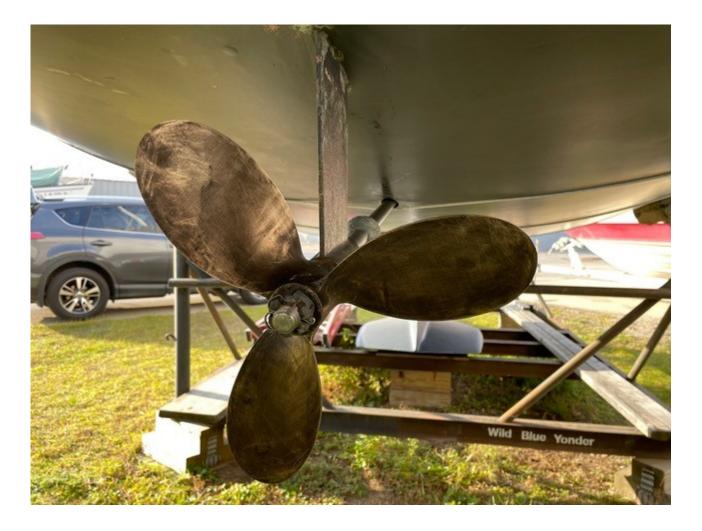
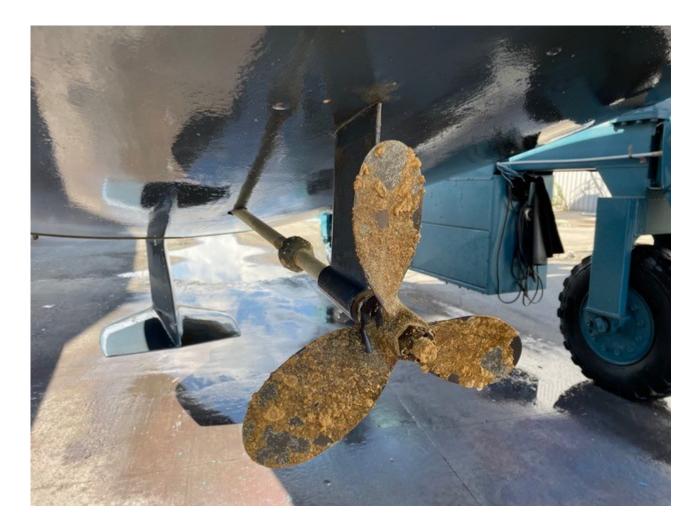
This past October, we hauled the boat for the season, and there was a hard thick coating mostly on the bronze prop, but also heavy on the stainless shaft tip and some on the zinc anode and bronze strut. My first reaction was, "Oh crap I just cooked a thousand-dollar prop with galvanic corrosion" but after an aggressive power washing and scraping with a metal putty knife, I found there was no pitting or metal lost In fact, the threads on the stainless shaft were to be found. untouched and even the cotter pin was 100% intact as you can see on the second attached photo after cleaning. The drivetrain was clean as a whistle when the boat was splashed in May of 2022, so the first attached photo shows one season's worth of buildup. What's strange is that nothing was really changed on the boat since the new isolator installation in 2020 and there was no buildup or anything odd in any previous I talked with the two boatyards that service our season. marina and even stranger is that out of all the boats, a couple of hundred that slip in Menominee, I was the only one with this odd coating.

Without some level of testing, it's difficult for me to speculate on the cause behind the buildup, however, it appears to be calcareous in nature. Calcareous coatings are often found on zinc anodes when used in fresh water, however, I have never seen that extend to the metals they are ostensibly protecting.
