November 2024 Newsletter – Inverter Disconnect

Photo Essay: Inverter Disconnect

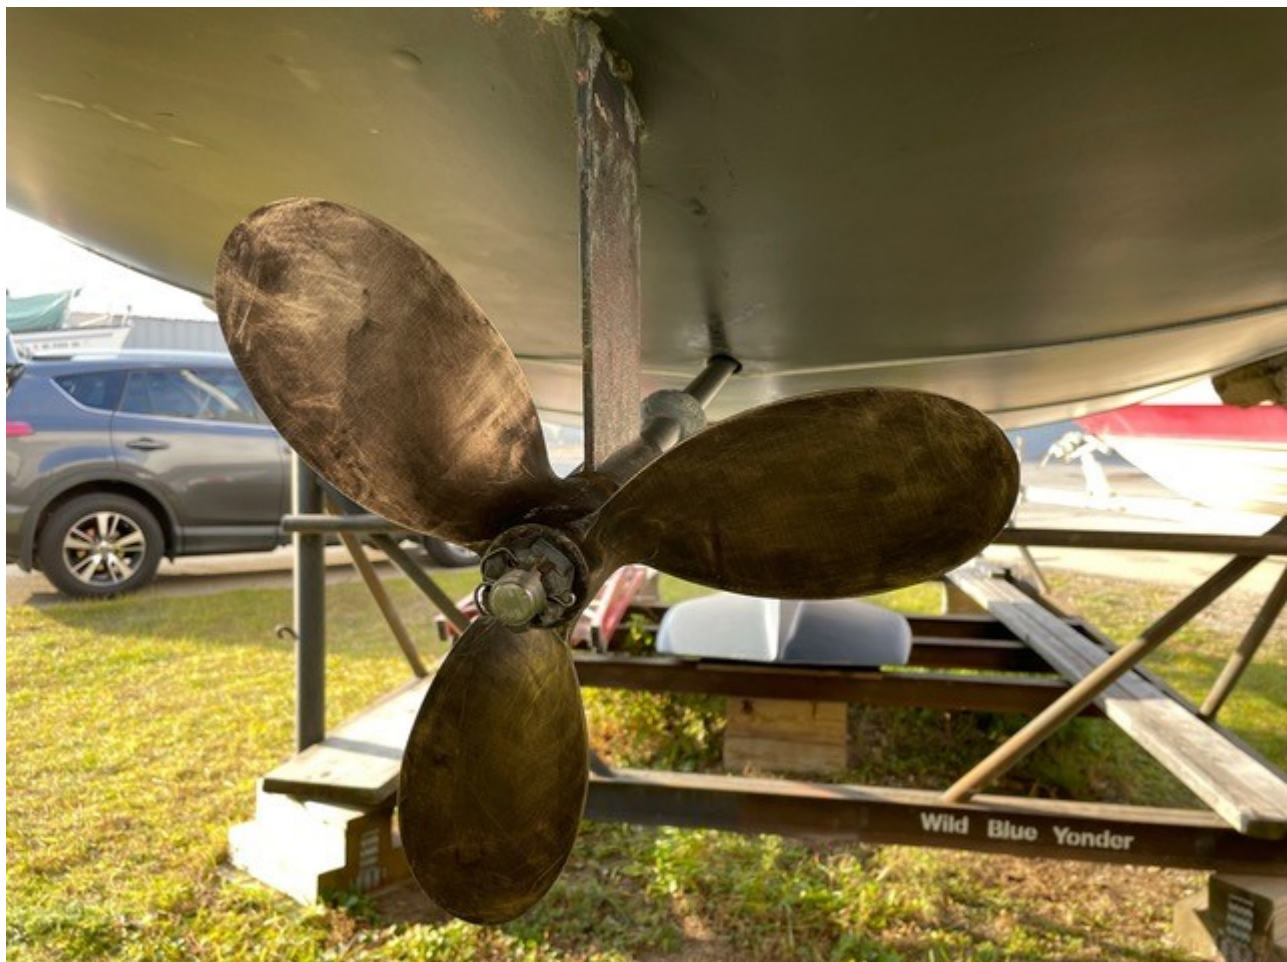
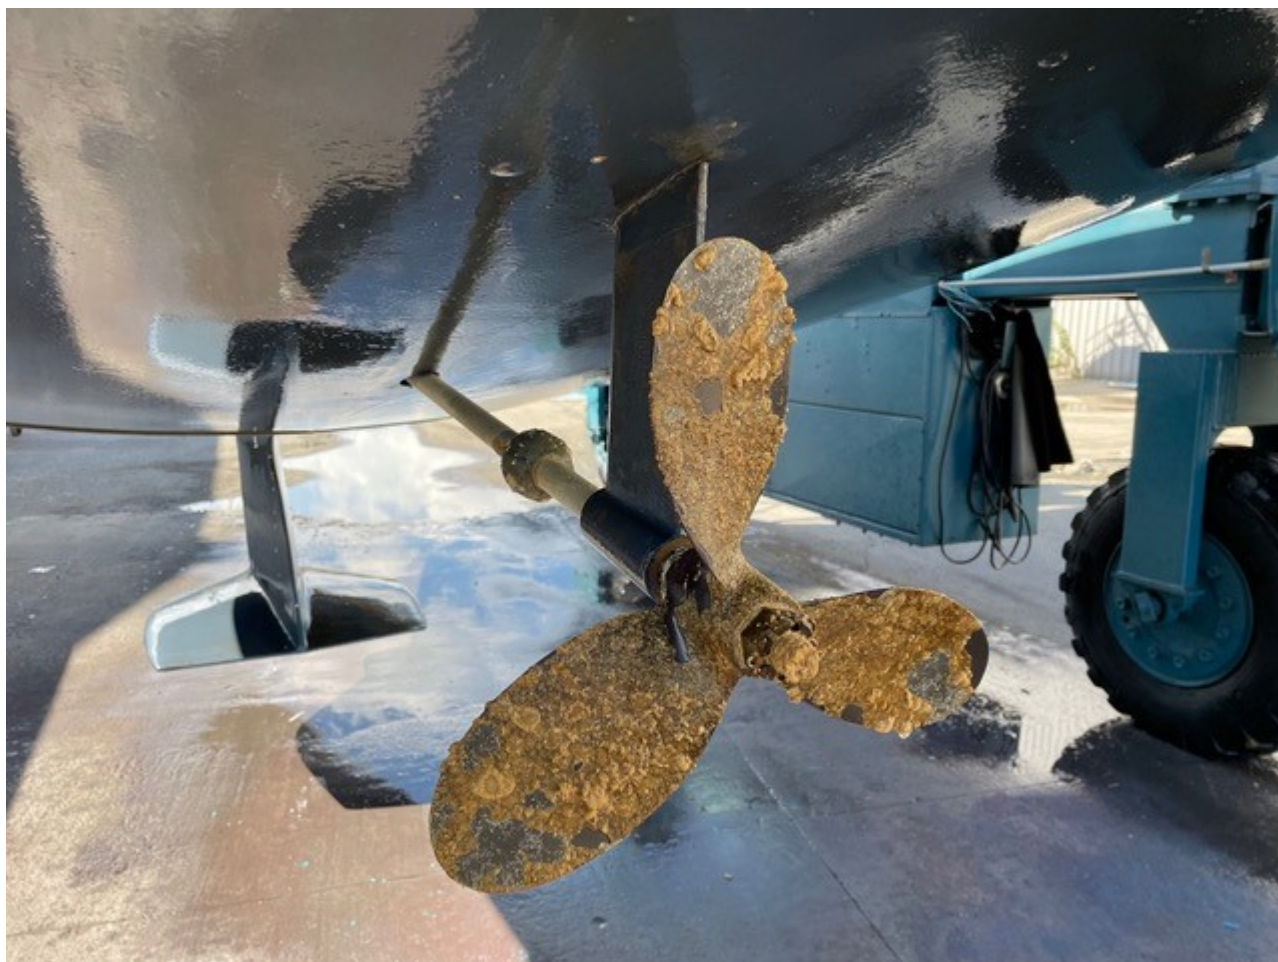
This past October, we hauled the boat for the season, and there was a hard thick coating mostly on the bronze prop, but also heavy on the stainless shaft tip and some on the zinc anode and bronze strut. My first reaction was, "Oh crap I just cooked a thousand-dollar prop with galvanic corrosion" but after an aggressive power washing and scraping with a metal putty knife, I found there was no pitting or metal lost to be found. In fact, the threads on the stainless shaft were untouched and even the cotter pin was 100% intact as you can see on the second attached photo after cleaning. The drivetrain was clean as a whistle when the boat was splashed in May of 2022, so the first attached photo shows one season's worth of buildup. What's strange is that nothing was really changed on the boat since the new isolator installation in 2020 and there was no buildup or anything odd in any previous season. I talked with the two boatyards that service our marina and even stranger is that out of all the boats, a couple of hundred that slip in Menominee, I was the only one with this odd coating.

across the stainless shaft and zinc itself. With this much build up, my guess is that there's some sort cathodic issue taking place and I'm pushing a positive current into the water, as you would on a pipeline using cathodic protection. I'm not sure if this could be the case, whether the isolator would block this from happening on the shore power, or where I should start looking to diagnose this problem. Any ideas on what's taking place here and course of action would be greatly appreciated. I obviously want to get it troubleshot before the summer season.

Without some level of testing, it's difficult for me to speculate on the cause behind the buildup, however, it appears to be calcareous in nature. Calcareous coatings are often found on zinc anodes when used in fresh water, however, I have never seen that extend to the metals they are ostensibly protecting.

My recommendation would be to replace the zinc with an aluminum anode, and then after launching the vessel carry out a reference cell test, to confirm you are neither over nor under-protected. I would also install an ABYC compliant galvanic isolator if not already present. You didn't mention if the vessel is bonded, however, if not, then each underwater metal, including the shaft must be tested. Either way, because the shaft is essentially isolated via an oil-filled transmission, its protection level should be tested.
