November 2024 Newsletter – Inverter Disconnect

Photo Essay: Inverter Disconnect

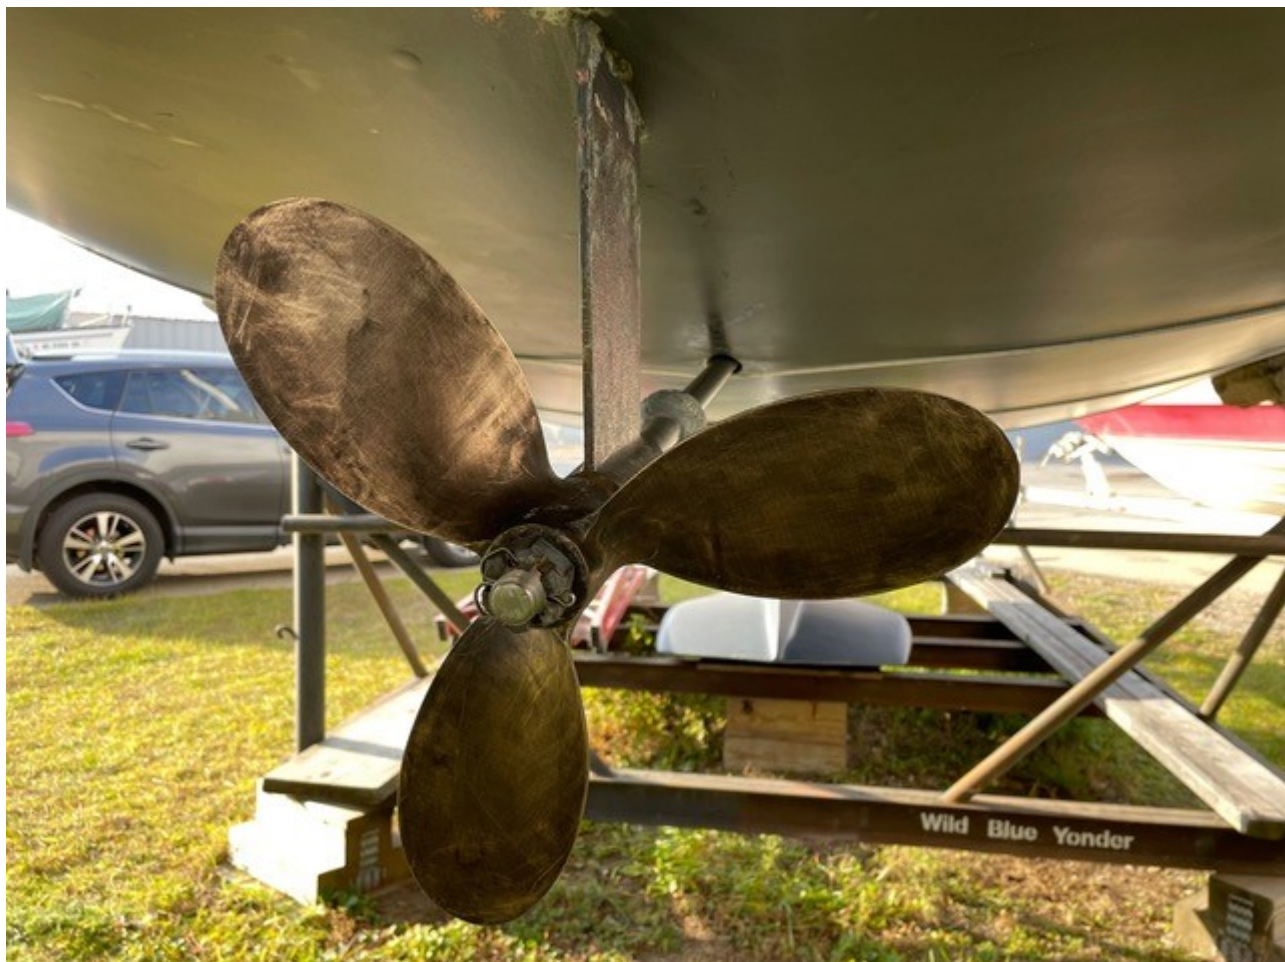
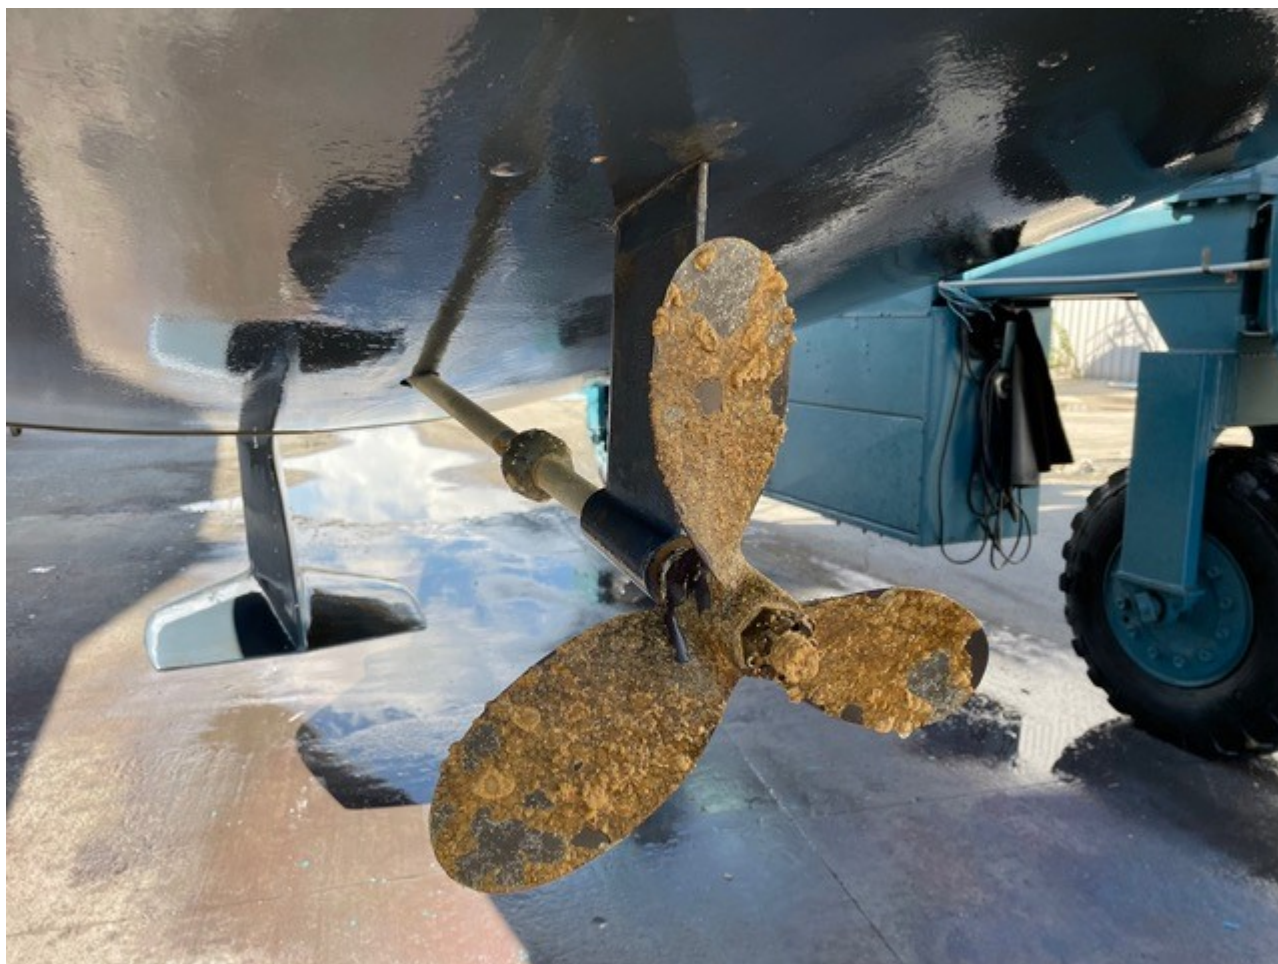
This past October, we hauled the boat for the season, and there was a hard thick coating mostly on the bronze prop, but also heavy on the stainless shaft tip and some on the zinc anode and bronze strut. My first reaction was, "Oh crap I just cooked a thousand-dollar prop with galvanic corrosion" but after an aggressive power washing and scraping with a metal putty knife, I found there was no pitting or metal lost to be found. In fact, the threads on the stainless shaft were untouched and even the cotter pin was 100% intact as you can see on the second attached photo after cleaning. The drivetrain was clean as a whistle when the boat was splashed in May of 2022, so the first attached photo shows one season's worth of buildup. What's strange is that nothing was really changed on the boat since the new isolator installation in 2020 and there was no buildup or anything odd in any previous season. I talked with the two boatyards that service our marina and even stranger is that out of all the boats, a couple of hundred that slip in Menominee, I was the only one with this odd coating.

Without some level of testing, it's difficult for me to speculate on the cause behind the buildup, however, it appears to be calcareous in nature. Calcareous coatings are often found on zinc anodes when used in fresh water, however, I have never seen that extend to the metals they are ostensibly protecting.

across the stainless shaft and zinc itself. With this much build up, my guess is that there's some sort cathodic issue taking place and I'm pushing a positive current into the water, as you would on a pipeline using cathodic protection. I'm not sure if this could be the case, whether the isolator would block this from happening on the shore power, or where I should start looking to diagnose this problem. Any ideas on what's taking place here and course of action would be greatly appreciated. I obviously want to get it troubleshot before the summer season.

My recommendation would be to replace the zinc with an aluminum anode, and then after launching the vessel carry out a reference cell test, to confirm you are neither over nor under-protected. I would also install an ABYC compliant galvanic isolator if not already present. You didn't mention if the vessel is bonded, however, if not, then each underwater metal, including the shaft must be tested. Either way, because the shaft is essentially isolated via an oil-filled transmission, its protection level should be tested.

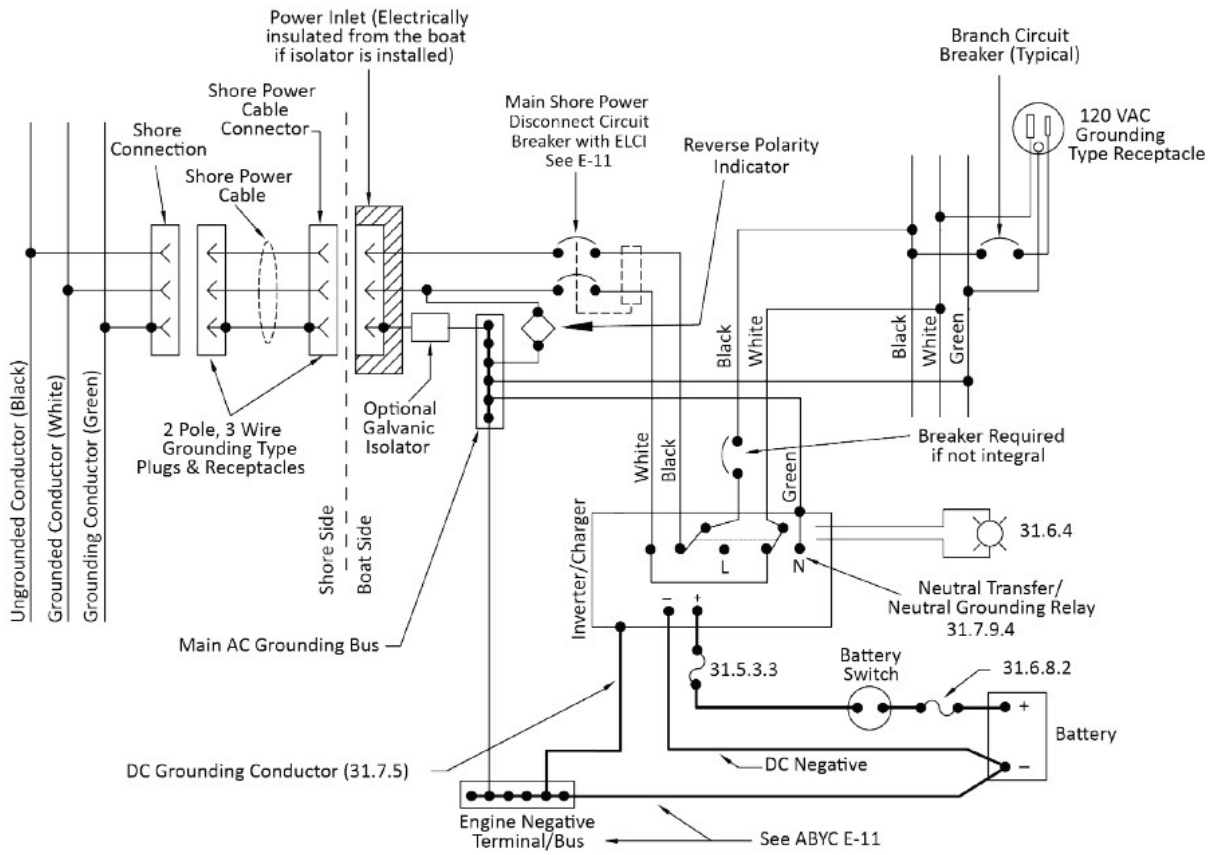
FIGURE 3 - Typical Inverter/Charger Installation With Internal Transfer To All AC Loads

The following diagrams (there are four, however, these two are relevant to your scenario), and associated text, from ABYC chapter A-31, Battery Chargers and Inverters, clearly depicts/describes the requirements for the DC Grounding and AC safety grounding conductors.

31.7.5.1 The DC grounding conductor (see FIGURE 1, FIGURE 2, FIGURE 3, and FIGURE 4) shall:

NOTE: The DC grounding conductor is not necessary if the case is made of plastic or nonconductive material and the case completely isolates the DC conductors from any grounded metallic internal parts, and there are no grounded metal parts the ungrounded DC terminal could contact.
