Antifouling Tactics Editorial: Fifteen Years

Antifouling Tactics

There's more to achieving a lasting and effective anti-fouling paint application than meets the eye; and much of it involves preparation.

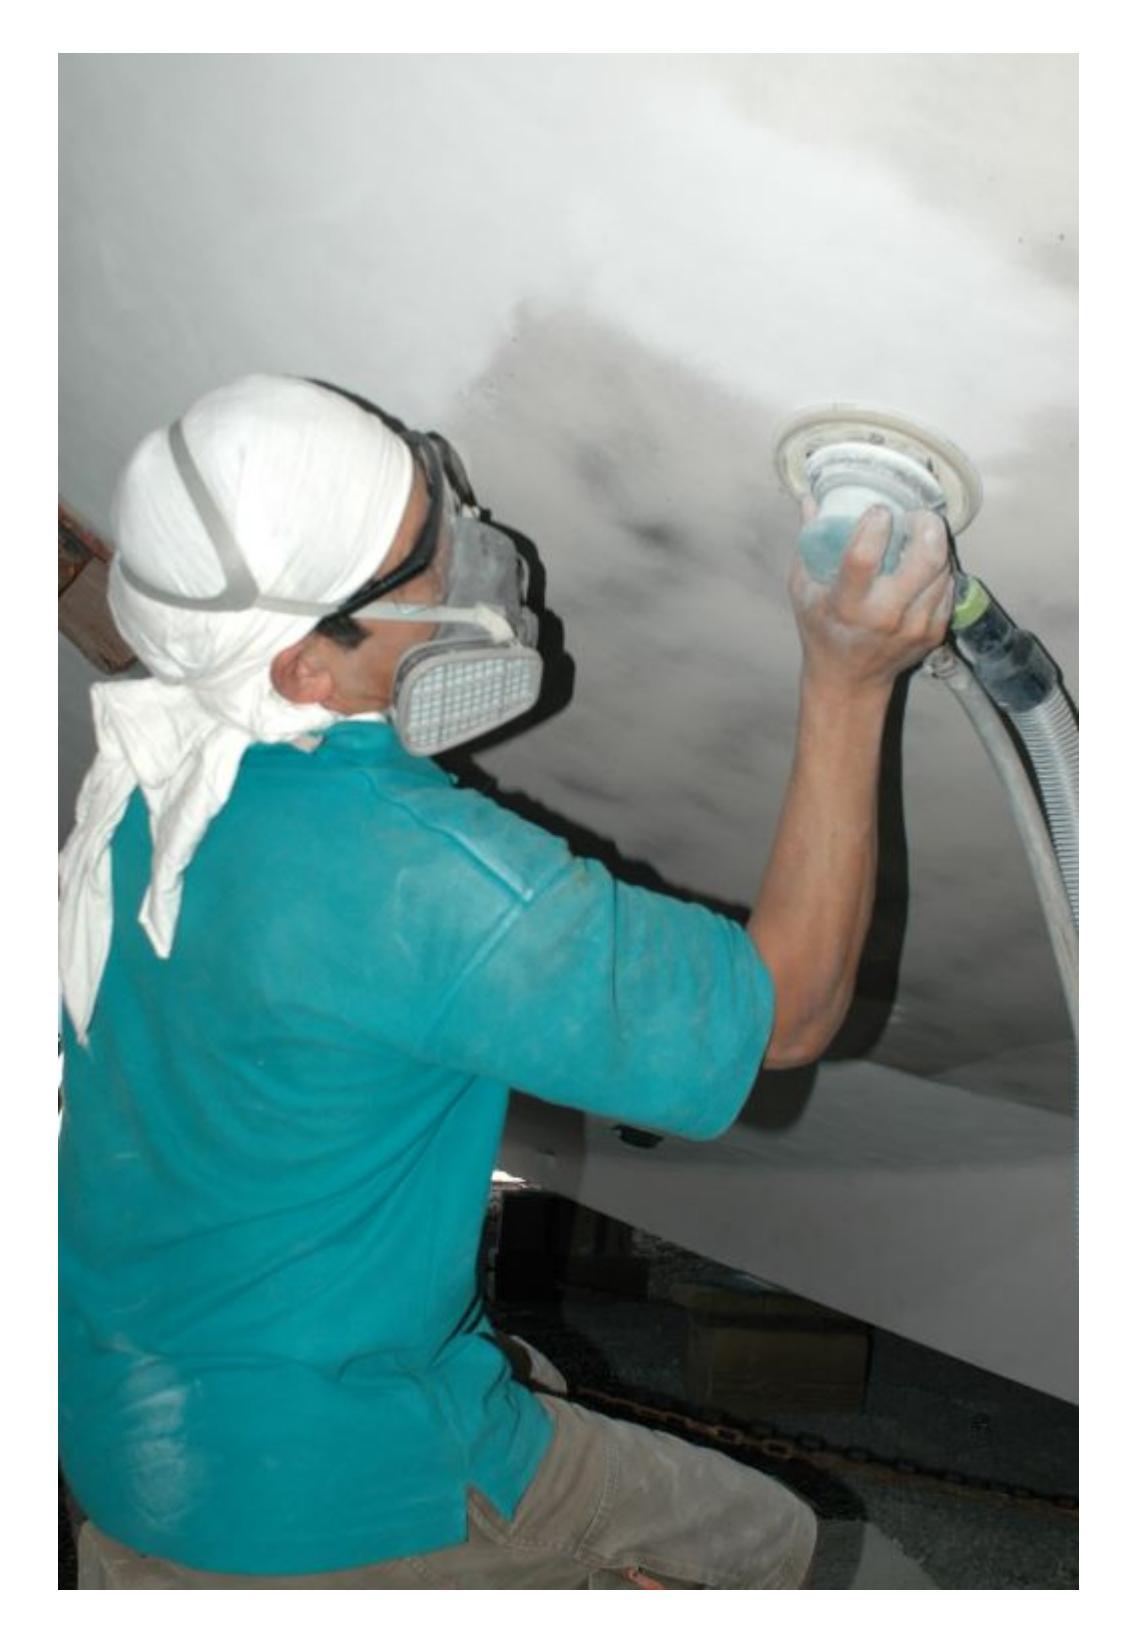
Profiling a virgin gelcoat bottom, using a "guide coat", a very light misting of spray paint, which helps those doing the sanding know where they have not yet abraded the surface.

Preparation of virgin gelcoat, fiberglass and alloy bottoms is especially critical. Out of the mold, or from the foundry (for plate aluminum), these surfaces are usually very smooth, and often contaminated with wax or oil, they are exactly the wrong type of finish for coating applications. The bond between paint and substrate in this location is purely mechanical, therefore profiling it with a "tooth", or roughedup surface, is critically important. I routinely encounter release of anti-fouling paint, and epoxy barrier/primer, after just a year or less of service, and in almost every case the substrate has not been properly profiled or dewaxed. It's a sure-fire way to waste thousands of dollars on an anti-fouling application.

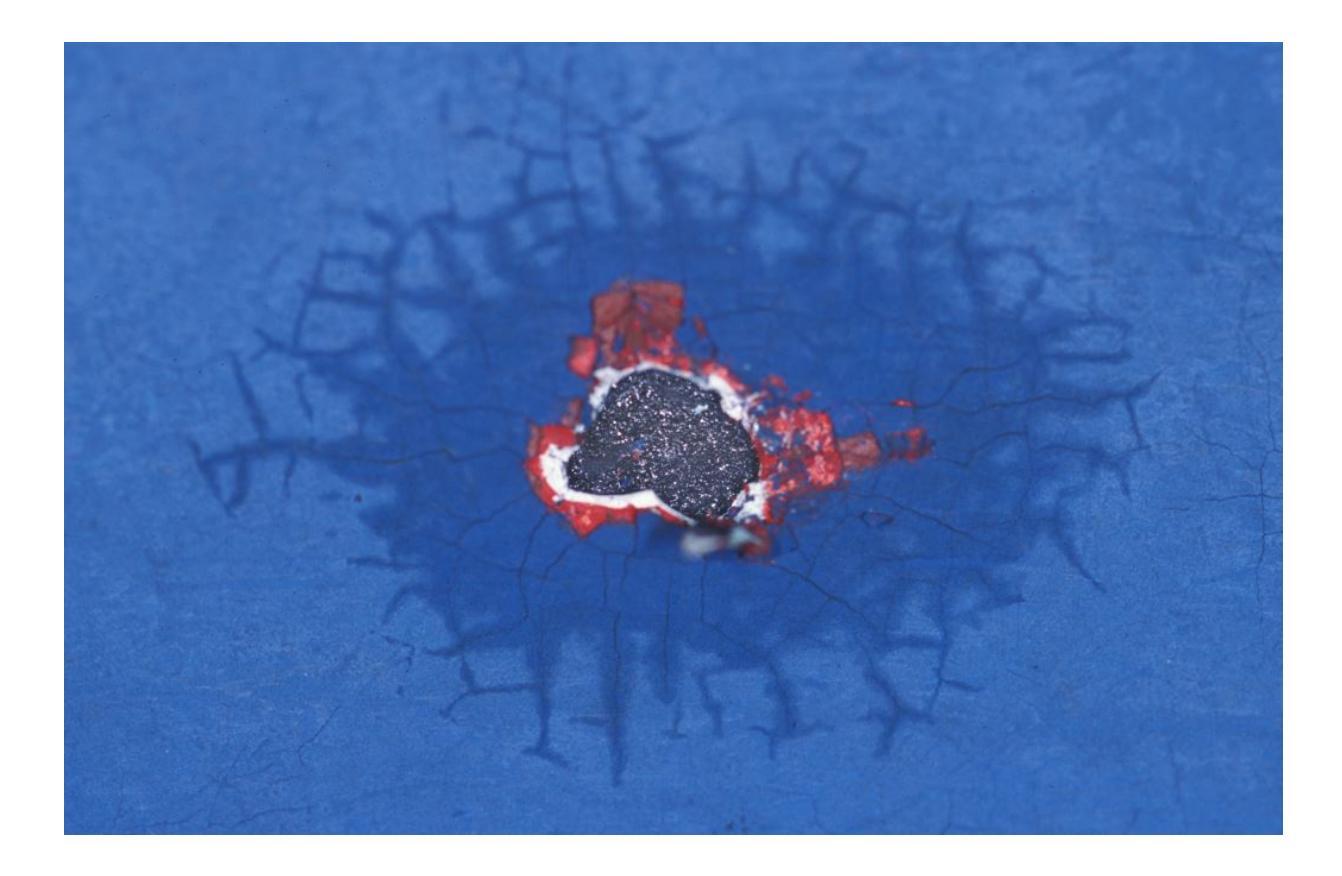
Hulls made using polyester resin are suspectable to osmotic blistering. Epoxy barrier coats can be used prophylactically, preventing water absorption by the laminate, which leads to osmosis; unlike primers, their effectiveness relies heavily on the thickness of the coating.

Epoxy barrier coats are used to prevent absorption of water by gelcoat and fiberglass laminates. Water absorption can lead to dreaded osmotic blisters, more on that here and here. If your vessel's builder used vinylester resin for the entire hull lamination, or a vinylester skin coat (the outer two or more laminates use vinylester resin with the remainder being polyester), or the laminate relies on epoxy resin, then an osmotic barrier coat is unnecessary. Builders who take one of those approaches, and today most do or should, often provide a warranty against osmotic blisters.

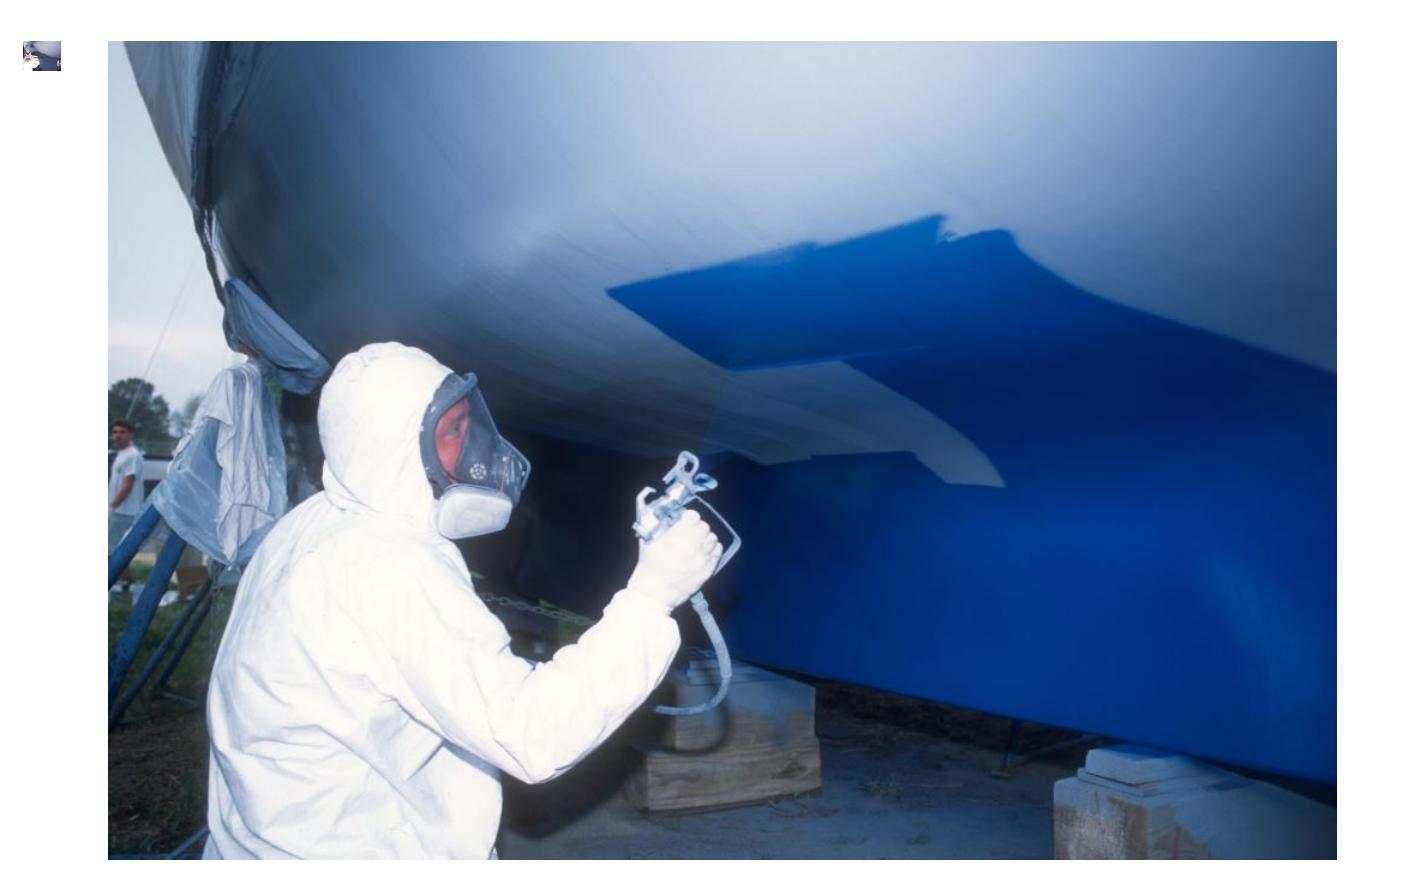
Both primer/barrier coats and anti-fouling paints can be applied with an air-less sprayer; using this approach yields an exceptionally smooth finish. Applying the first coat of anti-fouling over a primer/barrier within the chemical application window ensures a long-lasting, chemical bond.

Primers/barriers are often applied using rollers and brushes; however, air-less spraying is also an effective approach, and one that yields a very smooth finish, which may be desirable for sailing vessels, and for power vessels seeking the greatest fuel economy (and it just looks good).

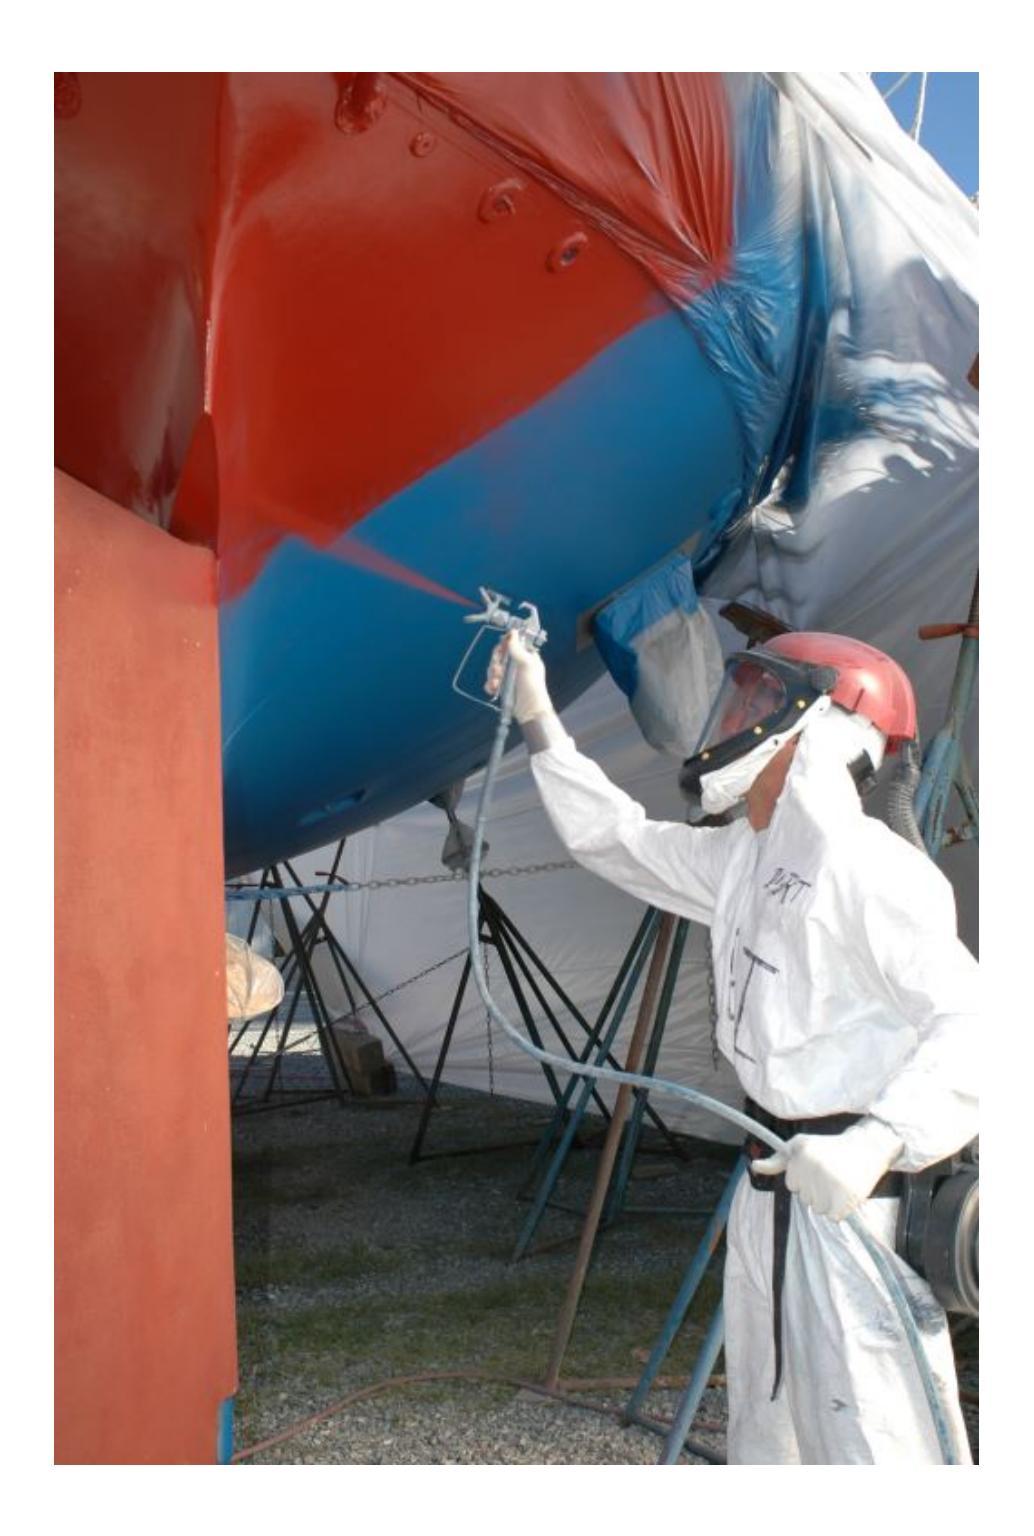
Unlike conventional spray paint application, which atomizes coatings within a stream of air, airless sprayers, as the name implies, use no air, which means they have very little overspray and coatings can be applied heavily. They are ideally suited for viscous coatings like epoxy and anti-foulant.

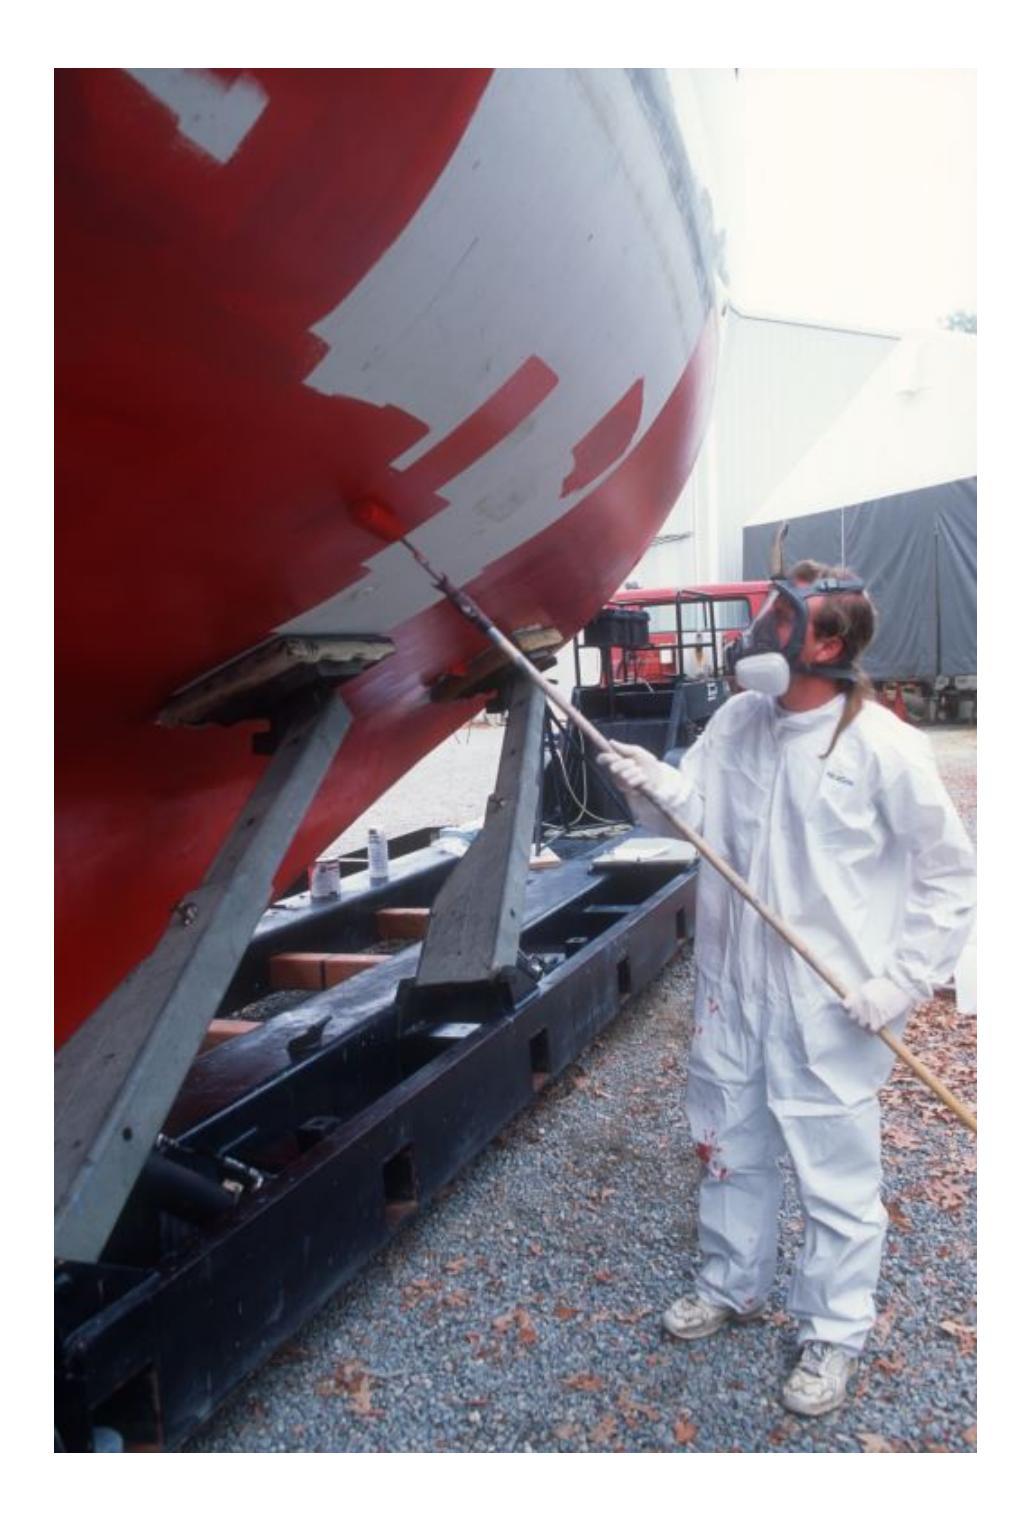
This applicator's personal protective gear is ideal.

Finally, when using epoxy primers/barriers, as well as anti-foulants, follow all application as well a personal protective gear instructions to the letter, as adhesion failures can be both frustrating and costly, and the volatile organic compounds within these coatings represent a serious health hazard.

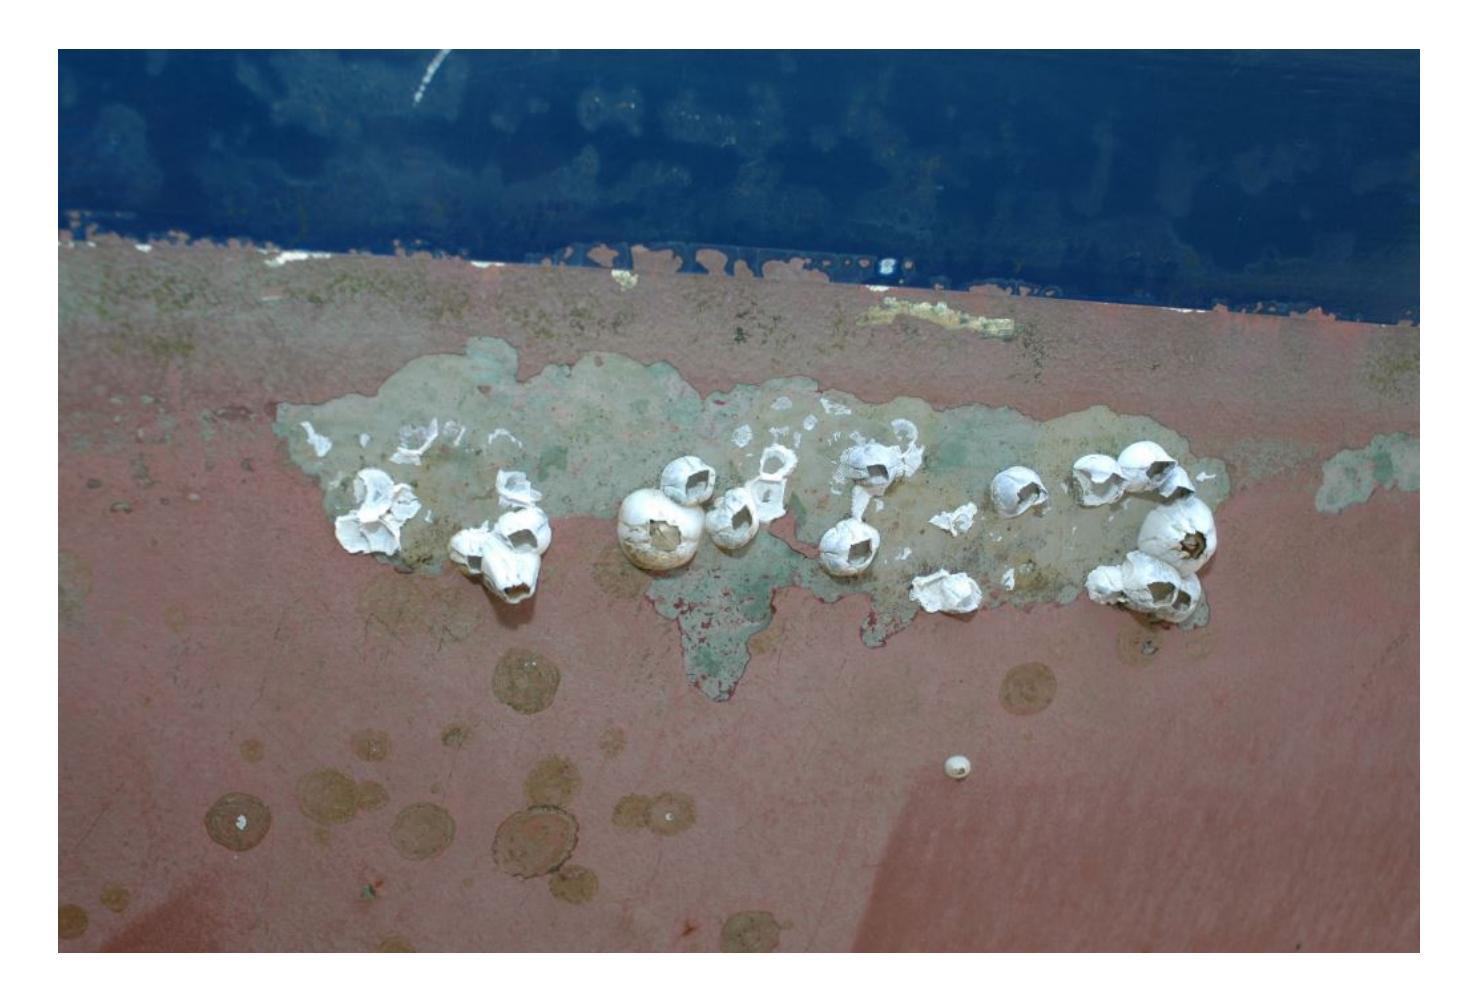
Flaking anti-fouling paint at the float line is an all too common occurrence; and it's almost always the result of applicators' failure to adequately clean this area before applying paint.

For subsequent applications of antifoulant two important criteria must be met. One, the paint being applied must be compatible with the paint that is already present. (Compatibility charts are available from most paint manufacturers and distributors.) Two, the surface over which paint is to be applied must be clean and free of all growth and debris (as noted earlier, even an invisible film can wreak havoc on a coating's adhesion). When vessels are hauled and pressure washed it's not unusual for the area beneath the slings to be overlooked. Once the slime in these areas dries, it turns a light buff color, which is easy to miss, especially on red bottoms, and is often simply rolled over with paint (the area just above the float line is notorious for this type of failure). Paint applied over these areas frequently releases shortly after the vessel is launched, allowing barnacles to strike.

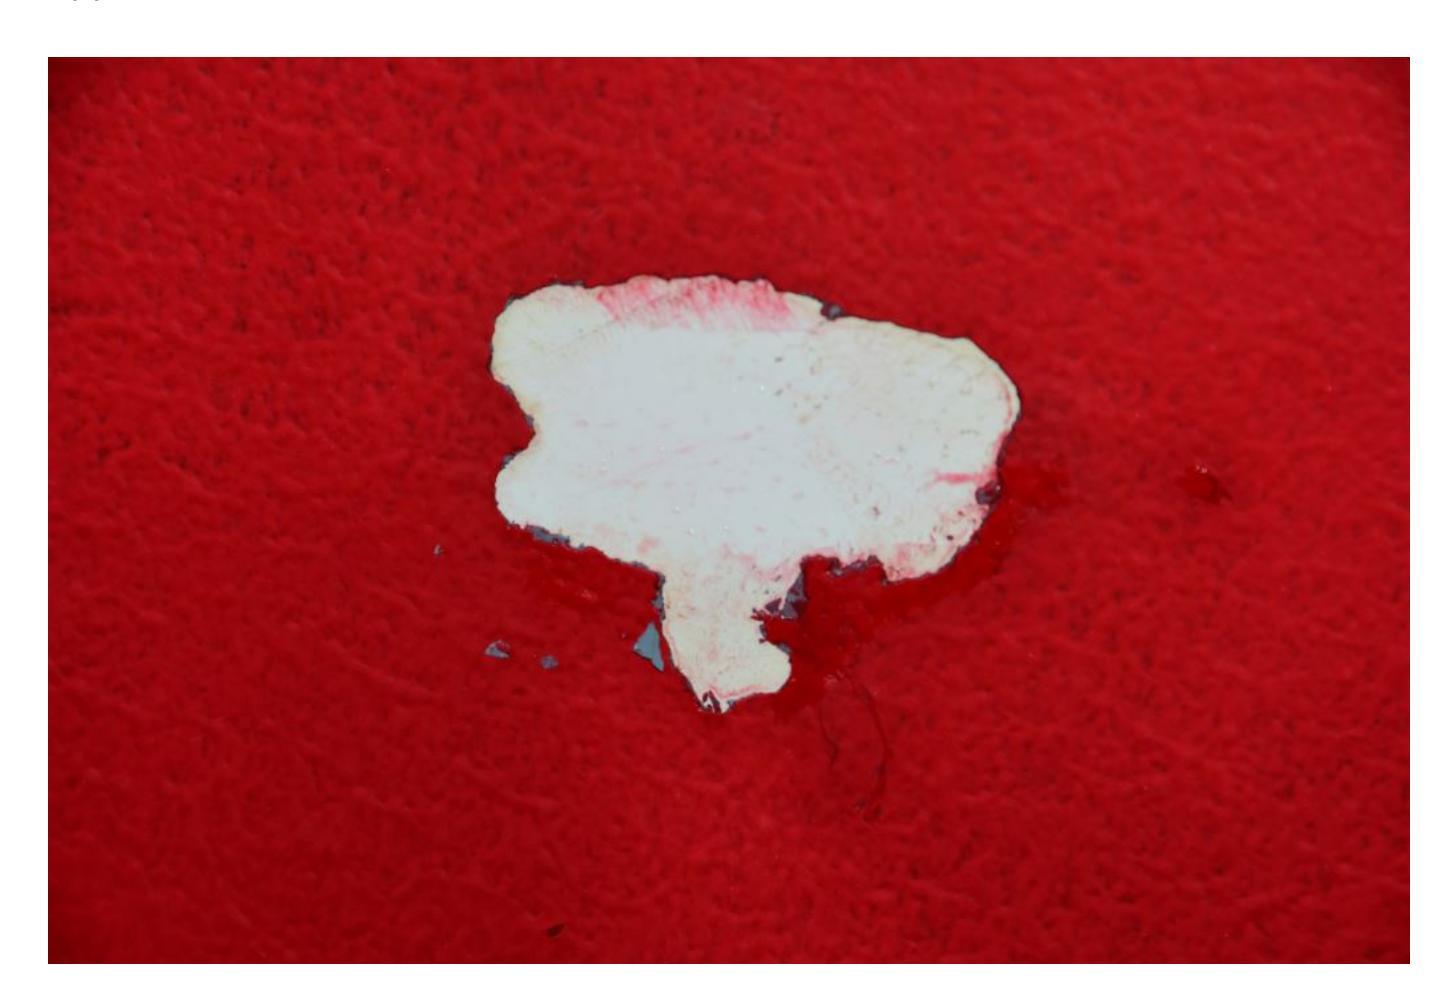
In spite of the fact that this bottom received an epoxy primer, the coating still suffered from release because the substrate was not profiled. The correction will require stripping the entire bottom, ensuring the surface is properly profiled, and re-applying the epoxy primer and anti-foulant. The vessel is less than two years old.

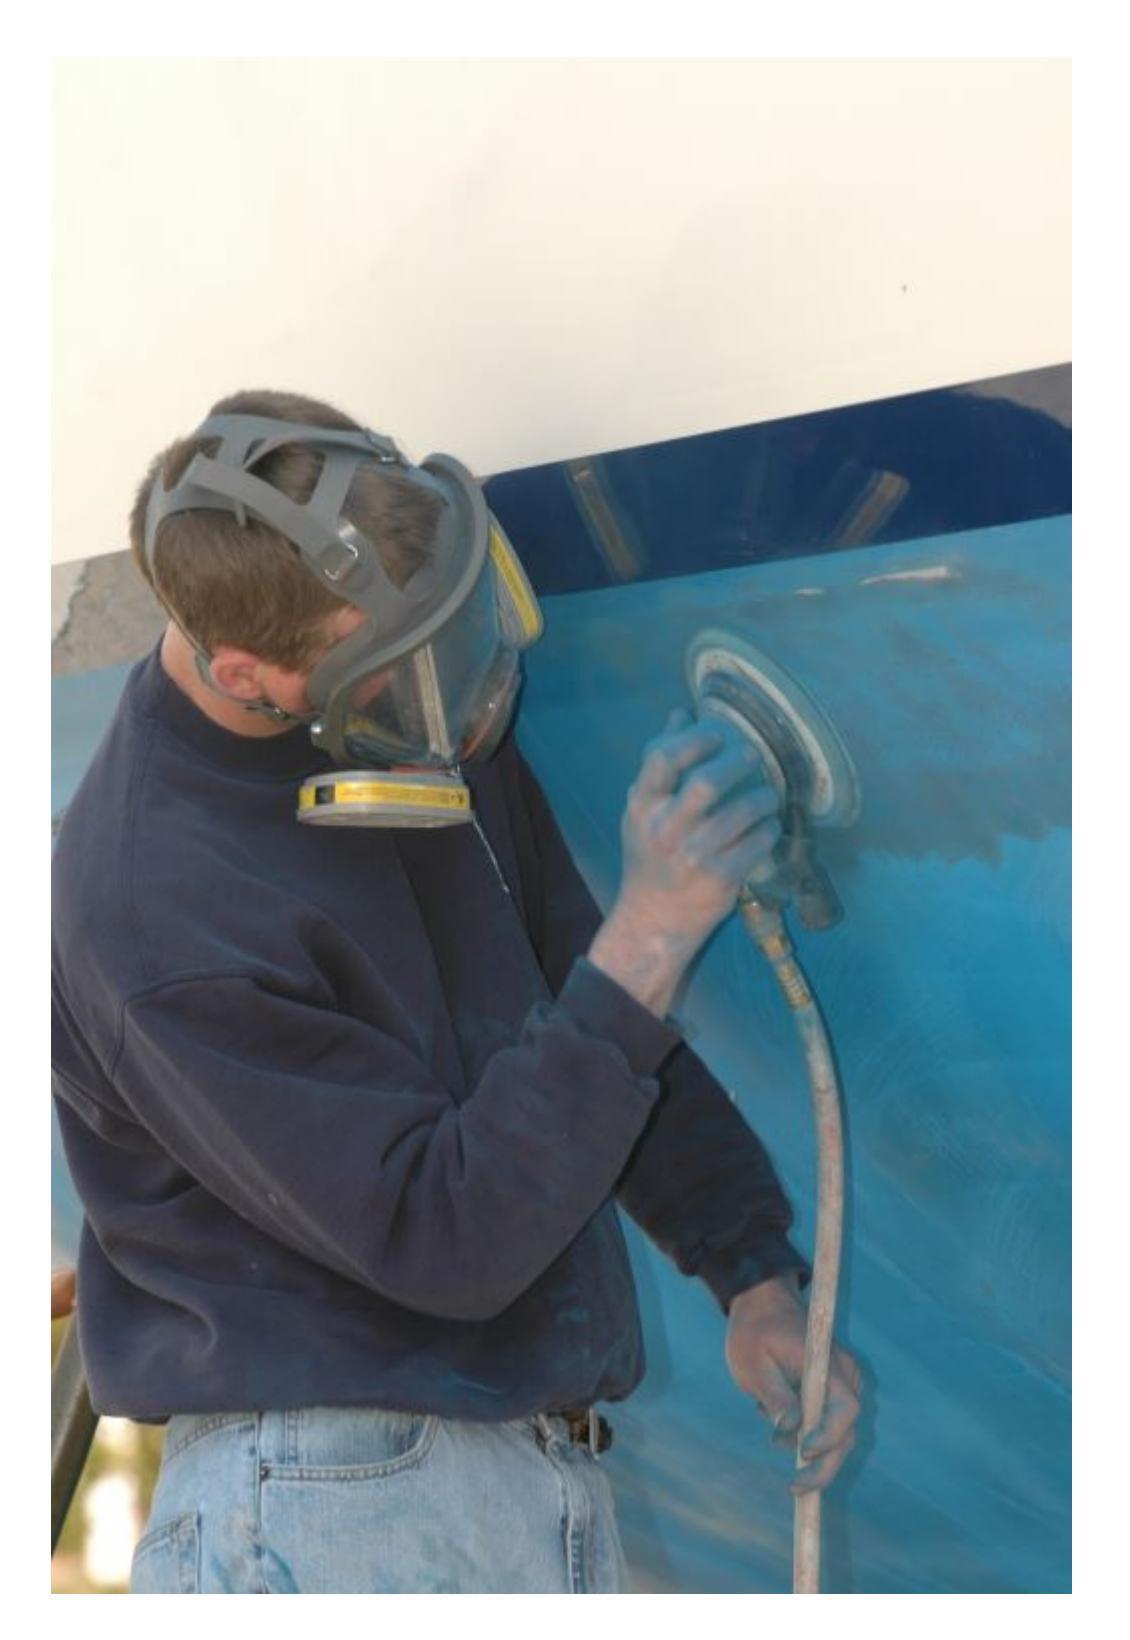
Dust from anti-fouling paint is a health hazard, full protective gear, including a respirator, gloves and coveralls should be worn when sanding.

Because of its toxic nature, antifouling paint must be applied with caution. I frequently see this requirement ignored in yards and at builders I visit the world over. Applicators should wear gloves, coveralls, and eye protection as well as a properly fitted respirator, and not a dust mask (note that unless they are of the full-face variety, respirators cannot be used by bearded individuals).

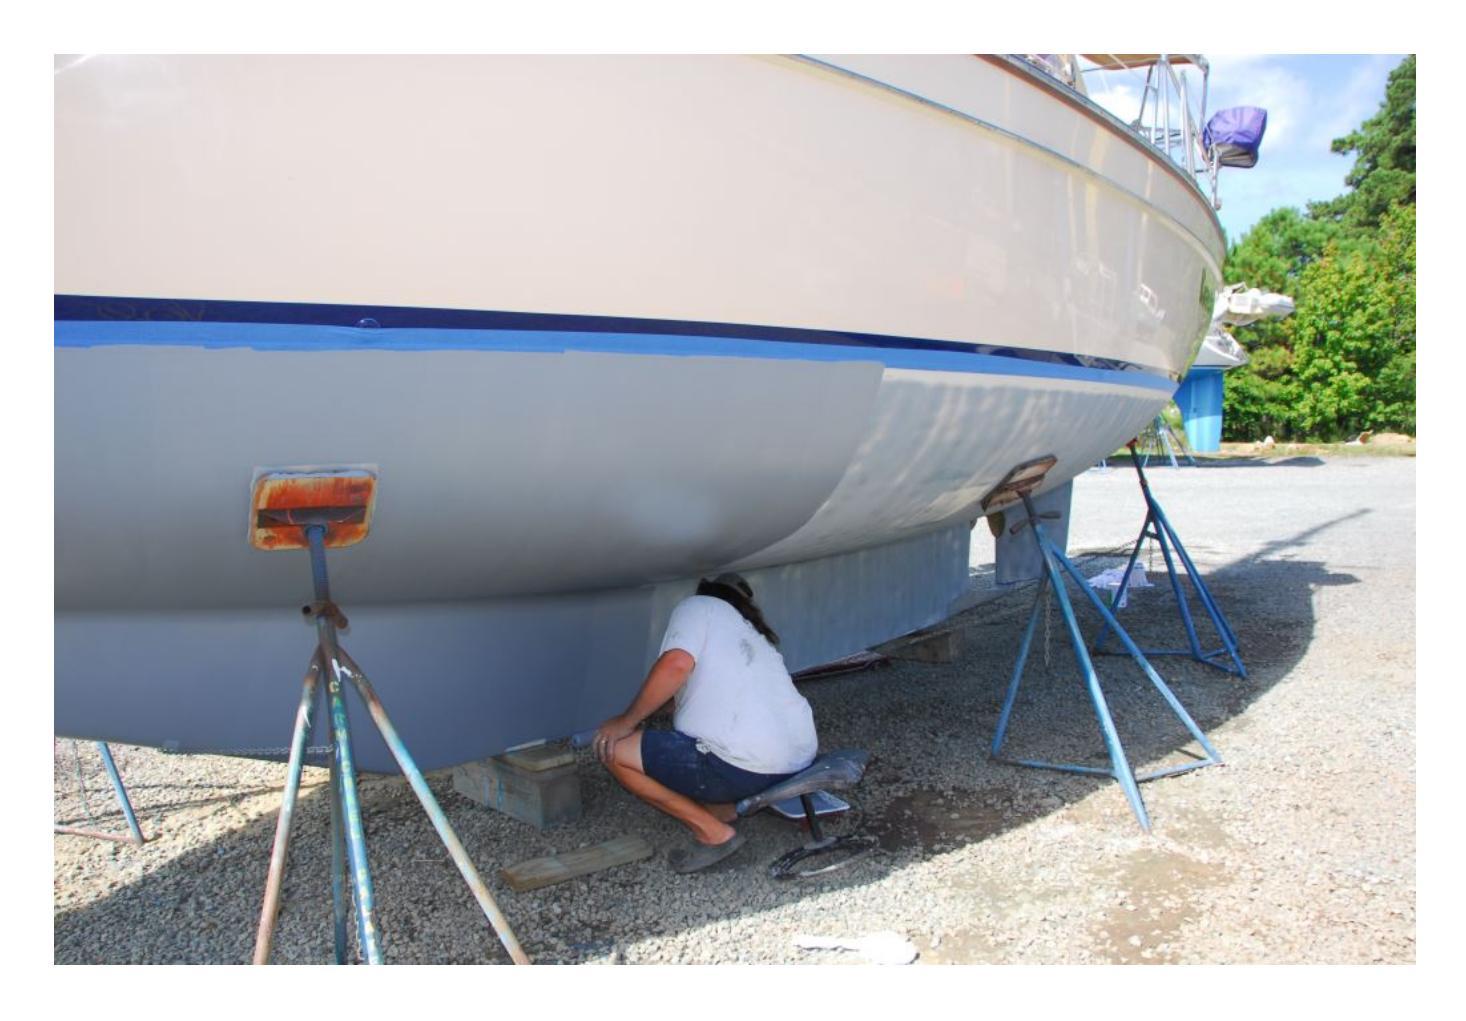
Two part epoxy primer/barrier coat also presents a health hazard to those applying it, follow all manufacturer instructions, including and especially where personal protective gear is concerned.

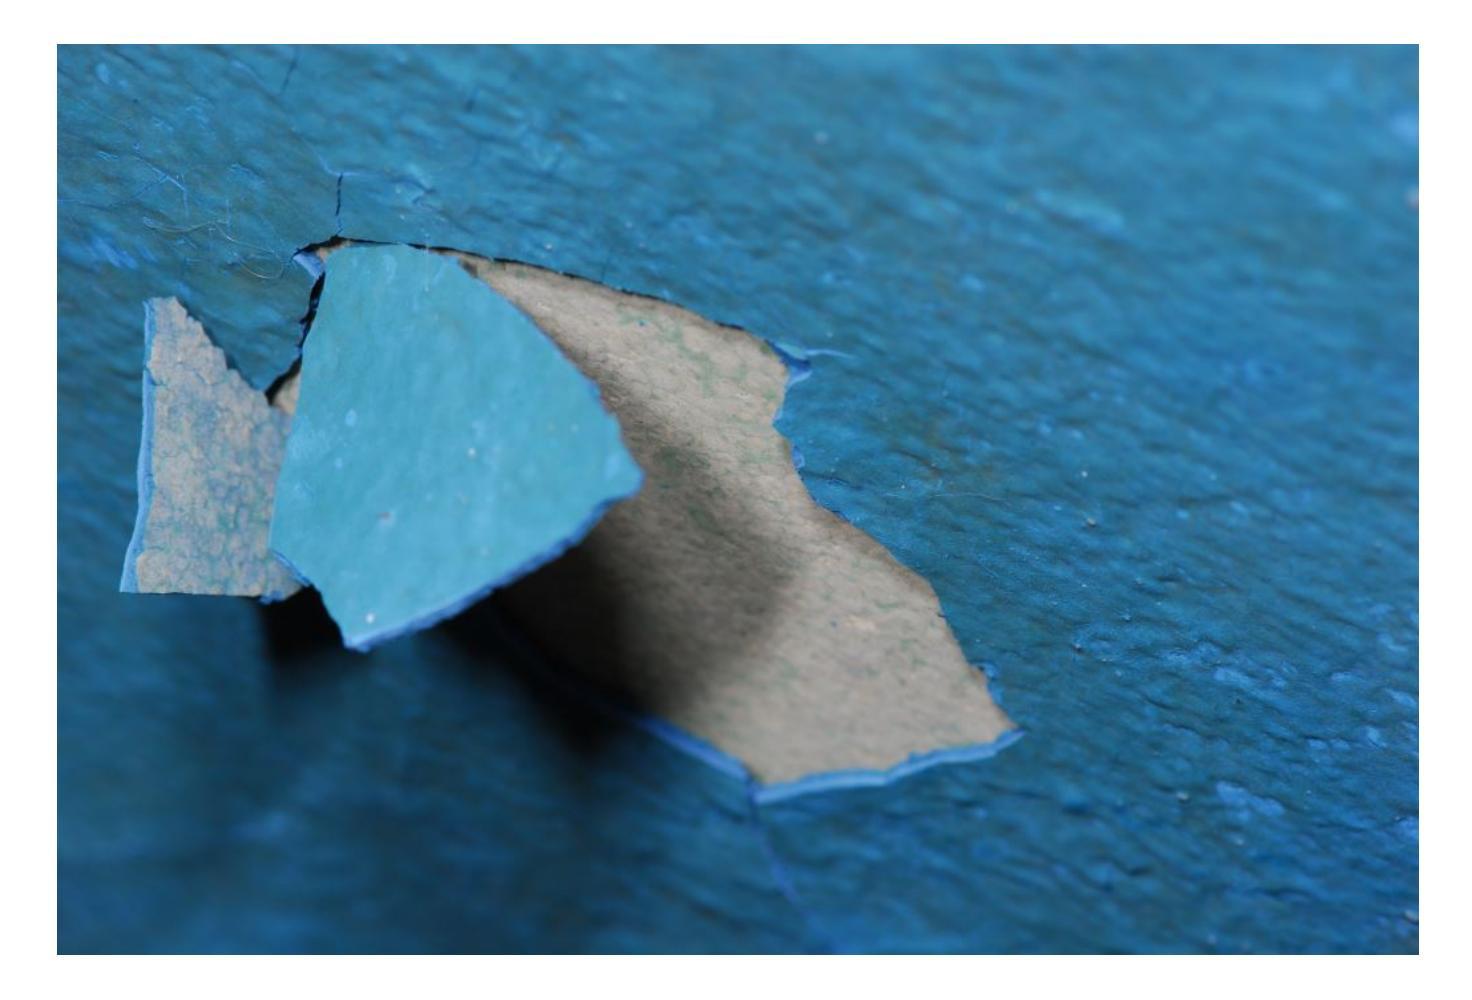
One of the drawbacks of hard anti-fouling coatings is their tendency to build up over time, which eventually leads to release, examples of both are shown here.

Broadly speaking there are two choices for anti-foulants, hard or ablative, with countless subcategories. Hard anti-foulants are much like conventional paint, once dry they don't rub or wash off easily. Their anti-fouling protection is provided by the surface that's exposed to the water. Once that's depleted, they are no longer effective. Ablative coatings, on the other hand, continuously slough, roughly analogous to a bar of soap, thereby exposing fresh anti-foulant. Which one is best for your application depends on use. If the vessel is unused for long periods, ablative coatings may be less effective as the lack of movement prevents exposure of fresh material. The primary drawback to hard anti-foulants is their tendency to build up after years of applications, which eventually requires costly stripping. If you opt for the ablative approach, consider initially applying three coats, with the first one (which is applied over the barrier/primer) a different color than the next two. This provides an 'indicator coat,' i.e., when you see the color of the first coat appear, you know it's time to renew the application.

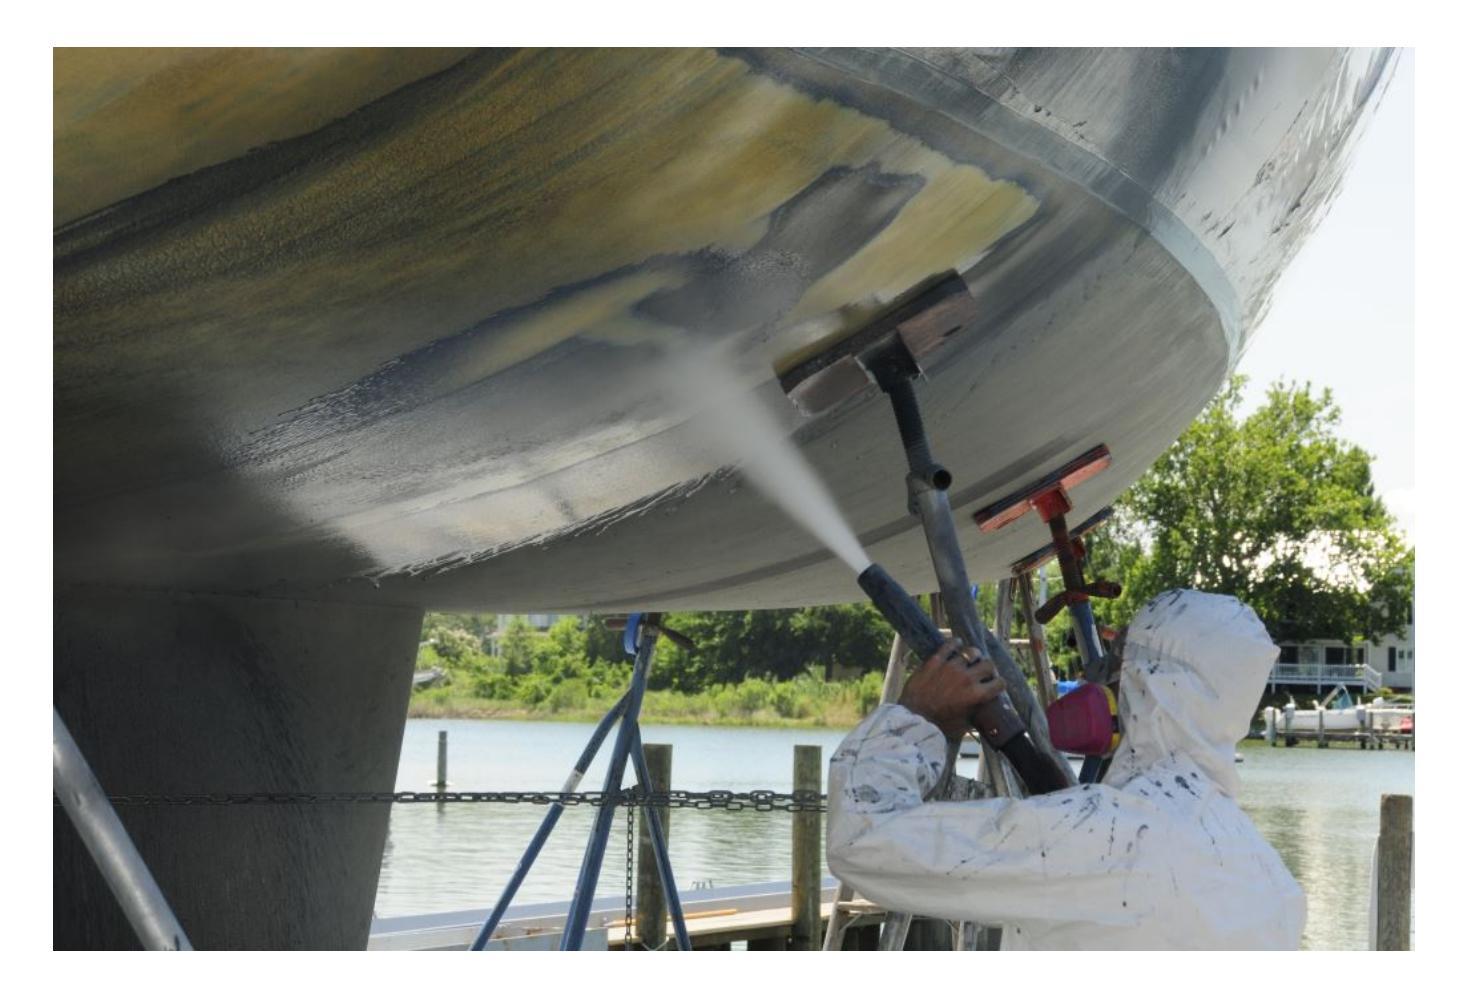
Bottom paint is best removed using the least invasive means possible, here a wet slurry of kieserite is being used to remove paint, without damaging the fiberglass substrate.
