# April 2024 Newsletter Steering Components

## **Photo Essay: Steering Components**

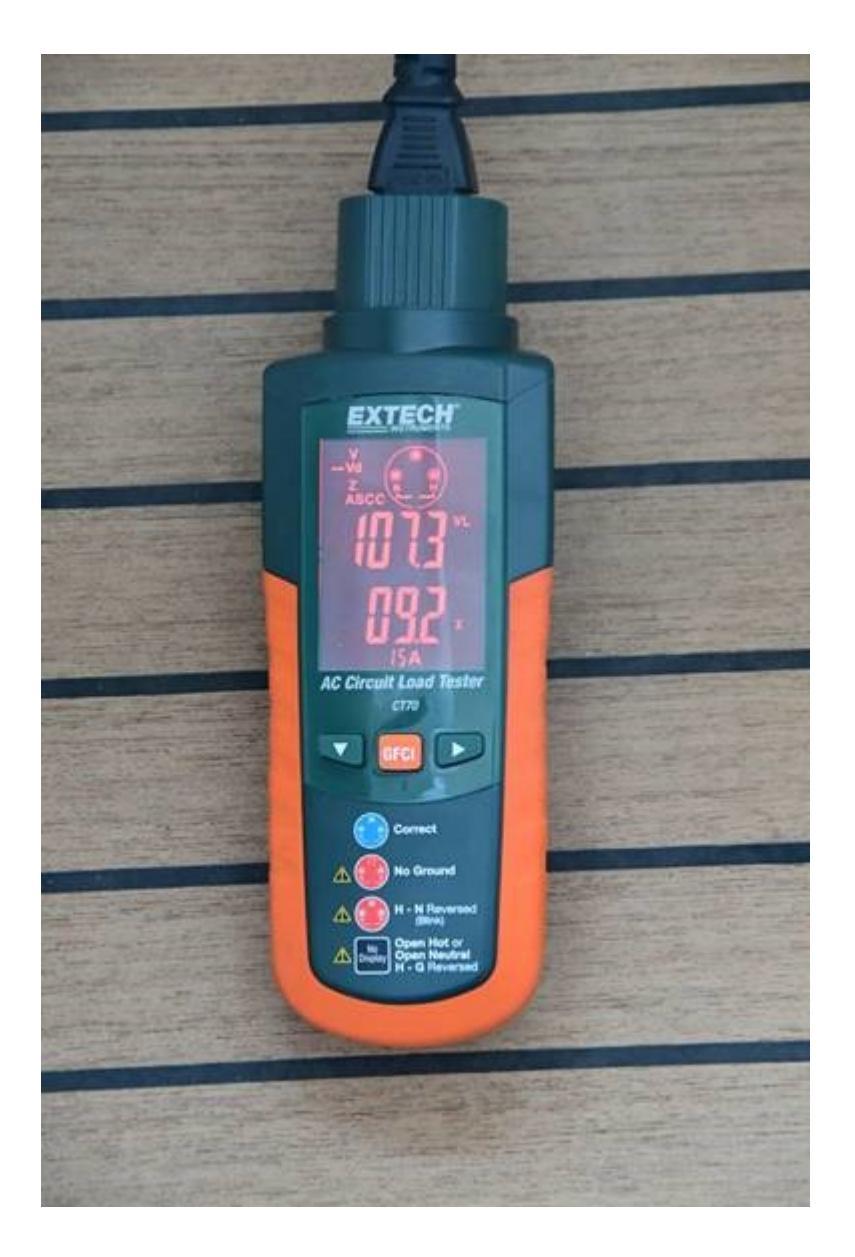
Testing for these phenomena is relatively easy provided you heave the requisite skill and experience. Initially, the polarity can be tested with a test tool like the one shown here. This, or one like it, should be in the tool bag of any technician who is troubleshooting electrical issues.

Another cause is leakage of shore power, 120 volts, through bonded underwater metals. This can be caused by faulty wiring aboard, or on the dock, including reverse polarity (your reverse polarity light, located on your main panel, should illuminate if this is present, assuming it is working; it too should be tested). This too is not necessarily harmful to a fiberglass hulls or most underwater metals, however, it is an indication of a serious fault, *one that can be deadly*, so it should be identified and resolved quickly. More on that subject here.
