Ask Steve: PVC Plumbing, Low Hour Engine Maintenance, Solar Panel Fire

By Steve D'Antonio

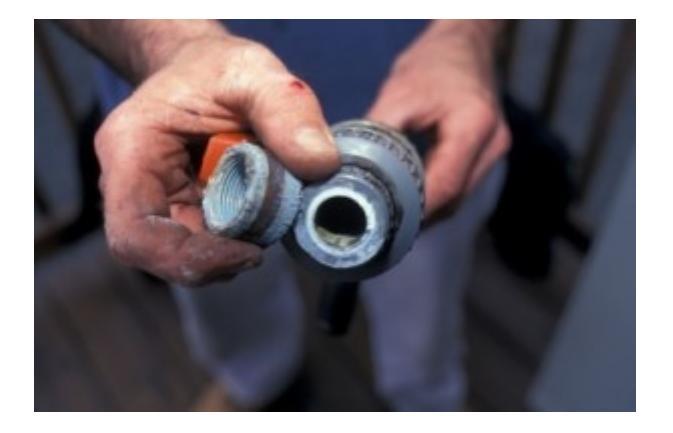
This PVC "pool" valve used as a seacock snapped off in the mechanic's hand as he closed it. Luckily, the boat was on land at the time. PVC has limited use as plumbing aboard boats for carrying raw water.

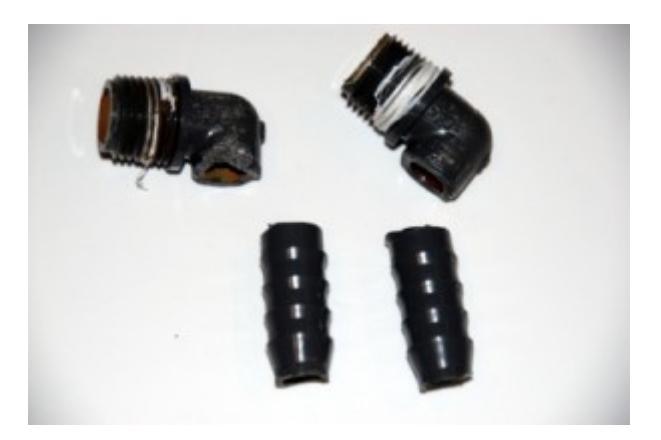
It is not uncommon to break off the end of PVC barbs when removing the hose, as happened to these two water maker fittings; they were just two years old. In most cases, PVC simply doesn't have the strength for raw water plumbing.

There was a time when ABYC seacock standards cited PVC's inadequate modulus of elasticity and tensile strength, however, that wording is now no longer used and PVC isn't referenced specifically. The guidelines do specify that any seacocks installation must be able to withstand the application of 500 pounds of static force for a duration of 30 seconds without failing to perform as intended (I read that to mean it doesn't break, leak or seize.) I'm fairly sure few PVC valves could withstand such a test. It's important to point out as well that ABYC guidelines have no bearing on raw water plumbing other than the actual seacock, while my "standards" do cover all raw water plumbing. A failure of a large raw water plumbing fitting, especially if the vessel is unattended.

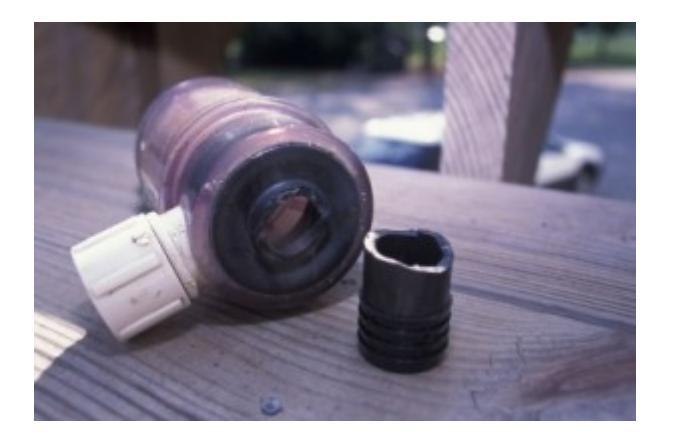
Sea water strainers should also be strong enough to pass the "stand on it" test. This PVC flush fitting failed and could easily have flooded the vessel.

My personal durability test calls for any components that could lead to flooding in the event of a failure, to be able to withstand being stood upon. If I can't stand on it without worrying about causing a failure and flooding, it's simply not rugged enough. Many PVC components and some metallic ones won't pass this test.

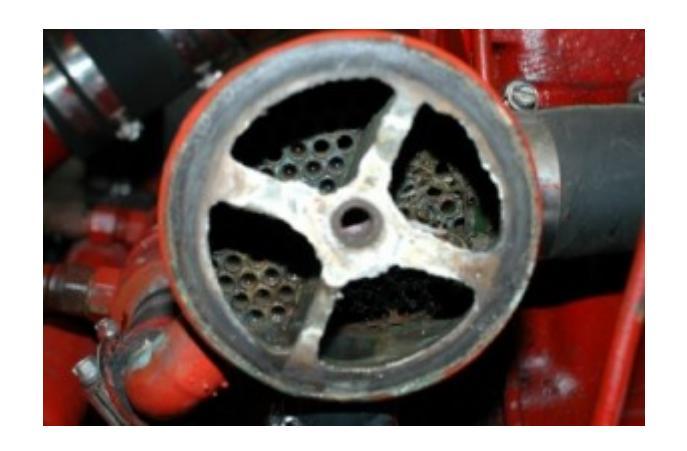
Engine and transmission heat exchangers should be periodically

checked to ensure their cleanliness, every other year or every 500-750 hours, which ever comes first. Debris and scale can clog both the sea water as well as the coolant sides, dramatically inhibiting the transfer of heat necessary for a cool running engine.

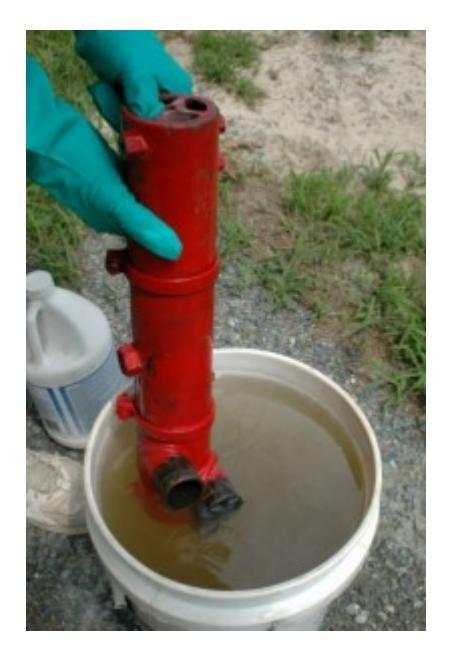
The traditional cleaning method: this heat exchanger has been removed for immersion in a cleaning solution. This is sometimes necessary, but not always. Now, cleaning can be carried out without removal or major disassembly.

My own recommendation calls for inspection and cleaning, but

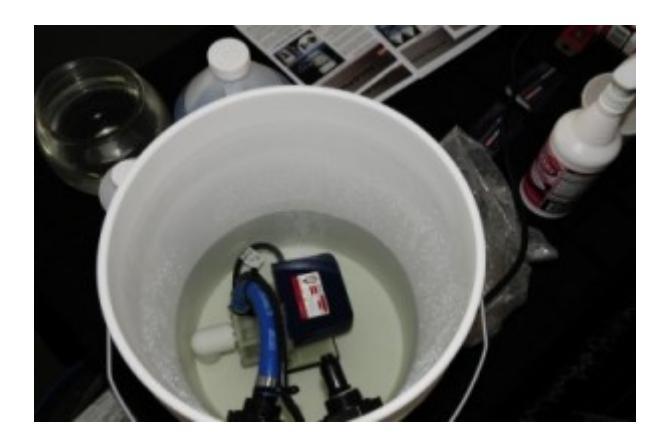
A proprietary "run bucket" like this includes a pump immersed in cleaning solution and hosing to connect it to the raw or coolant sides of an engine, generator or air conditioning system.

You could clean all of these components, except the exhaust elbow, using a proprietary cleaning agent and pump system available from Trac Ecological. The cleaning solution http://trac-online.com/index.php?option=com_virtuemart&Itemid= 62 and http://trac-online.com/index.php?option=com_virtuemart&Ite

mid=73 are used together to clean raw water cooled components. I've used or supervised the use of this system many times and can attest to its effectiveness.

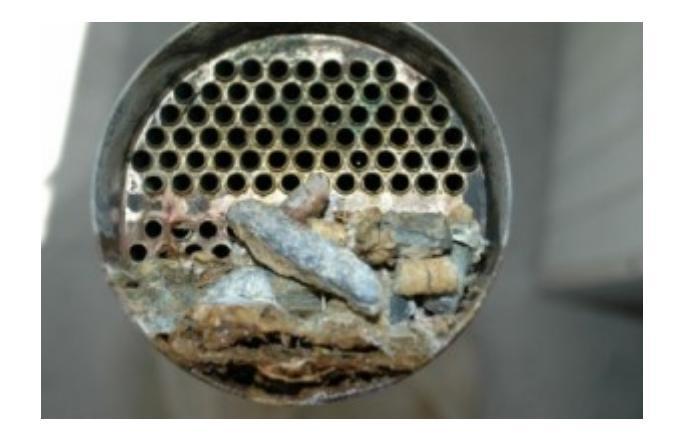
This heat exchanger obviously had not been checked for some time. Nearly half of the surface area of the tubes were blocked by old pencil zincs and scale. And yes, the engine was chronically overheating.

The cleaning protocol will remove lime scale, barnacle and other shell material as well as zinc anode "debris", however, it will have no effect on rubber such as impeller parts, pine straw (I've seen this clog heat exchangers) or sea grass. For this reason, I still recommend the main heat exchanger end caps be removed for inspection purposes, and if there are any heat exchangers in line before the raw water pump, for hydraulic or fuel cooling for instance, these too should be inspected. In the latter cases these heat exchangers typically cannot be disassembled, which simply means removal of the inlet hose and a look inside with a flashlight.

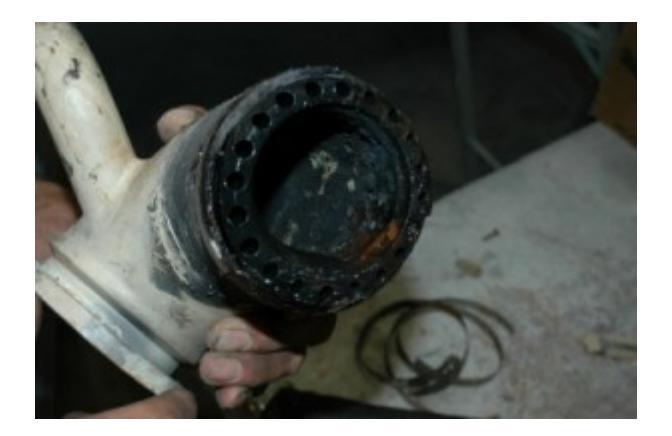
Blockages in the injected water discharge holes can cause hot spots in the exhaust hose, which can in turn fail as a result. Such a failure can be devastating as no overheat or other warning will be given to the operator and the engine room/compartment will be filled with hot, atomized seawater and soot.

Because cleaning solution can't be easily circulated through it using the above-mentioned pump system, the exhaust elbow would still have to be inspected visually, which would require removal of the hose. Exhaust elbow spray rings do suffer from blockages and corrosion, so a thorough visual inspection every three or four years is a good idea. Sincerely,

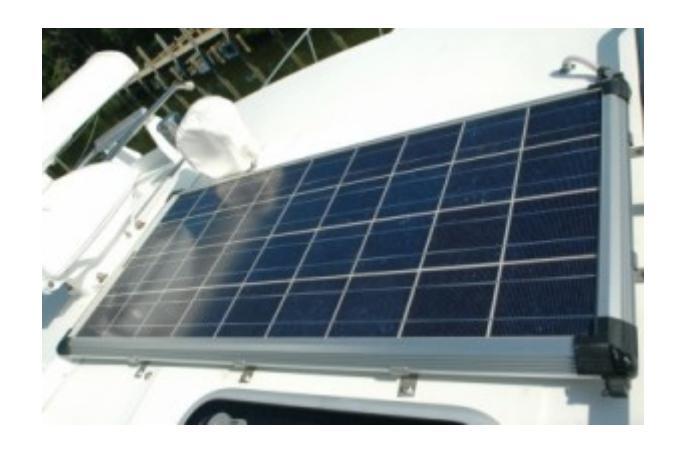
Solar panels must be mounted in locations that afford them the best view of the sun, but must be wired correctly to prevent fires.

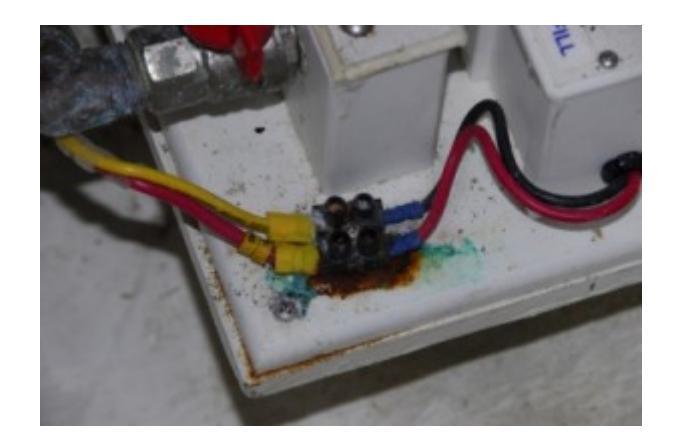
Water dripping on an electrical connection can cause corrosion which can lead to a high resisitance, high heat problem, but not necessarily a dead short. Any junction as poor as this should be replaced immediately.

In this case, whether OCP would have saved the day is open to debate. (It's similar to another letter I answered several months ago regarding shore power cord ends that get wet. They have been known to overheat and cause a fire without tripping a circuit breaker. High resistance does not necessarily create high current draw.) The fire in the junction box likely represented a high resistance short. High resistance shorts behave more like a load, generating heat in this case, but potentially not drawing enough power to blow a fuse. Rather than a conventional low resistance short, the latter trip breakers and blow fuses readily.

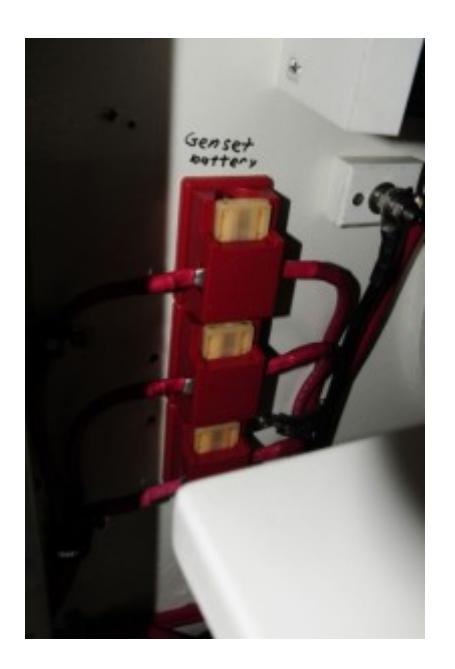
Fuses are not necessarily a deterrent to fires, particualrly where high resistance shorts are concerend.

Regardless, as previously-mentioned, every wire connected to the battery or the positive distribution bus, save one, must be equipped with OCP, and OCP at the solar panel makes good sense too. The one exception is the vessel's starter, it's exempt from this guideline, which for diesel-powered boats is established by the American Boat and Yacht Council's chapter E-11, and by the USCG for gasoline powered vessels (in the latter case it is, as part of the Code of Federal Regulations, the law).

A water proof junction box certainly would make sense in an installation of this sort, again, ashore or afloat, and a fuse or circuit breaker is simply a prerequisite.
