Closed Crankcase Ventilation: What is it and what purpose does it serve?

Text and photos by Steve D'Antonio Copyright December 2013

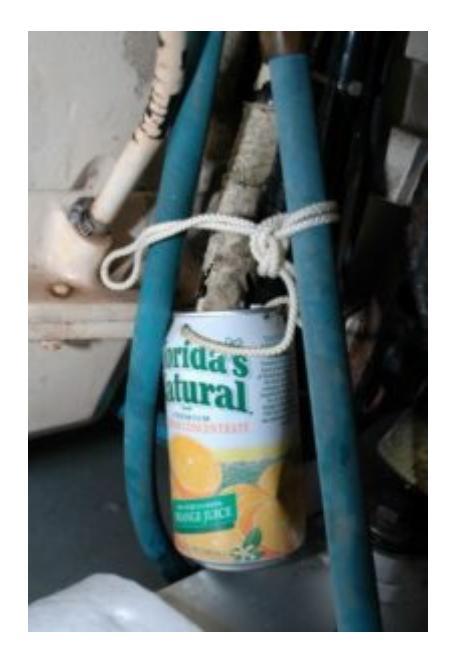
Fifteen or more years ago this is what commonly passed for a crankcase ventilation "system". The orange juice can is actually an option, it's been added by the vessel's owner to catch condensing oil vapor that exits from this hose. Most units were simply a hose that was routed from the valve cover and down the side of the engine, which under normal circumstances emitted water and oil vapor and the occasional drop of oil.

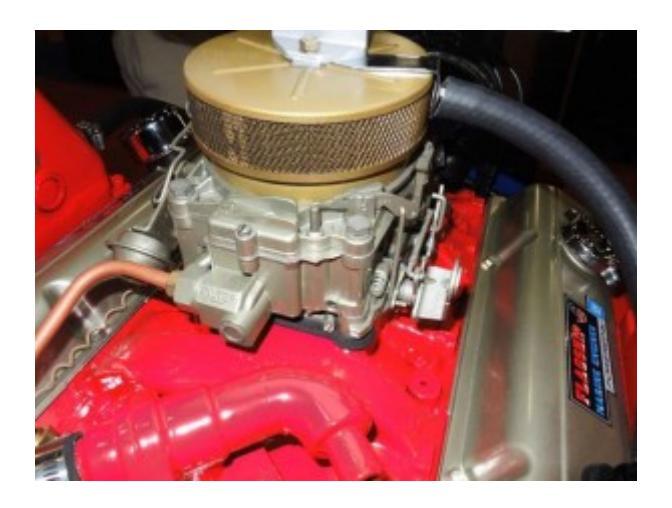
A traditional crankcase ventilation system used on a gasoline V-8 engine. Hoses from each valve cover direct crankcase gasses into the flame arrestor and from there into the carburetor. Baffles in the valve covers reduced, but didn't eliminate, the flow of oil vapor that was ingested into the air intake.

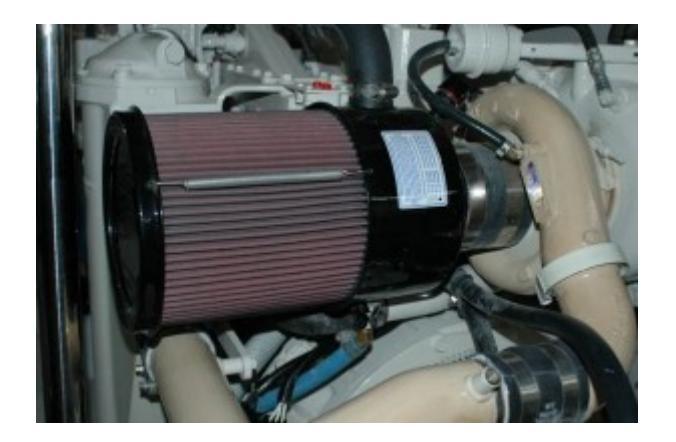
After market crankcase ventilation systems like the one shown here are now common, many are supplied as original equipment by engine manufacturers. The blue hose at the bottom drains coalesced oil back to the oil pan.

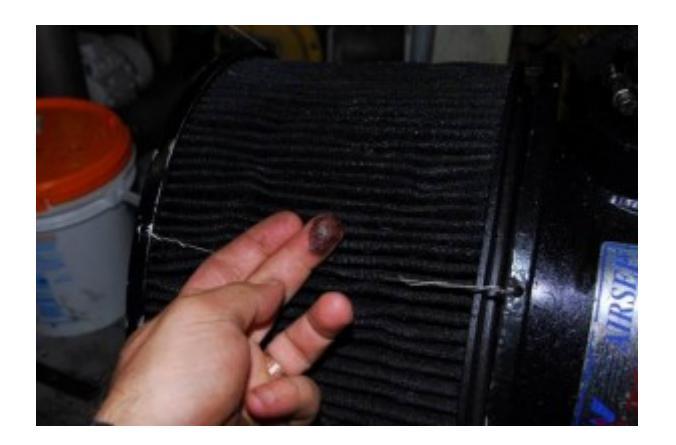
This air filter, part of an aftermarket crankcase ventilation system, is saturated with oil and long overdue for service, and the same is likely true of the engine it serves as well.

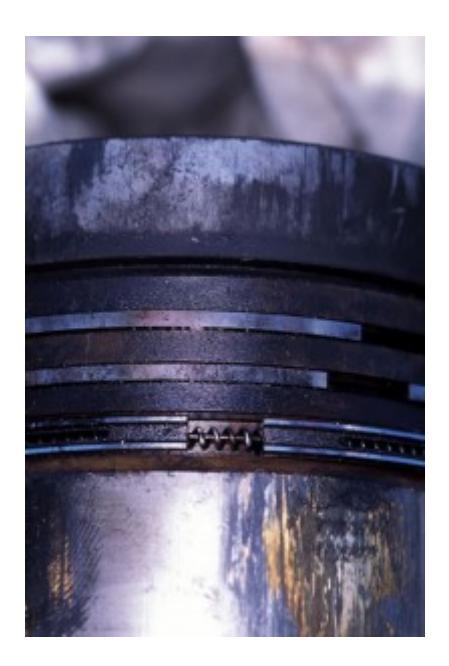
Worn out, broken or otherwise damaged piston rings can be the source of excessive crankcase pressure. In spite of the fact that they are metal, they achieve a remarkably good seal between the piston and cylinder wall. The upper two rings contain the cylinder's compression, the lower rings, with the spring-like device, are designed to remove oil from the cylinder wall on the piston's downward stroke.

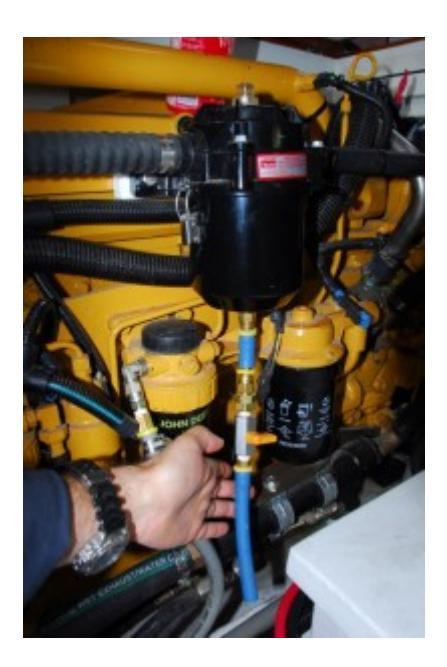
This crankcase ventilation system installation represents good intentions with poor execution. Oil vapor that is coalesced inside the black canister must be plumbed to drain back to the oil pan.

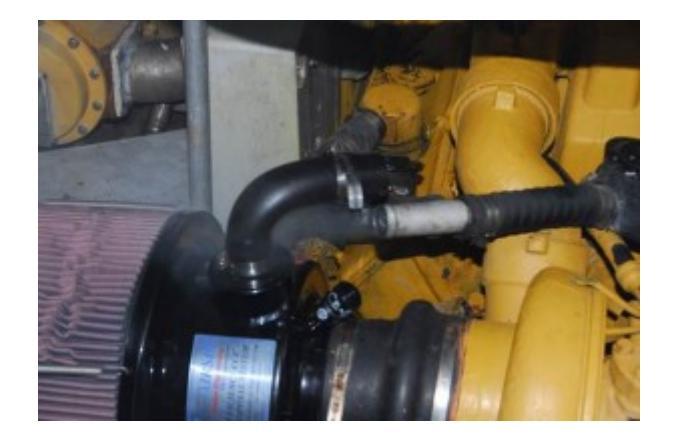
The "Stanley Steamer" effect exhibited by this disconnected crankcase ventilation hose is a clear indication of excessive pressure.

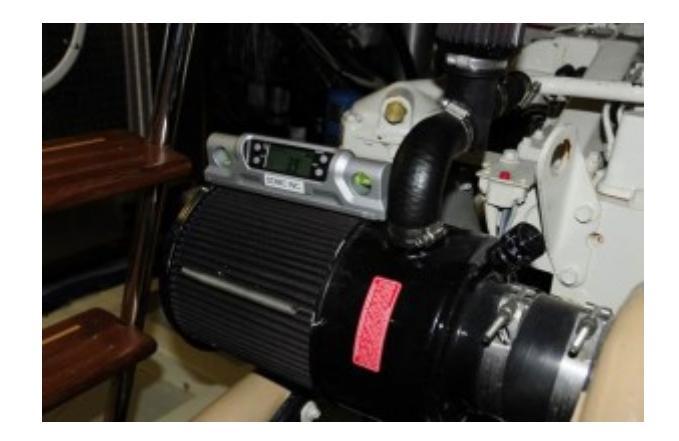
As valuable as they are, after-market crankcase ventilation

systems are only effective when properly installed. This one isn't, its outboard end droops down, preventing oil from draining properly.

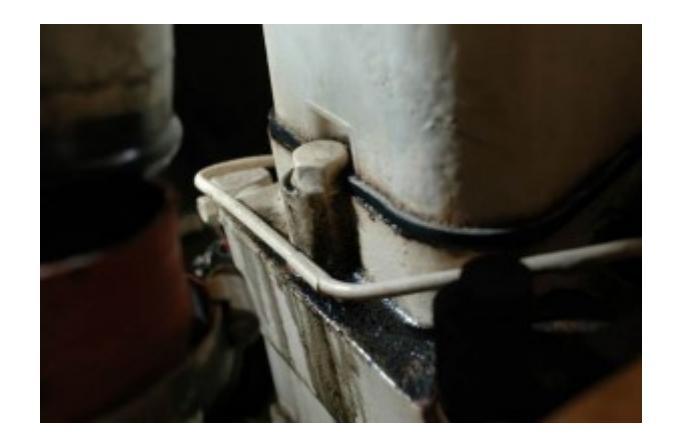
Telltale signs of excess crankcase pressure are often visible if you know what to look for. In some cases, a seemingly simple oil leak is in fact the result of pressure pushing oil past seals or gaskets. Chronic crankcase or valve cover leaks in that reappear after they have been repaired are also a sign of potential excess pressure.

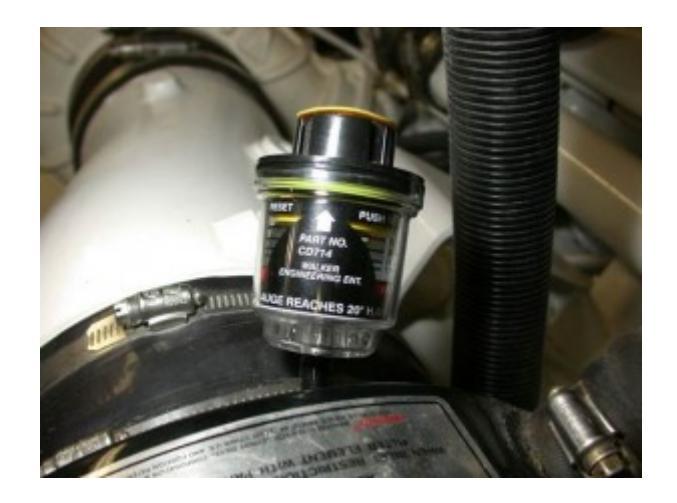
An added benefit of many crankcase ventilation systems is the addition of an air filter vacuum monitor, which alerts the operator to the need for element replacement. Such filter monitors can be added to many air filter housings, even those that don't benefit from after-market crankcase ventilation systems.

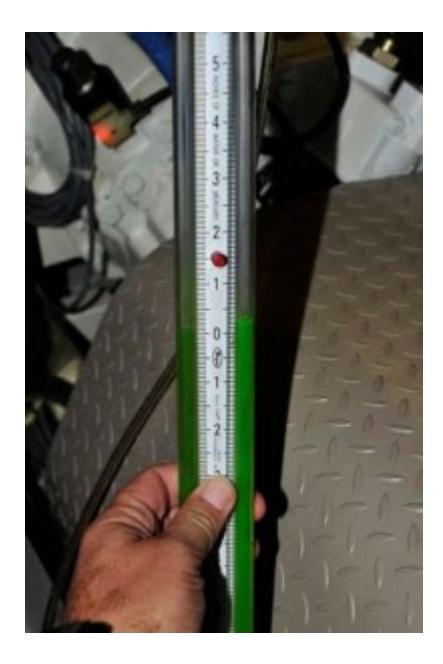
A burden tube manometer is sometimes used by mechanics to

check both crankcase and exhaust system pressure.

Installing a CCV on an engine in this state is tantamount to balancing bald tires. Crankcase pressure can be easily measured by a mechanic. This test is performed using a manometer, while the engine is under load (it *cannot* be accurately performed while dockside). This test should be carried out of excessive blow by is present, as well as during a pre-purchase inspection, it can provide a window into the operating condition of the engine. In addition to worn piston rings or glazed cylinder walls, excessive crankcase pressure may also be the result of leaking turbo-charger seals, which can leak exhaust gasses into the crankcase via the oil return plumbing. If high crankcase pressure is identified, all of these possibilities should be investigated.

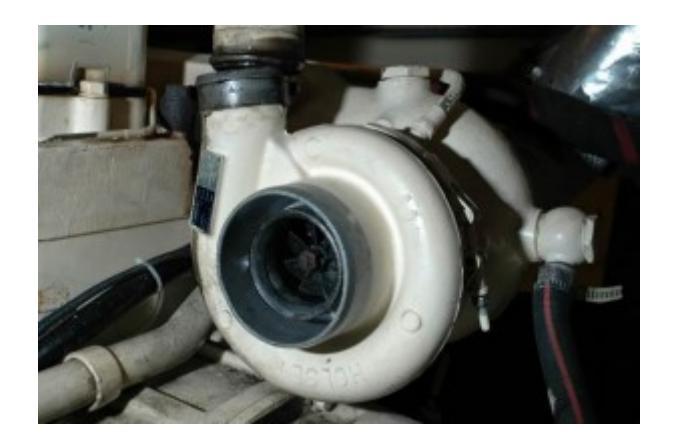
A potential source of increased crankcase pressure that's often overlooked, leaking turbocharger seals should be checked before assuming high pressure is the result of other internal engine wear or damage.

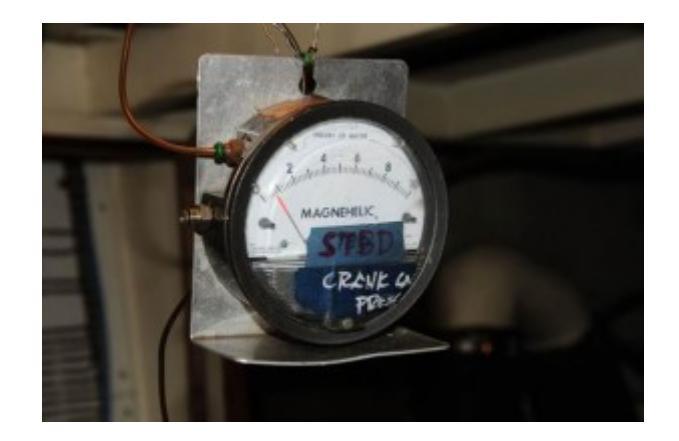
Crankcase pressure gauges are also available in an analogue dial format, like the one shown here. The typical unit of measure for these and slack tube manometer is inches of water. This one has a range of 0-10. While it varies with engine manufacturer, a maximum allowable crankcase pressure of four inches of water is not unusual.

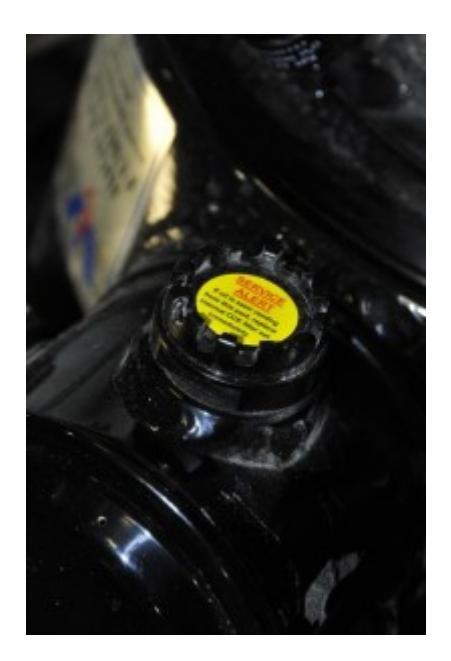
Depending on the unit, some crankcase ventilation system manufacturers call on users to be alert for venting of oil, like the one shown here, while others rely on a window into which a red sleeve is pushed if the unit becomes restricted.
