The Ins and Outs of Cored Composite Construction

Hardware Installation

By Steve D'Antonio Copyright July 2013

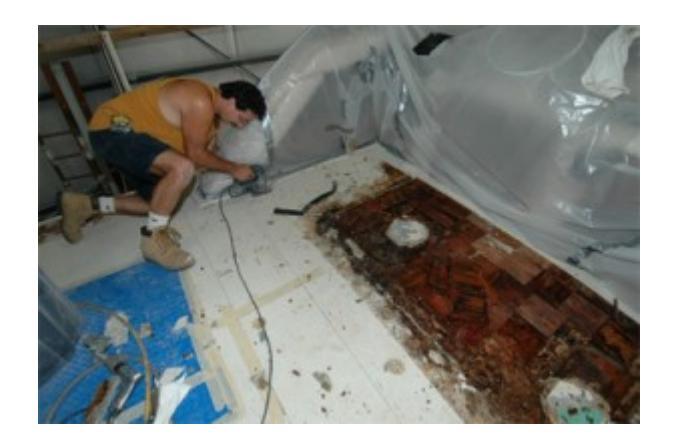
Fiberglass cored composite construction is a reliable, proven boat building technique that when executed properly yields a stiff, light structure.When it goes awry, however, as is the case here, repairs are nearly always costly and invasive.

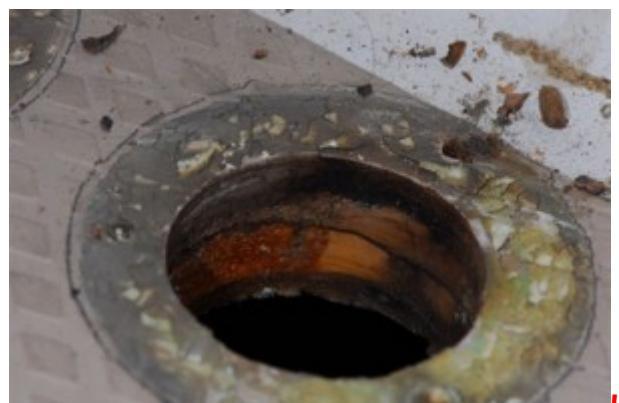
When core material, wood in this case, is visible at a deck "penetration", such as this fuel fill, the only thing standing between it and water saturation is sealant. Sealant, even by most manufacturers' own admission, has a finite life of no more, and often less, than ten years. And, don't be fooled by the thin coating of resin on this core material, it is far too delicate to prevent water entry and does nothing to prevent water from entering through fastener holes, visible around the perimeter.

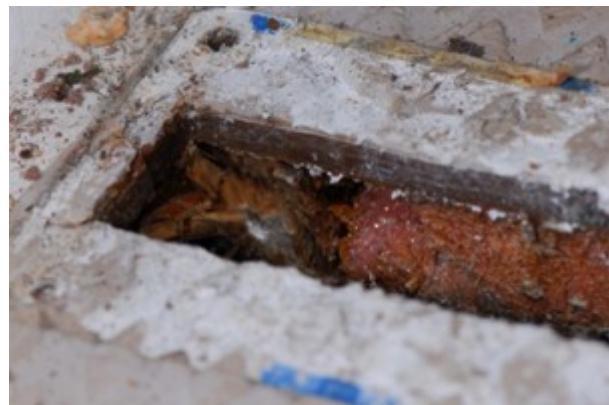
Chain plate penetrations are

notorious for acting as avenues of water ingress and core saturation. While any deck hardware can serve as an entry point for water, highly loaded structures push sealant to its limit, often resulting in early failure and saturation.

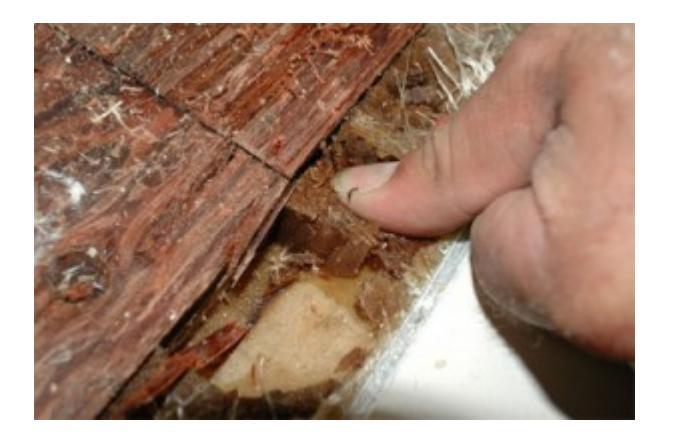
This flybridge deck has been cored with a mixture of small plywood blocks and end grain balsa, which is both saturated and decaying. While other core materials exist, ones that are less prone to water absorption, the failure is a result of execution rather than material selection; the core was not properly closed out.

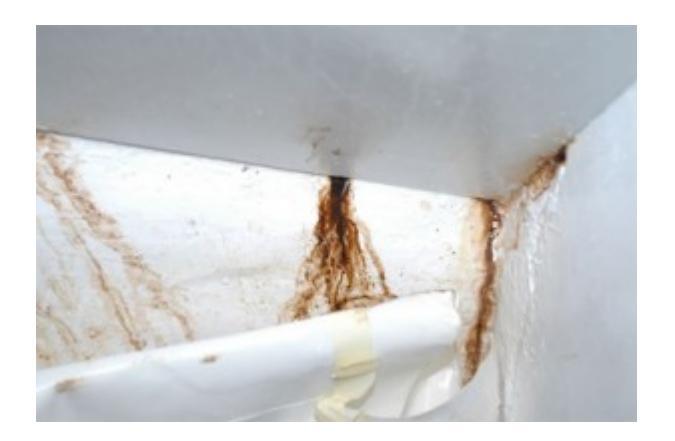
The telltale brown "coffee stain", it's not a pretty sight and it nearly always bodes poorly for the vessel and its owner. Proper core repairs are nearly always expensive, nearly always more expensive than the preventive measures.

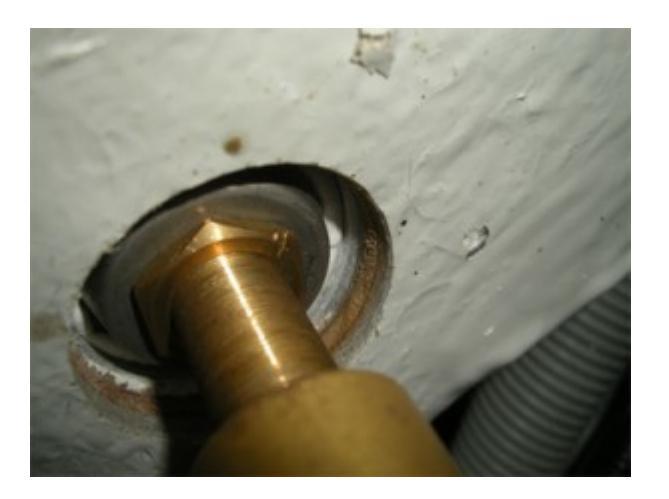
Plywood core material is visible at the penetration for a windlass foot switch. Bedding is also visible, when it eventually dries out; water will leak past the switch flange and be absorbed by the core.Because plywood and other conventional timer has a long grain structure, water can migrate far within the composite, often many feet from the entry point.

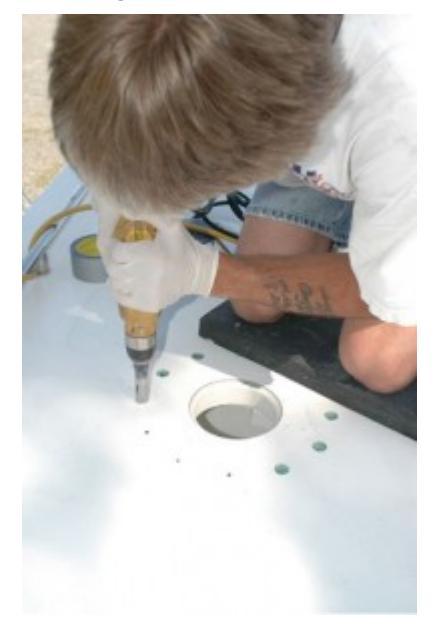
Drilling oversized holes in a cored composite structure...

Ideally, when your boat was built the naval architect detailed where each piece of deck or hull hardware would be installed. Knowing this, the builder laminated into these areas either solid fiberglass or special high density core that's designed for this purpose. Then, the folks drilling the holes on the shop floor installed the hardware using the accepted method of measure, drill, apply sealant and install. However, this is often not the case. Naval architects fail to specify, and/or builders fail to install, these special hardware pads during the lamination process, or hardware is added after the design is complete or years after the boat is delivered. In either case, another approach is required. A thumbnail sketch of the preferred procedure follows; it's one you, the builder of your boat, or your boat yard of choice should follow whenever a cored composite structure is penetrated for hardware installation. After the location for the hardware is determined, mark and drill the holes for the fastener to be used. Then, re-drill only the outer skin hole about half again as large as the previous size. For example, a 1/4 (.25)" hole would be re-drilled to 3/8 (.375)". Dig or, "reef" out the core material for a distance of about 1/2 (.50)" around the inside of the hole

using a pick or a bent nail or Allen wrench chucked into a drill (be sure to wear eye protection). Cover the lower hole from inside the cabin, deck or hull with masking tape and then fill the void using epoxy thickened to the consistency of mayonnaise (West System and 406 or 404 filler works well). This is often referred to as backfilling, or as a procedure boat yard folks call it reefing and backfilling. Apply the epoxy slowly using a small brush or syringe to prevent air entrapment. (For especially deep holes, the void may have to be filled in two "pourings". When epoxy cures it creates an exothermic reaction, it releases heat, if that heat is unable to dissipate because the pool of epoxy is too deep, it could overheat, damaging the surrounding fiberglass and/or core, or it may even catch fire.)

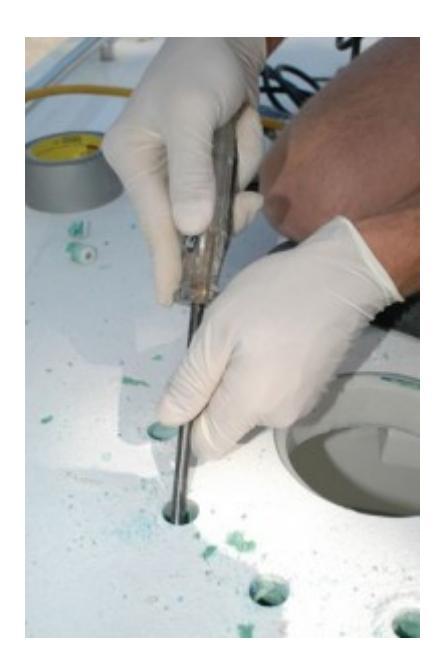
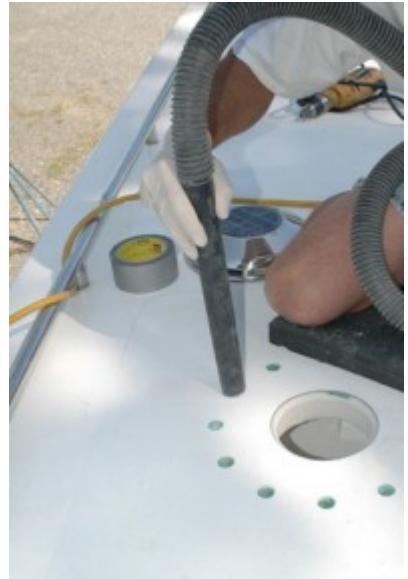
...reefing out the core material the loose core material.

Vacuuming out

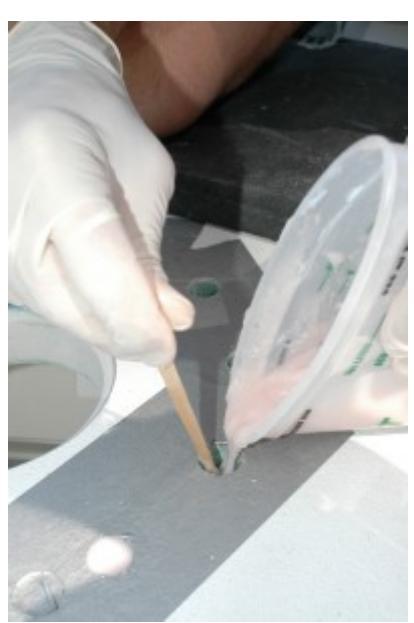
Filling the holes with thickened epoxy.

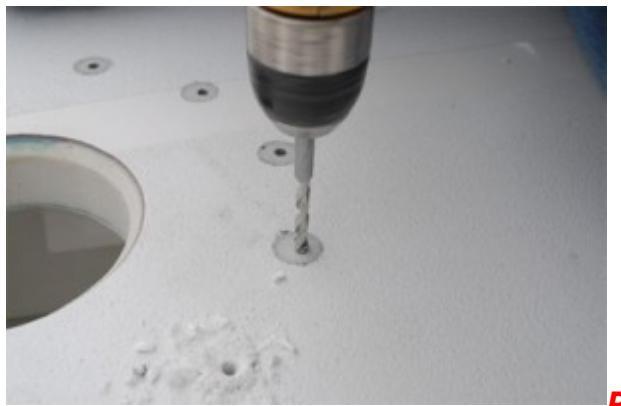
Re-drilling through the cured

Once the epoxy has fully cured, re-drill both holes slightly oversized and chamfer the edges of the outer hole to create a land or recess for sealant. A $\frac{1}{4}$ (.25)" fastener would call for a 5/16 (.3125)" hole. Now, wipe the area down with a damp rag to remove amine blush, a water soluble wax that forms on the surface of cured epoxy. Solvent is not necessary for*this*wax and it should not be used. Then, wipe the hardware to be installed*and the fasteners*, as well as fiberglass or gelcoat, with a clean rag moistened with 3M General Purpose Adhesive Cleaner to remove wax, oil and other contaminants.

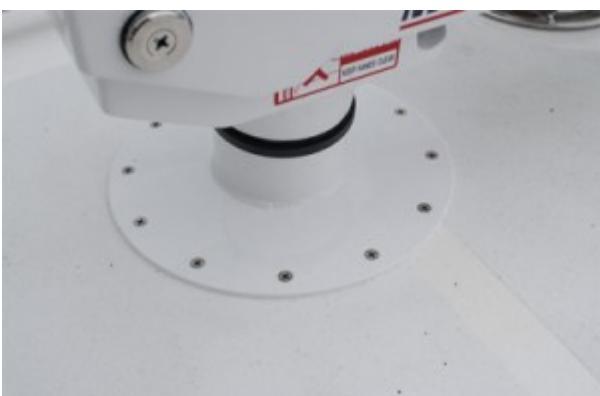
epoxy. The finished product, this crane has been installed in a manner that precludes water entry into the core. If, when, the bedding fails water may leak past the fasteners or stand pipe, however, it will not enter the core.

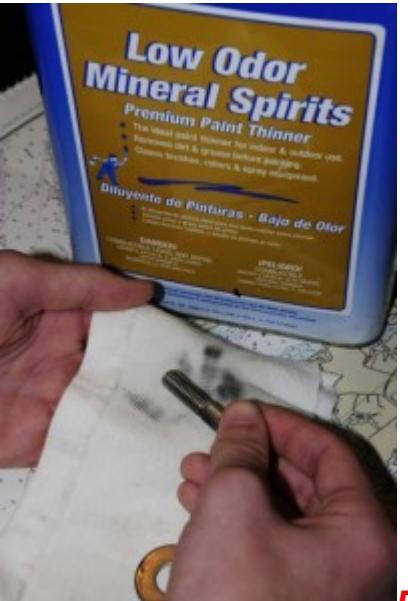
Degreasing, de-waxing or de-oiling is among the most important preparatory steps for hardware bedding. Solvent must be used in this case because these contaminants are not water soluble. Ideally, hardware should not be bedded over non-skid surfaces. In practice, particularly for aftermarket hardware installations, this may be unavoidable. When it is, every effort should be made to thoroughly clean and free non-skid of dirt, debris and especially wax. Doing so may require the use of a stiff plastic bristle brush and solvent.

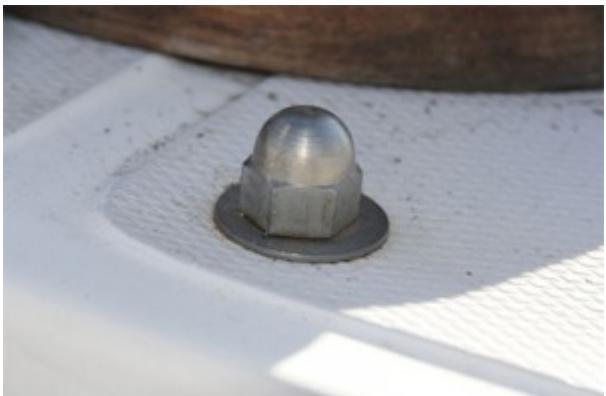
This through bolt is compressing and crushing the core within this cored composite structure. If the laminate was solid in this area, if high density core material had been used, or if it had been reefed and backfilled, this failure would not have occurred. Make no mistake about it, this structure is now compromised, it is weaker and more prone to water penetration.

With this approach, you've achieved two ends. One, you've virtually eliminated the possibility of water entry into the core at the fastener penetration. Two, and just as importantly, the epoxy annulus prevents the fastener from crushing the core (a quarter inch fastener can exert over 500 pounds of pressure on the core, four closely spaced fasteners could apply a ton of force). If the fastener crushes the core it will almost certainly lead to water ingress because of the funnel-like depression that's created.

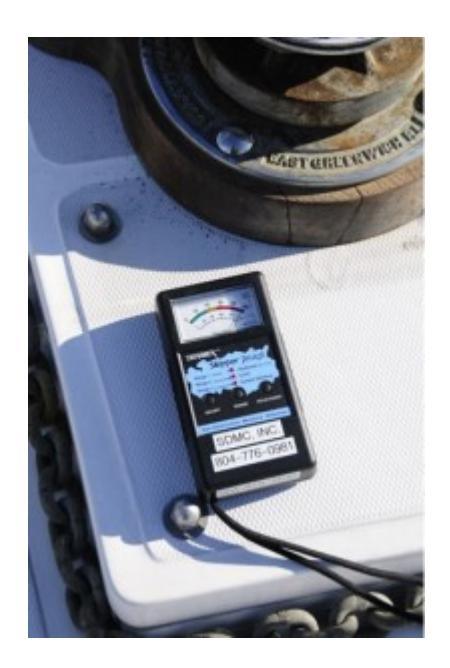
Water is most likely to penetrate cored structures adjacent to hardware installations, particularly those that are highly stressed.

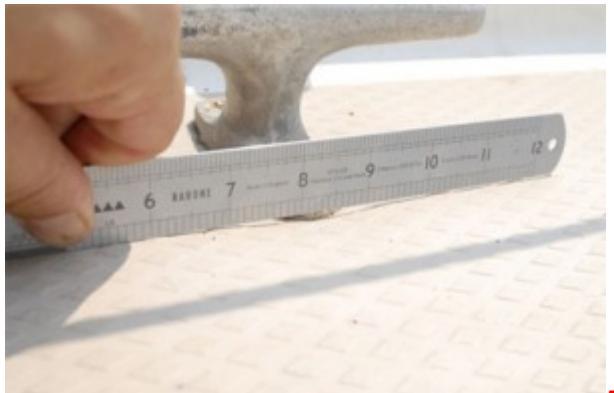
This cleat is installed in a cored composite deck without the benefit of high density core or reefing and back filling. As a result, the core has been crushed, creating a depression, in which water will accumulate, where it will ultimately find its way into the core.

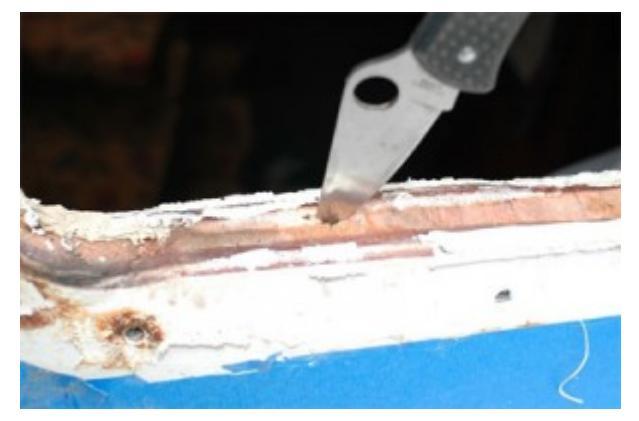
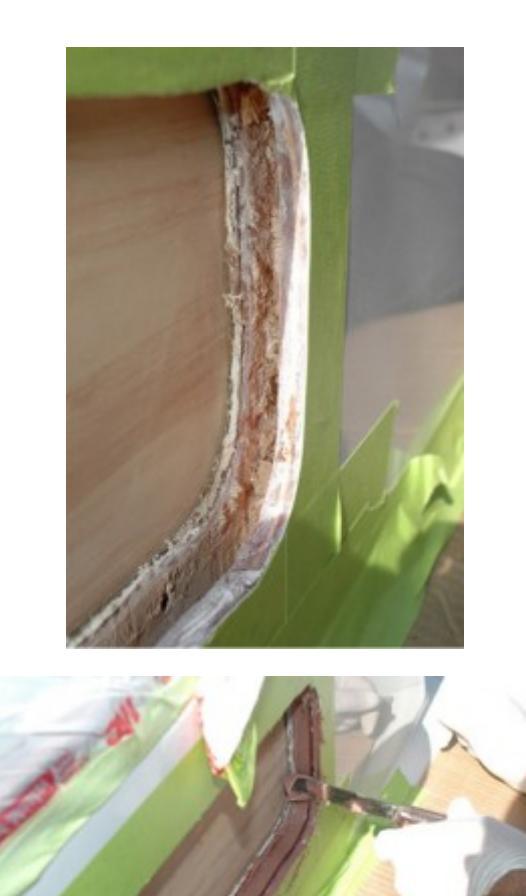
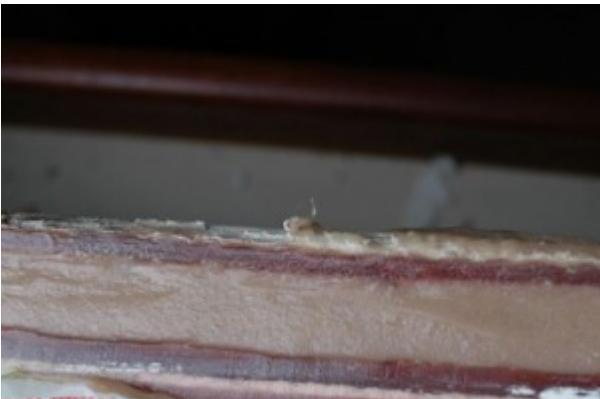
Whenever a cored composite structure is penetrated, water penetration, and localized crushing, can be avoided by following the closeout procedure. If water does enter in improperly closed out structure, the repair process, depicted in the images above, is as follows...wet and decayed core; reefed out core; epoxy backfilling and cured epoxy filler.
