Feature: Risks of Undersized Bonding/Grounding Wires — Editorial: You Have Enemies?

Risks of Undersized Bonding/Grounding Wires

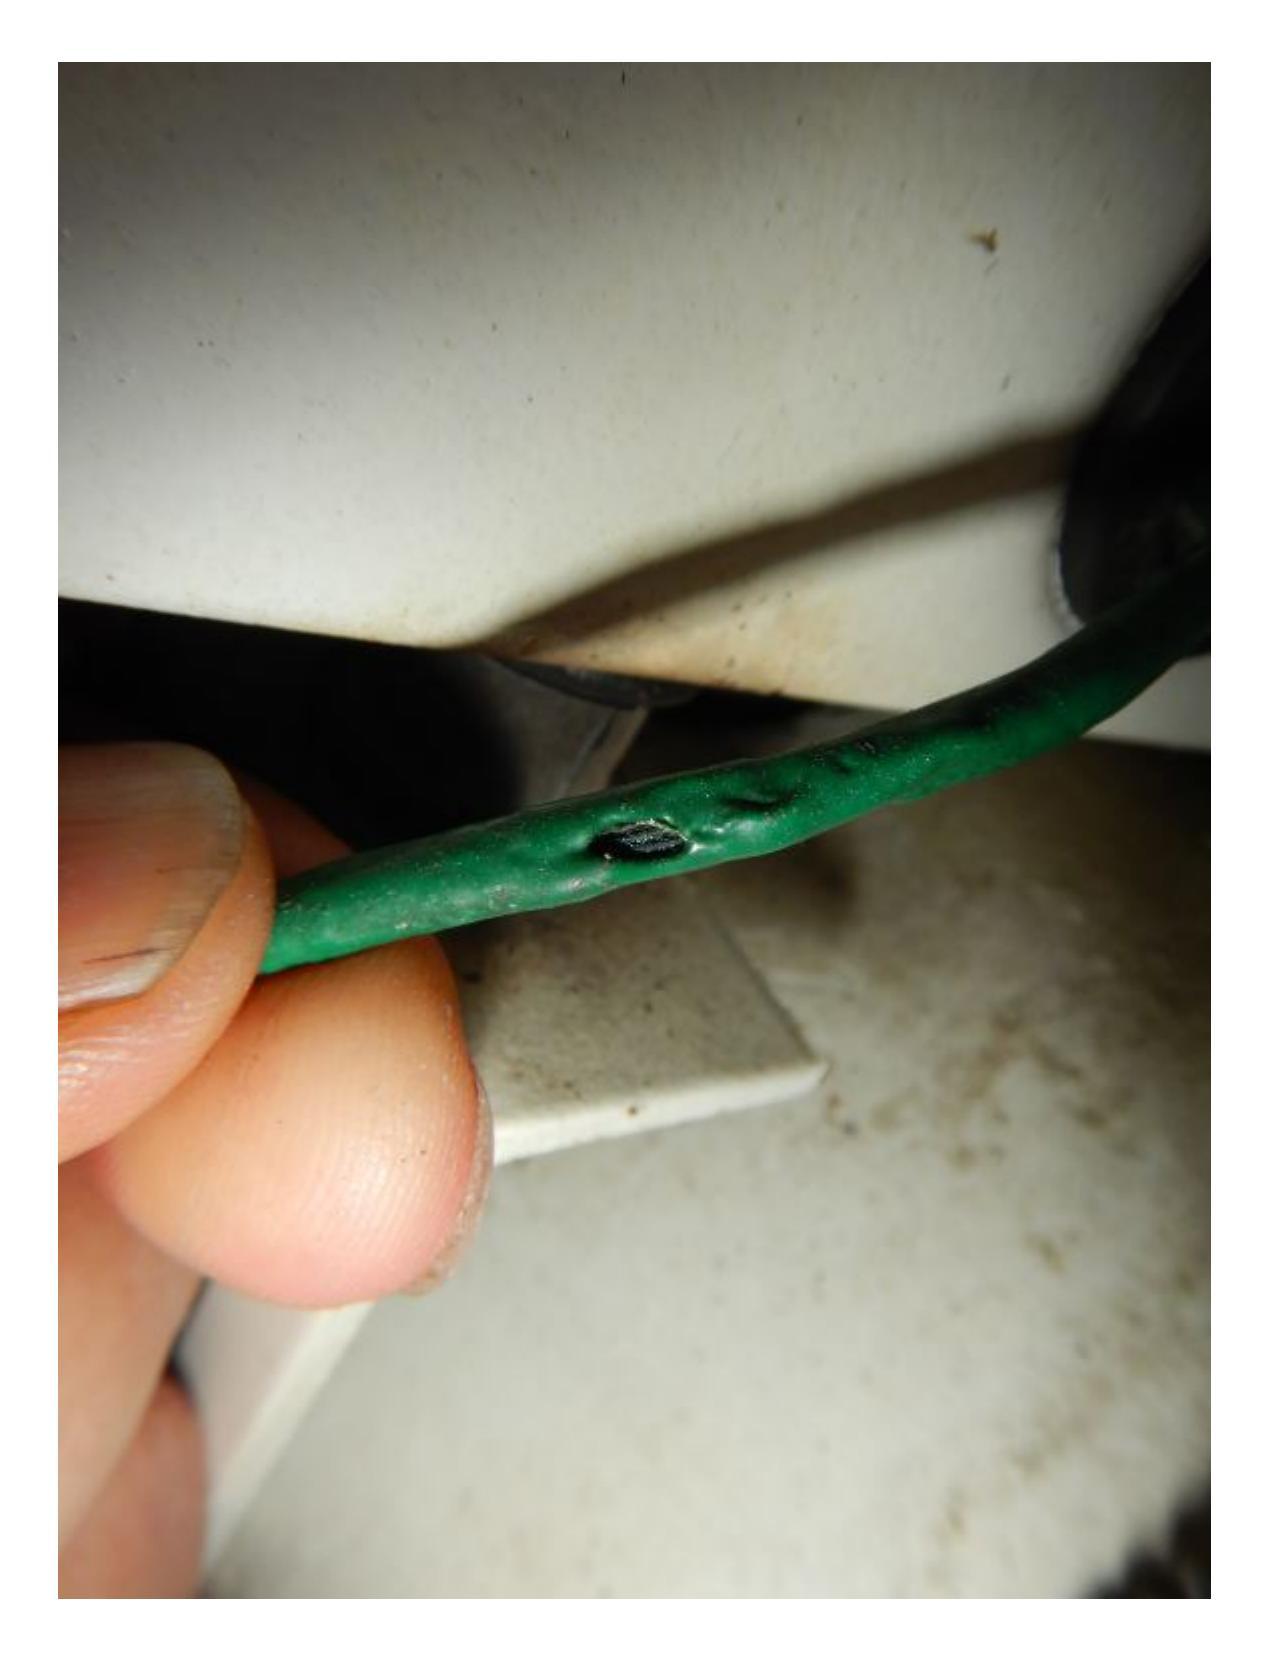
This DC grounding or bonding cable has been overloaded; it overheated, causing the insulation to melt. Under normal operating conditions, DC grounding and bonding conductors should not carry current, however, if they are called upon to do so, they must posses sufficient ampacity to avoid overheating. In response to an article I had written on bonding systems, I received this letter from a colleague...

"Last year I encountered a situation where a well-known and respected boatyard had added a bonding system to a 42 (12.8m) motor yacht. They used #8 wire for the system and did a nice and tidy job of it. The bonding system included a wire to the metal housing for the bow thruster.

What the yard didn't consider is that the bonding wire was now also acting as the DC grounding wire for the bow thruster housing (not to be confused with the DC negative cable). However, when the bow thruster motor developed a short, the #8 bonding wire tried to carry all of the full fault current. That started a small fire, which extinguished itself. Fortunately, the bow thruster was used only for a few seconds, which prevented it from burning causing a full-fledged fire. But the #8 bonding system wire couldn't carry enough current to blow the 250-amp fuse.

Without looking up the reference in ABYC E-11, I believe that the DC grounding wire should be no smaller than one size less than the DC current carrying cables, which I recall as being 2/0 on this particular bow thruster installation.

The point of this comment is that any wire connected to the metal housing of equipment or device that has a DC electric motor (or an inverter or charger) needs to be large enough to carry the DC fault current in case of a short, so that the fuse or circuit breaker can do its job. I see this mistake quite a bit, and surprisingly get a lot of pushback from yards and techs who just don't understand the requirement."

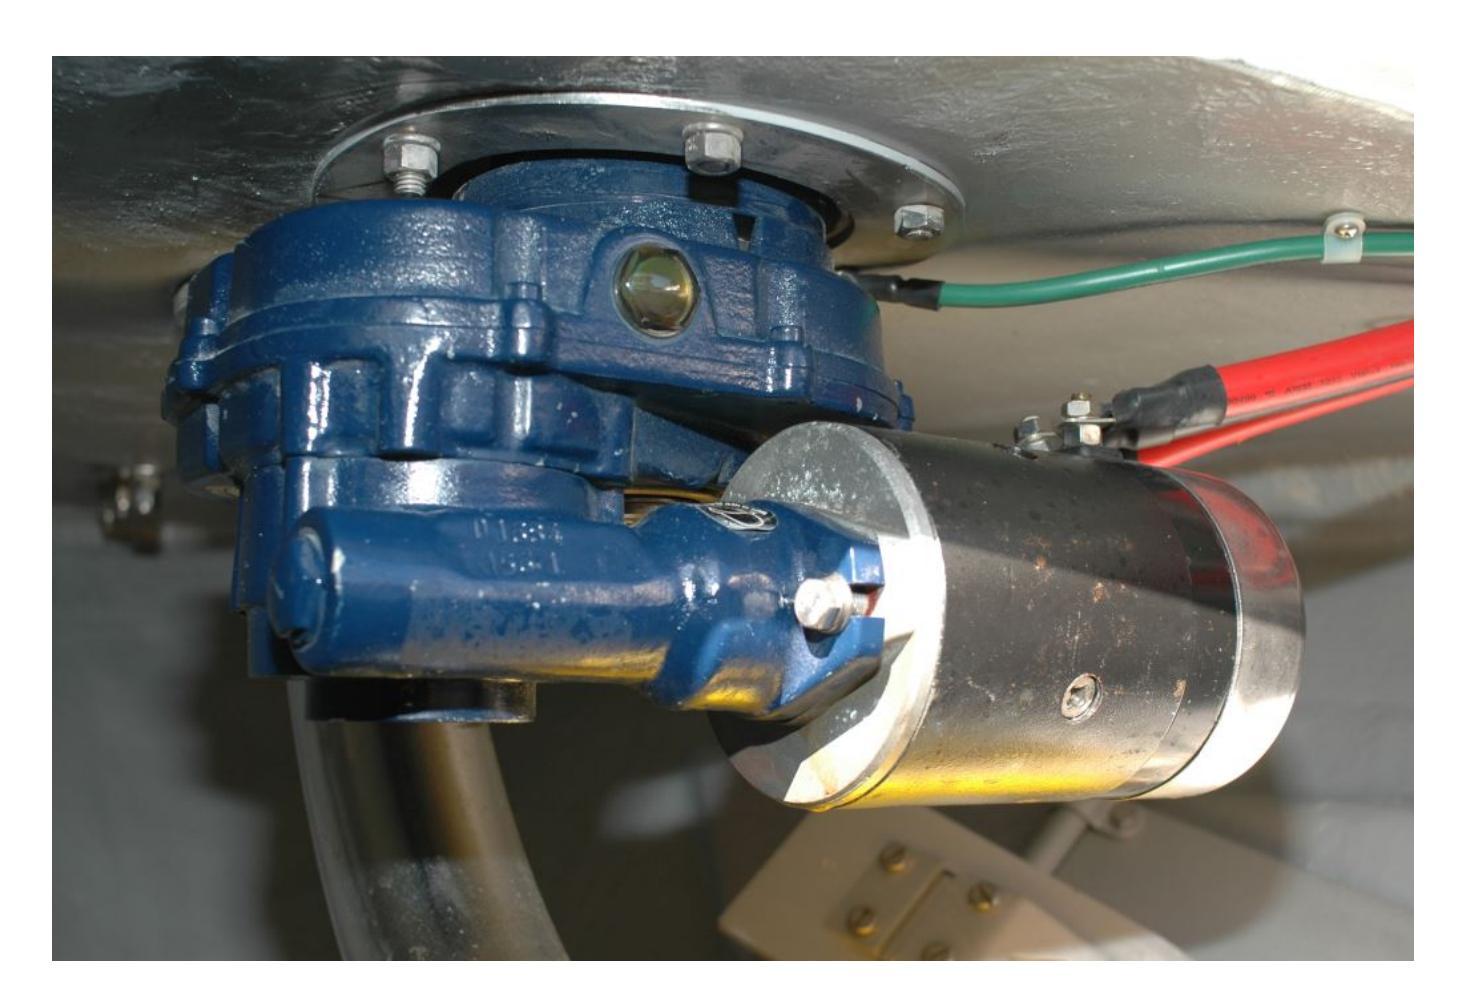
While optional, grounding deck equipment like windlasses is common. If that approach is taken, the grounding wire must be large enough to carry fault current from the windlasses' DC positive cable. This one is undersized.

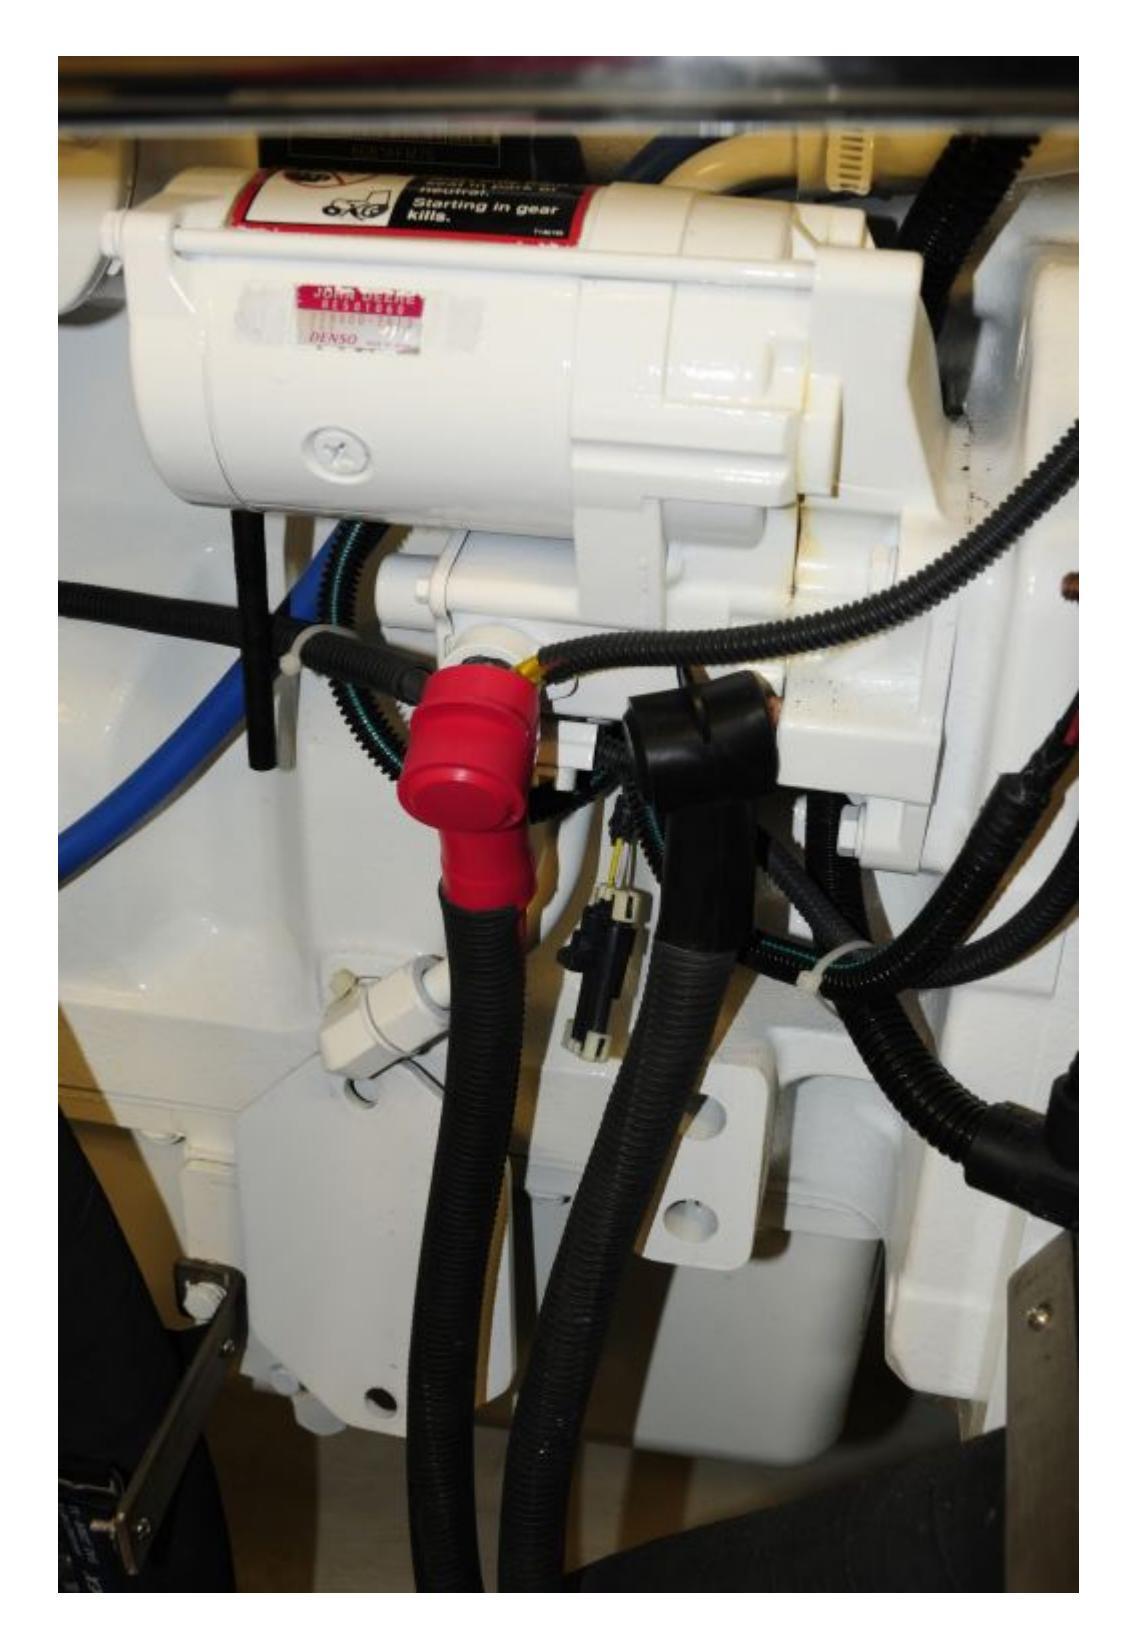
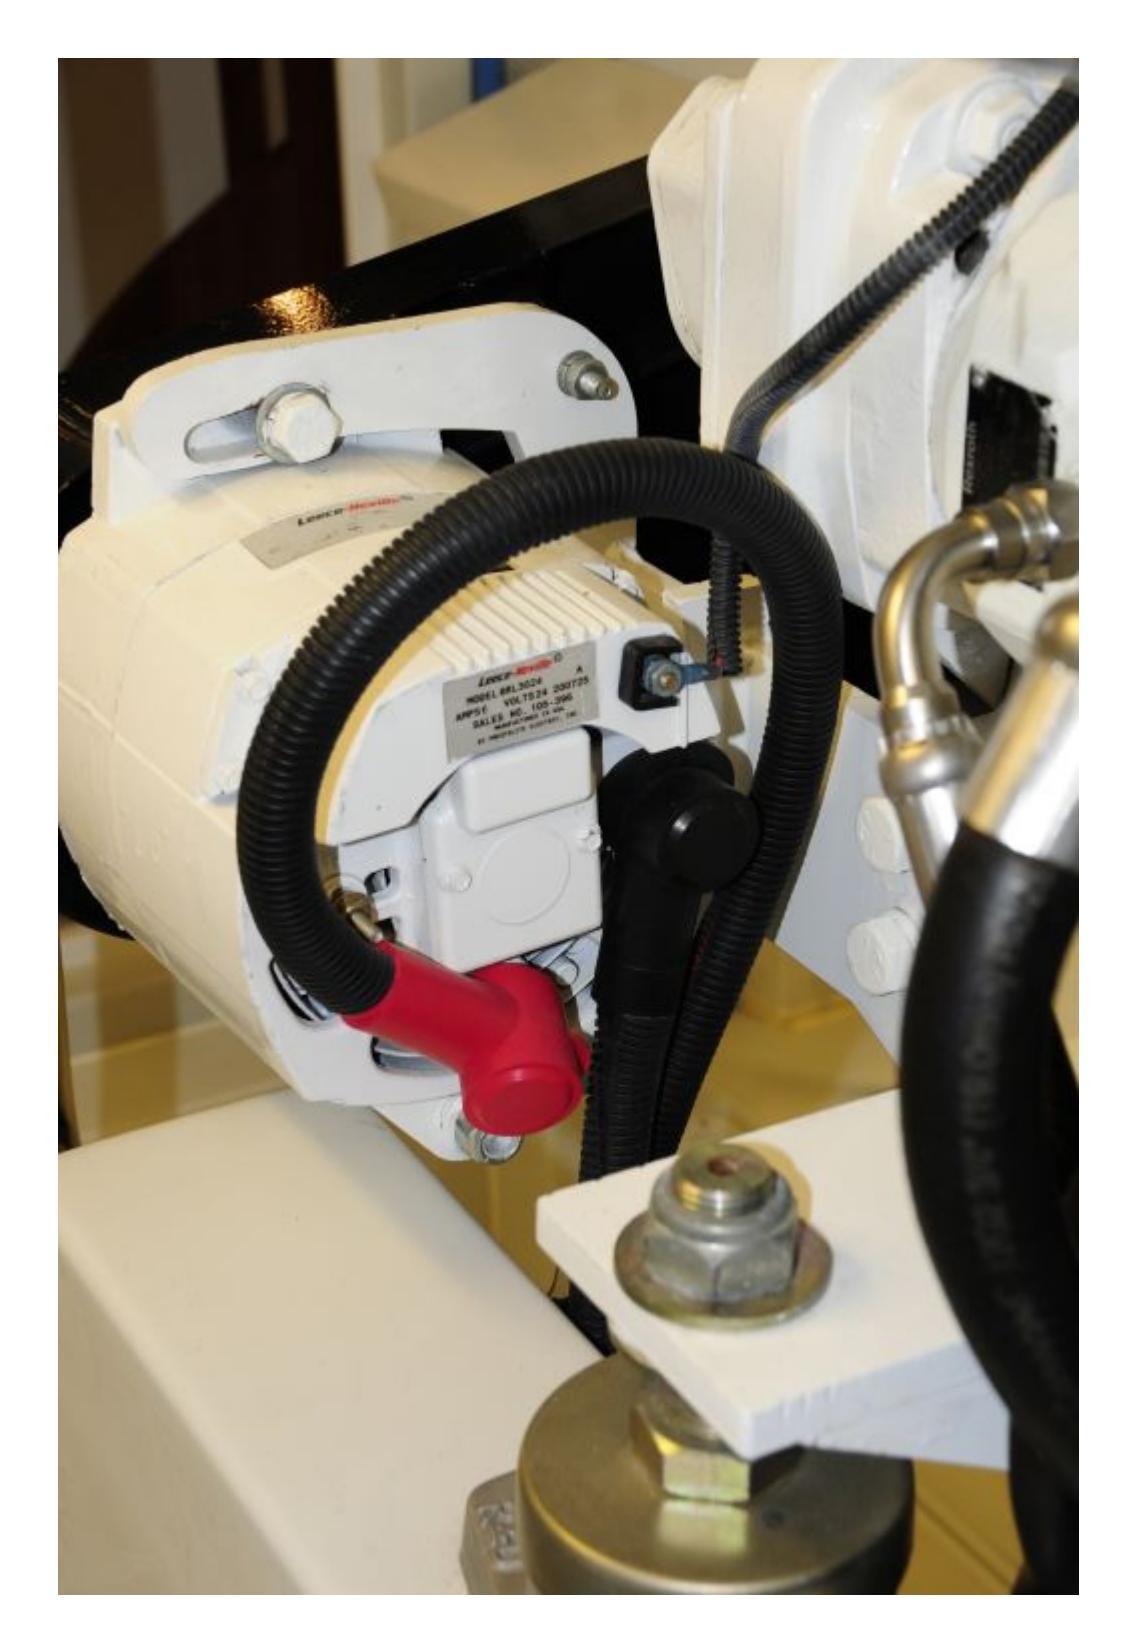
When isolated ground starters and alternators are used, the engine block is non-current-carrying, which means it can therefore be DC grounded. The grounding cable used must be large enough to carry full fault current from the largest DC positive conductor, which is usually the one supplying the starter, which is also typically not protected by over-current protection (a fuse); it is the only conductor which is exempt

from this ABYC rule, making the prospect of a short to the block even more dire.

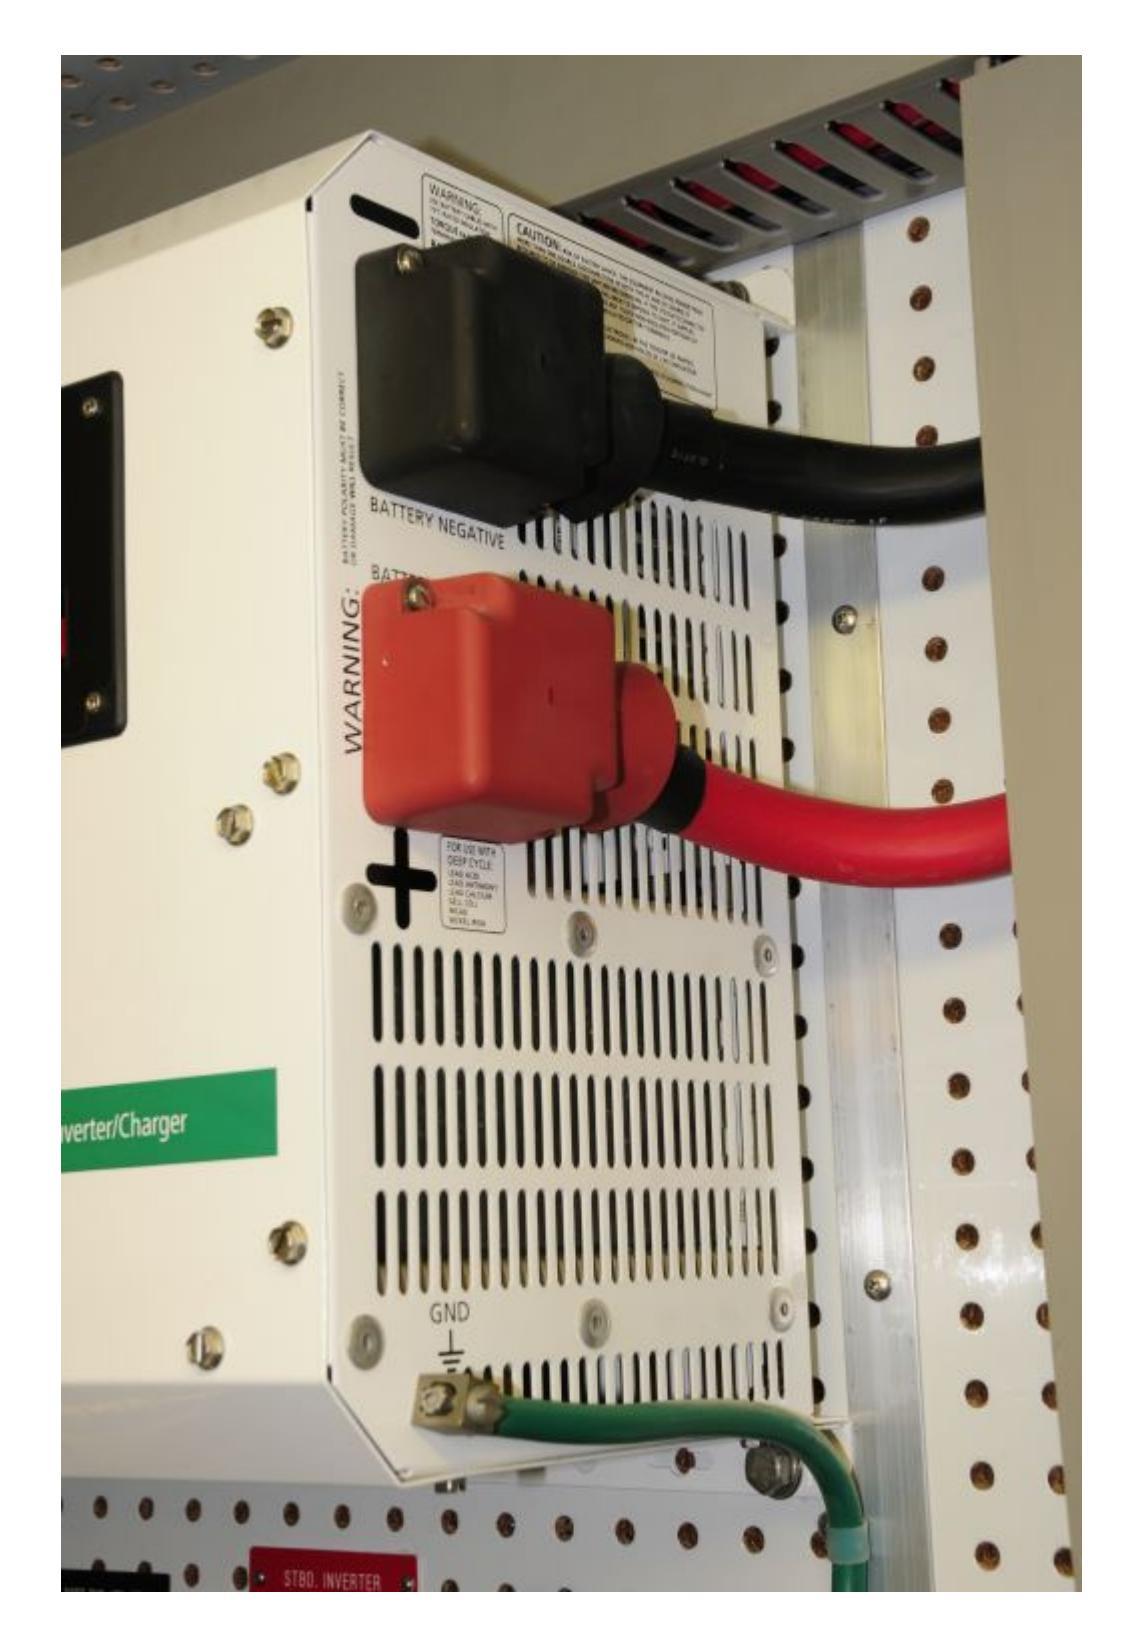
Inverter chassis grounding wires frequently violate the ampacity rule for these conductors. This undersized chassis grounding wire could not carry fault current from the DC positive supply cable, should it make contact with the enclosure. This grounding lug also uses a non-ABYC compliant direct-bearing fastener. If the short you mentioned was a short between the positive supply cable and the thruster chassis, and the chassis was non-current carrying, then the bonding wire became the return path. It would quickly be overloaded and overheat, and potentially cause a fire. Thus, one could argue that the addition of the undersized bonding wire actually caused this problem. If the chassis was not isolated, when the short occurred the DC negative cable would have carried the fault, ideally blowing the fuse.

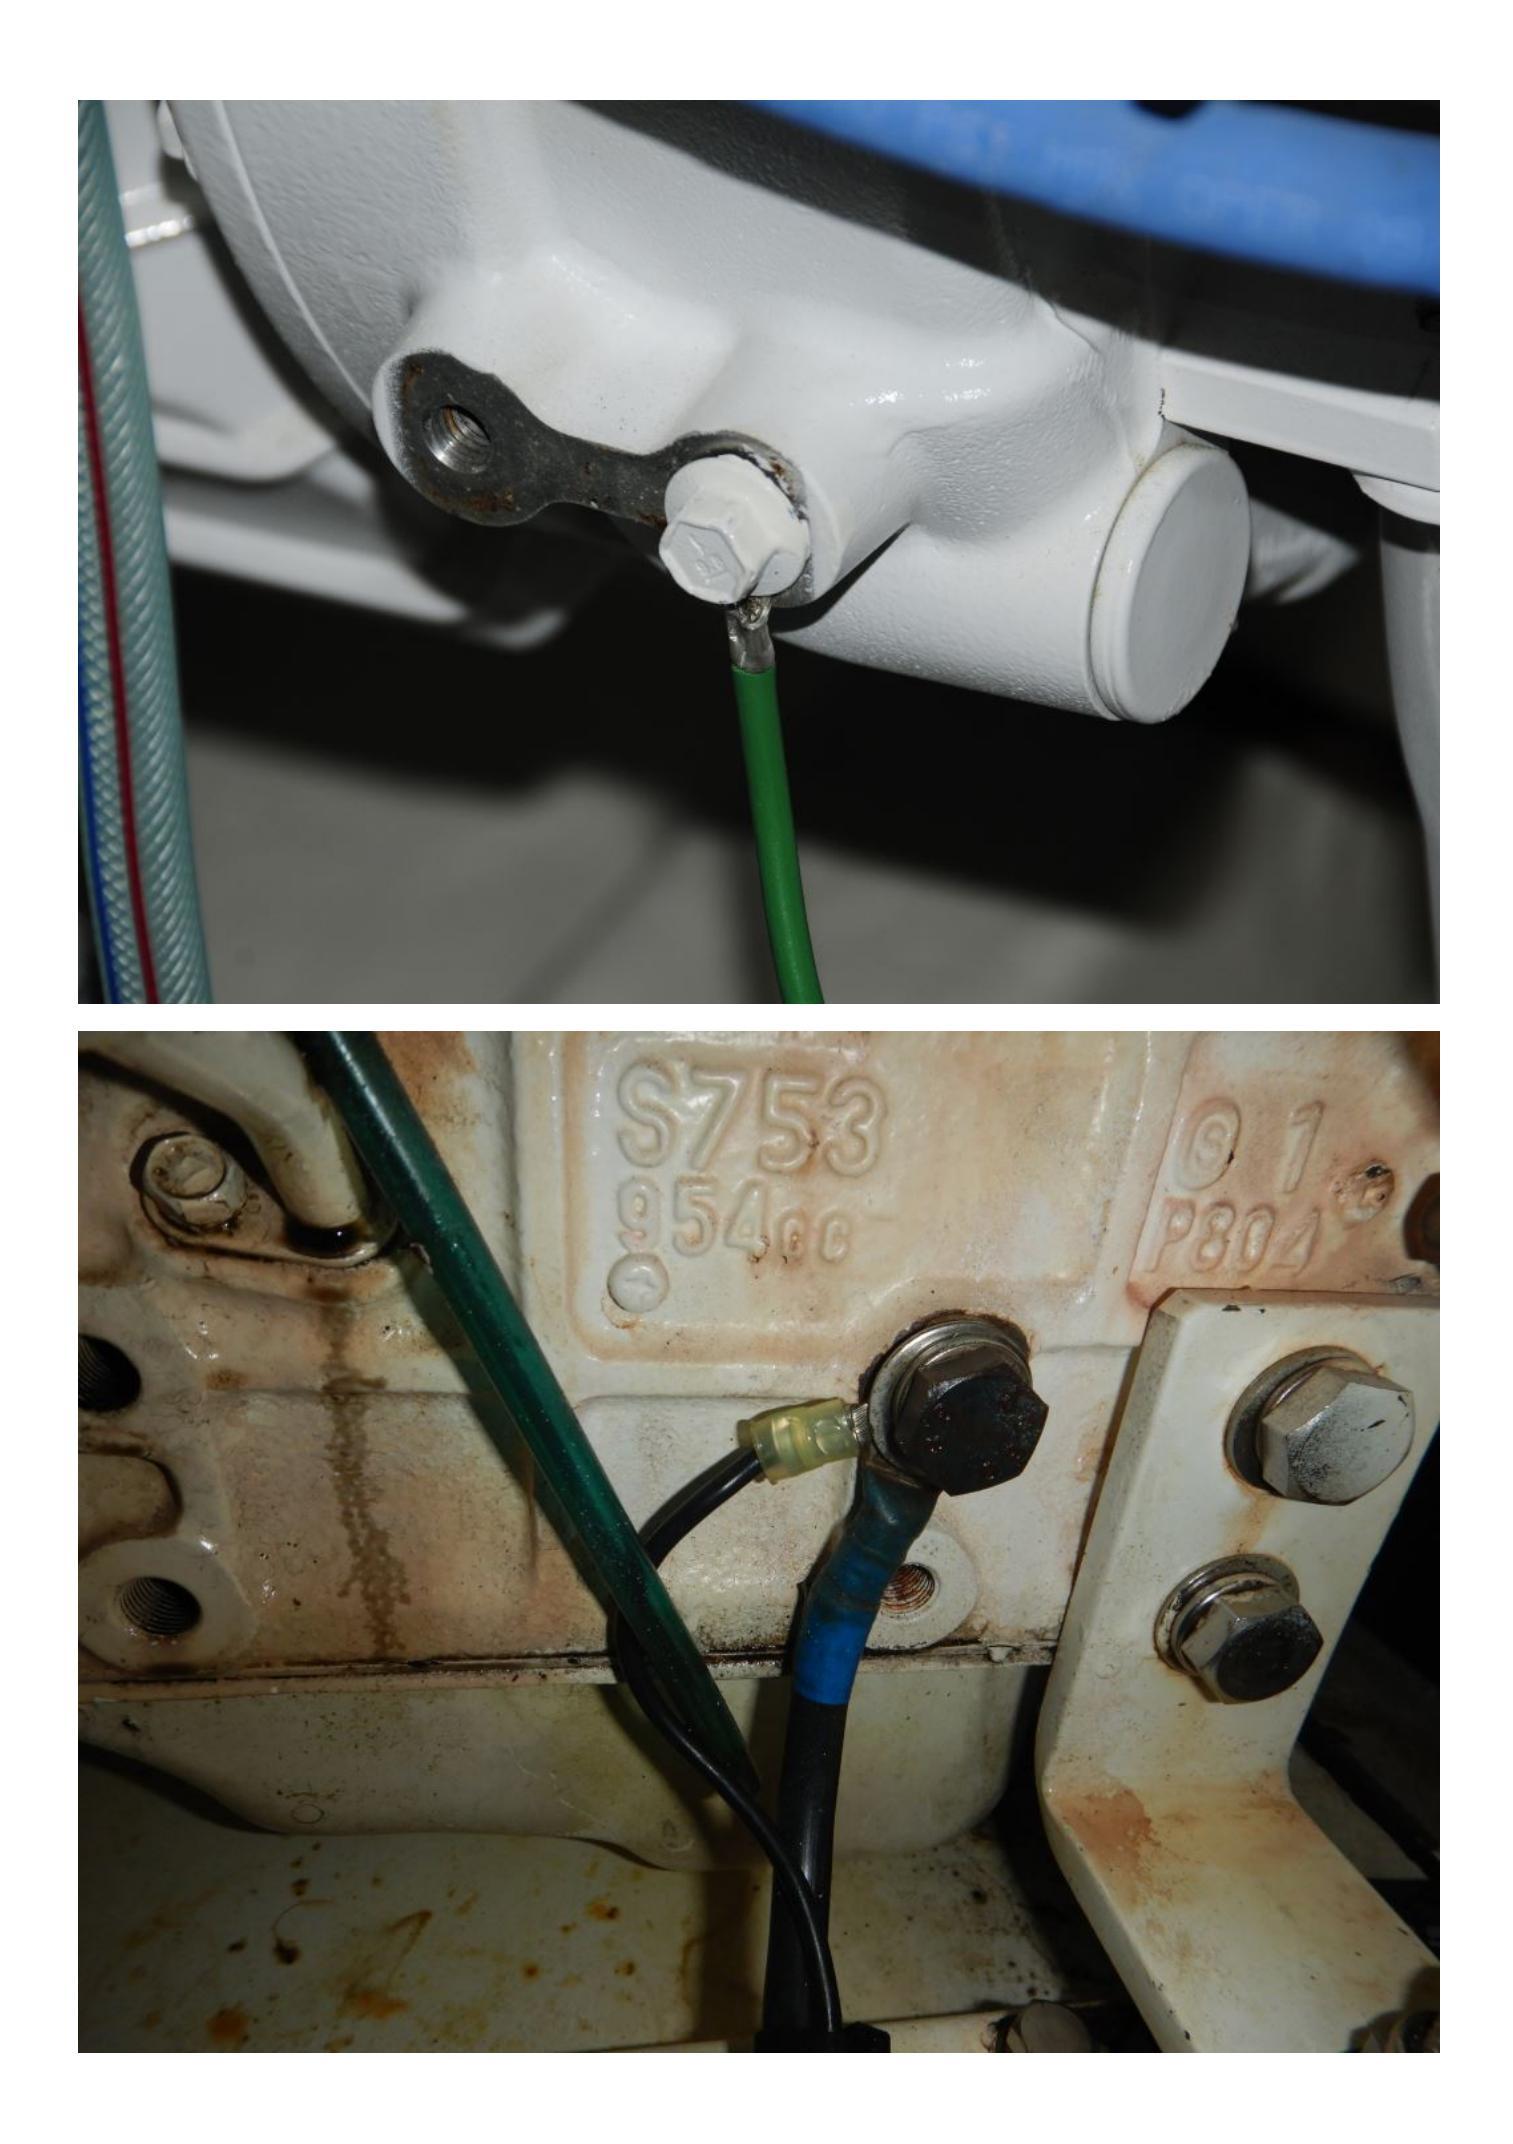
Small gauge wires used for engine block grounding are both incorrect and dangerous. If they are called upon to carry cranking, charging or fault current, they will overheat, which in turn could lead to a fire.

If the engine block is current carrying, i.e., the DC negative cable is connected to the block and the block is normally part of the circuit, If that primary DC negative cable becomes compromised, or it is somehow disconnected (I've seen this occur during battery replacement for instance), these small conductors can be called upon to carry cranking, charging, or fault, current, quickly causing them to become overloaded, and overheated, which can lead to a fire. Or, if the DC positive cable shorts against the block, these wires will carry at least some of the fault current, again potentially overheating.

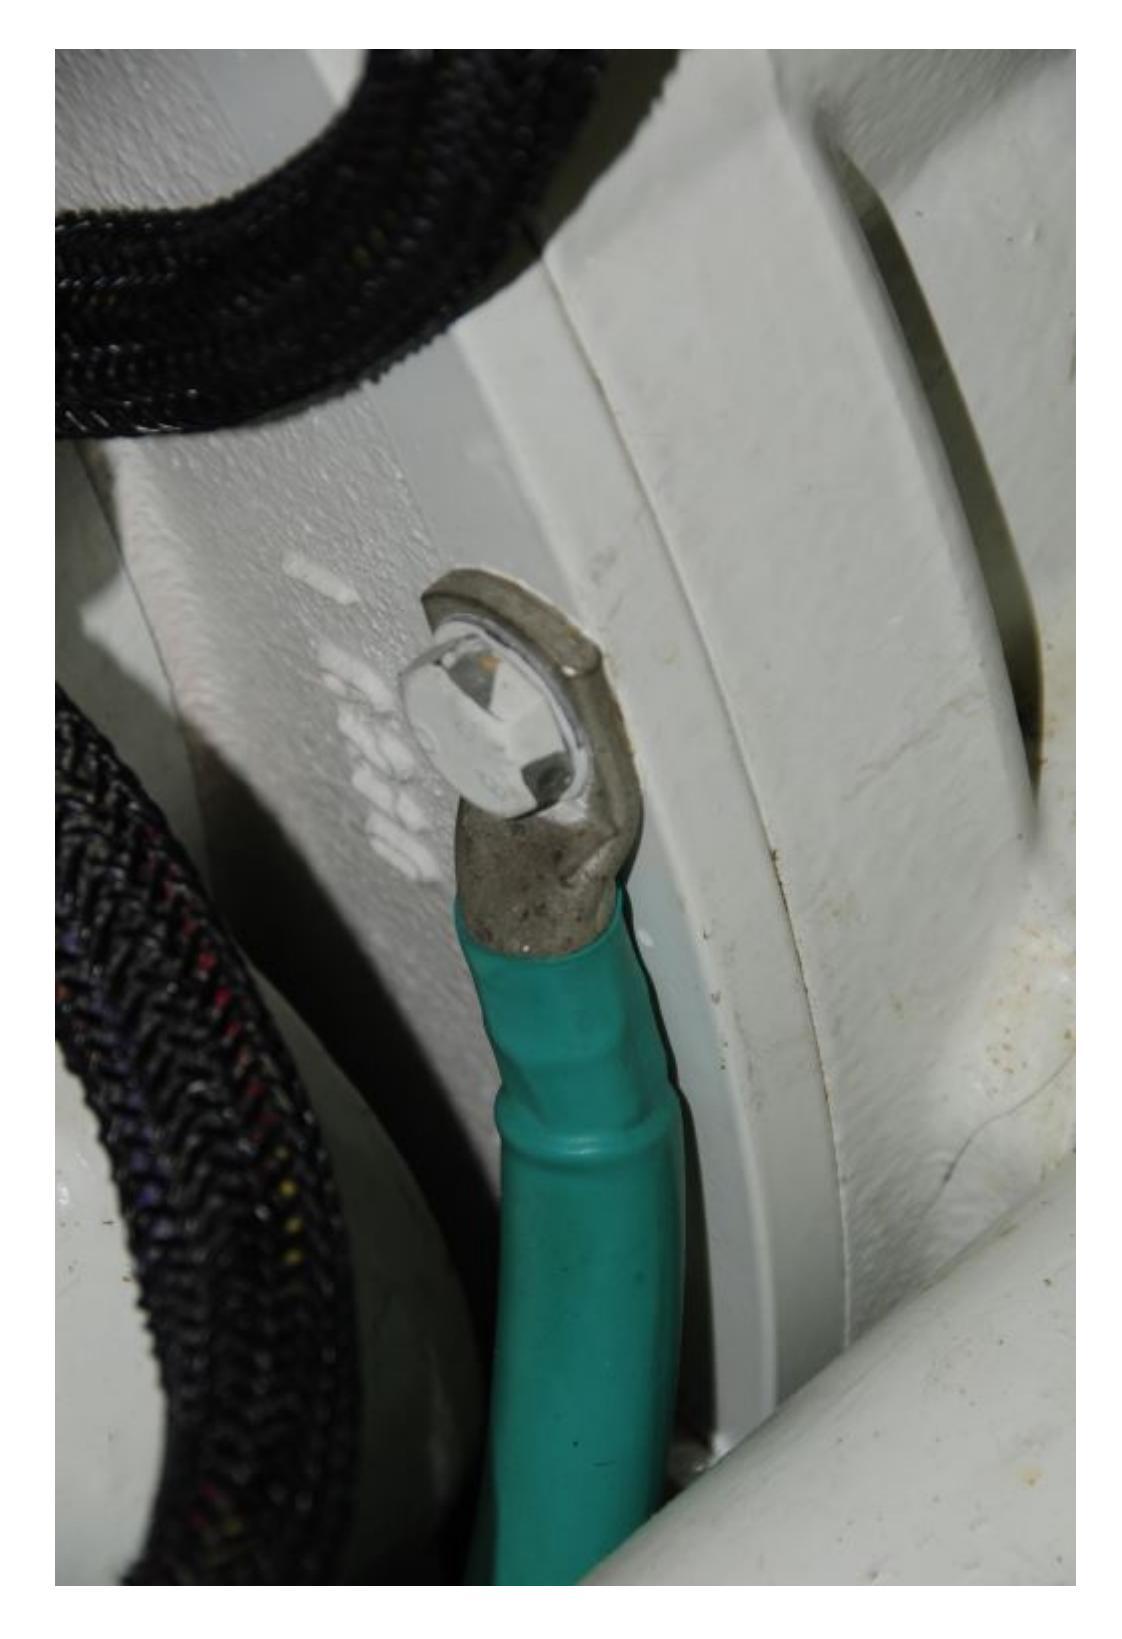
Grounding cables connected to engine blocks must be large enough to carry starter cable fault current, this one is appropriately sized (they should be installed over unpainted surfaces).

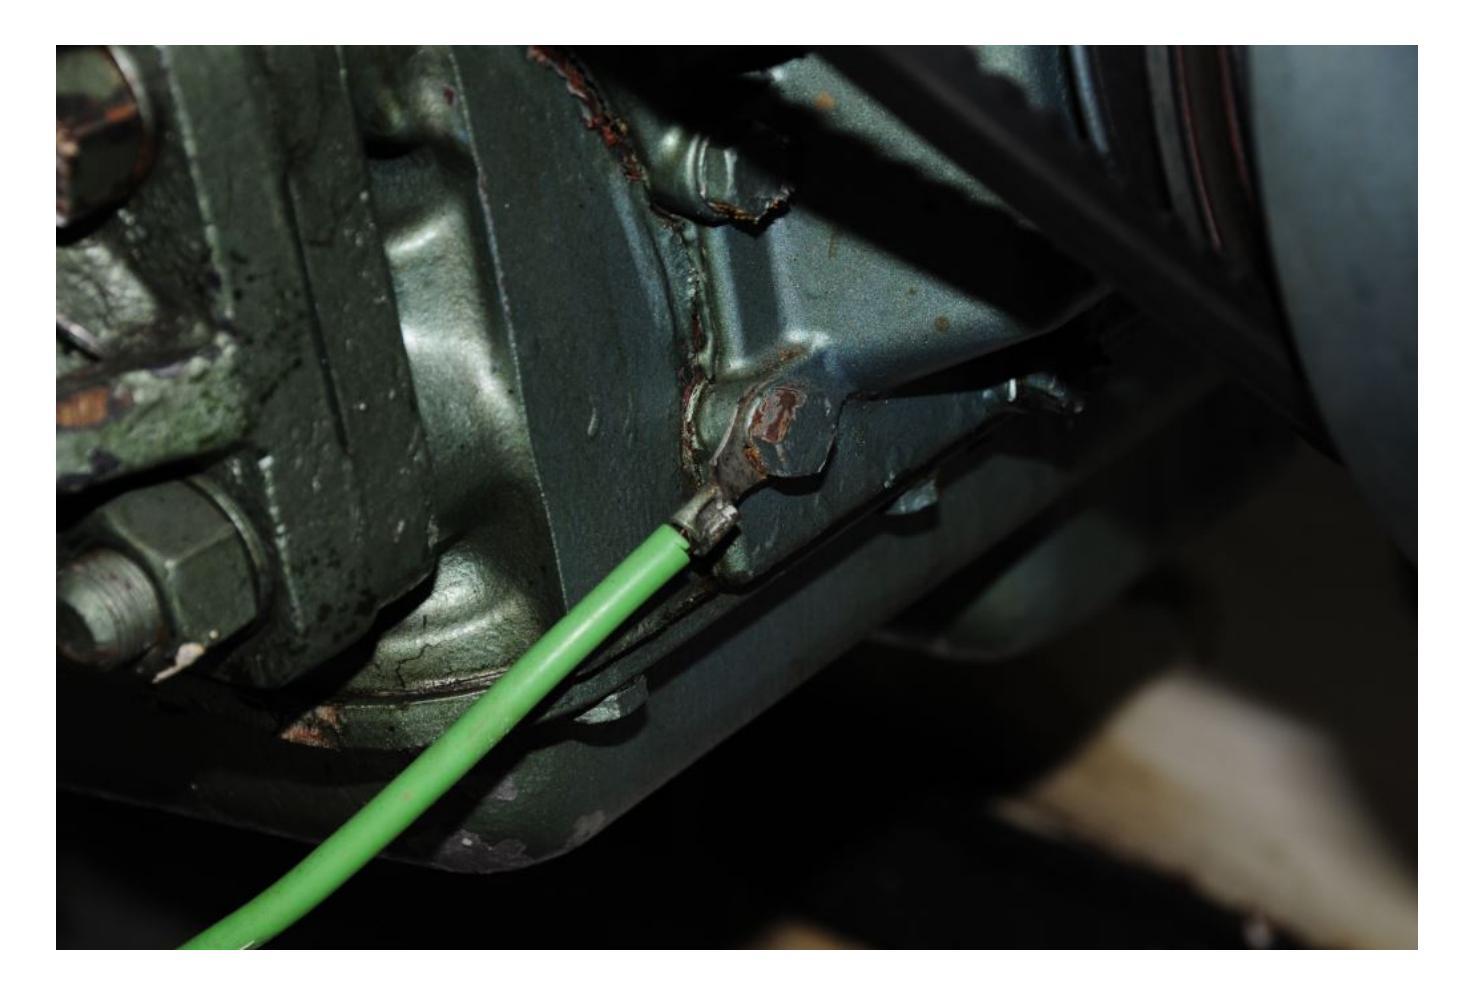
This engine block is grounded, and is therefore normally current-carrying; the starter and alternator use the block to complete the connection to DC negative. It should *not* have a grounding wire, and this one is undersized to boot.
