July 2021 Newsletter "Vented Loop Remote Drains"

Photo Essay: Vented Loop Remote Drains

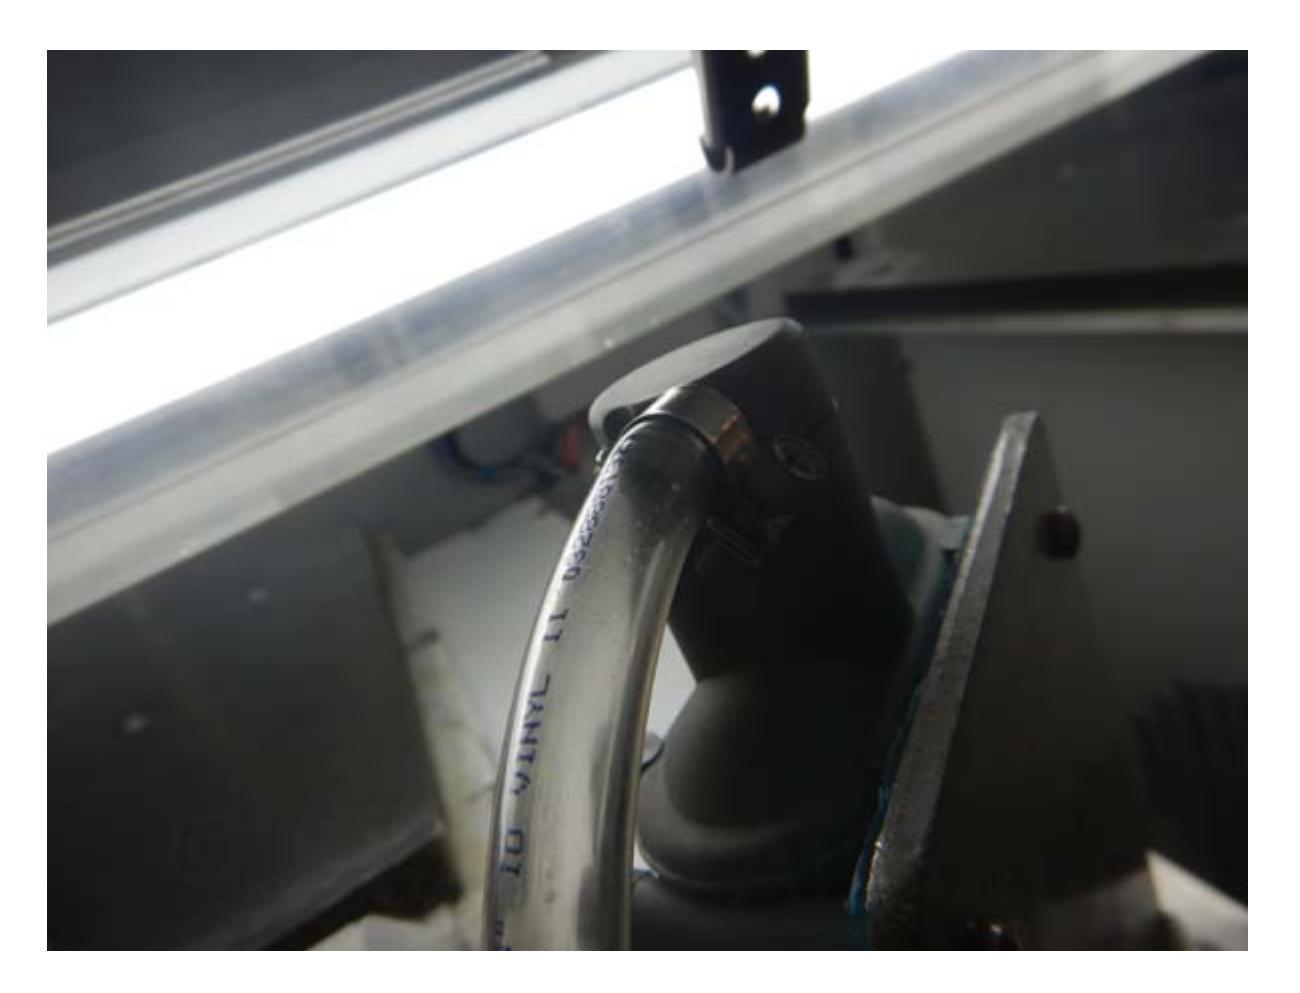
In the accompanying images, a genset vented loop remote hose has kinked. Clear PVC hose, like that which is used here, is prone to this phenomenon, especially when warm. If you choose to remotely vent a vented loop, do so using crush/kink-proof hose, such as Type A or B marine fuel hose, making sure it is routed well above bilge water and terminated in a location where you will notice leakage, which is your signal to repair or replace the vented loop or its check valve. Additionally, it's critically important that the hose be routed so that it drains completely; i.e. it must run continuously down-hill from the vent, so water, and salt, cannot accumulate within.

As simple as vented loops are, they do occasionally fail, with the most common mode being external leakage of water, and since they are often mounted above machinery, like engines and gensets, there is a natural and understandable temptation on the part of installers to fit a remote hose to the loop, most of which are equipped with a small pipe to hose adapter designed for this purpose, routing that leakage away from sensitive gear. As commendable as this effort may be, it's fraught with the potential for disaster. If, for instance, the vent hose is routed to the bilge, and the bilge accumulates water, enough to submerge the end of the hose, water, instead of air, will be drawn into the vented loop, thereby preventing it from breaking the siphon, which in turn could lead to flooding. More insidious is the kinked or crushed remote hose scenario. In that case, the hose may be routed far from bilge water, however, if air cannot pass through it, because it, once again is crushed or kinked, a siphon may be established. I've encountered both scenarios, including those that led to a flooded new genset and flooded year-old propulsion engine.

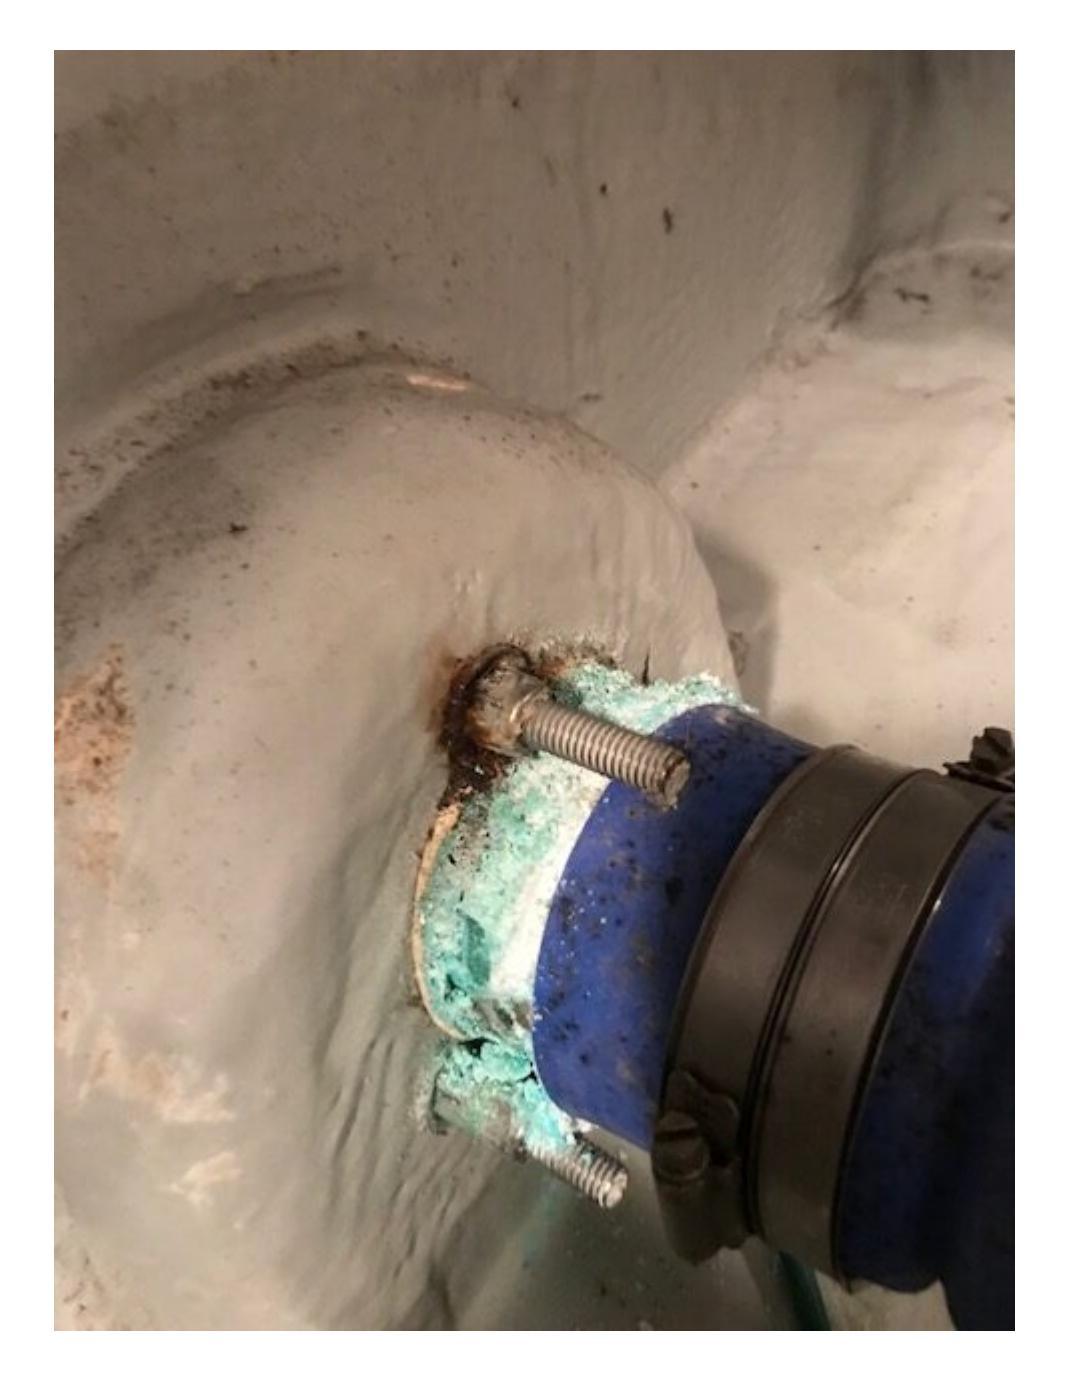
My friend Lee and I have an identical situation, shown in the photograph below. (Lee's boat is a 2005 twin screw Mainship 34 and mine is a 2004 single screw Mainship 30).

I have had this corrosion (?) for several years and Lee noticed his for the first time several months ago. The green ground wire to this part is clean and securely attached to one of the 3 bolts holding the part in place in the shaft log. Zincs on the prop shaft, trim tabs and main zinc on the transom (to which all green wires terminate) are doing their job and are replaced each year. The raw water strainer for engine cooling and the smaller strainer for the A/C have a similar greenish tinge to the surface but no fuzzy material that can be removed. Both strainers have green grounding wires.

When you clean the area shown in the photo with a brass brush, the outer fuzzy layer comes off easily but leaves a greenish patina on the fitting's surface. In a week or two the fuzzy layer re-appears and the process of removal repeats itself. The fitting itself seems to be solid but looks can be deceiving. Can you diagnose the cause of the problem and recommend ways to keep it from happening? Thank you in advance for any help you can offer.

The phenomenon you are experiencing is common, it occurs to virtually every copper-based alloy used in marine (and other) applications; the best-known example is bronze deck hardware such as ports and cleats, as well as the Statue of Liberty, copper roofs and many others. Known as verdigris, or cuprous oxide, it's both normal and harmless. Based on your photo, unless the appearance is bothersome to you, it should be of little concern. If however, you ever see pink associated with underwater or raw water copper alloys such as bronze that is of concern as it indicates another type of corrosion called dezincification, you can read more about it here.

Of far greater concern is the rust emanating from beneath the stainless steel through bolt. Stainless steel is a less than ideal material for use in below the waterline applications such as this. Fasteners are especially problematic since most off the shelf varieties are made from 18-8 alloy, the least corrosion-resistant of those suited for marine applications (for stainless steel, 316 is preferred). Used inside the vessel they are fine, however, they can be problematic on deck where they are prone to staining, and they should definitely not be used for submerged applications such as this. Silicon, zinc-free bronze is a far better choice for this fastening role. For more on this subject see this article.
