May 2024 Newsletter – Not A Cord Grip

Photo Essay: Not a Cord Grip

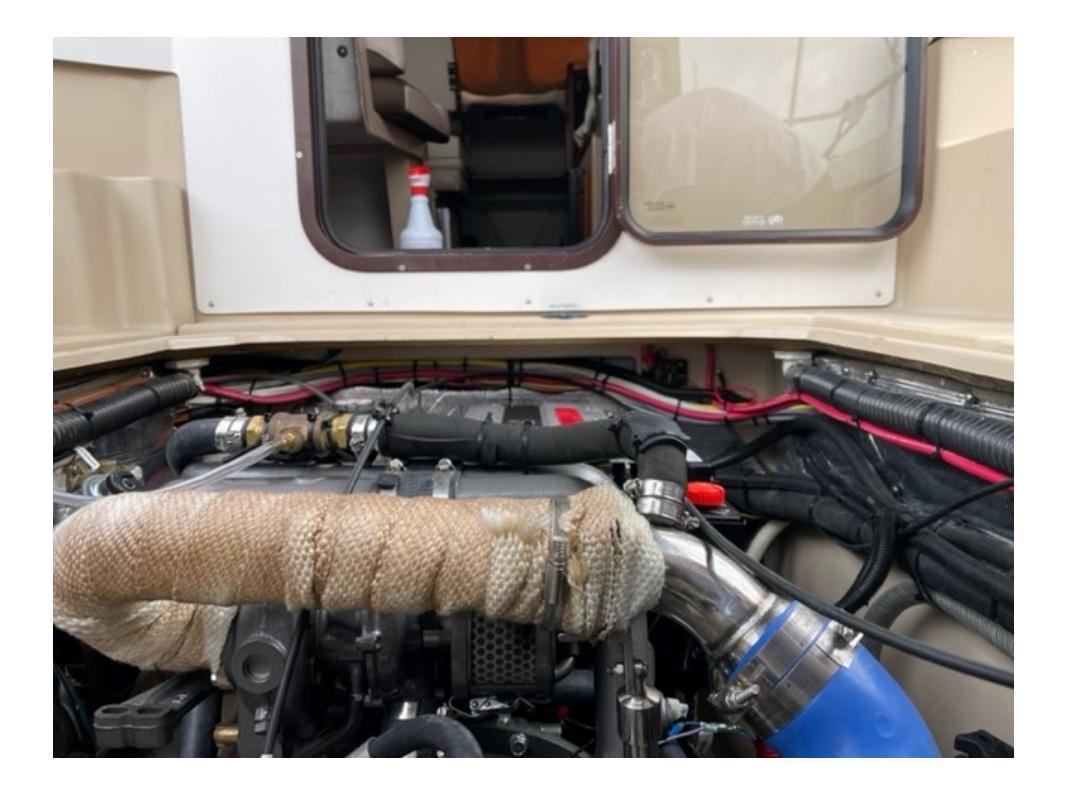
I am looking for help and advice on my boat's newly installed exhaust system. This year I had my 25' Ranger Tug re-powered and I am concerned about the placement of the mixing elbow water injection. See picture. Looking at the picture, it appears to me that the design is marginal and there is a possibility of water backing up into the turbo.

I would suspect while the engine is running that the exhaust system would work fine. However, when starting or stopping the engine if there is any water in the upper elbow and the boat is listing to port or rocking water could enter the turbo.

Based on the photo alone, which is not necessarily definitive, the down angle of the mixing nozzle does not look abnormal. Many engine manufacturers specify a required minimum angle where water is injected into the exhaust gas stream, John Deere's is 25 degrees, Cummins' is 15 degrees. I'm not certain if Yanmar provides such a specification, however, if they do then using a digital level I'd confirm this installation meets that requirement (and in the absence of a Yanmar spec, I'd say 15 deg. would be the minimum). Additionally, the highest point of the riser must be a minimum specified distance above the waterline, which again is specified by the engine manufacturer. There's no way to know what that is from the photo, however, this should be checked. Again, my observation is purely anecdotal based on the photo.

There are four other observations worth sharing. The first, the insulation covering the dry exhaust section appears to be inadequate. At full throttle, under load, the surface of that insulation should not exceed 200 degrees Fahrenheit. I'd prefer to see a purpose-made insulation wrap or blanket that can be easily removed for inspection. More on exhaust system design, installation, and insulation, here.

The second, unless it's beyond the frame, I do not see a wet exhaust temperature alarm sensor. These are typically strapped to the exhaust hose immediately after the mixing elbow, the blue silicone hose in your case. This is an ABYC requirement, it will alert you to a pending overheat scenario long before any damage occurs. More on those here.

The third, what looks like shift and throttle cables are routed close to, if not touching the exhaust. These cables should be routed away from the exhaust, especially the dry exhaust section.

The fourth, there is a bronze T installed in the raw water injection hose, laying on top of the engine, to which a clear PVC hose has been attached. I'm not certain what the clear hose is used for (stuffing box injection perhaps, or is it an anti-siphon device?), however, it is not rated for raw water applications.

Finally, in cases of repowers, my recommendation is that installers be tasked by having them to agree to all relevant ABYC Standards, as well as engine manufacturer installation requirements.
