Paint and Aluminum — How to Ensure a Good Mix

Ensuring the Longevity of Paint When Applied Over Aluminum Components

April 2011

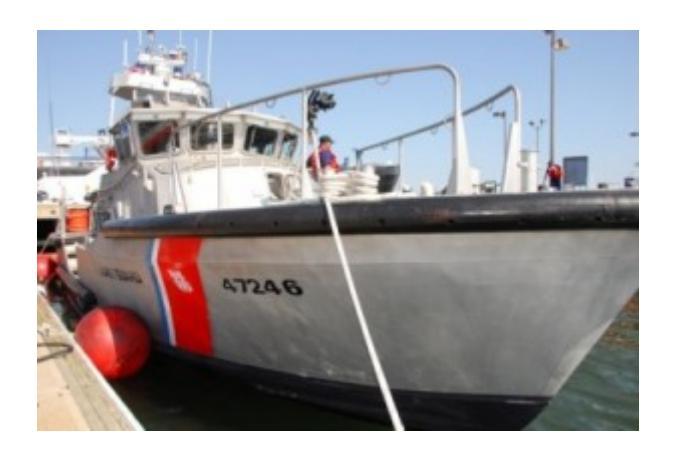
Military, commercial, scientific and a few recreational vessels built using aluminum alloy often utilize the unpainted approach, and with good reason

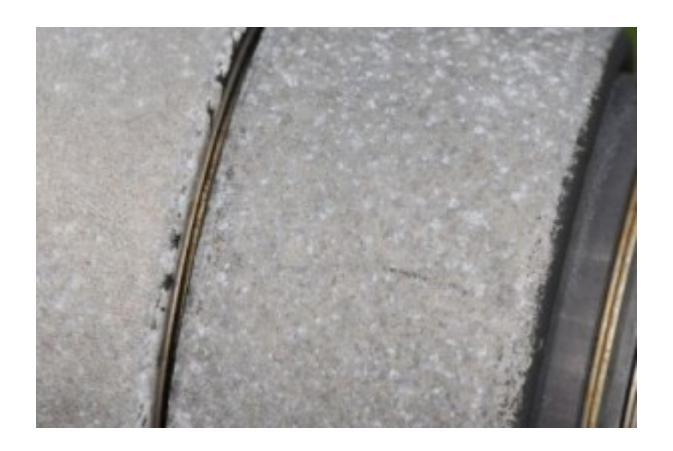
While the natural state aluminum is desirable from a corrosion point of view, many believe the appearance less than attractive

The drawback to this chemical process is the appearance; left to its own devices aluminum also develops shallow pits and a gritty, powdery texture. The byproduct of aluminum's exposure to oxygen is alumina or aluminum oxide, the grit or powder, which acts as a passivation layer. In and of itself this material isn't harmful and the process is somewhat selfarresting, unless it's abraded or cleaned away, at which point it begins anew. The abrasiveness of aluminum oxide should not be underestimated; it's used in the production of sanding its hardness is second only to that media as of Every effort should, therefore be made to prevent diamonds. it coming in contact with glass, paint, varnish and other sensitive surfaces. Never dry wipe one of these surfaces if contaminated with aluminum oxide.

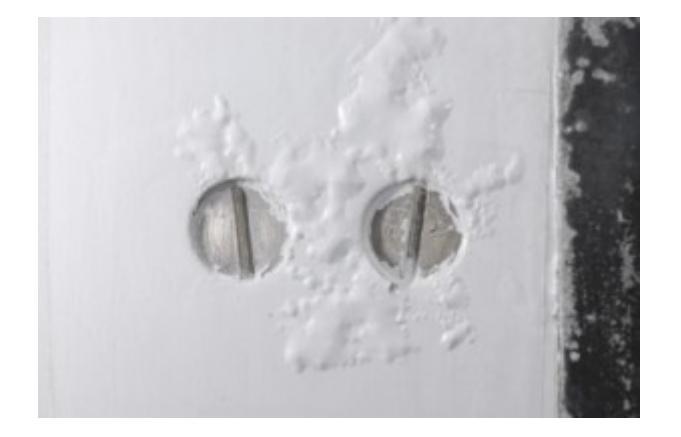
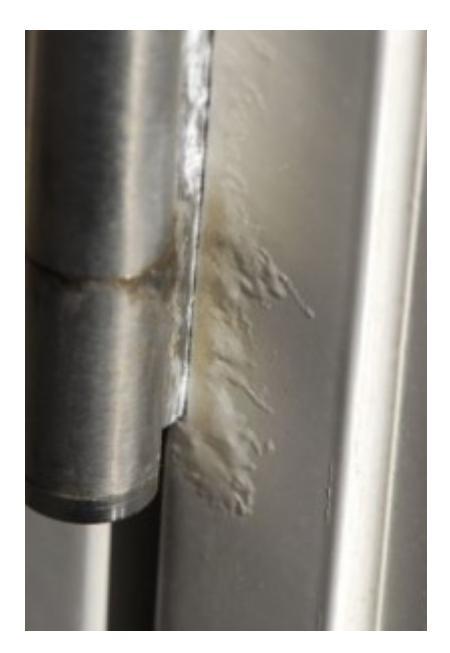
Blisters such as these are a clear sign that corrosion is occurring under the surface. However, it's a symptom of the paint coating having been breached.

When painted, aluminum's surface is essentially starved of oxygen and as such it's incapable of developing and/or maintaining its corrosion resistant oxide coating. Provided the paint coating remains contiguous and unbroken this presents no problems, no oxygen and no water means corrosion can't occur. However, once the coating is breached, no matter how small or seemingly insignificant that transgression of the coating may be, it establishes the recipe for a corrosion cascade. Water ultimately enters the breach, where it reaches and reacts with the aluminum, creating aluminum oxide. The reaction initially has access to air via the breach through which the water passes, however, as the aluminum oxide is formed it expands and lifts the paint, allowing the water to travel further and further from the initial entry point, beneath the paint. Eventually oxygen can no longer reach the area of interaction, creating an environment ripe for poultice The result is the formation of an unsightly corrosion. bulge, beneath which lurks the byproduct of blister or poultice corrosion, aluminum hydroxide. If you've never seen it, aluminum hydroxide looks something like freezer burned vanilla ice cream, it's often gooey until the blister's surface breaks, at which point it will dry out and revert more or less to a powdery state.

When I encounter this all too common problem the theory most often put forth by professionals and consumers alike is that the aluminum was improperly or inadequately prepared or primed prior to the application of paint. After all, the failure is one of adhesion; the paint has failed to "stick" to the aluminum, right? Although this scenario does occur, it is in fact much less common than anecdotal reports would indicate. In most cases the cause of the corrosive wound is a result of an "injury"; the paint's coating is breached, allowing water to reach a material, aluminum, which is initially reactive with air. Once the process begins it's nearly impossible to stop.

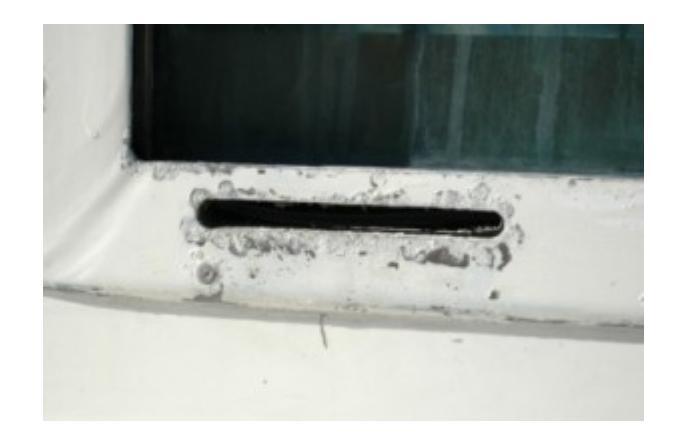
Sharp, un-radiused corners are notorious for becoming the spawning grounds for corrosion

If the paint is breaching because of "sharp edge failure", the solution to this problem is a redesign or modification of the assembly, aluminum surfaces over which paint is applied should be rounded or radiused to prevent thin coating areas. Sharp corners, points or edges must be eliminated.

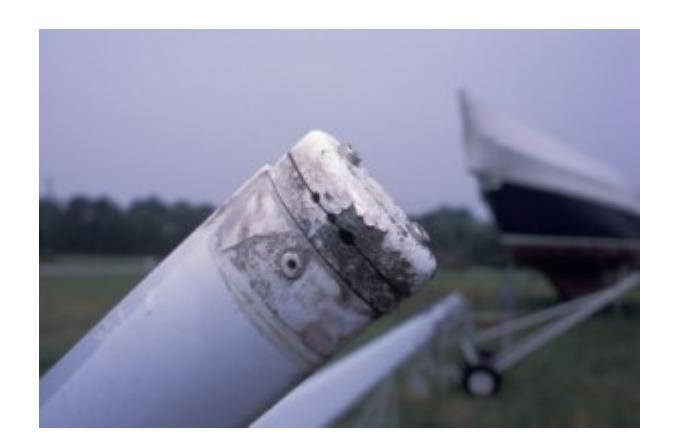
It's no coincidence that the paint failures occur adjacent to hardware, in areas of abrasion or where the surface remains wet, such as, in this case, under a spreader boot.

Take a look at the painted aluminum hardware on your boat or aboard the next vessel you visit. Almost invariably the blisters and bubbles begin adjacent to hardware or fasteners or in high traffic areas, hatch frames/sills for instance. The surface preparation and paint application are rarely the cause of the failure; it's the damage to the coating caused by the hardware during the installation process, or traffic, each screw head, striker plate, each canvas snap, pad eye, hatch handle, access cover, lock set, etc. fractures the paint, allowing the poultice corrosion demon to gain a foothold.

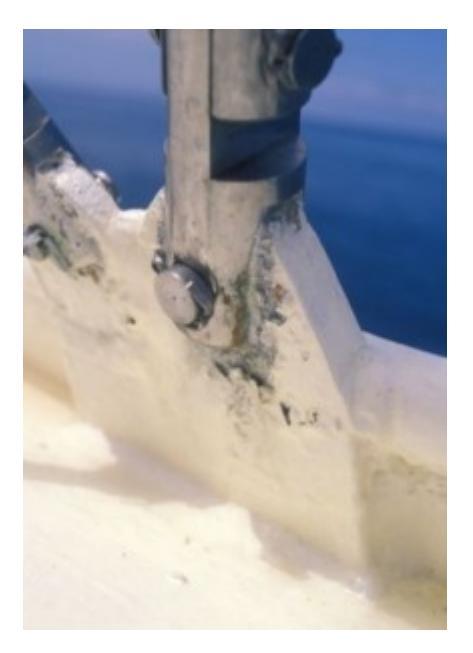
The turnbuckle on the sailing vessel's rig has abraded the paint on the chain plate, leading to severe corrosion. In this case, the interaction between the aluminum and the stainless steel are adding yet another dimension to the process, galvanic corrosion, which will be discussed in an upcoming column

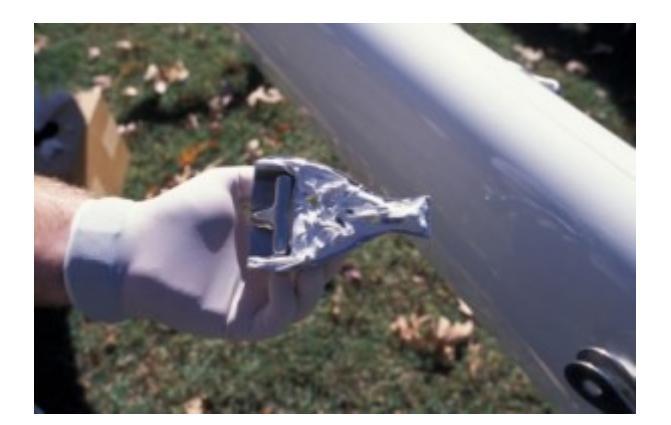
Liberally bedding all hardware that is installed on painted aluminum surfaces with a polyurethane bedding compound will, for the most part, prevent the paint failure from occurring

The solution to this problem takes on just one form, prevention. Once the corrosion has set in any paint that has already blistered or lifted is doomed, it must be removed and spot repaired or the entire structure must be repainted. Preventing the problem is exceptionally easy, each and every piece of hardware, every screw and fastener must be bedded in a high quality polyurethane or polysulfide bedding compound. The painted surface and the hardware should each be cleaned and degreased using 3M General Purpose Adhesive Cleaner or mineral spirits. Then, apply bedding compound to the surface that will make contact with and likely "break" the paint coating. Fastener threads should also be cleaned and coated, this will prevent galvanic corrosion and the subsequent seizure of the fastener threads. Install the hardware, wipe excess sealant and clean using the

aforementioned product. The sealant will fill paint breaches that occur when the hardware is torqued, preventing water entry and the subsequent poultice corrosion.

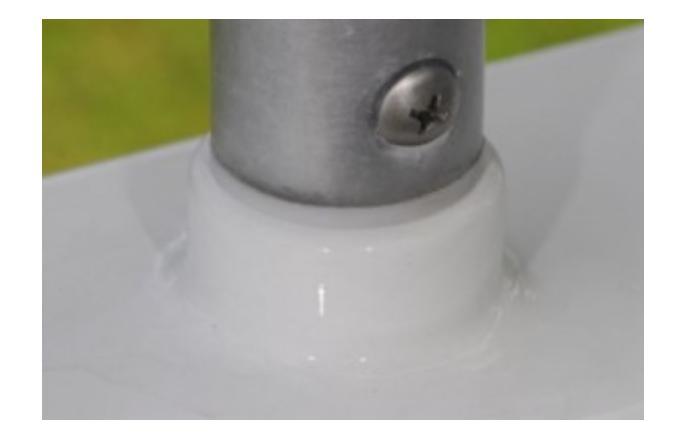
Inserting a non-metallic insulator between painted aluminum and other hardware, regardless of its alloy, can prevent paint damage. However, while beneficial, this approach may still lead to paint failure as a result of water entrapment

Conscientious aluminum boat and hardware builders and installers often insert non-metallic shims or insulators between hardware and painted aluminum structures in an attempt to mitigate damage to the paint as well as stemming corrosion resulting from interaction between dissimilar metals (I'll cover this subject in an upcoming column). While this approach can be effective and has its place, the insulator will prevent or minimize paint damage caused by hardware, it does have its drawbacks. In high load scenarios insulators may be crushed or damaged, leading the mechanical failure of the assembly. Additionally, water can migrate between the insulator and the painted surface, where it will be retained. Because two part linear polyurethane paints are not designed for continuous immersion, water in this condition will eventually lead to blistering and failure. If insulators are used, they too should be bedded.

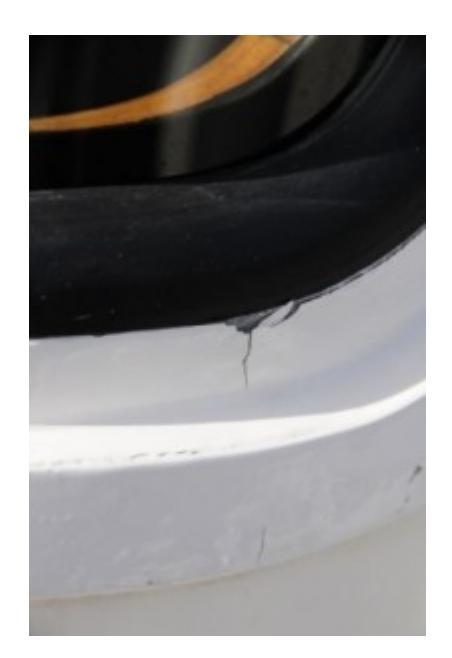
Sharp edged designs have difficulty holding sufficient paint thickness, which ultimately exposes the aluminum, which in turn leads to water migration under the coating

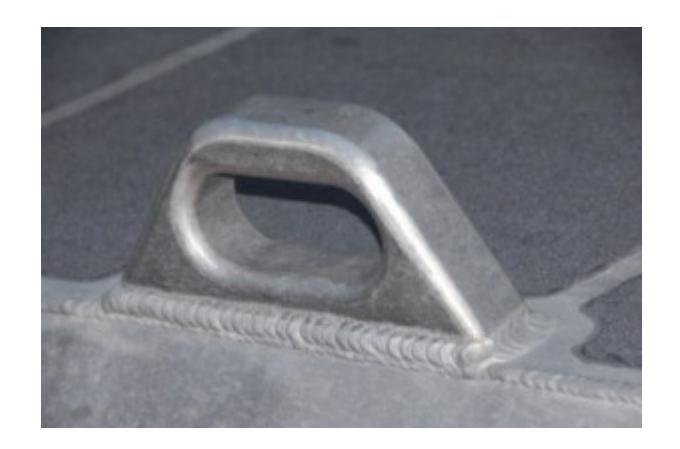
If you don't mind the appearance, un-painted aluminum offers the greatest corrosion resistance with the least amount of maintenance

The longest lasting, lowest maintenance aluminum installations are those that remain unpainted, evidenced by the profusion of

bare-hulled rescue, utility, fishing and scientific as well as select recreational vessels. This holds true of individual deck hardware and equipment including window frames, windlasses and deck hatches. A further refinement of the unpainted approach involves anodizing, a surface treatment that reduces the formation of aluminum oxide, which improves corrosion resistance and the appearance of aluminum hardware that's left in its natural state. Given the choice, and where its aesthetics can be accepted or tolerated, forgoing paint for anodizing will almost certainly result in hardware that looks good now and, more importantly, in years to come.
