Seacock Selection, Service, and Avoiding the Pitfalls

By Steve D'Antonio Photos by Steve D'Antonio

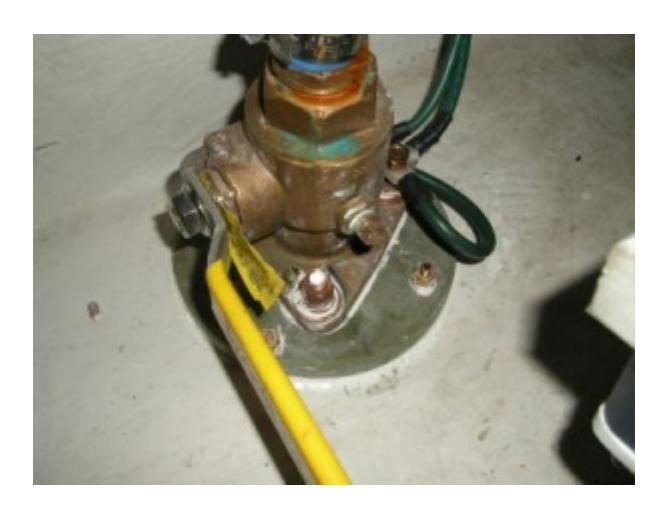
Proper seacock installations, like the one shown here, are robust and reliable. Many, on the other hand, fail to make the grade.

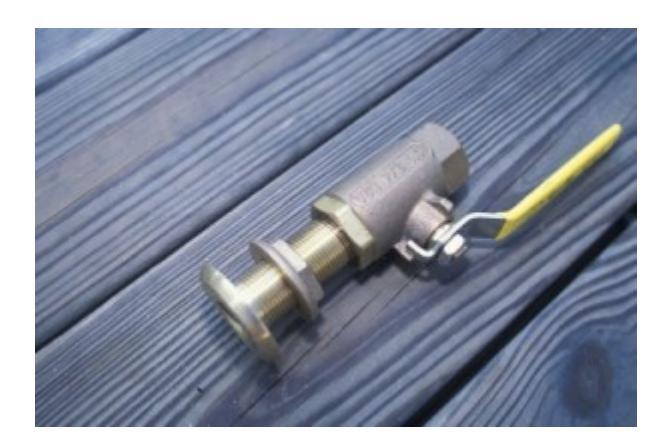
This arrangement, a ball valve mated to a through hull fitting often passes for a seacock, however, it's anything but.

A reliable, robust seacock installation begins with selecting the right components. Far too often, what passes for a seacock is in fact a mismatched collection of plumbing components. The most common hardware faux pas, mentioned in the previous paragraph, involves the mating of a through hull fitting, the mushroom-shaped male-threaded component, with an in-line ball valve. Make no mistake about it, regardless of the quality of the construction, these components were never designed by their respective manufacturers to be mated to each other for one exceedingly simple reason, the threads are entirely incompatible. Through hull fittings utilize straight or NPS threads, while in-line ball valves rely on tapered or NPT threads. The two may initially engage, however, it's difficult to obtain more than two or three threads of engagement. Make certain your through hull fittings are attached to purpose made, flanged marine sea valves, all of which utilize properly mating NPS threads.

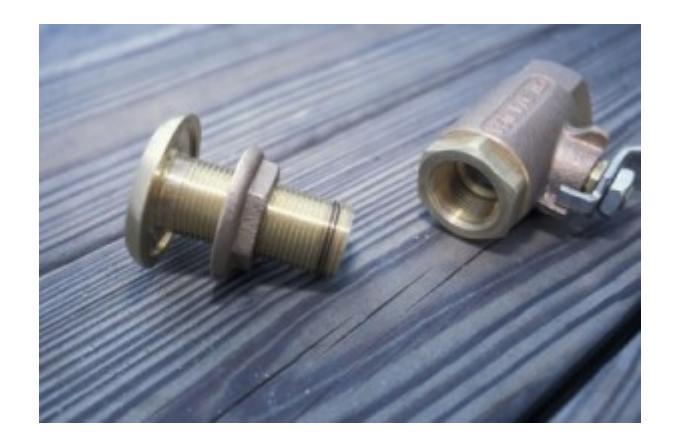
The primary reason for this assembly's failure to meet seacock

standards is very simple, the threads are incompatible. The black line indicates the woefully inadequate engagement.

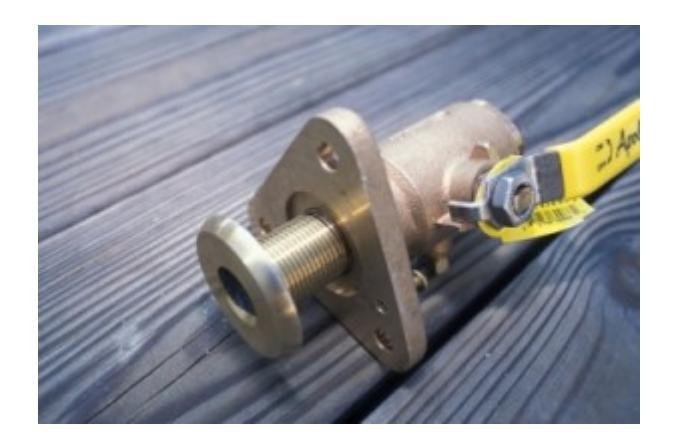
Through hull fittings and proper, flanged seacocks share the same thread type, NPS or straight.

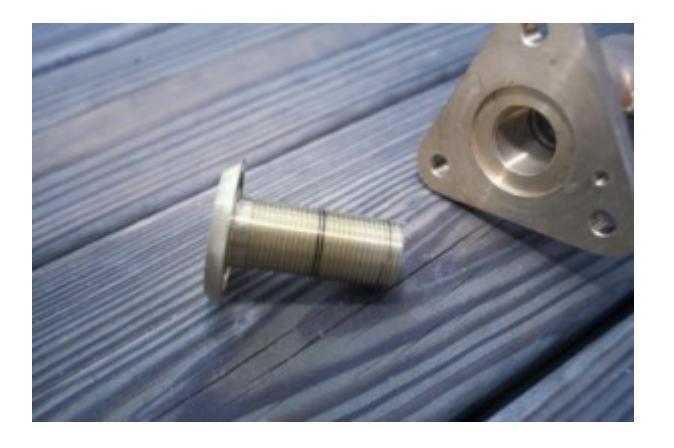
The black line on this through hull fitting indicates the substantial thread engagement this assembly acheives, making it exceptionally strong.

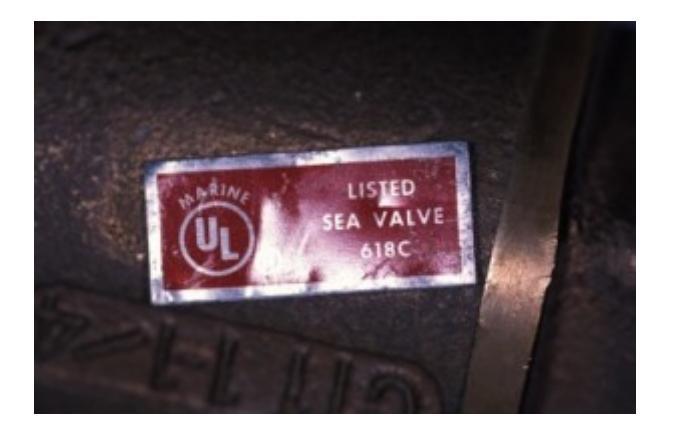
Not all UL Listed valves are UL Listed Marine Sea Valves.

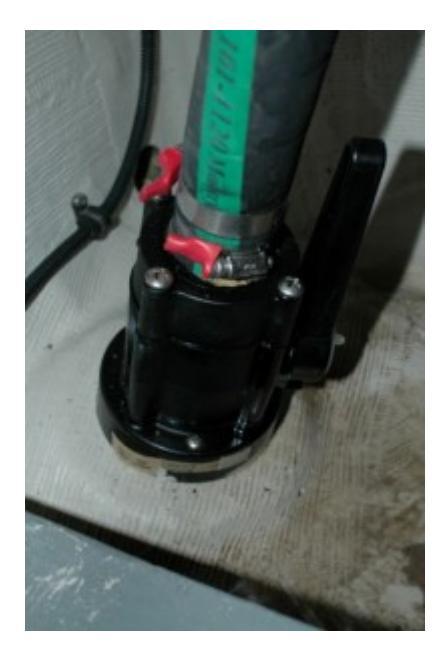
The stringent requirements for metallic as well as nonmetallic seacocks means very few carry UL Marine approval or meet ABYC standards.

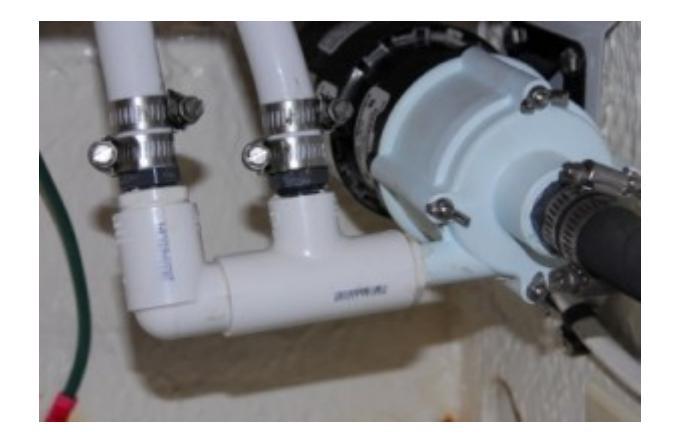
Conventional PVC plumbing is ill-suited for raw water use and should be avoided in locations where its failure will lead to flooding.

Plastic or non-metallic seacocks and through hull fittings, on the other hand, should utilize glass reinforced polymers (Forespar's Marelon is one example) for their construction. Like brass, plastics such as PVC and nylon should never be used in any raw water applications, seacocks or otherwise. It's telling that no seacocks made from those materials carry a UL Marine Sea Valve rating. Among other locations, I often see conventional plastics employed in air conditioning system and water makers installations. In those cases, many manufacturers, particularly those making watermakers, utilize PVC and other non-metallic plumbing fittings. If one of their fittings fails and leads to flooding, or worse, you or your insurance company may have a case against that manufacturer. If on the other hand you, your boat builder, or a subcontractor use PVC for installation of a water maker, air conditioning system, seacock or any other raw water component, and it fails, you may be left holding the proverbial bag.

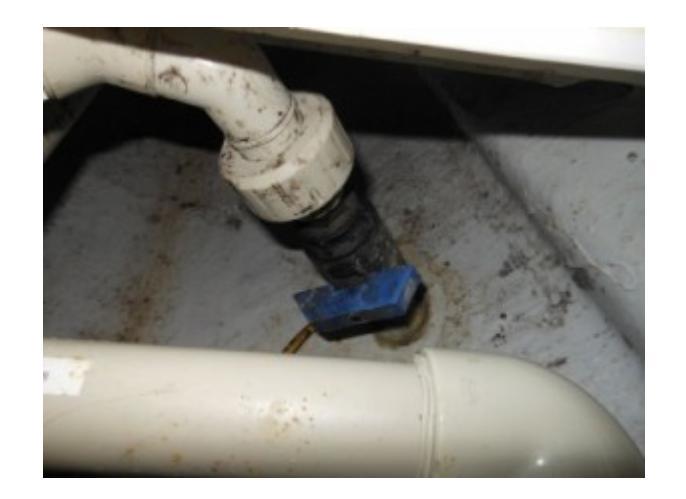
This "seacock" is in fact a polyethylene irrigation valve, making it inappropriate for use as a sea valve. The rigidly attached PVC plumbing imparts leverage to the installation, further jepordizing its reliability. In my experience, there's a tendency for professionals to use silicone-based lubricants on seacocks, believing them to somehow be superior and "space-age". In fact, while silicone is an excellent lubricant, its typically light viscosity means it's easily washed off or out of the valve. My preference for all metallic seacock lubrication, other than those that use rubber balls or cones, is Lubrimatic's Marine Wheel Bearing Grease, it's water-insoluble, sticky and, unlike silicone, lithium and other "light" greases, it resists being washed off. It's green in color. Rubber cone valves call for a non-petroleum —based lubricant such as the aforementioned Teflon-based MareLube.

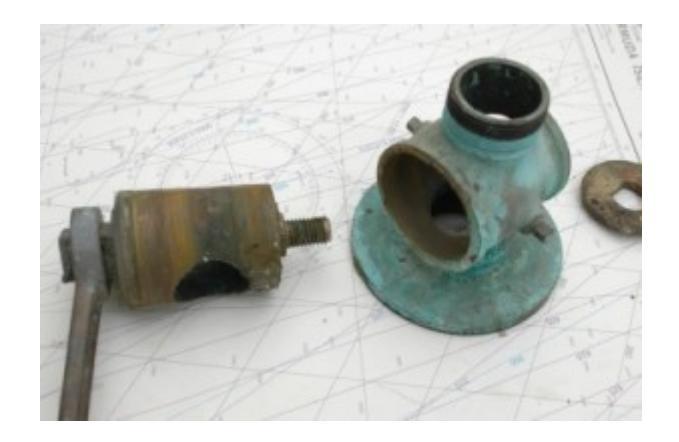
Traditional cone valves are extremely rugged and capable of being rebuilt over and over again.

Traditional cone-style seacocks may be disassembled and rebuilt, or at the very least lubricated, over and over again (I've successfully serviced 40-year old units.) Depending on their service environment this may be necessary from every one to five years. They may be taken apart, cleaned with a solvent such as mineral spirits, sanded with emery cloth to remove irregularities, lapped using valve grinding compound, lubricated and then reassembled. Some seacocks may be temporarily fit with grease or zerk fittings, which can be installed in place of the drain plugs. With the seacock in the open position, grease may be pumped into the cone area. Because most zerk fittings are made of mild steel, they should not be left in place after greasing is complete and make certain the drain plug is not corroded before it's reinstalled. If the plug must be replaced it, like drain plugs on all raw water equipment such as sea strainers and water pumps, must be made of bronze rather than brass.

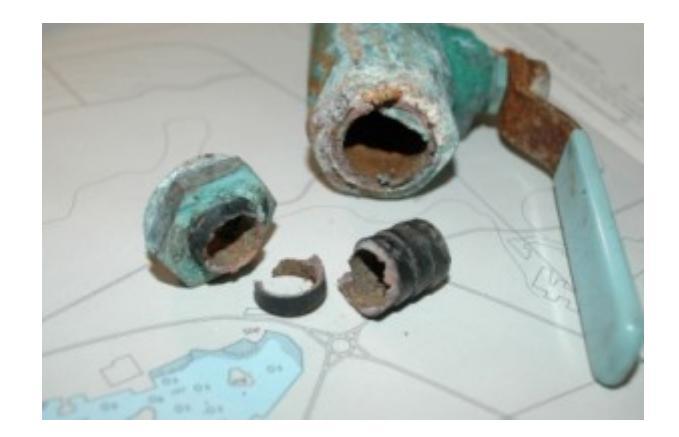
Don't make the brass mistake. Because of its susceptibility to dezincification, brass should never be used in any raw water plumbing application. True, zinc-free bronze, on the other hand is ideal.

Seacocks are primarily available in two materials, bronze and non-metallic or plastic. There's much more to the story than simply selecting one of the two. Bronze seacocks must be made of the proper alloy, one that contains little or no zinc (bronzes are often referred to as zinc-free copper alloys.) Determining what a seacock is made of can be difficult if not If, however, it carries a UL Marine Sea Valve impossible. symbol or name plate, then you can be certain it's made of the proper alloy. (Beware, a UL Listed valve is not the same as a UL Listed Sea Valve; many valves carry a UL listing, very few are Sea Valves or seacocks.) Brass, on the other hand is, because of its high zinc content, strictly forbidden for use in any raw water application. An exception to this rule being leaded red brass which is used for manufacturing many pipe nipples (straight pipe lengths that are threaded on both ends), it contains, or should contain no more than 15% zinc.
