# Stainless Steel – Miracle Metal?

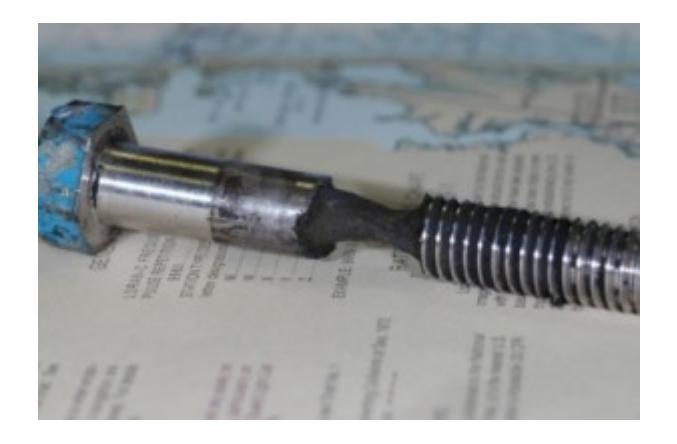
#### This "wasp-waisted" strut bolt represents a classic example of crevice corrosion

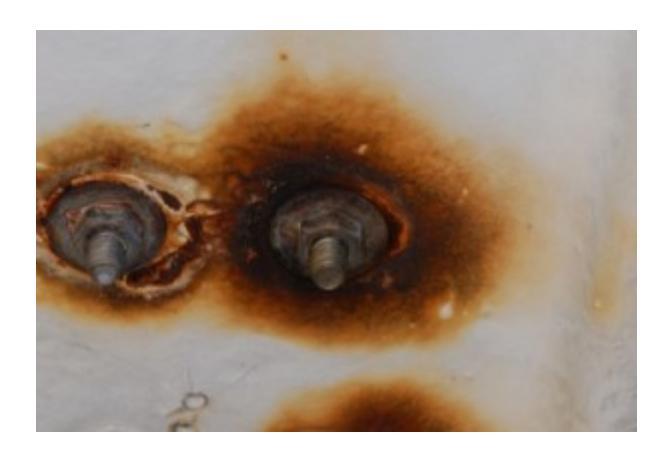
Some grades of stainless steel are more corrosion

### resistant than others. These fasteners are likely 304 series and as such are staining, a clear indication that crevice corrosion is occuring

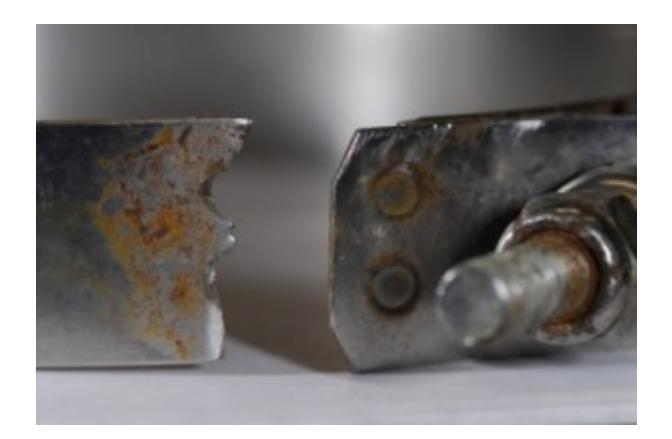
### StainlessT-Bolt hose clamps are usually very strong, however, the folded design traps water, creating an ideal environment for crevice corrosion.

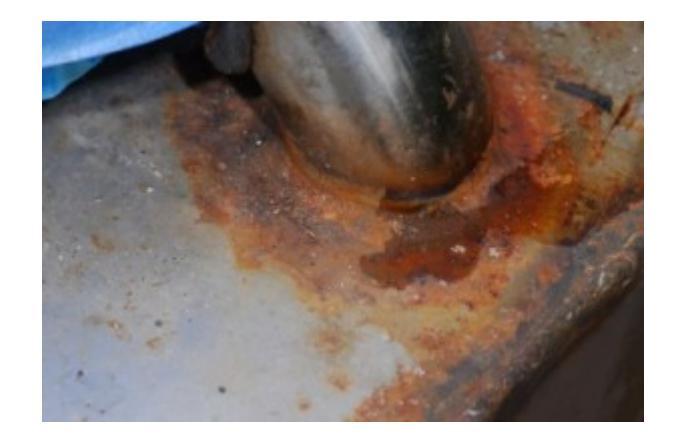
The use of the incorrect stainless alloy, it wasn't "L" or low carbon, precipitated an early end for this tank.

There exists yet another designation where marine grade stainless alloys are concerned and it involves their carbon content. Stainless alloys that are to be welded for rails, brackets, water and fuel tanks, port light frames, swim platform supports or anything else, must utilize only low carbon alloy stainless steel, which is identified with an "L" suffix, such as 304L and 316L. The reason for this requirement is a peculiarity of stainless steel known as carbide precipitation or weld decay. When stainless or any metal is welded, it's heated to high temperatures. This high temperature can cause a migration of chromium away from the weld area, leaving behind a zone adjacent to the weld of what ultimately behaves like ordinary carbon steel, i.e. it rusts. Weld migration that is a result of fabrication using the incorrect grade of or non-low carbon stainless steel sometimes becomes evident early on in the life of the part by a clearly defined, discolored or darkened "path" that encompasses the weld. Depending upon its exposure to moisture and whether that moisture is fresh or seawater-based, the area adjacent, usually about an eighth of an inch on either side of the weld may begin to show signs of corrosion or discoloration within months or even weeks.

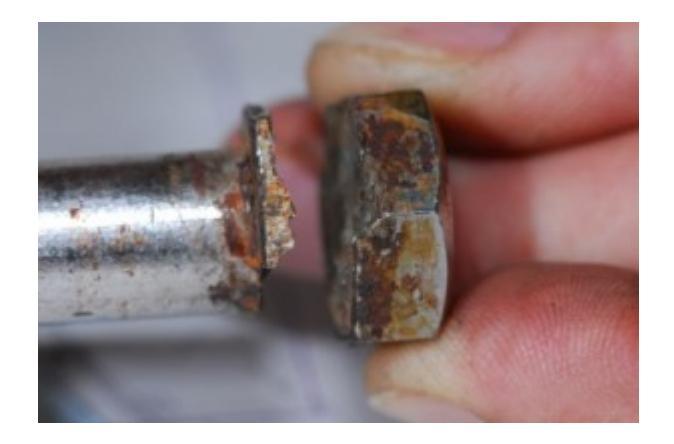
## There wasn't much strength left in this corroded bolt head. Corrosion gains a foot hold in micro-cracks or crevices that form in highly stressed components

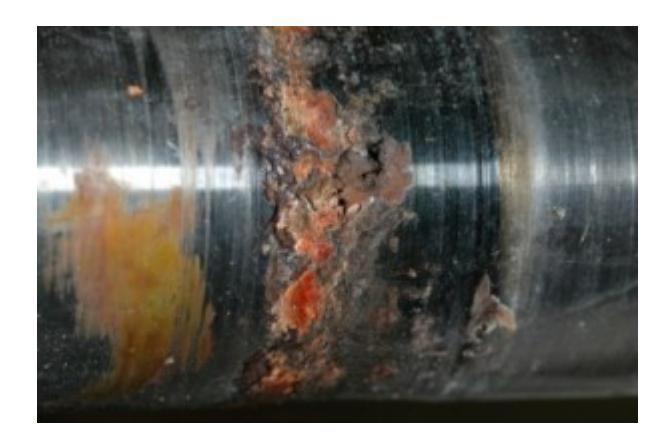
## Less corrosion resistant stainless shaft alloys often suffer from crevice corrosion, especially in the oxygen deprived stuffing box region, shaft log and under cutless bearings, all areas that aren't readily visible.

Propeller shafts fall into a special category. Because they require both exceptional strength and corrosion resistance, propeller shafts are *typically* fabricated from a proprietary stainless alloy that includes a host of other trace elements. These mixtures yield the ideal combination for the environment in which shafts operate. Trade names such as Aquamet, Aquatech and Aqualoy among others are available in several strength and corrosion resistance grades. The most corrosion resistant of which, and therefore the most desirable for recreational applications where use and oxygen exposure is limited, is designated as 22. Shafts made of this alloy and grade are as close as a boat builder can get to corrosionproof where steel-based alloys are concerned. Shafts manufactured from ordinary stainless steel, on the other hand, even 316 alloy, frequently suffer from crevice corrosion attacks, occasionally within less than a year of being placed in service beneath cutless bearings and stuffing box packing,

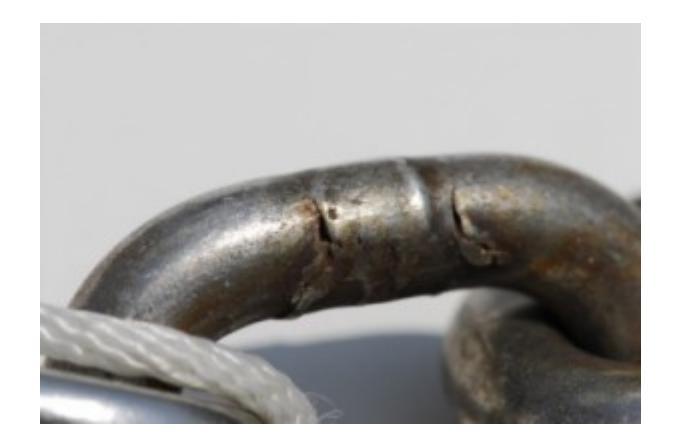
One would think that stainless steel anchor chain would be the Cadillac of ground tackle. However, just like many other stainless steel alloys it can fall prey to corrosion under the right circumstances.
