January 2018 Newsletter

Photo Essay: Shore Power Plugs and Fire Prevention

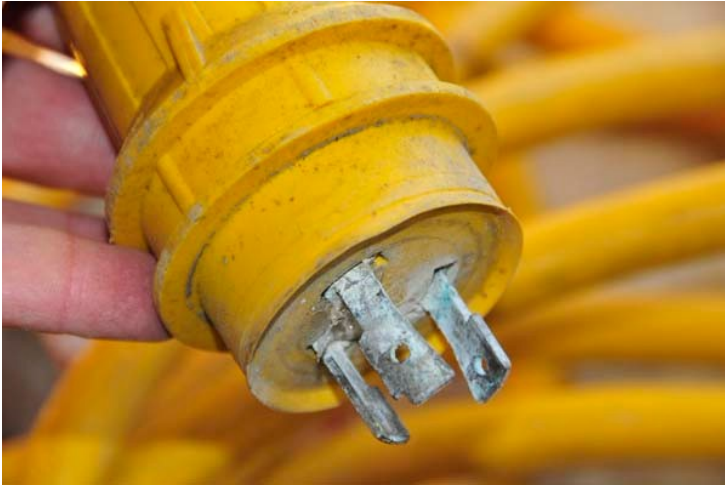
In this month's image, a 120 volt 30 amp (3,600 Watt) male plug is shown. Not only are its blades heavily oxidized (it looks as if this fell overboard once or twice), perhaps equally as concerning is the missing locking ring. When this plug is used with a connection that supports such a ring (a Y adapter for instance), the ring must be used, securing the plug in place. Unfortunately, nearly all dockside pedestals lack the ability to engage such a ring, making it especially important for users to ensure the cable is well-supported, with a wrap around the pedestal or by lashing it in place.

Inspect your cord connections regularly, clean contacts and use a corrosion inhibitor, secure cords, and replace missing locking rings and you'll substantially reduce the possibility of overheating and fires.
