## ③ NOBLE EFFORTS

*Aluminum is an ever-present material on a cruising sailboat, so understanding its properties and preventing it from corrosion are important goals.* BY STEVE D'ANTONIO

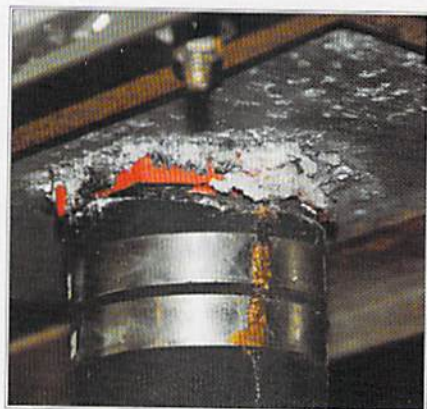
**When exposed to stagnant water, aluminum can no longer maintain its corrosion-resistant oxide coating (top). Condensation dripping from a bronze water pump has caused this aluminum base to corrode (middle). Spreader tips are notorious for suffering from poulitce corrosion (bottom).**

The other malady to which aluminum is susceptible is called poulitce corrosion. This is referred to as simple corrosion, in that no other metals are involved. When exposed to air, aluminum almost instantly develops a tough transparent coating that serves as a corrosion inhibitor. Even underwater, provided it's not stagnant, aluminum is exposed to enough dissolved oxygen for this coating to form. If aluminum is starved of oxygen, however, and it remains exposed to moisture, the environment becomes ideal for the formation of poulitce corrosion. Because the oxide coating cannot form without oxygen, the aluminum becomes active; it corrodes, and in the process forms a white byproduct called aluminum hydroxide, which resembles freezer-burned vanilla ice cream.

The most common conditions for poulitce corrosion occur when stagnant water is trapped against aluminum, beneath blistered paint, under a gasket or insulator, beneath spreader boots, or even where it comes into contact with wood, which by its porous nature retains water. Other than painting, poulitce corrosion is prevented by ensuring aluminum is continually exposed to oxygen.
