Sulfation Negation

If hard crystals have formed in the plates of your batteries, you've got problems. Here's how to address them. *By Steve D'Antonio*

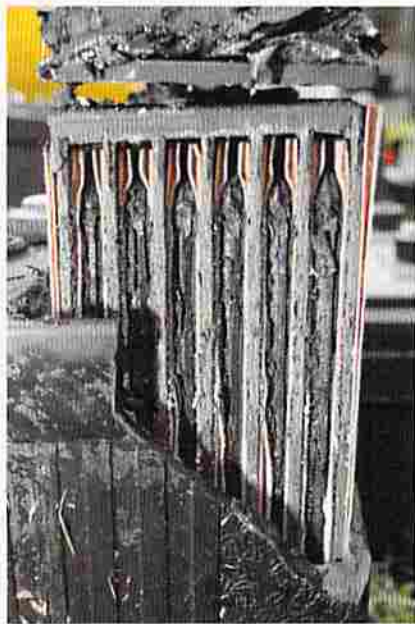
The disemboweled plates of this battery died a premature death from sulfation (left). Large house battery banks that are undercharged or that remain discharged for long periods often suffer loss of capacity through sulfation (top right). Some batteries can be salvaged through a process called equalization using a constant-volt and -current shop charger (bottom right).

percent; and/or left in a state of deep discharge; or, in a worst-case scenario, left completely dead for an extended period of time, wherein they may suffer from a phenomenon known as sulfation, when hard crystals form in the battery's plates, each crystal diminishing the battery's capacity. (Note: The difference between a fully discharged and fully charged 12-volt battery is a mere 0.6 volts when measured at rest,
