Antifouling Tactics – Editorial: Fifteen Years

Antifouling Tactics

There's more to achieving a lasting and effective anti-fouling paint application than meets the eye; and much of it involves preparation.

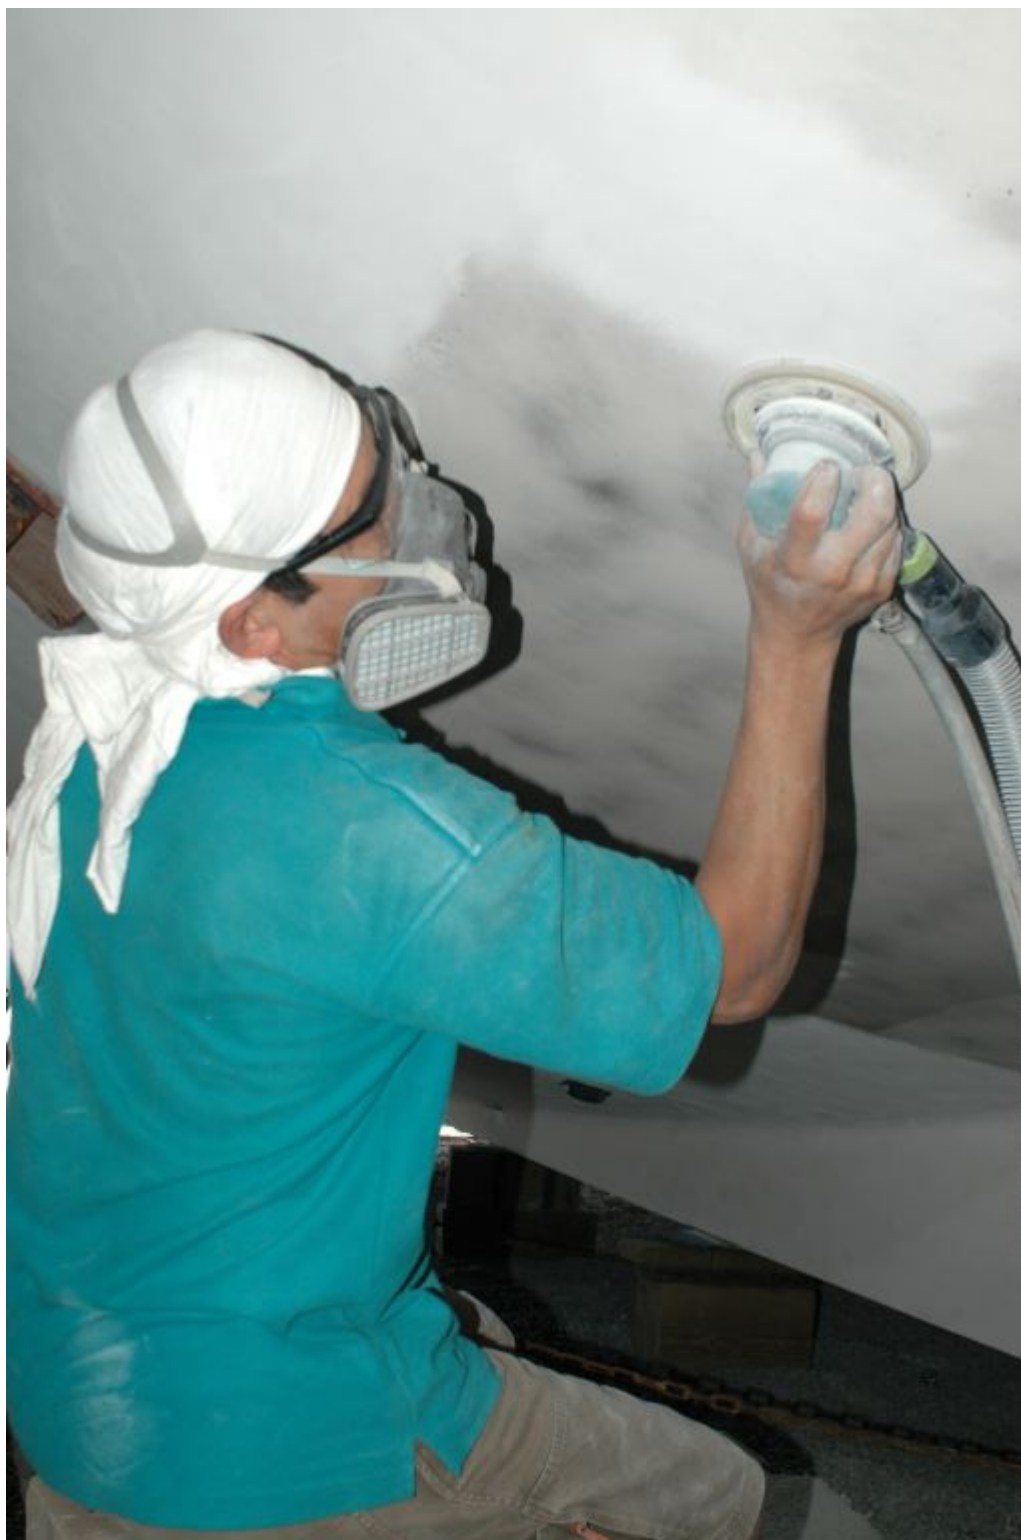
Profiling a virgin gelcoat bottom, using a “guide coat”, a very light misting of spray paint, which helps those doing the sanding know where they have not yet abraded the surface.

Preparation of virgin gelcoat, fiberglass and alloy bottoms is especially critical. Out of the mold, or from the foundry (for plate aluminum), these surfaces are usually very smooth, and often contaminated with wax or oil, they are exactly the wrong type of finish for coating applications. The bond between paint and substrate in this location is purely mechanical, therefore profiling it with a "tooth", or roughed-up surface, is critically important. I routinely encounter

release of anti-fouling paint, and epoxy barrier/primer, after just a year or less of service, and in almost every case the substrate has not been properly profiled or dewaxed. It's a sure-fire way to waste thousands of dollars on an anti-fouling application.

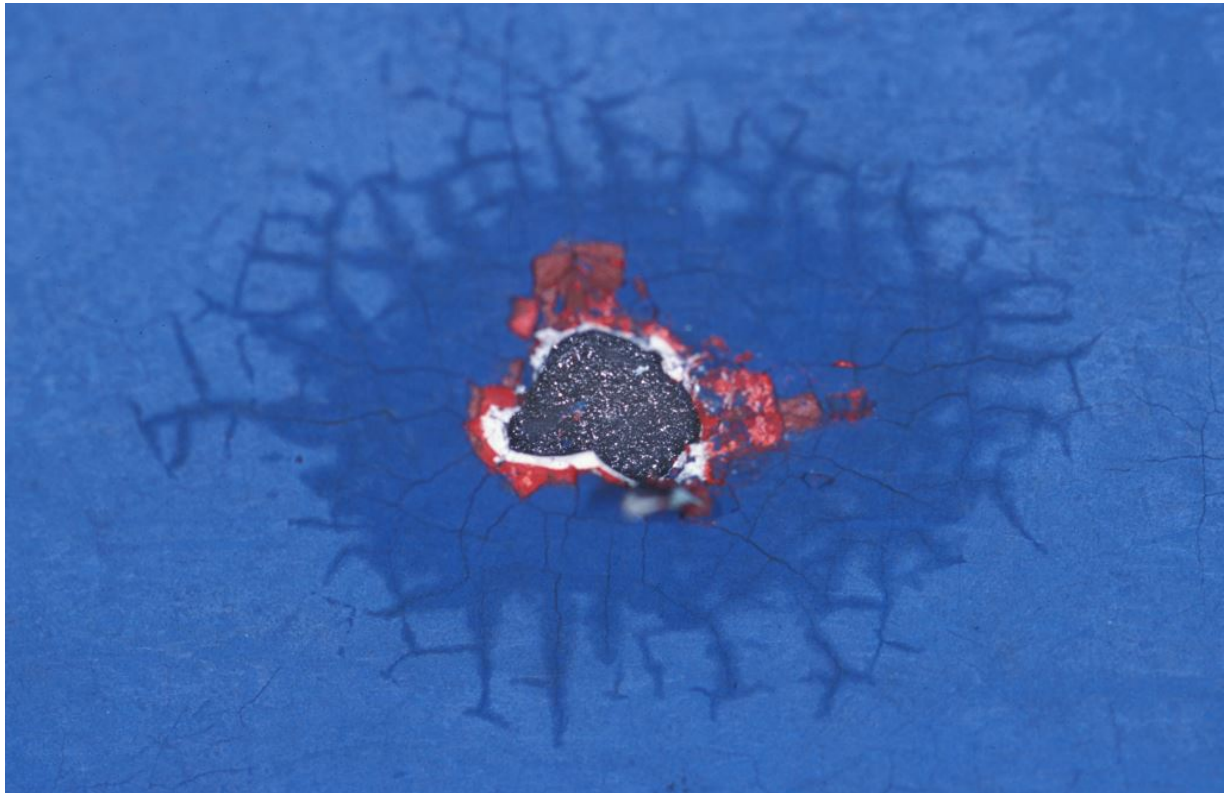
Hulls made using polyester resin are susceptible to osmotic blistering. Epoxy barrier coats can be used prophylactically, preventing water absorption by the laminate, which leads to osmosis; unlike primers, their effectiveness relies heavily on the thickness of the coating.

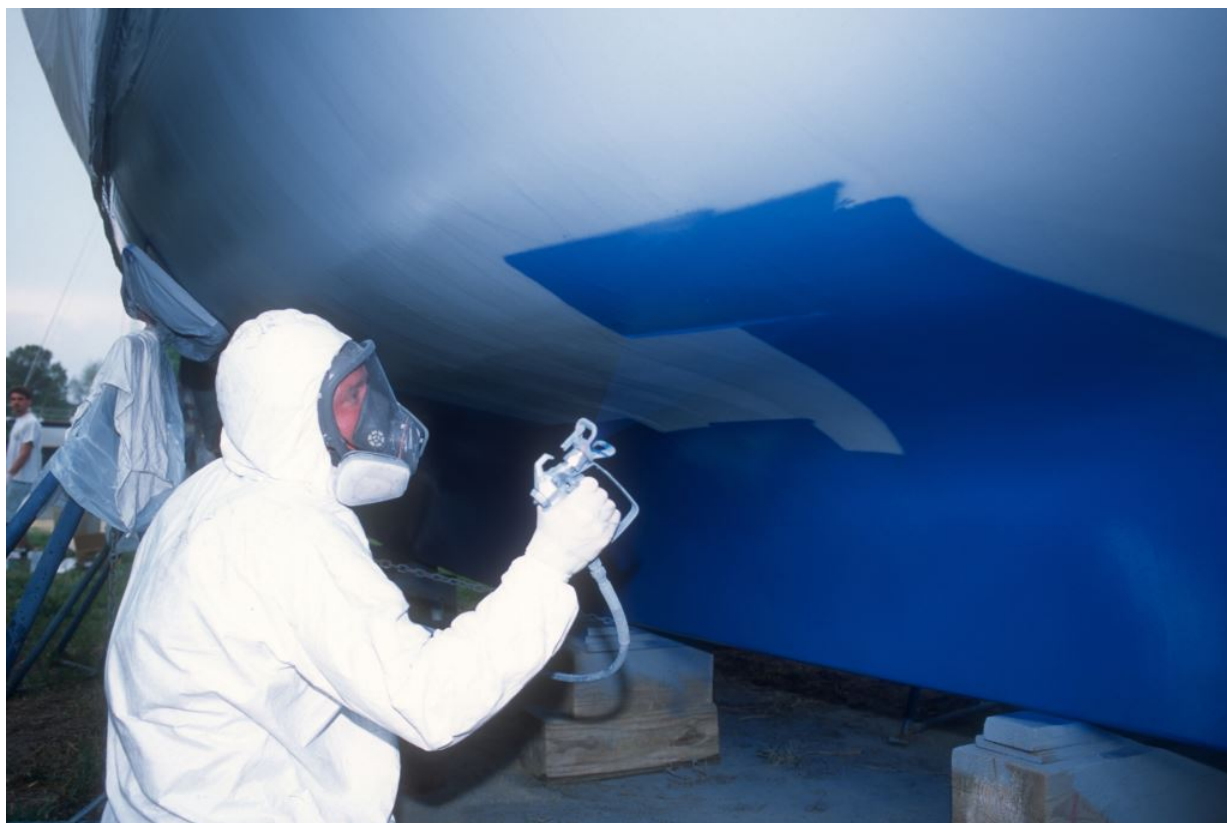
Both primer/barrier coats and anti-fouling paints can be applied with an air-less sprayer; using this approach yields an exceptionally smooth finish.

Applying the first coat of anti-fouling over a primer/barrier within the chemical application window ensures a long-lasting, chemical bond.

Primers/barriers are often applied using rollers and brushes; however, air-less spraying is also an effective approach, and one that yields a very smooth finish, which may be desirable for sailing vessels, and for power vessels seeking the greatest fuel economy (and it just looks good).

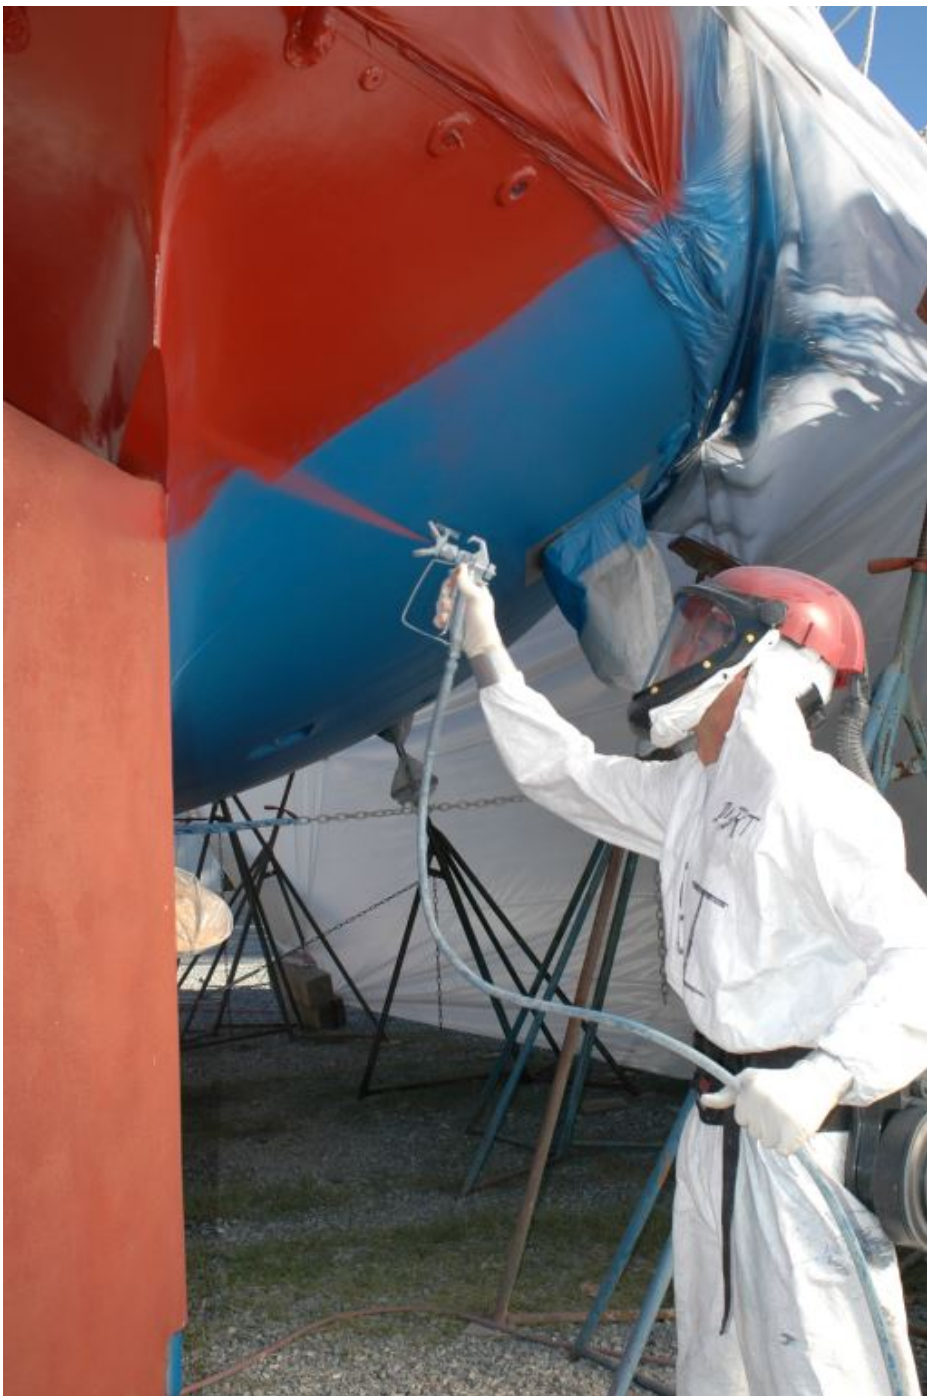
Unlike conventional spray paint application, which atomizes coatings within a stream of air, airless sprayers, as the name implies, use no air, which means they have very little overspray and coatings can be applied heavily. They are ideally suited for viscous coatings like epoxy and anti-foulant.

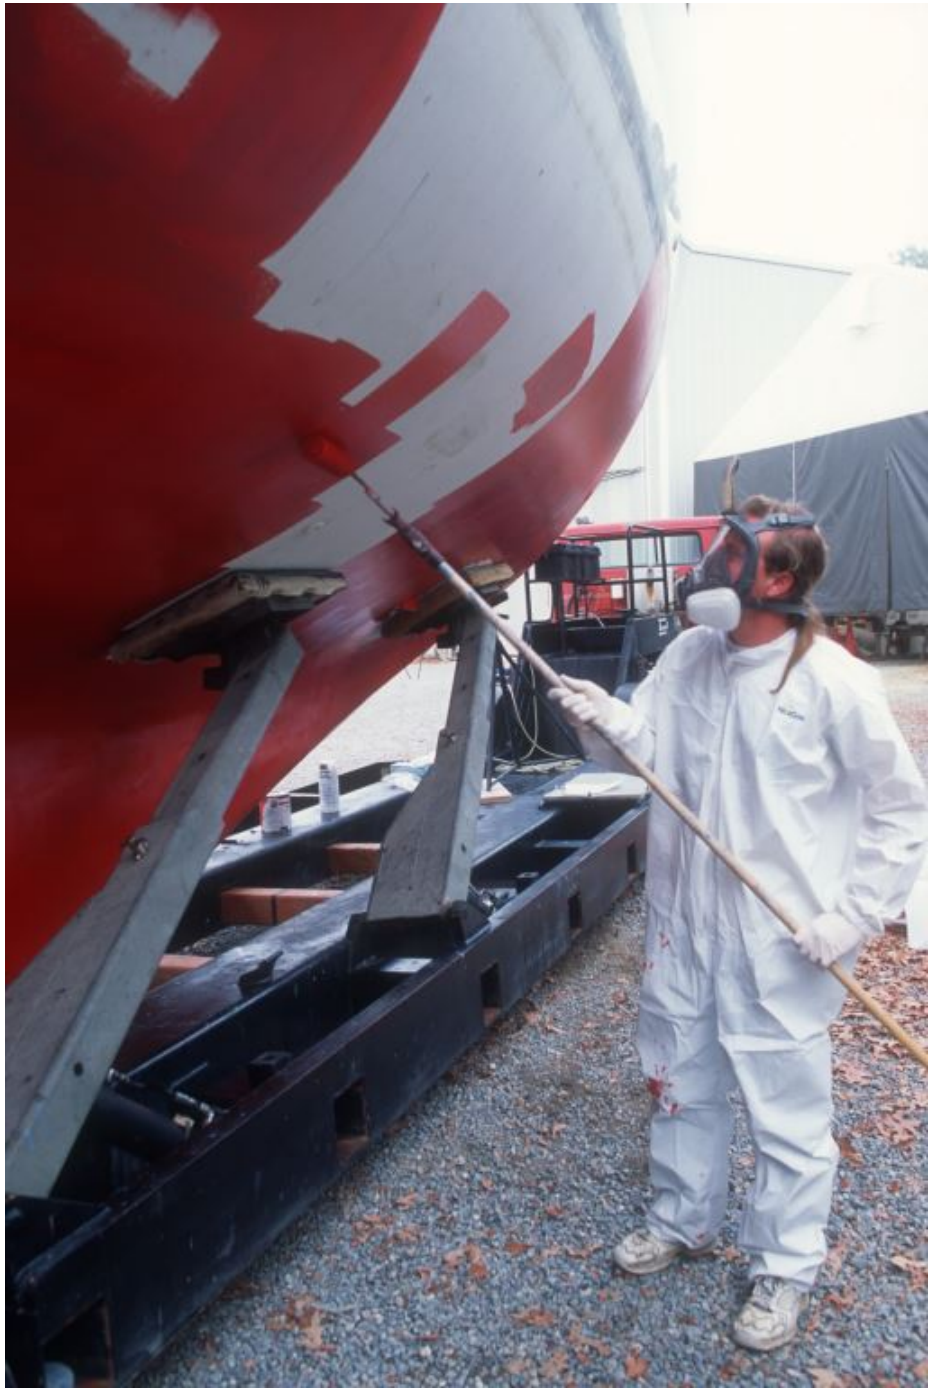
This applicator's personal protective gear is ideal.

Finally, when using epoxy primers/barriers, as well as anti-foulants, follow all application as well as personal protective gear instructions to the letter, as adhesion failures can be both frustrating and costly, and the volatile organic compounds within these coatings represent a serious health hazard.

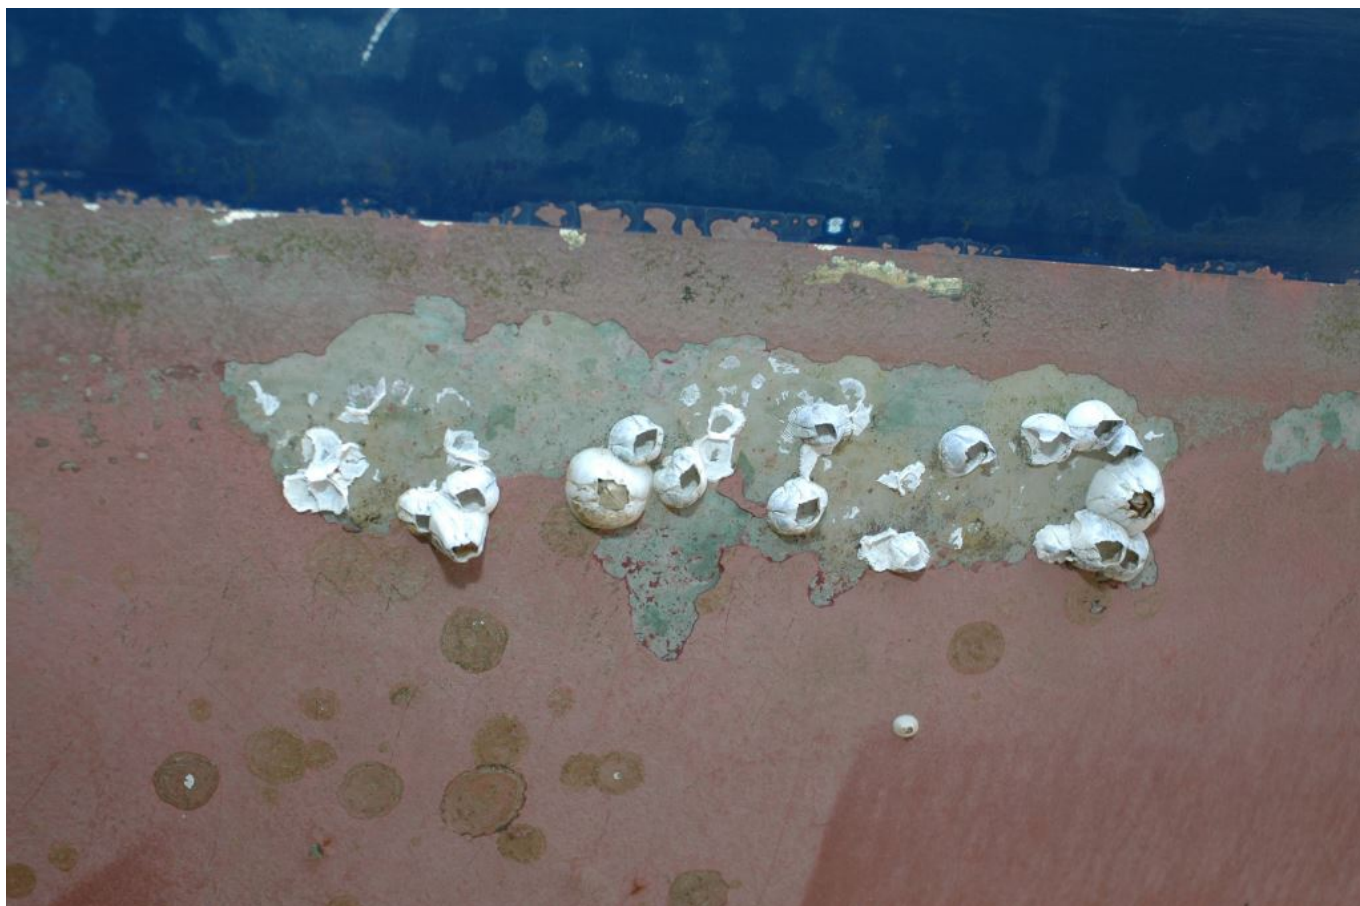
Flaking anti-fouling paint at the float line is an all too common occurrence; and it's almost always the result of applicators' failure to adequately clean this area before applying paint.

For subsequent applications of antifoulant two important criteria must be met. One, the paint being applied must be compatible with the paint that is already present. (Compatibility charts are available from most paint manufacturers and distributors.) Two, the surface over which paint is to be applied must be clean and free of *all* growth and debris (as noted earlier, even an invisible film can wreak havoc on a coating's adhesion). When vessels are hauled and pressure washed it's not unusual for the area beneath the slings to be overlooked. Once the slime in these areas dries, it turns a light buff color, which is easy to miss, especially on red bottoms, and is often simply rolled over with paint (the area just above the float line is notorious for this type of failure). Paint applied over these areas frequently releases shortly after the vessel is launched, allowing barnacles to strike.

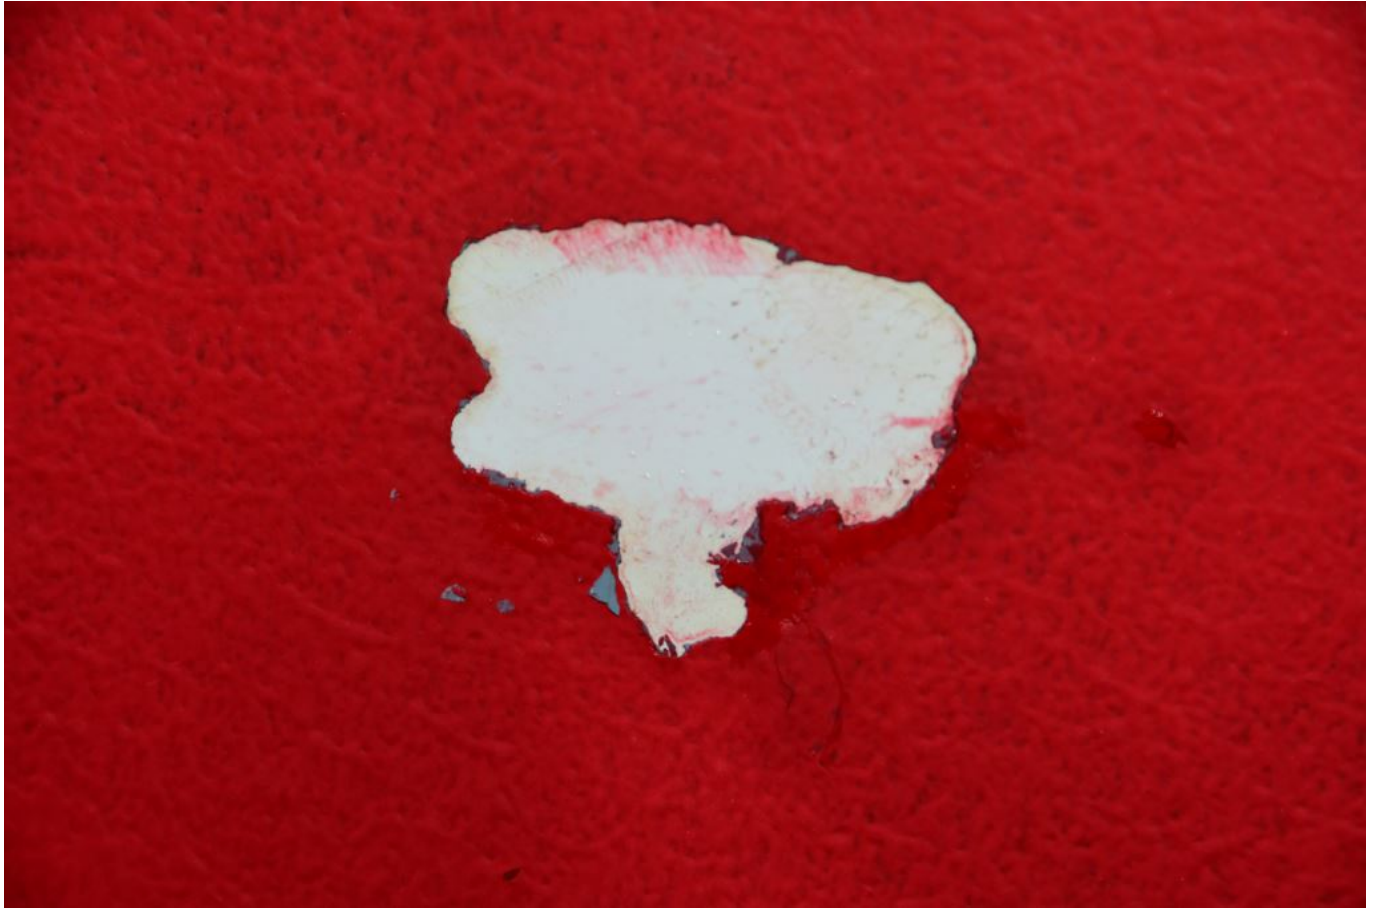
In spite of the fact that this bottom received an epoxy primer, the coating still suffered from release because the substrate was not profiled. The correction will require stripping the entire bottom, ensuring the surface is properly profiled, and re-applying the epoxy primer and anti-foulant. The vessel is less than two years old.

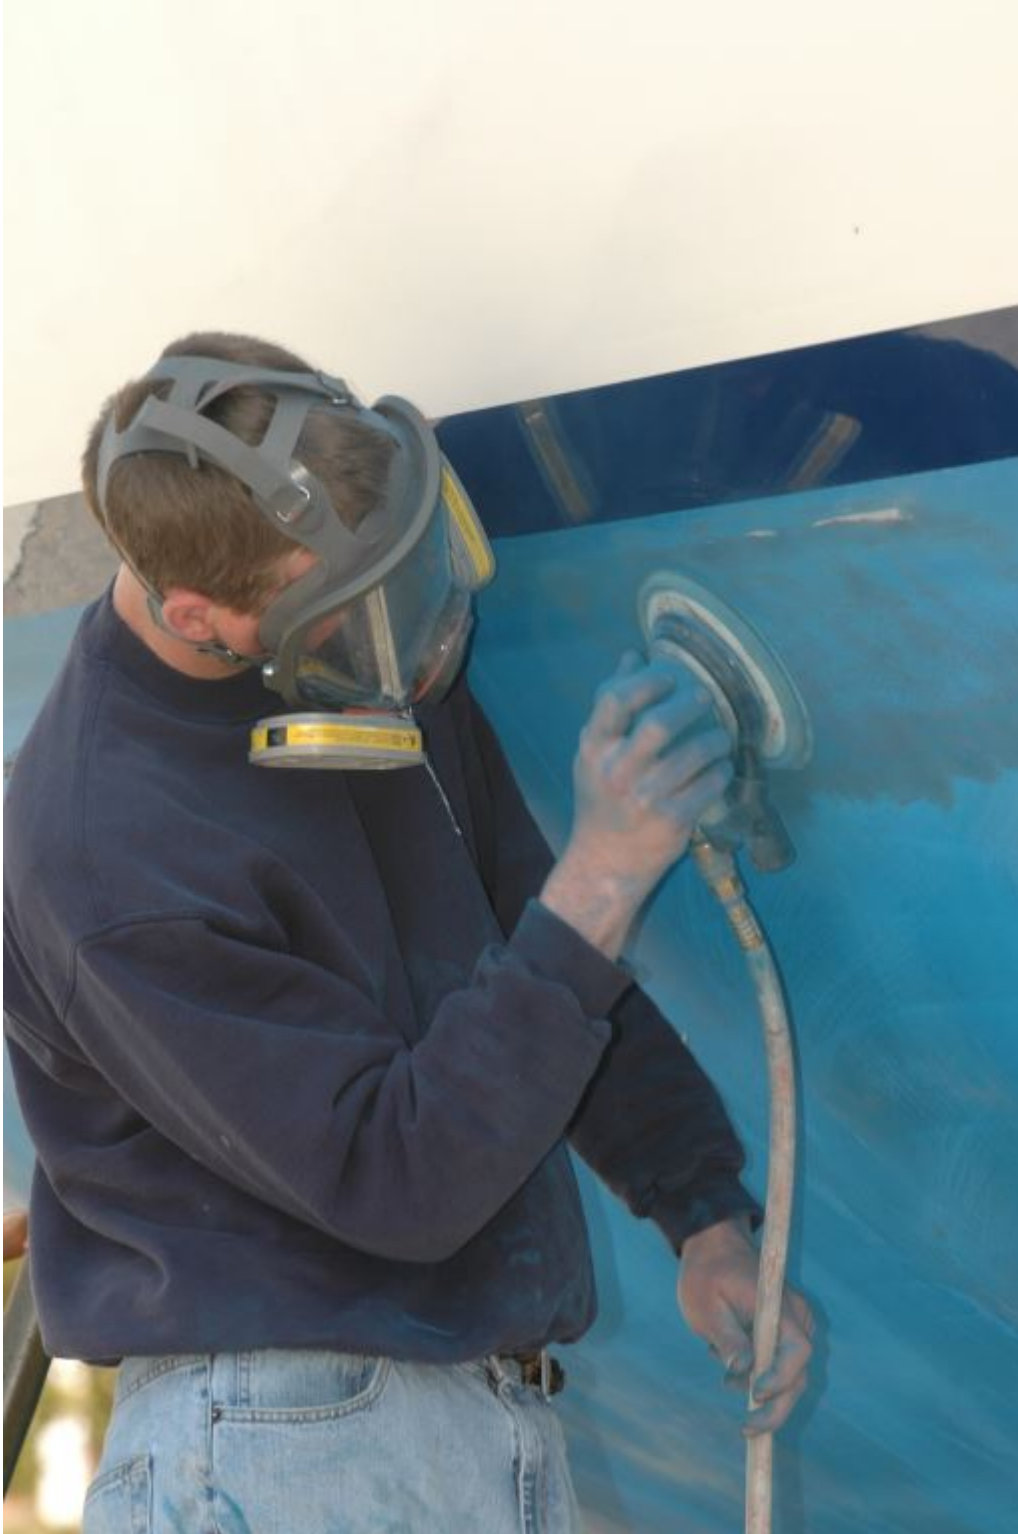
Dust from anti-fouling paint is a health hazard, full protective gear, including a respirator, gloves and coveralls should be worn when sanding.

Because of its toxic nature, antifouling paint must be applied with caution. I frequently see this requirement ignored in yards and at builders I visit the world over. Applicators should wear gloves, coveralls, and eye protection as well as a properly fitted respirator, and not a dust mask (note that

unless they are of the full-face variety, respirators cannot be used by bearded individuals).

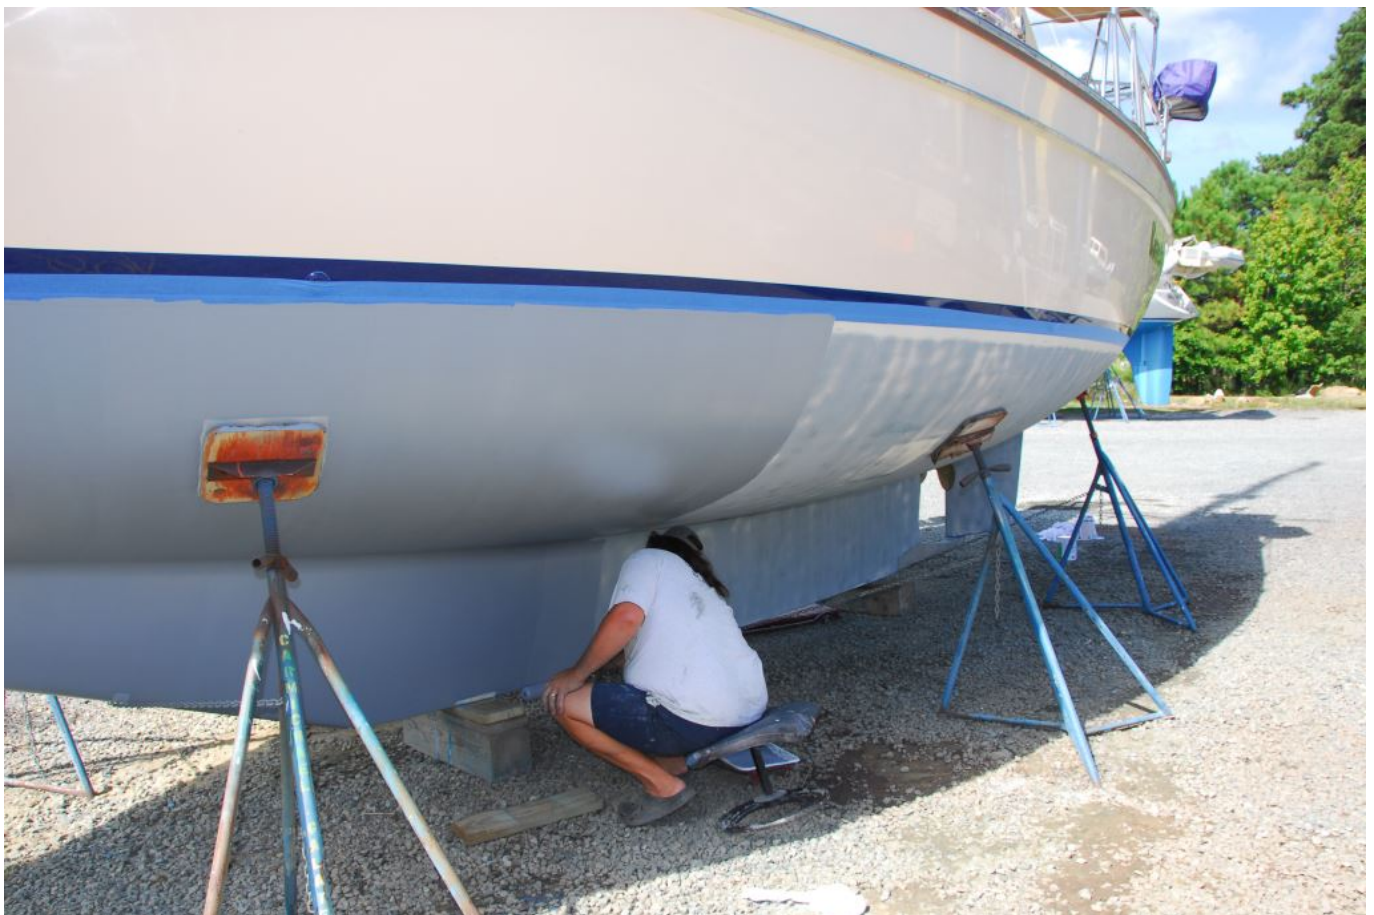
Two part epoxy primer/barrier coat also presents a health hazard to those applying it, follow all manufacturer instructions, including and especially where personal protective gear is concerned.

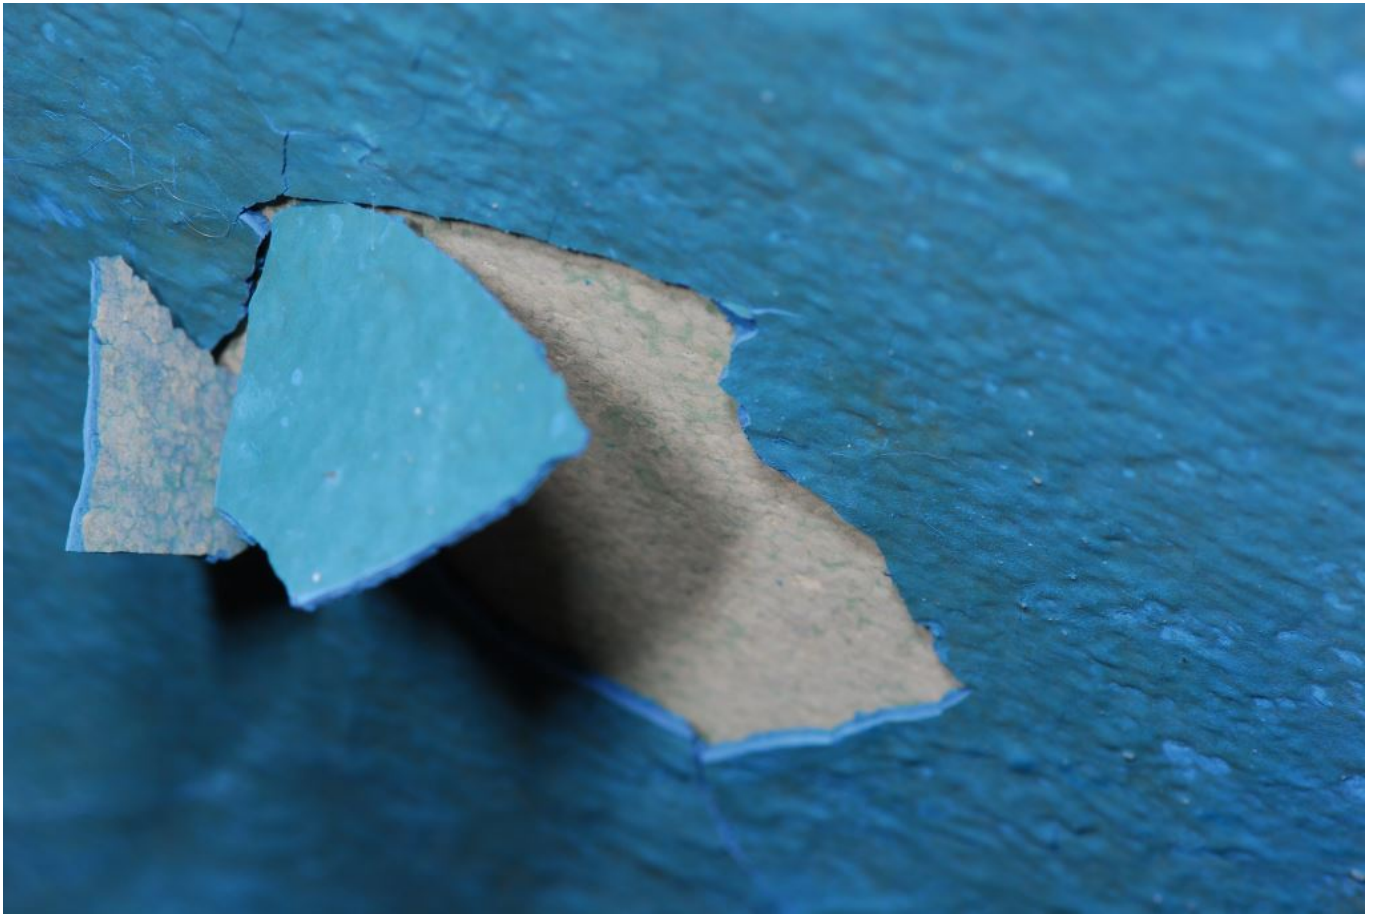
One of the drawbacks of hard anti-fouling coatings is their tendency to build up over time, which eventually leads to release, examples of both are shown here.

Broadly speaking there are two choices for anti-foulants, hard or ablative, with countless subcategories. Hard anti-foulants are much like conventional paint, once dry they don't rub or wash off easily. Their anti-fouling protection is provided by the surface that's exposed to the water. Once that's depleted, they are no longer effective. Ablative coatings, on the other hand, continuously slough, roughly analogous to a bar of soap, thereby exposing fresh anti-foulant. Which one is best for your application depends on use. If the vessel is unused for long periods, ablative coatings may be less effective as the lack of movement prevents exposure of fresh material. The primary drawback to hard anti-foulants is their tendency to build up after years of applications, which eventually requires costly stripping. If you opt for the ablative approach, consider initially applying three coats, with the first one (which is applied over the barrier/primer) a different color than the next two. This provides an 'indicator coat,' i.e., when you see the color of the first coat appear, you know it's time to renew the application.

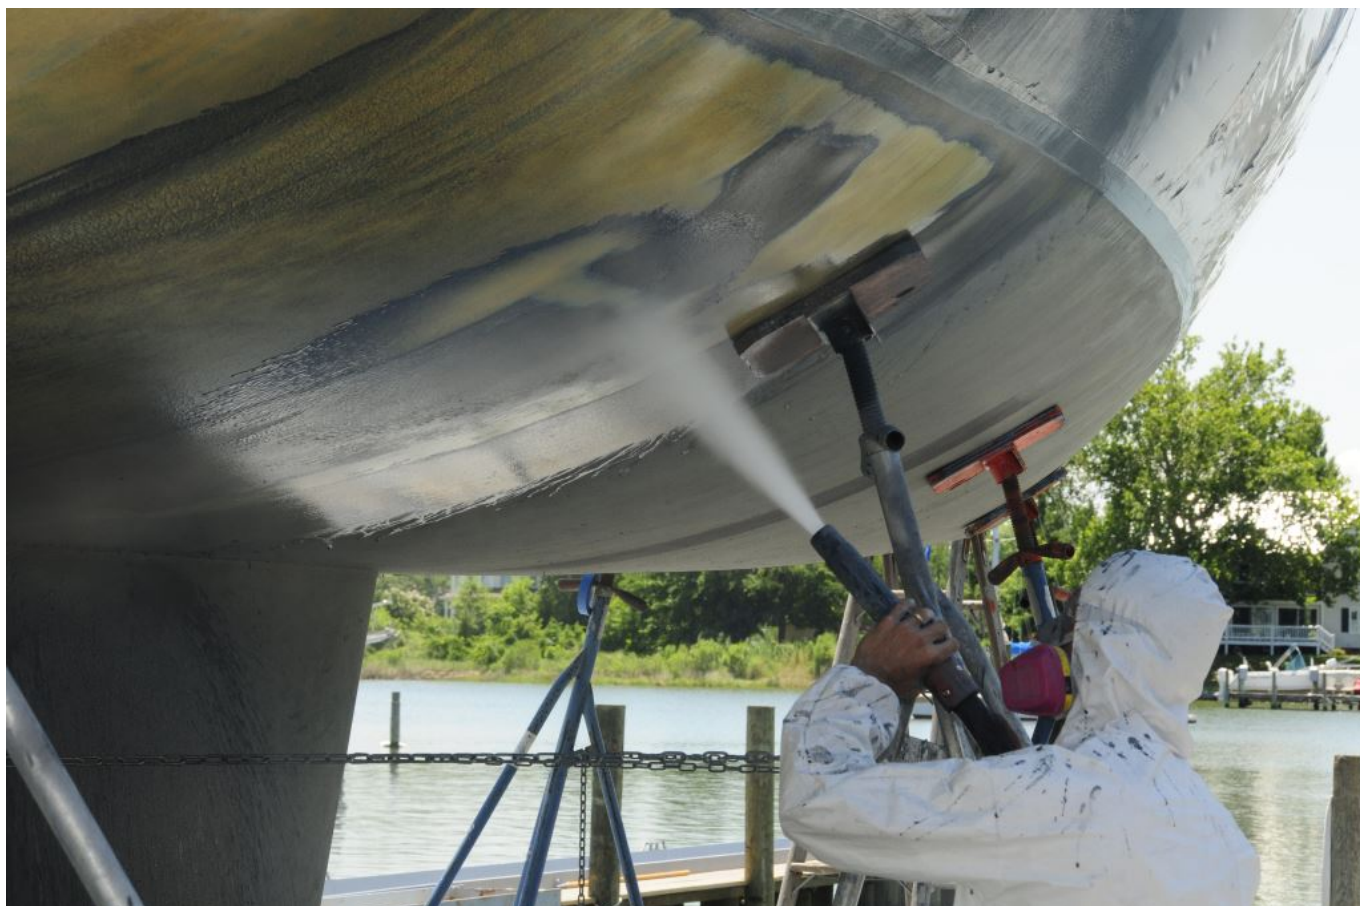
Bottom paint is best removed using the least invasive means possible, here a wet slurry of kieserite is being used to remove paint, without damaging the fiberglass substrate.
