# Ask Steve: PVC Plumbing, Low Hour Engine Maintenance, Solar Panel Fire

By Steve D'Antonio

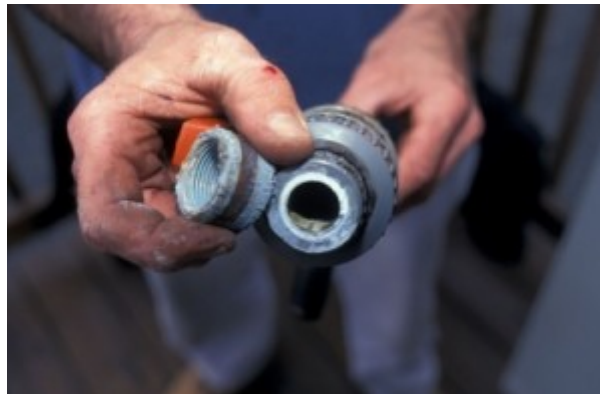
This PVC "pool" valve used as a seacock snapped off in the mechanic's hand as he closed it. Luckily, the boat was on land at the time. PVC has limited use as plumbing aboard boats for carrying raw water.

Thank you for the note and query. The question you've posed is not only a very good one, it's also one that's commonly asked. The "rule" regarding the use of PVC is strictly my own, however, it's based on firsthand experience of failures where this material is concerned. I've seen dozens of PVC plumbing components fail in marine applications (see attached example photos.) I suspect failures are exacerbated by vibration, extreme temperature cycling and excessive leverage

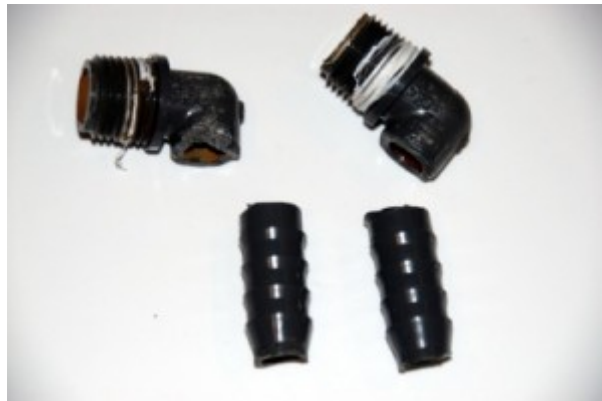
**It is not uncommon to break off the end of PVC barbs when removing the hose, as happened to these two water maker fittings; they were just two years old. In most cases, PVC simply doesn't have the strength for raw water plumbing.**

There was a time when ABYC seacock standards cited PVC's inadequate modulus of elasticity and tensile strength, however, that wording is now no longer used and PVC isn't referenced specifically. The guidelines do specify that any seacocks installation must be able to withstand the application of 500 pounds of static force for a duration of 30 seconds without failing to perform as intended (I read that to mean it doesn't break, leak or seize.) I'm fairly sure few PVC valves could withstand such a test. It's important to point out as well that ABYC guidelines have no bearing on raw water plumbing other than the actual seacock, while my "standards" do cover all raw water plumbing. A failure of a seacock is only marginally more serious than a failure of a large raw water plumbing fitting, especially if the vessel is unattended.

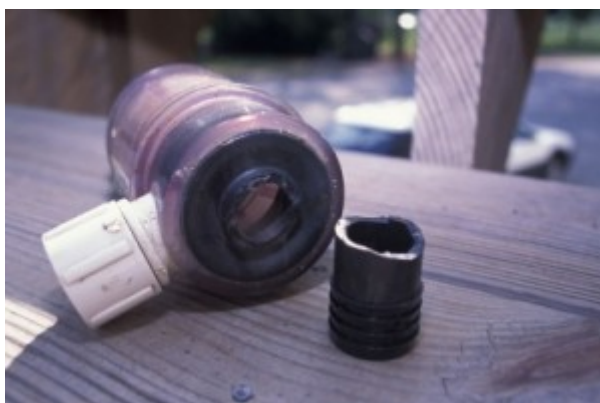
**Sea water strainers should also be strong enough to pass the "stand on it" test. This PVC flush fitting failed and could easily have flooded the vessel.**

My personal durability test calls for any components that could lead to flooding in the event of a failure, to be able to withstand being stood upon. If I can't stand on it without worrying about causing a failure and flooding, it's

simply not rugged enough. Many PVC components and some metallic ones won't pass this test.

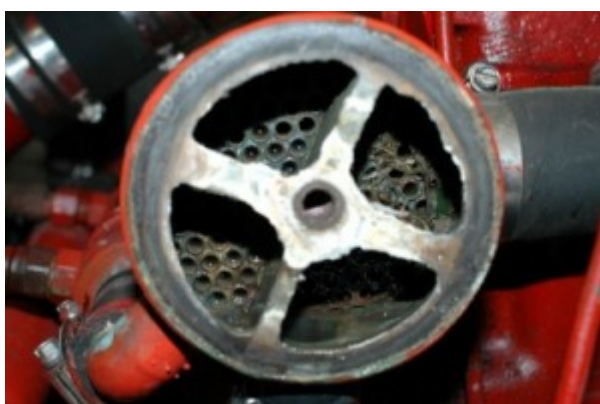
**Engine and transmission heat exchangers should be periodically**

checked to ensure their cleanliness, every other year or every 500-750 hours, whichever comes first. Debris and scale can clog both the sea water as well as the coolant sides, dramatically inhibiting the transfer of heat necessary for a cool running engine.

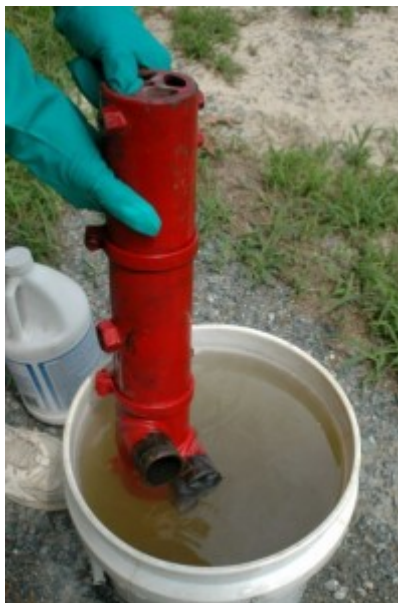
**The traditional cleaning method: this heat exchanger has been removed for immersion in a cleaning solution. This is sometimes necessary, but not always. Now, cleaning can be carried out without removal or major disassembly.**

My own recommendation calls for inspection and cleaning, but

not necessarily disassembly, of the engine's main heat exchanger every two years. However, you do have an alternative, at least for part of this process.

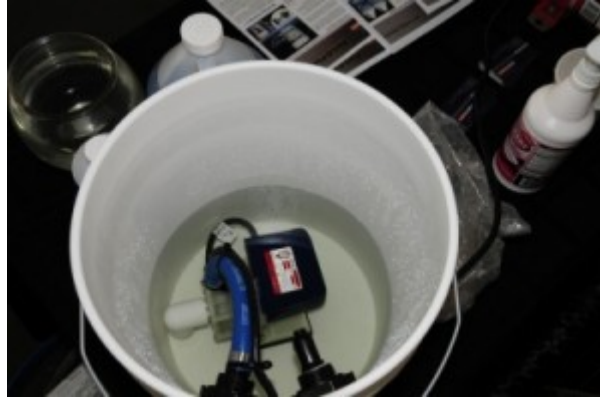
**A proprietary "run bucket" like this includes a pump immersed in cleaning solution and hosing to connect it to the raw or coolant sides of an engine, generator or air conditioning system.**

You could clean all of these components, except the exhaust elbow, using a proprietary cleaning agent and pump system available from Trac Ecological. The cleaning solution [http://trac-online.com/index.php?option=com\\_virtuemart&Itemid=62](http://trac-online.com/index.php?option=com_virtuemart&Itemid=62) and [http://trac-online.com/index.php?option=com\\_virtuemart&Itemid=73](http://trac-online.com/index.php?option=com_virtuemart&Itemid=73) are used together to clean raw water cooled components. I've used or supervised the use of this system many times and can attest to its effectiveness.

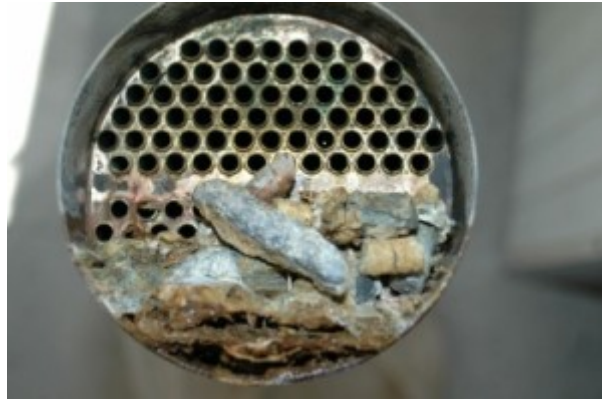
**This heat exchanger obviously had not been checked for some time. Nearly half of the surface area of the tubes were blocked by old pencil zincs and scale. And yes, the engine was chronically overheating.**

The cleaning protocol will remove lime scale, barnacle and other shell material as well as zinc anode "debris", however, it will have no effect on rubber such as impeller parts, pine straw (I've seen this clog heat exchangers) or sea grass. For this reason, I still recommend the main heat exchanger end caps be removed for inspection purposes, and if there are any heat exchangers in line before the raw water pump, for hydraulic or fuel cooling for instance, these too should be inspected. In the latter cases these heat exchangers typically cannot be disassembled, which simply means removal of the inlet hose and a look inside with a flashlight.

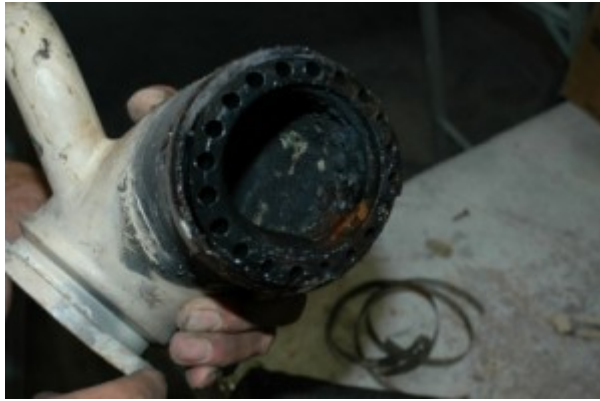
**Blockages in the injected water discharge holes can cause hot spots in the exhaust hose, which can in turn fail as a result. Such a failure can be devastating as no overheat or other warning will be given to the operator and the engine room/compartments will be filled with hot, atomized seawater and soot.**

Because cleaning solution can't be easily circulated through it using the above-mentioned pump system, the exhaust elbow would still have to be inspected visually, which would require removal of the hose.

Exhaust elbow spray rings do suffer from blockages and corrosion, so a thorough visual inspection every three or four years is a good idea.

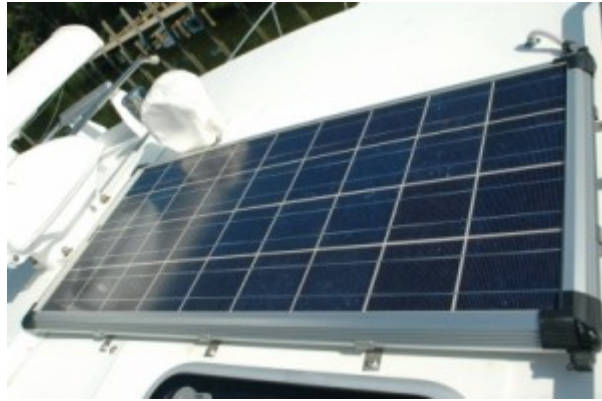
**Solar panels must be mounted in locations that afford them the best view of the sun, but must be wired correctly to prevent fires.**

When it comes to over-current protection (OCP), fuses, and circuit breakers, solar panels are no different than any other appliance, regardless of whether they consume or produce electricity. Ashore or afloat, all wires connected to a battery's positive post, or the vehicle's/vessel's positive distribution, either directly or indirectly, must be equipped with a fuse or circuit breaker as close as reasonably possible to the battery or positive distribution bus. I've probably uttered this phrase hundreds of times in my career: every inch of wire between the battery and the fuse/CB, if there is one, is unprotected and will overheat and possibly cause a fire in the event of a short circuit. With some caveats, the marine standard allows for up to 72 inches of unprotected wire, i.e. before the fuse/CB is installed, however, the closer the better. For all but the smallest solar panels, and certainly for arrays, installing OCP at the panel also makes good sense (some come equipped with a fuse) as their output could create enough heat in the event of a short, even if the OCP at the battery does blow.

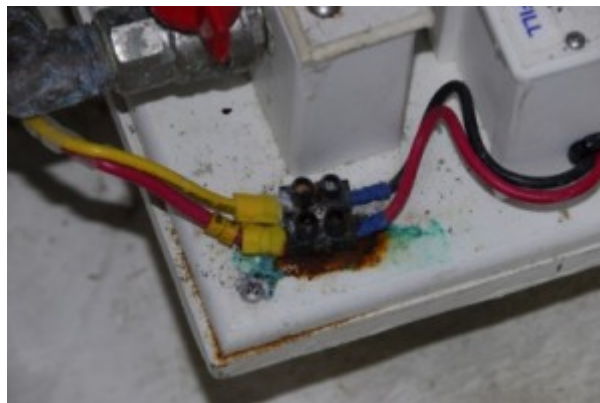
**Water dripping on an electrical connection can cause corrosion which can lead to a high resistance, high heat problem, but not necessarily a dead short. Any junction as poor as this should be replaced immediately.**

In this case, whether OCP would have saved the day is open to debate. (It's similar to another letter I answered several months ago regarding shore power cord ends that get wet. They have been known to overheat and cause a fire without tripping a circuit breaker. High resistance does not necessarily create high current draw.) The fire in the junction box likely represented a high resistance short. High resistance shorts behave more like a load, generating heat in this case, but potentially not drawing enough power to blow a fuse. Rather than a conventional low resistance short, the latter trip breakers and blow fuses readily.

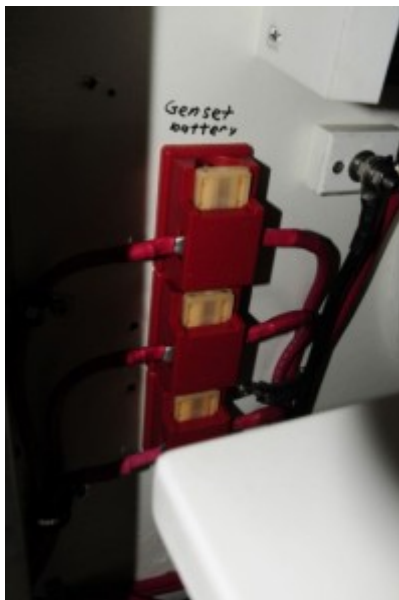
**Fuses are not necessarily a deterrent to fires, particularly where high resistance shorts are concerned.**

Regardless, as previously-mentioned, every wire connected to the battery or the positive distribution bus, save one, must be equipped with OCP, and OCP at the solar panel makes good sense too. The one exception is the vessel's starter, it's exempt from this guideline, which for diesel-powered boats is established by the American Boat and Yacht Council's chapter E-11, and by the USCG for gasoline powered vessels (in the latter case it is, as part of the Code of Federal Regulations, the law).

A water proof junction box certainly would make sense in an installation of this sort, again, ashore or afloat, and a fuse or circuit breaker is simply a prerequisite.
