Ask Steve: PVC Plumbing, Low Hour Engine Maintenance, Solar Panel Fire

By Steve D'Antonio

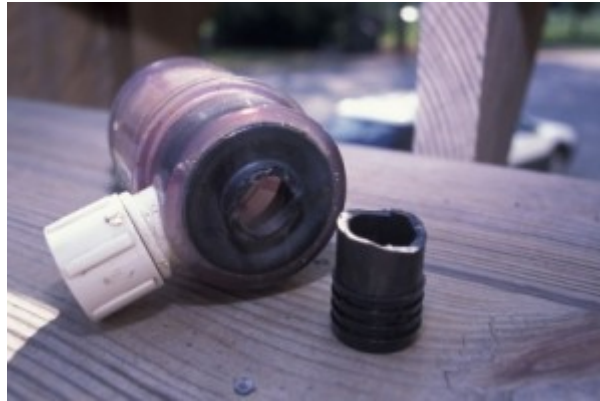
Sea water strainers should also be strong enough to pass the "stand on it" test. This PVC flush fitting failed and could easily have flooded the vessel.

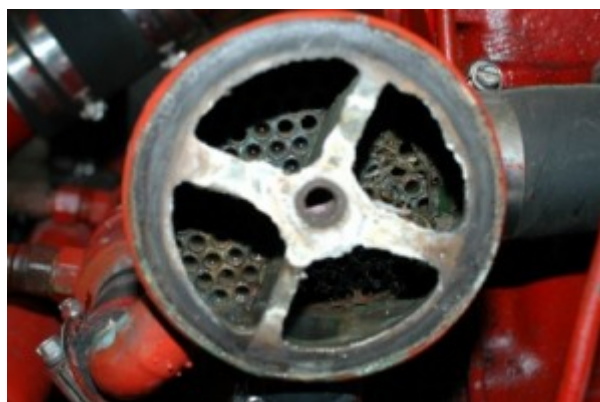
Engine and transmission heat exchangers should be periodically

checked to ensure their cleanliness, every other year or every 500-750 hours, whichever ever comes first. Debris and scale can clog both the sea water as well as the coolant sides, dramatically inhibiting the transfer of heat necessary for a cool running engine.

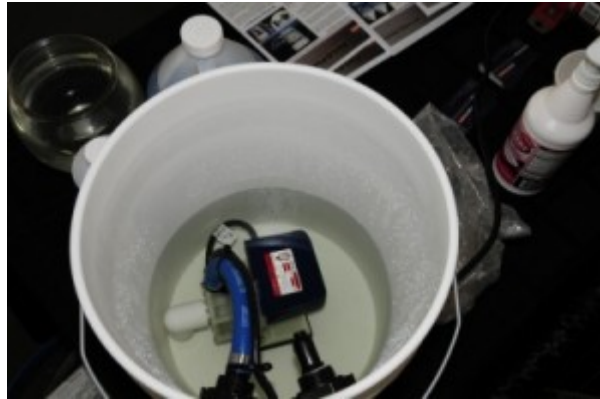
A proprietary "run bucket" like this includes a pump immersed in cleaning solution and hosing to connect it to the raw or coolant sides of an engine, generator or air conditioning system.

You could clean all of these components, except the exhaust elbow, using a proprietary cleaning agent and pump system available from Trac Ecological. The cleaning solution http://trac-online.com/index.php?option=com_virtuemart&Itemid=62 and http://trac-online.com/index.php?option=com_virtuemart&Itemid=73 are used together to clean raw water cooled components. I've used or supervised the use of this system many times and can attest to its effectiveness.

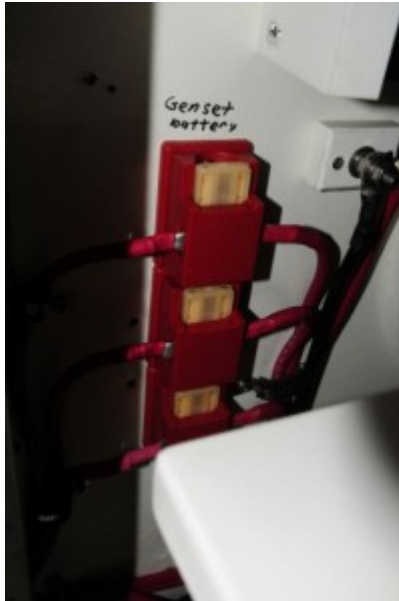
Fuses are not necessarily a deterrent to fires, particularly where high resistance shorts are concerned.
