# Ask Steve: PVC Plumbing, Low Hour Engine Maintenance, Solar Panel Fire

By Steve D'Antonio

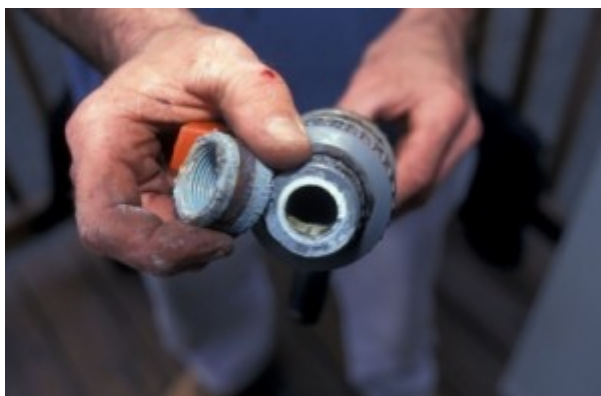
This PVC “pool” valve used as a seacock snapped off in the mechanic’s hand as he closed it. Luckily, the boat was on land at the time. PVC has limited use as plumbing aboard boats for carrying raw water.

Thank you for the note and query. The question you've posed is not only a very good one, it's also one that's commonly asked. The "rule" regarding the use of PVC is strictly my own, however, it's based on firsthand experience of failures where this material is concerned. I've seen dozens of PVC plumbing components fail in marine applications (see attached example photos.) I suspect failures are exacerbated by vibration, extreme temperature cycling and excessive leverage

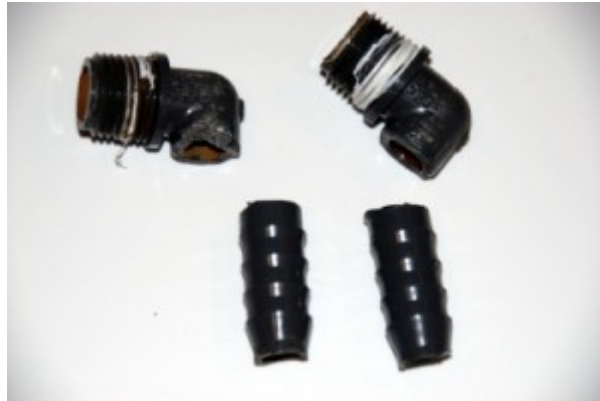
**It is not uncommon to break off the end of PVC barbs when removing the hose, as happened to these two water maker fittings; they were just two years old. In most cases, PVC simply doesn't have the strength for raw water plumbing.**

There was a time when ABYC seacock standards cited PVC's inadequate modulus of elasticity and tensile strength, however, that wording is now no longer used and PVC isn't referenced specifically. The guidelines do specify that any seacocks installation must be able to withstand the application of 500 pounds of static force for a duration of 30 seconds without failing to perform as intended (I read that to mean it doesn't break, leak or seize.) I'm fairly sure few PVC valves could withstand such a test. It's important to point out as well that ABYC guidelines have no bearing on raw water plumbing other than the actual seacock, while my "standards" do cover all raw water plumbing. A failure of a seacock is only marginally more serious than a failure of a large raw water plumbing fitting, especially if the vessel is unattended.

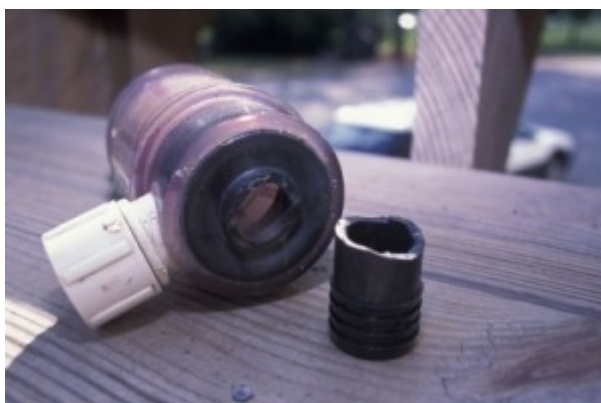
**Sea water strainers should also be strong enough to pass the "stand on it" test. This PVC flush fitting failed and could easily have flooded the vessel.**

My personal durability test calls for any components that could lead to flooding in the event of a failure, to be able to withstand being stood upon. If I can't stand on it without worrying about causing a failure and flooding, it's

simply not rugged enough. Many PVC components and some metallic ones won't pass this test.

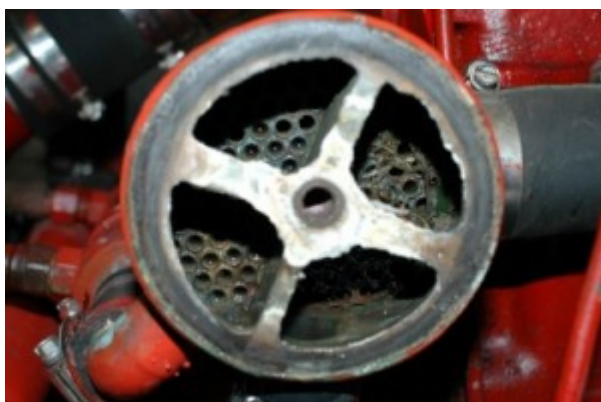
**Engine and transmission heat exchangers should be periodically**

**checked to ensure their cleanliness, every other year or every 500-750 hours, whichever comes first. Debris and scale can clog both the sea water as well as the coolant sides, dramatically inhibiting the transfer of heat necessary for a cool running engine.**

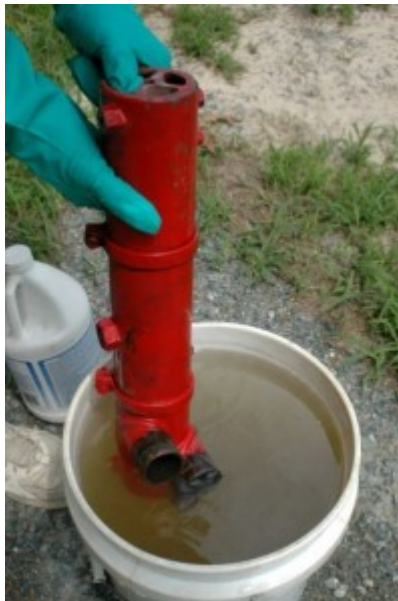
**The traditional cleaning method: this heat exchanger has been removed for immersion in a cleaning solution. This is sometimes necessary, but not always. Now, cleaning can be carried out without removal or major disassembly.**

My own recommendation calls for inspection and cleaning, but

necessarily disassembly, of the engine's main heat exchanger every two years. However, you do have an alternative, at least for part of this process.

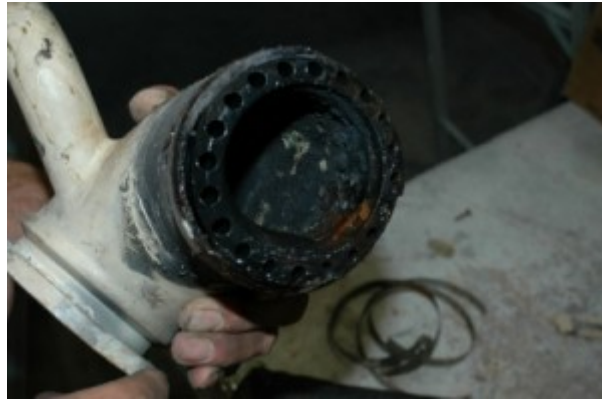
**Blockages in the injected water discharge holes can cause hot spots in the exhaust hose, which can in turn fail as a result. Such a failure can be devastating as no overheat or other warning will be given to the operator and the engine room/compartment will be filled with hot, atomized seawater and soot.**

Because cleaning solution can't be easily circulated through it using the above-mentioned pump system, the exhaust elbow would still have to be inspected visually, which would require removal of the hose.

Exhaust elbow spray rings do suffer from blockages and corrosion, so a thorough visual inspection every three or four years is a good idea.
