# Conventional Wisdom for Conventional Stuffing Boxes

Text and photos by Steve D'Antonio

## **Conventional Wisdom for Conventional Stuffing Boxes**

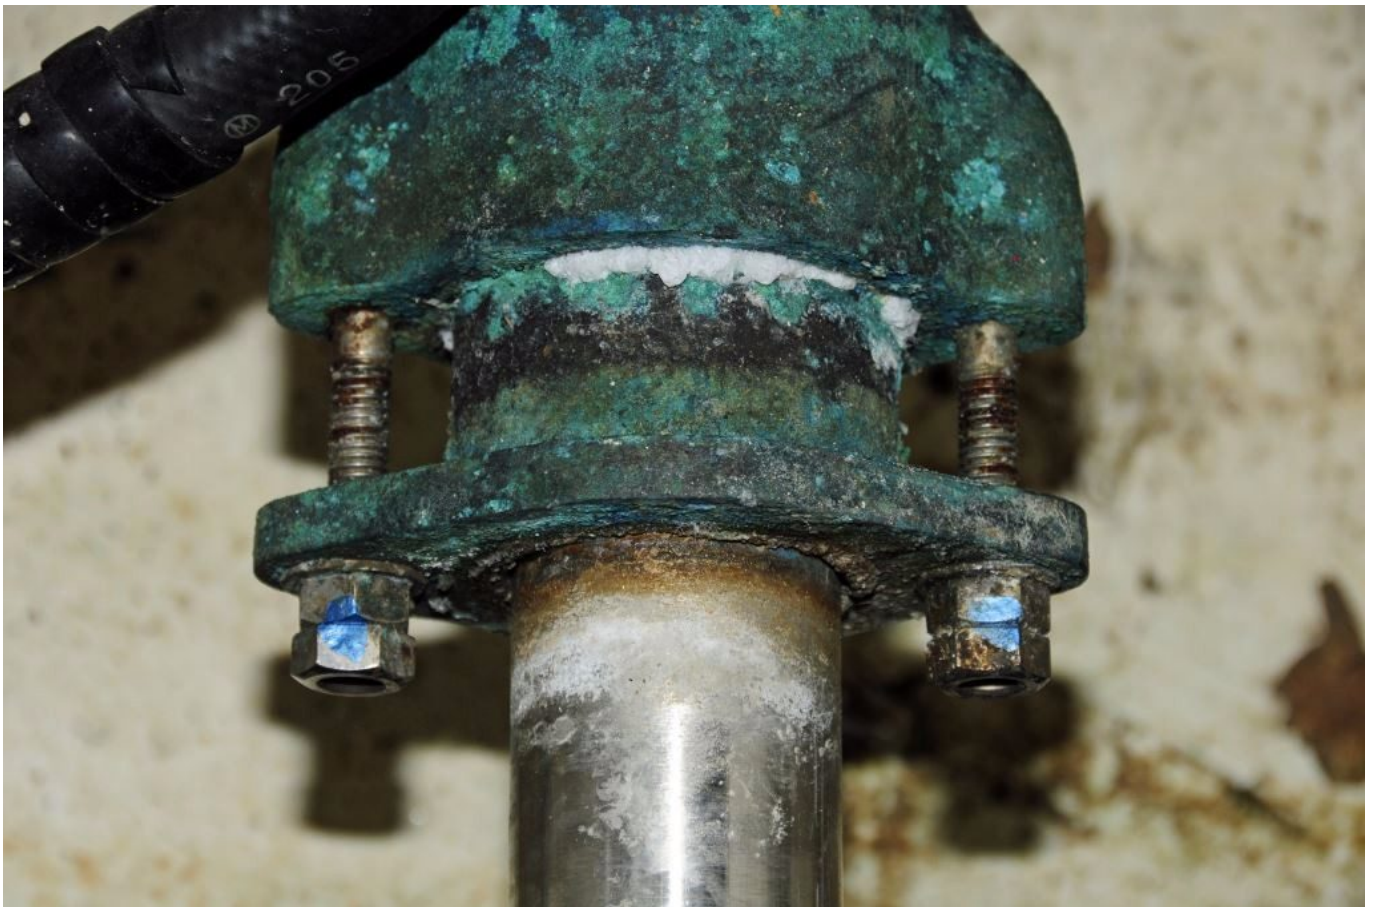
**The stainless steel studs used on some stuffing boxes can suffer from corrosion. In many case these can be cleaned, and the studs corrosion inhibited; if extreme, however, these should be replaced. Bronze studs, on the other hand, are virtually immune to this phenomenon.**

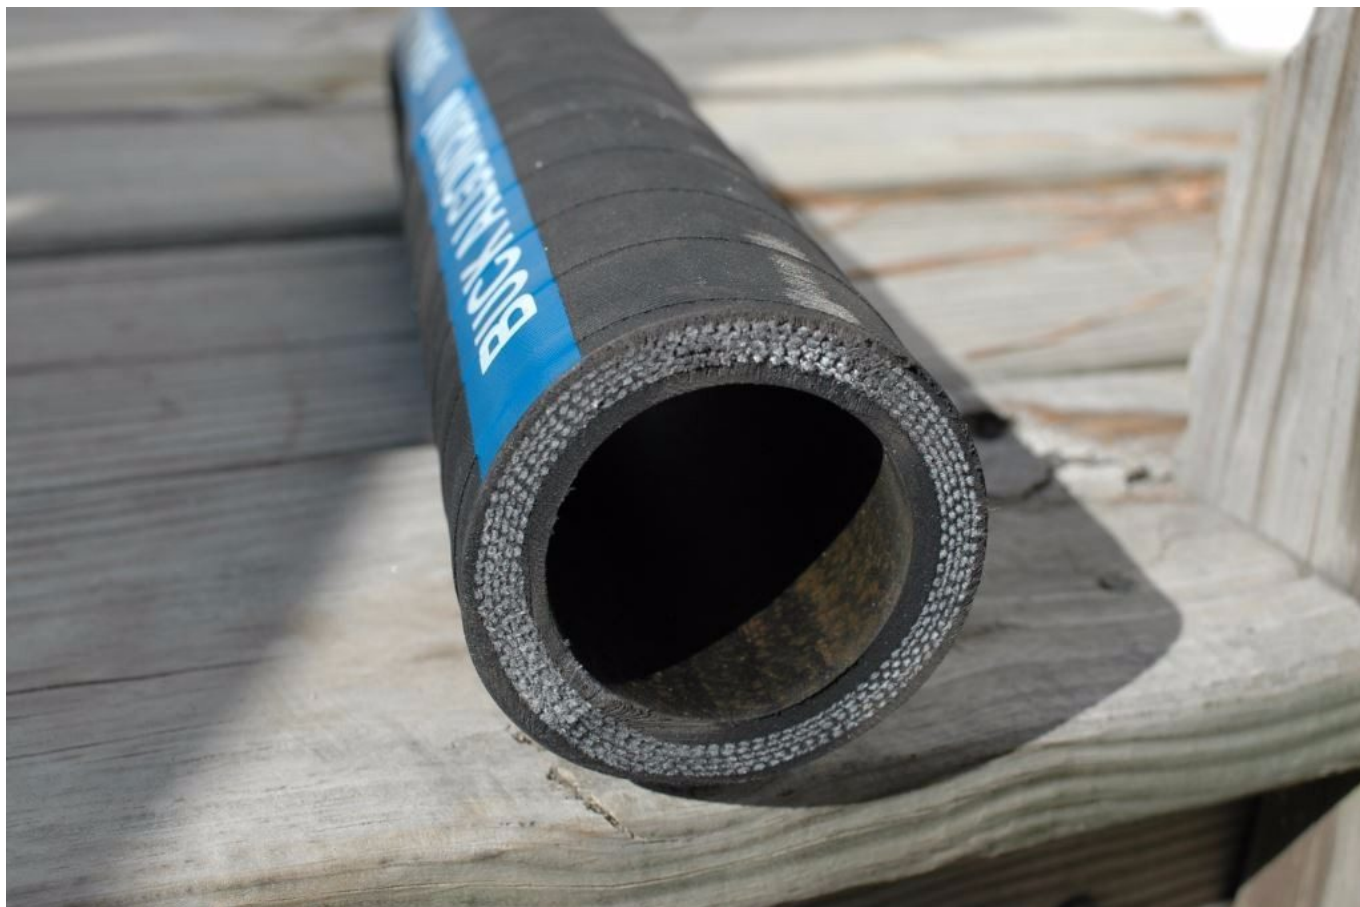
**With additional plies, seen here, when compared to ordinary raw water hoses, proprietary stuffing box hose is especially rugged and twist resistant.**

While it may look ordinary, the hose used with conventional stuffing boxes is, or should be, proprietary. Ordinary raw water or exhaust hose may utilize two or three plies, while proprietary stuffing box hose incorporates five plies. Because hose used in stuffing box applications lives an especially hard life, it's submerged, vibrated and routinely twisted in forward and reverse, the added heft of five plies is a clear value added, and equates to longer life. Replacement of the stuffing box hose is invariably time consuming in that it requires separation of the propeller shaft from the transmission coupling. It is also, therefore, a task that must be carried out while the vessel is hauled. Conventional, conservative wisdom dictates that stuffing box hoses should be preemptively replaced approximately every five to seven years or when warranted by visible hose deterioration. One critical issue involves hose length, or more importantly, the length of "free hose" between the stuffing box pipe to hose adapter and the shaft log. This free hose length must be long enough to allow the hose to float freely on the shaft, avoiding side-loading, binding, and the overheating it can cause.

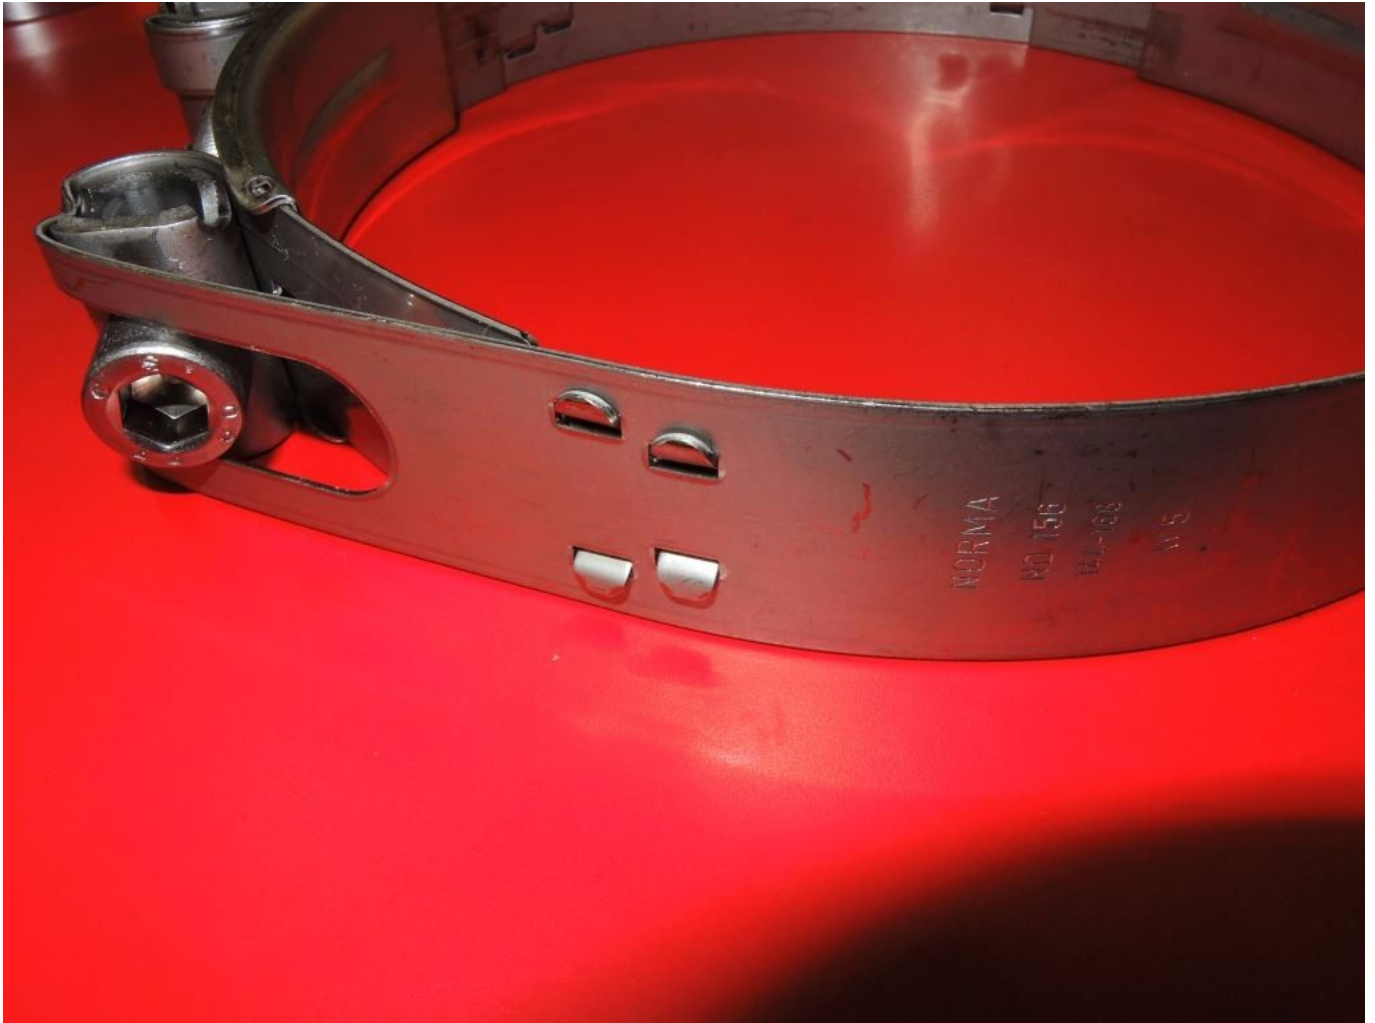
**Because of their resistance to corrosion, interlocking, as opposed to spot welded, hose clamps are ideally suited for conventional stuffing box use.**

Replacing clamps is straightforward and relatively easy. Replacements should be made from all 316 alloy stainless steel, including the screw, and their bands should be solid rather than perforated (for more on hose clamp selection and

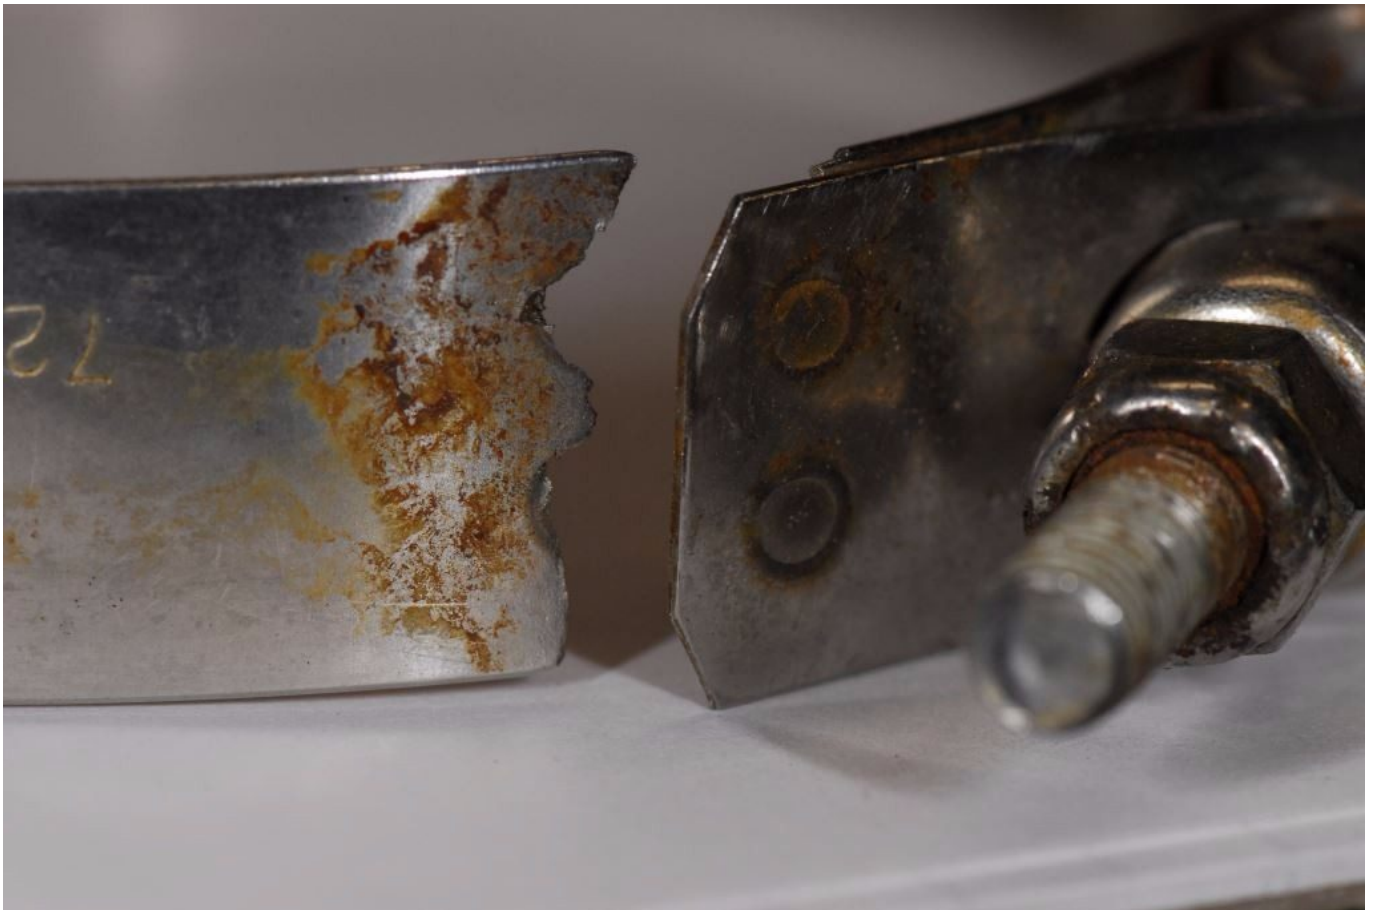
**Folded, spot welded T bolt clamps are prone to crevice corrosion. The one shown here, used on a stuffing box, has parted; the fold was oriented along the bottom of the stuffing box hose.**

Instead, use clamps that are mechanically interlocked rather than folded and welded. If the spot welded variety is used, ensure the fold is oriented at the top or 12:00 o'clock position on the hose, to prevent it from being continuously exposed to leaking water. Contrary to popular belief, there is no need to alternate fastener position on hose clamps.

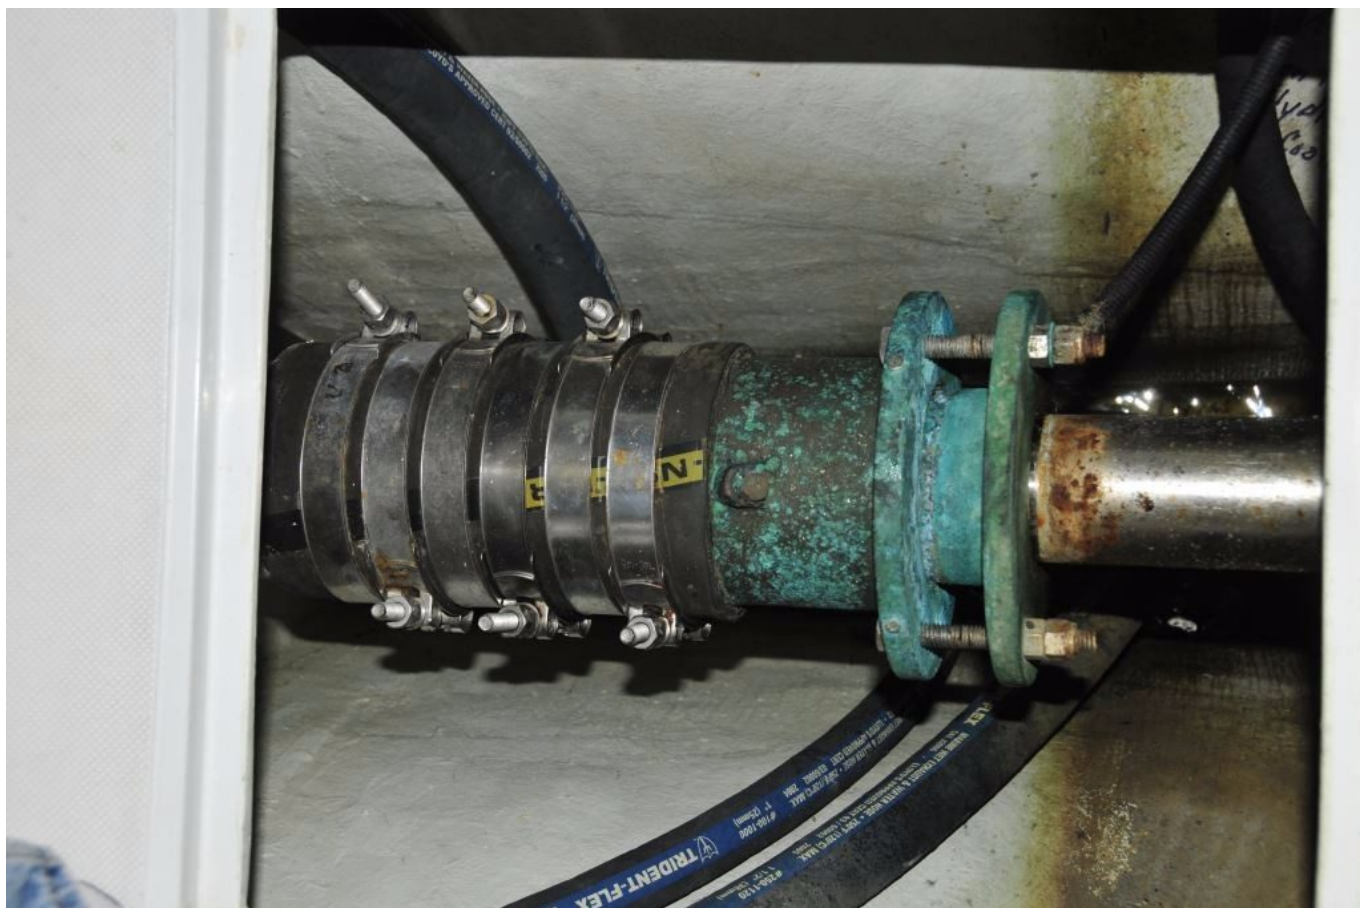
Perhaps this is a case of hose clamp overkill; the additional clamps are of no real value and could be detrimental if they aren't located over the stuffing box or shaft log. Stuffing boxes should be equipped with double, high quality hose clamps at each end. Furthermore, too many clamps, combined with a hose that is too short, could prevent the stuffing box from "floating" on the shaft, and self-aligning.

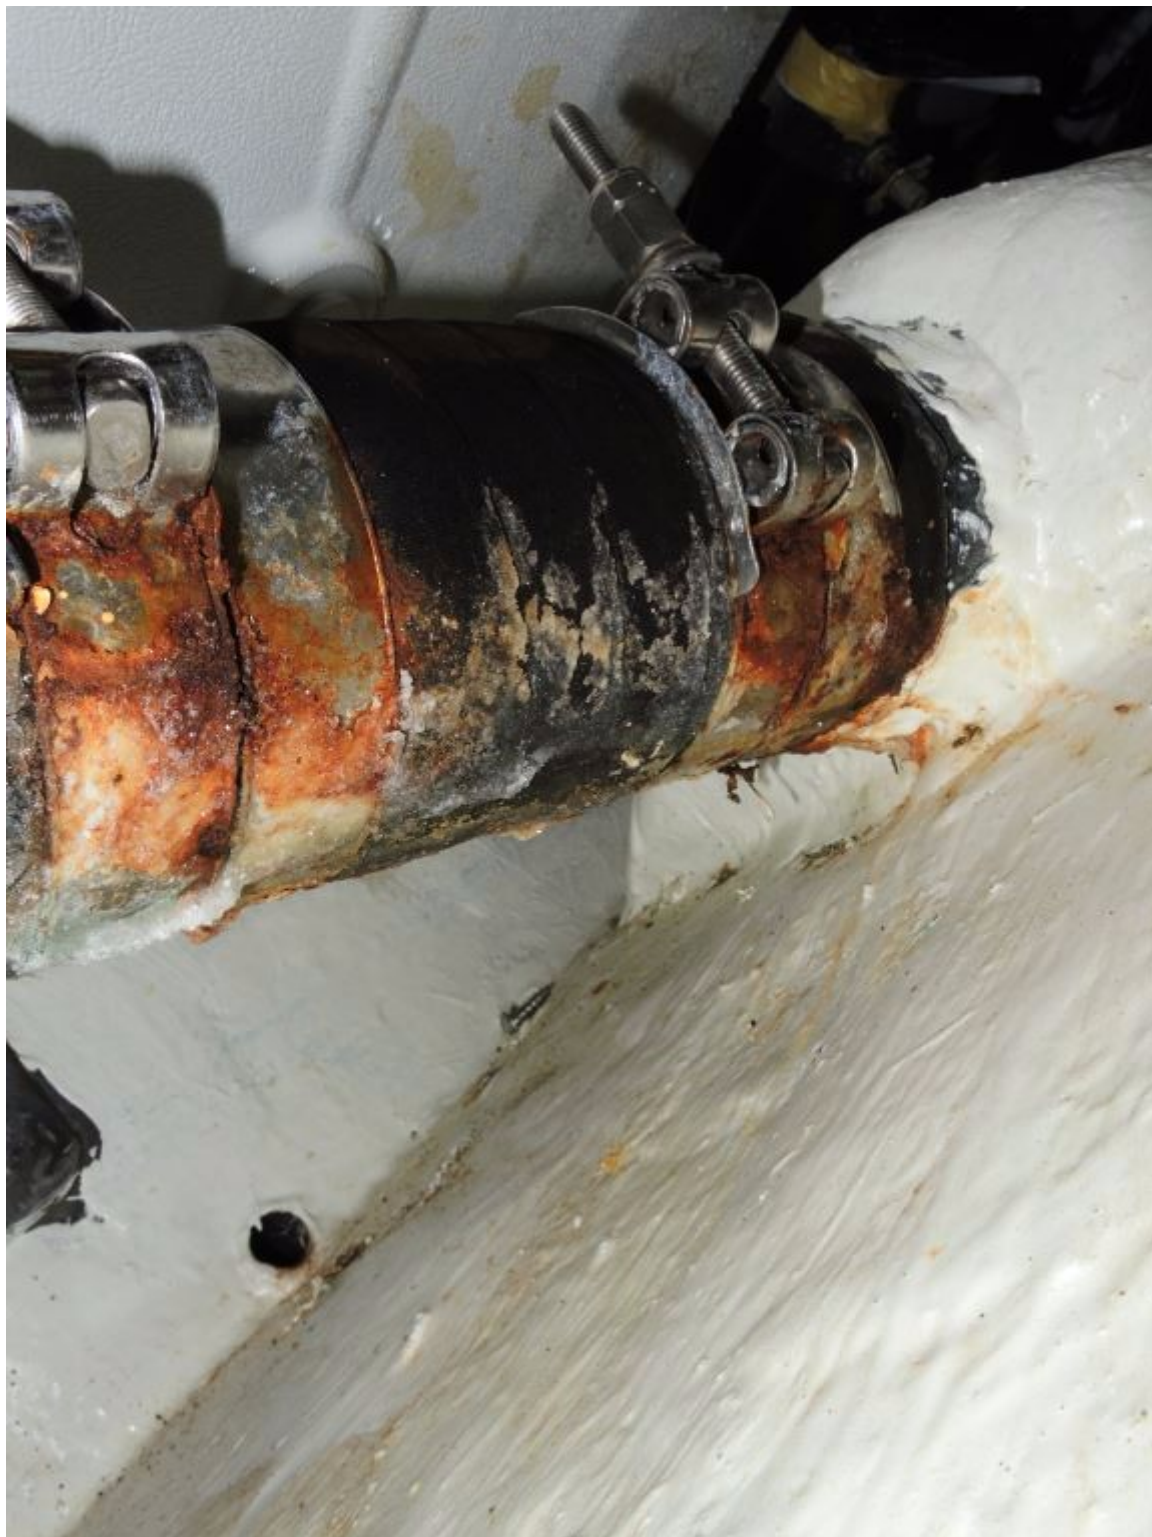
**Chronically leaking stuffing boxes lead to more than just wet bilges. These clamps are seriously corroded as a result of**

## **regular exposure to seawater.**

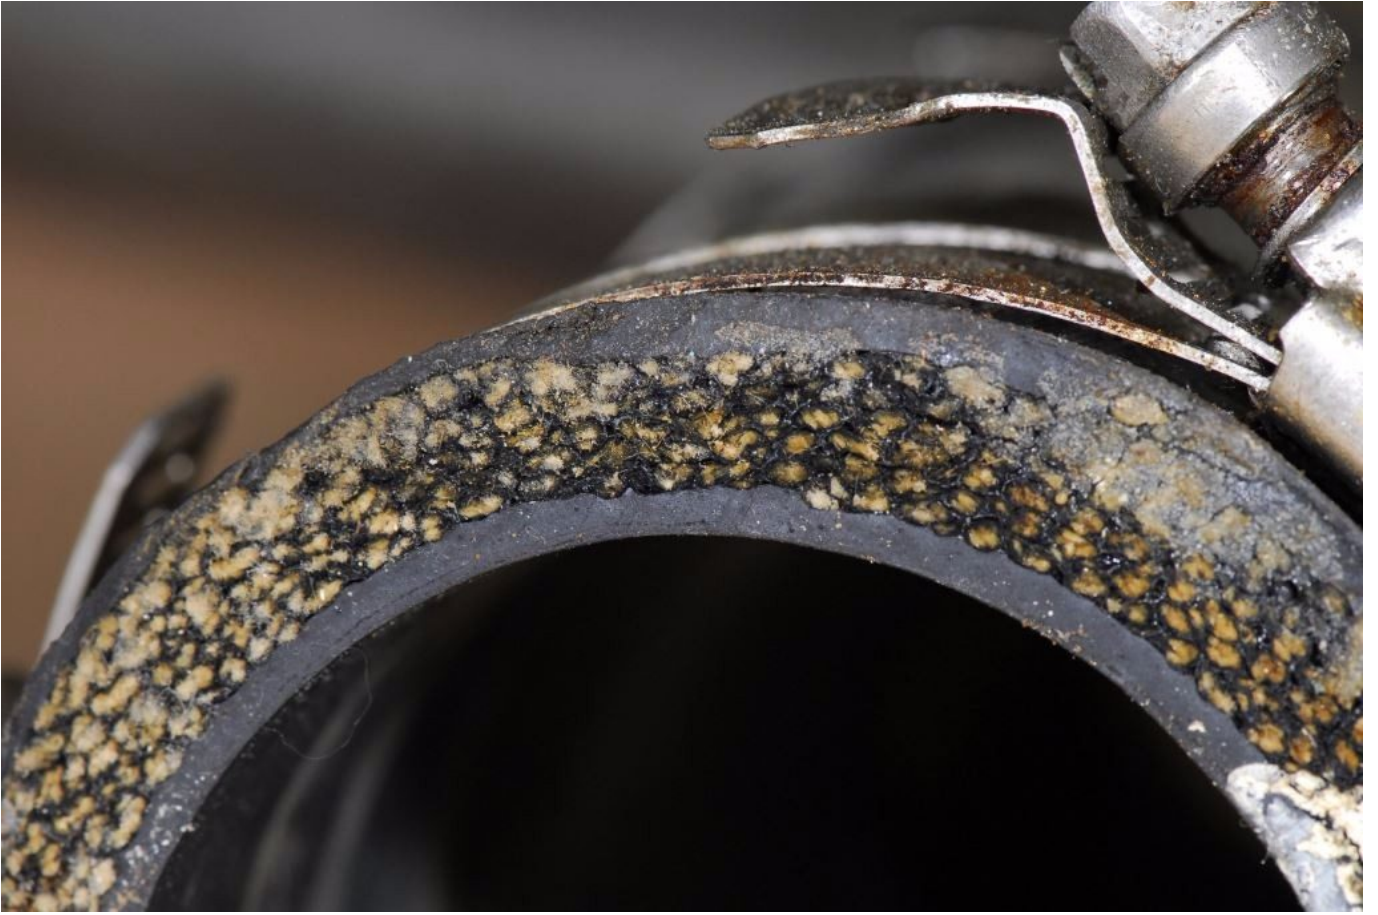
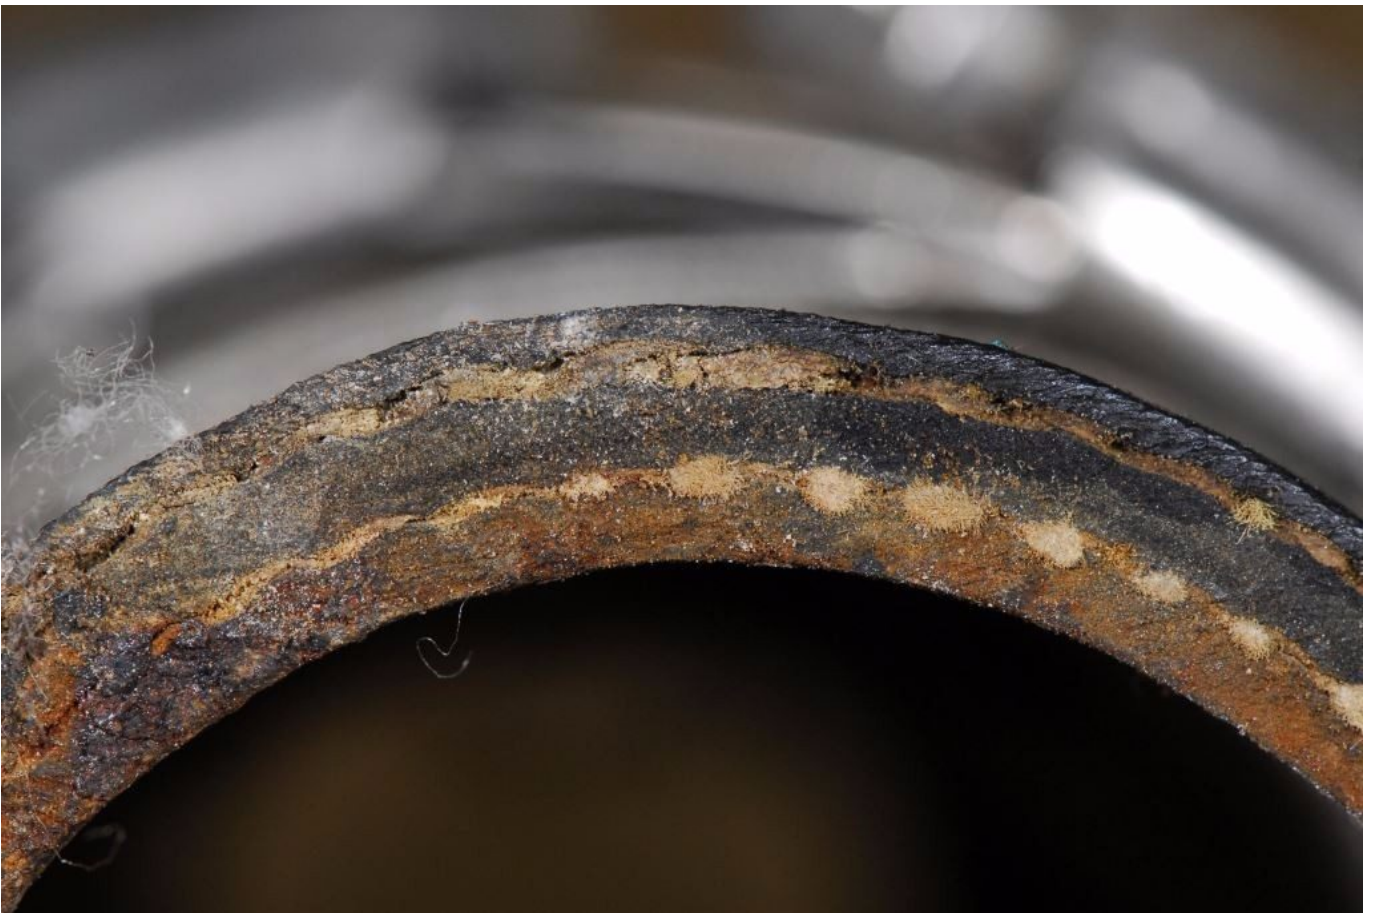
The five plies of a stuffing box hose (top) are clear to see,

compared to ordinary hose's three plies (above).

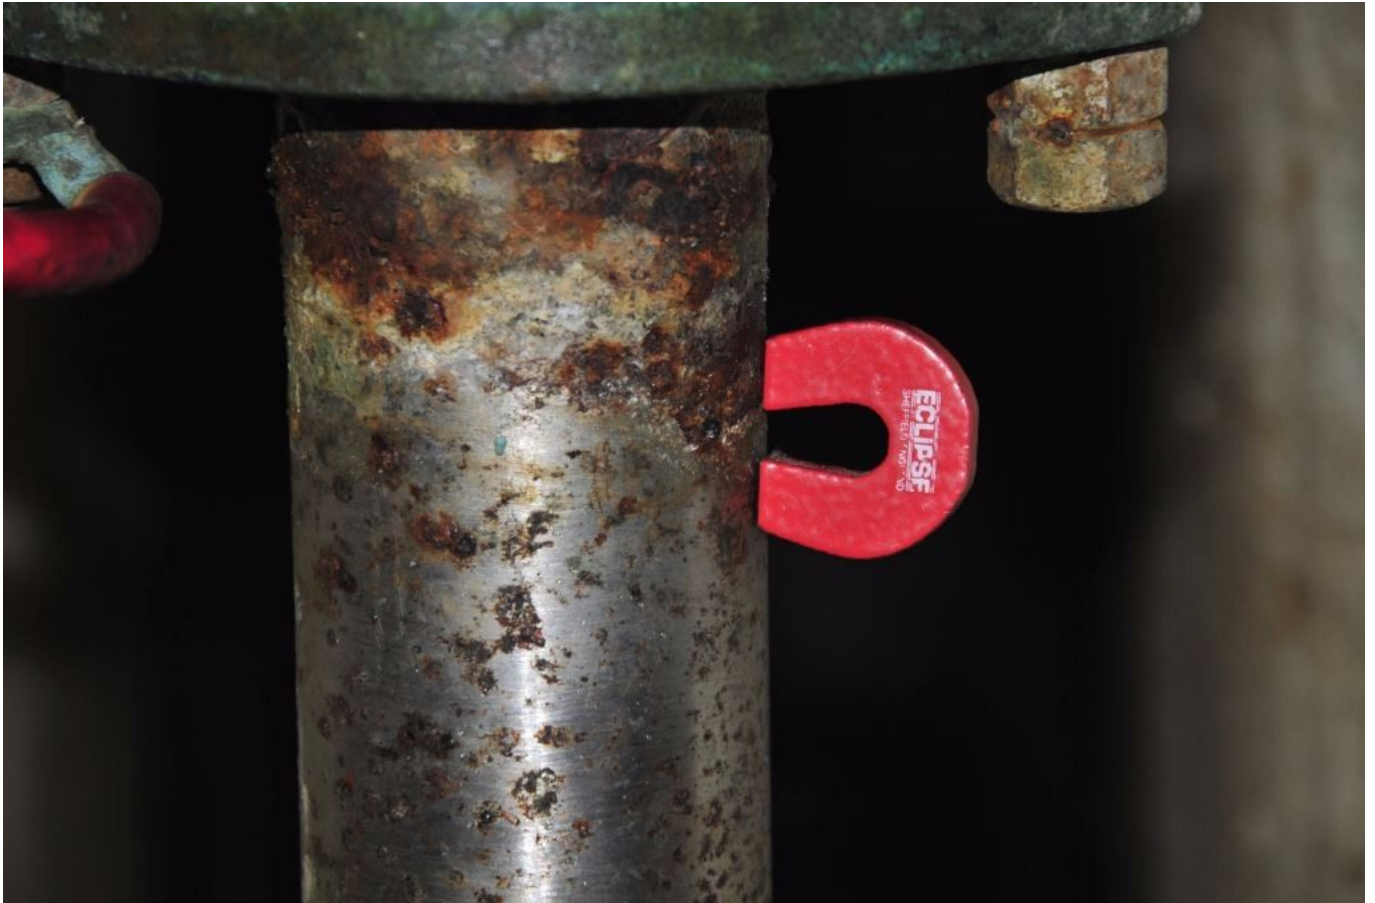
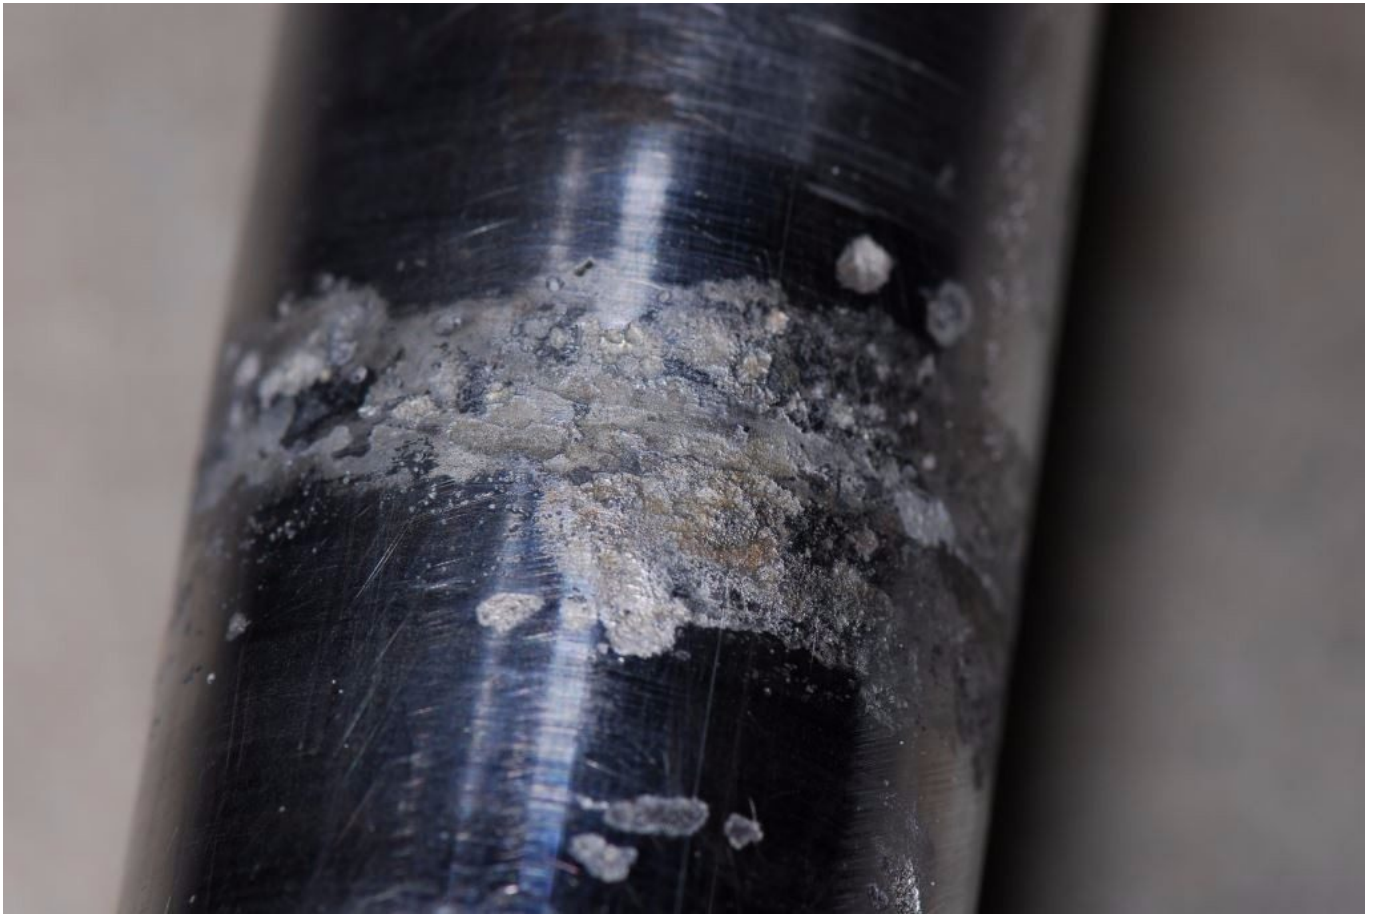
**When stuffing boxes leak chronically, even after repacking, there's usually a reason. In many cases it's the result of a pitted shaft (above), which chews into the packing material with each revolution. With a few exceptions, when shafts are magnetic (top), they are also more prone to this sort of corrosion.**

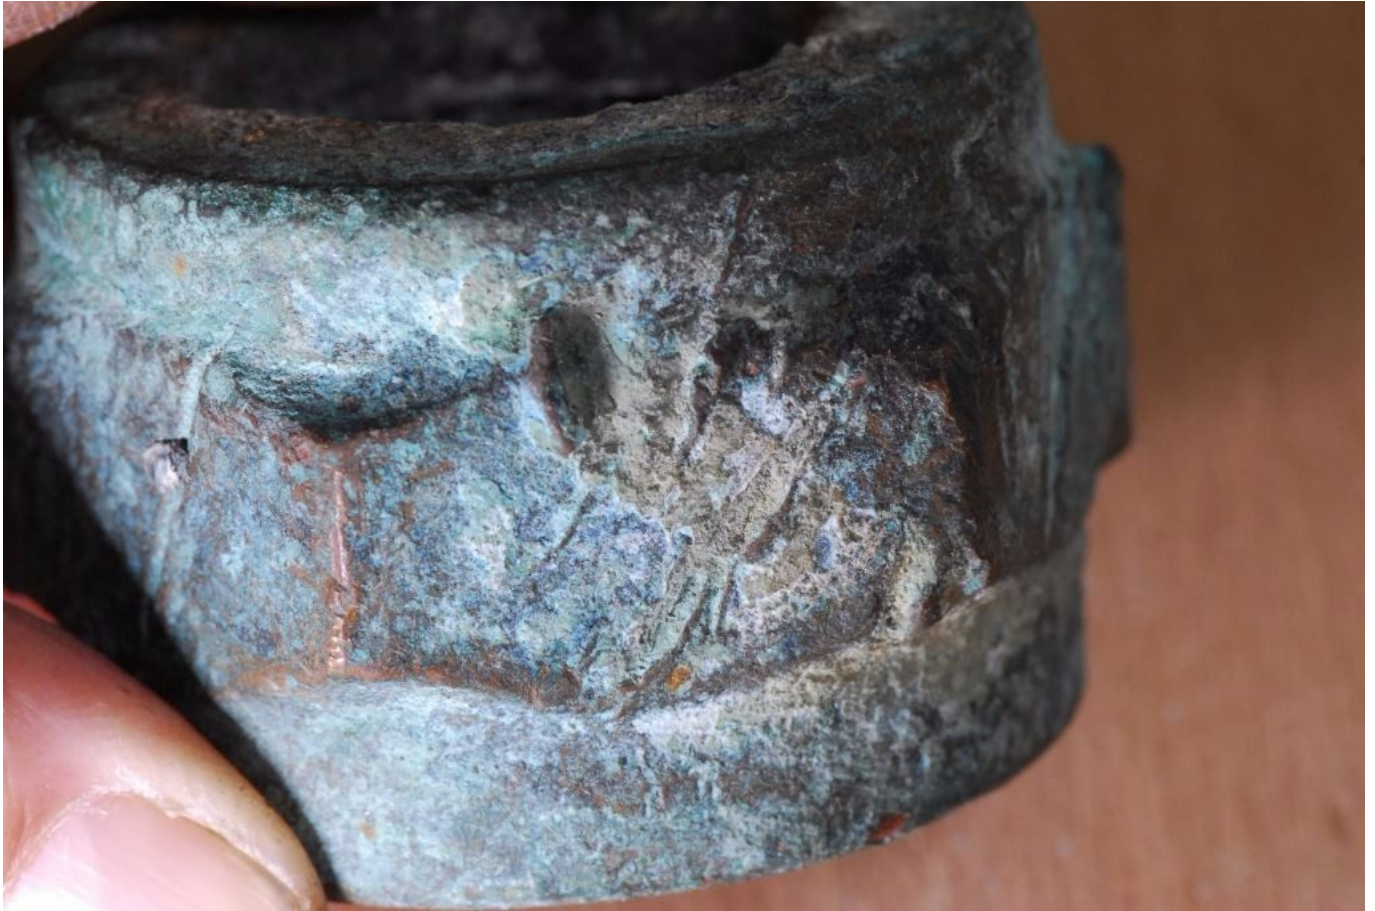
**This packing nut has been loosened, and/or tightened using a chisel, damaging the nut's flats. This practice should be avoided, particularly when tightening. Proper wrenches should be used.**

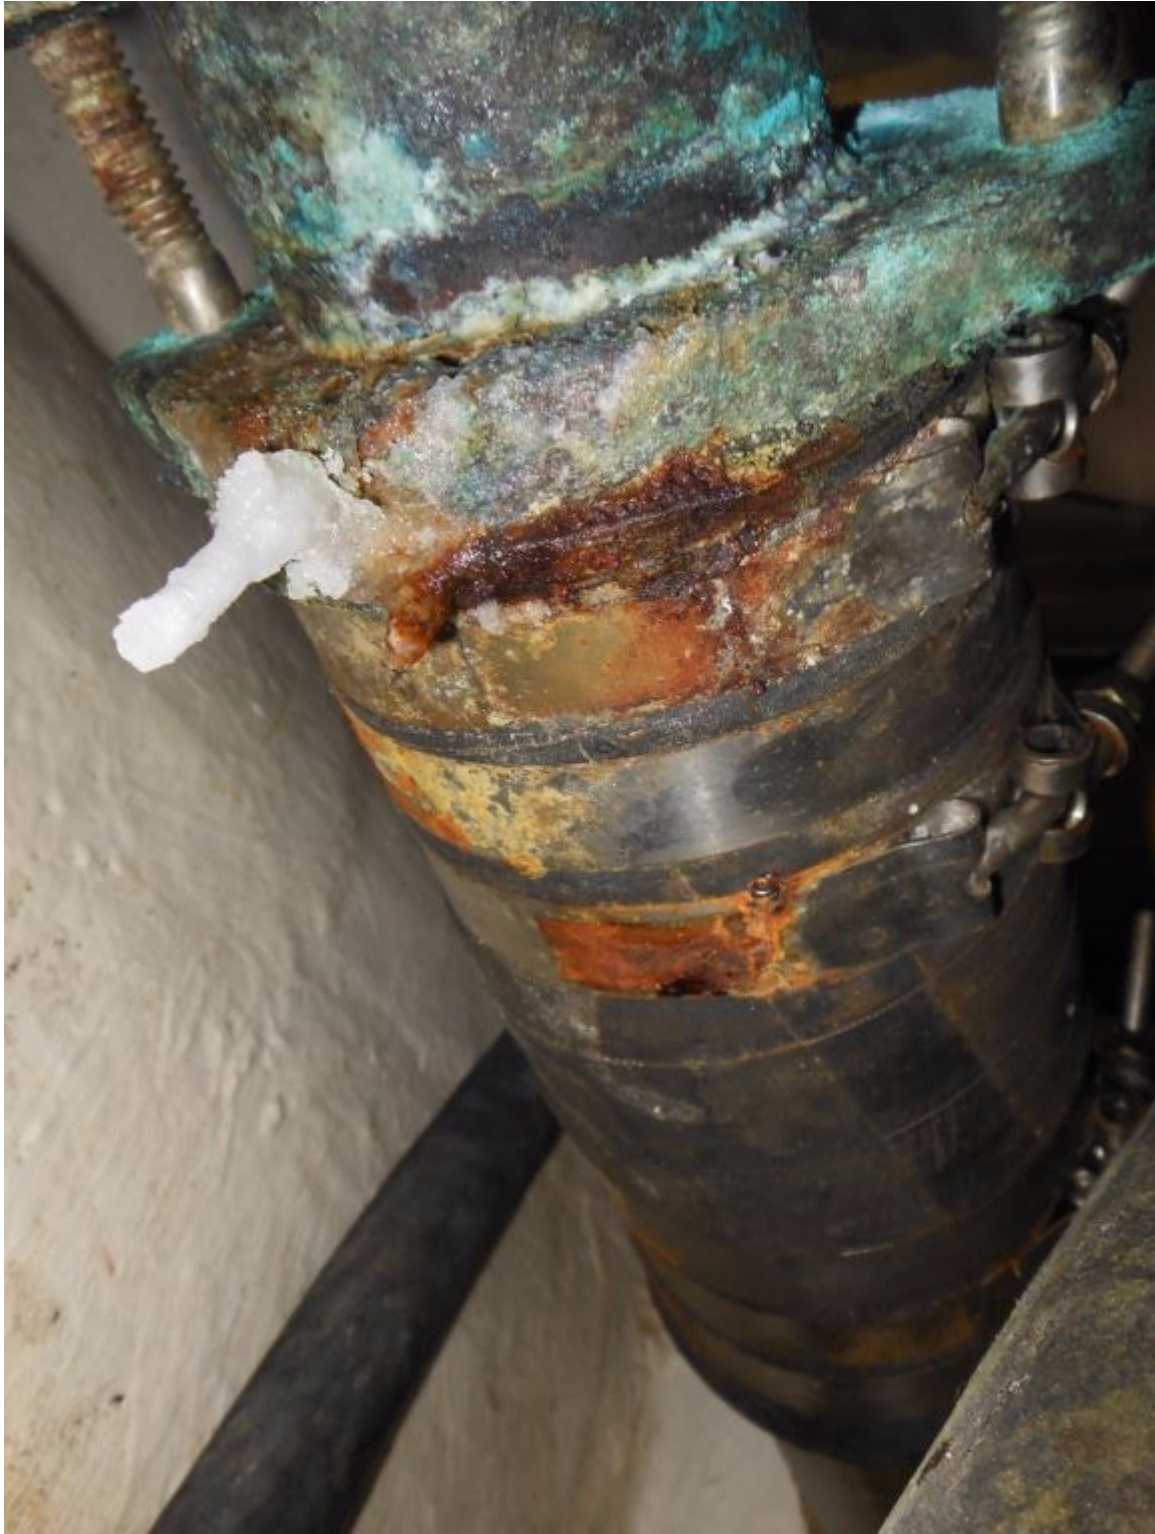
**This salt stalactite tells a story, this stuffing box is**

**almost certainly leaking too much. Anything more than that which is required to keep a stuffing box cool is simply leakage.**

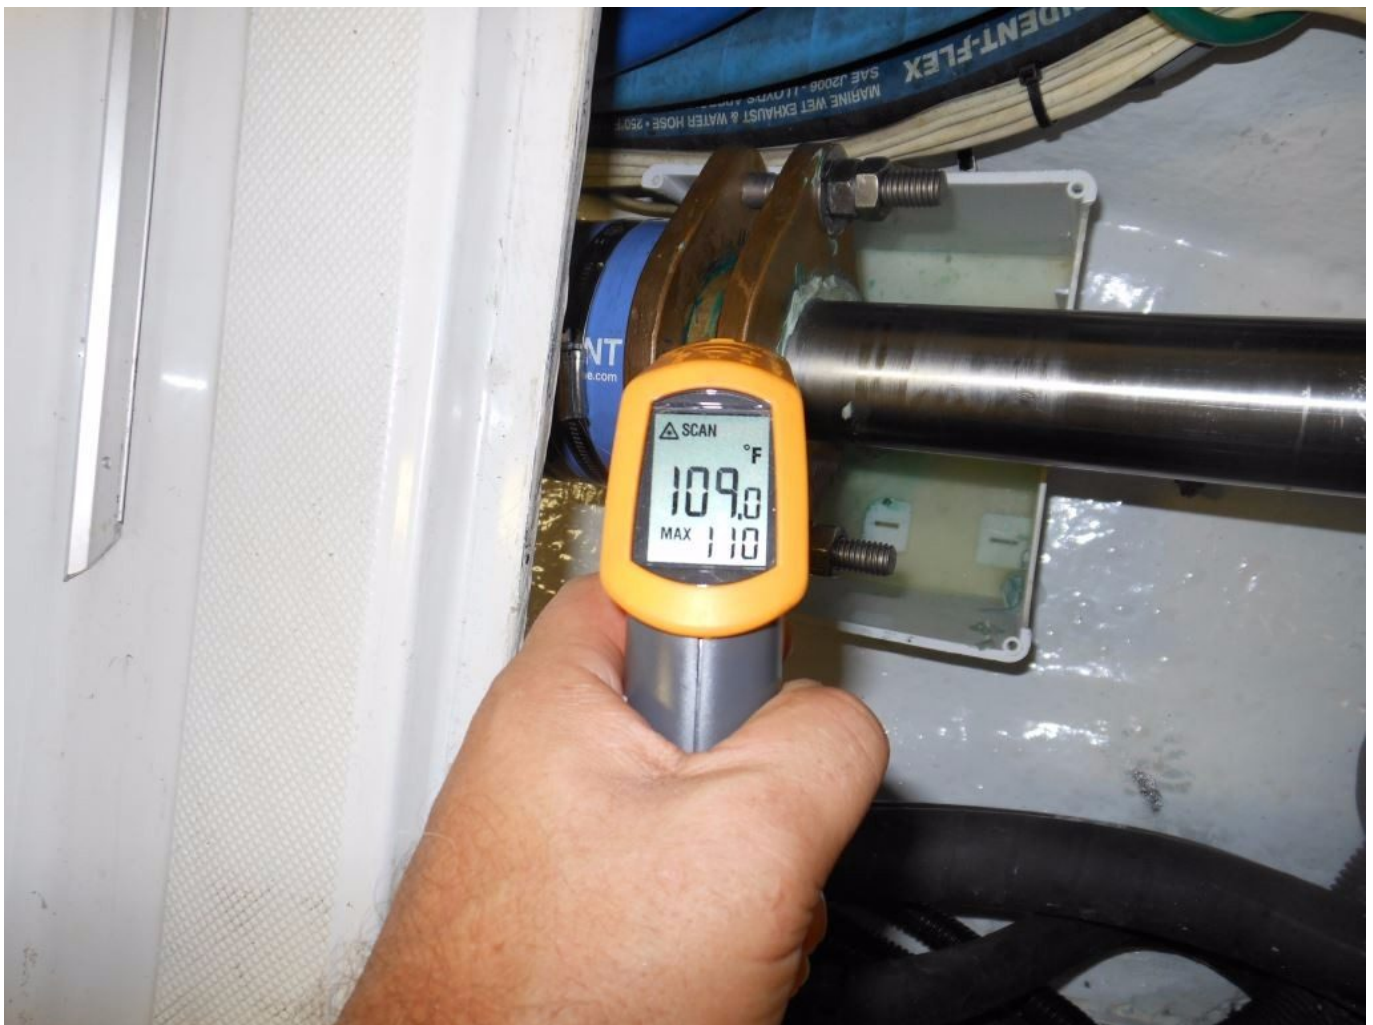
**Infrared pyrometers have changed the way stuffing boxes are adjusted, now it's a measurable balance between heat and drip**

rate.

The watch phrase when repacking a stuffing box, regardless of the material, is careful monitoring for the first few hours of operation. Using an infra-red pyrometer, the stuffing box temperature should be monitored during this time, shooting the stuffing box and not the shaft (highly reflective surfaces such as shafts and hose clamps will often give erroneous readings); adjustments should be made if necessary. No part of the stuffing box should exceed more than 30°F-40°F above ambient seawater temperature, regardless of drip rate, while at any speed. In fact, with access to an infrared pyrometer, drip rates are much less important than they once were.

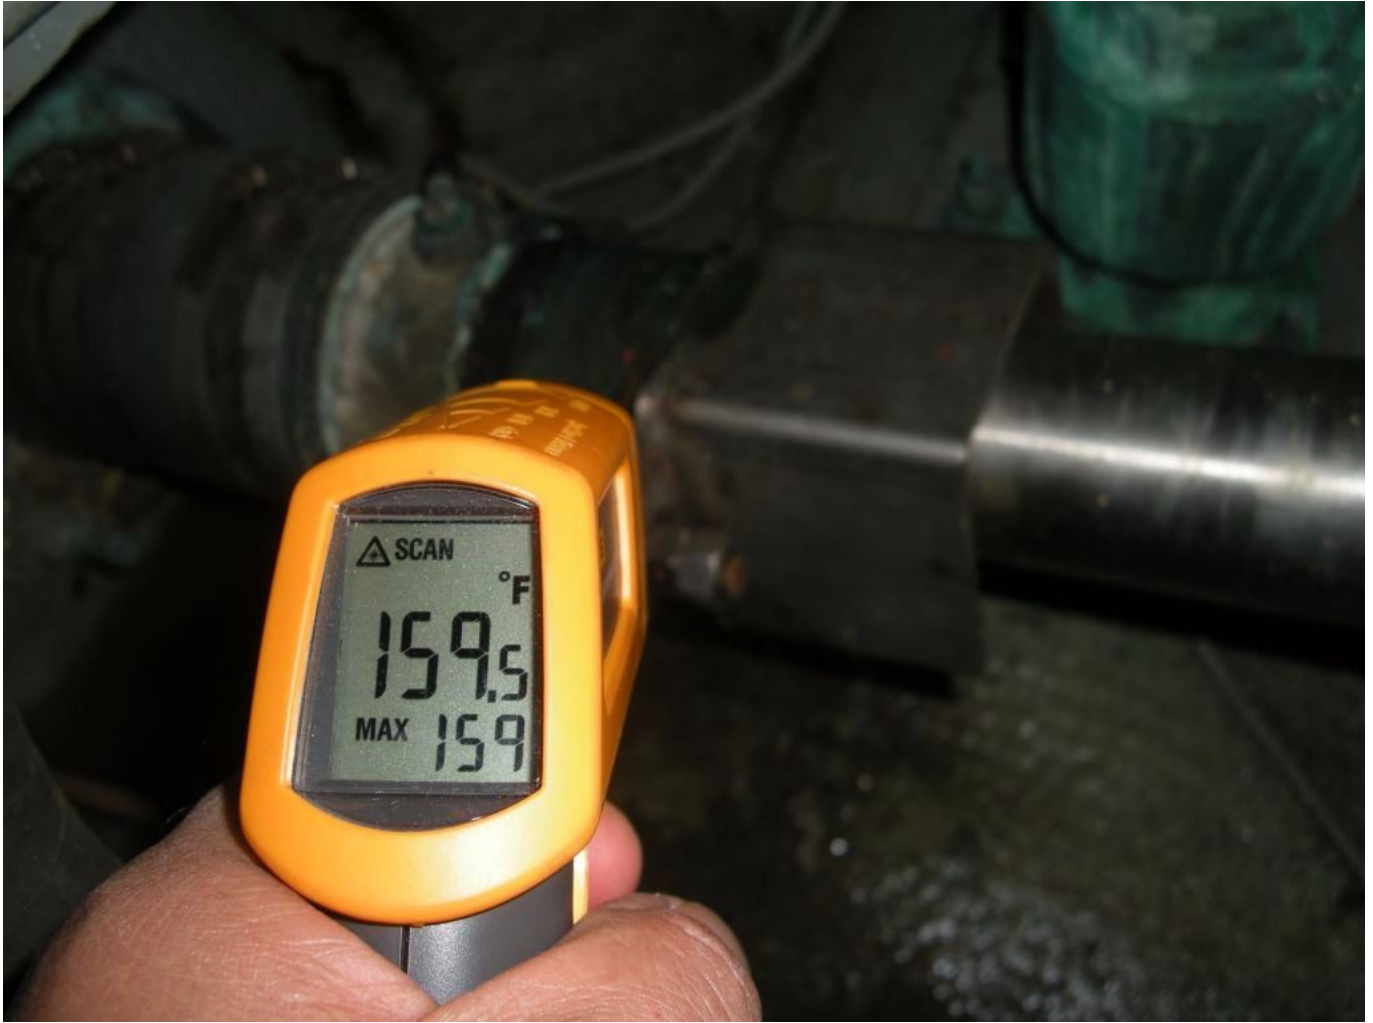
Stuffing box temperature should not exceed that of the water in which the vessel is operating by more than 30°F-40°F. The one shown here is clearly starved for water and is overheating.

Ultimately, the arbiter of correct stuffing box adjustment is temperature rather than drips per minute. Once properly adjusted, the stuffing box should leak little and be no hotter than about 30°F-40°F above ambient water temperature. If it is over tightened the wax in the packing will melt and run out of the stuffing box as a liquid, often accumulating under the stuffing box as a greenish pyramid, after which it will leak copiously. If necessary, this entire procedure can be carried out while the vessel is afloat. Once the packing nut is removed simply secure several wraps of a rag around the stuffing box where the shaft exits to temporarily stem the flow of water. Water will leak during reassembly; however, provided you work quickly it will be comparatively little. Check your stuffing box regularly and provide it with the care it needs. Doing so will yield the dividends in both longevity

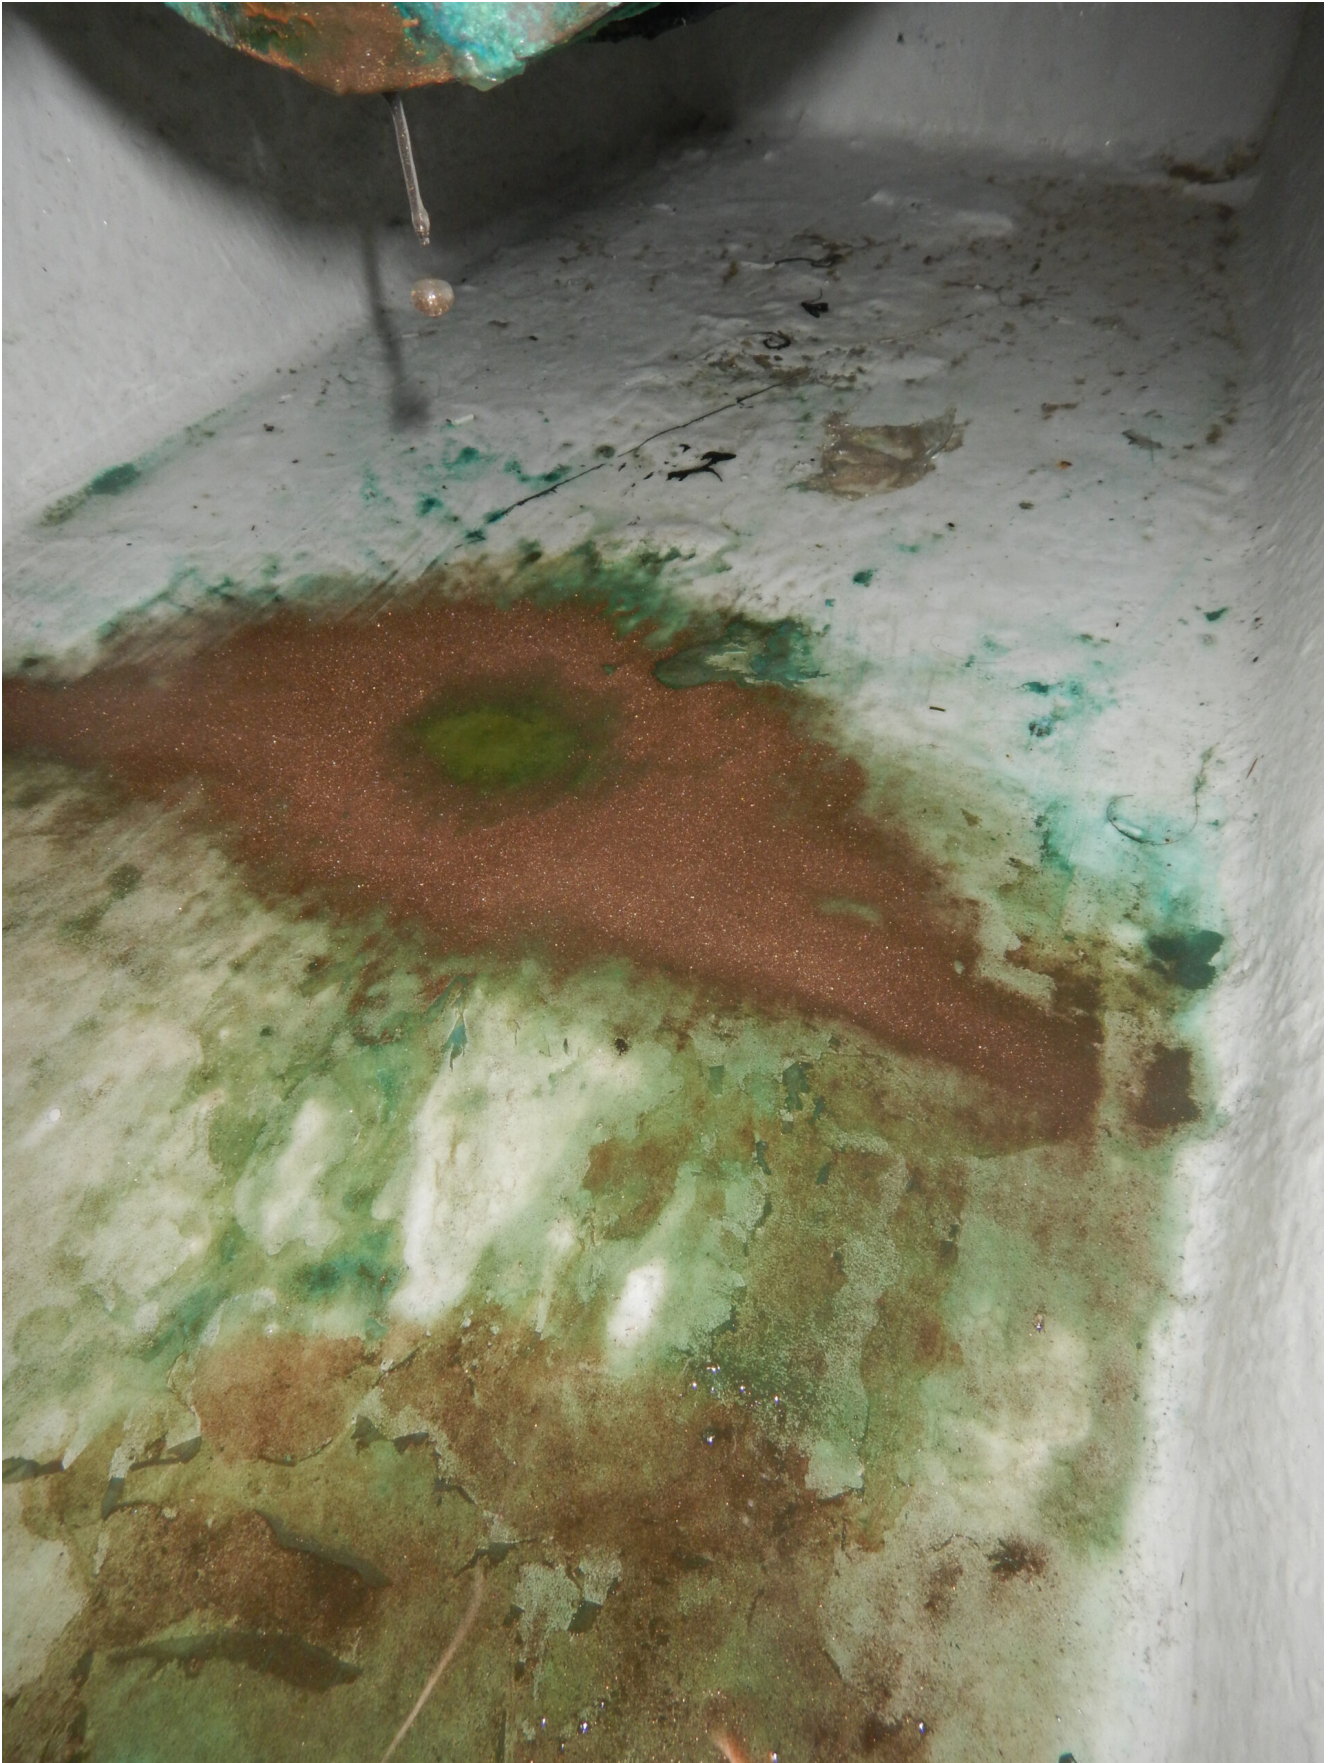
**A stuffing box that is side loaded, from overly stiff hose, or a shaft that is not centered in the shaft log, or one whose clearance is inadequate (see images below), can suffer extreme**

wear, the result of which is a 'bronze slurry', like that shown here.
