# Conventional Wisdom for Conventional Stuffing Boxes

Text and photos by Steve D'Antonio

## **Conventional Wisdom for Conventional Stuffing Boxes**

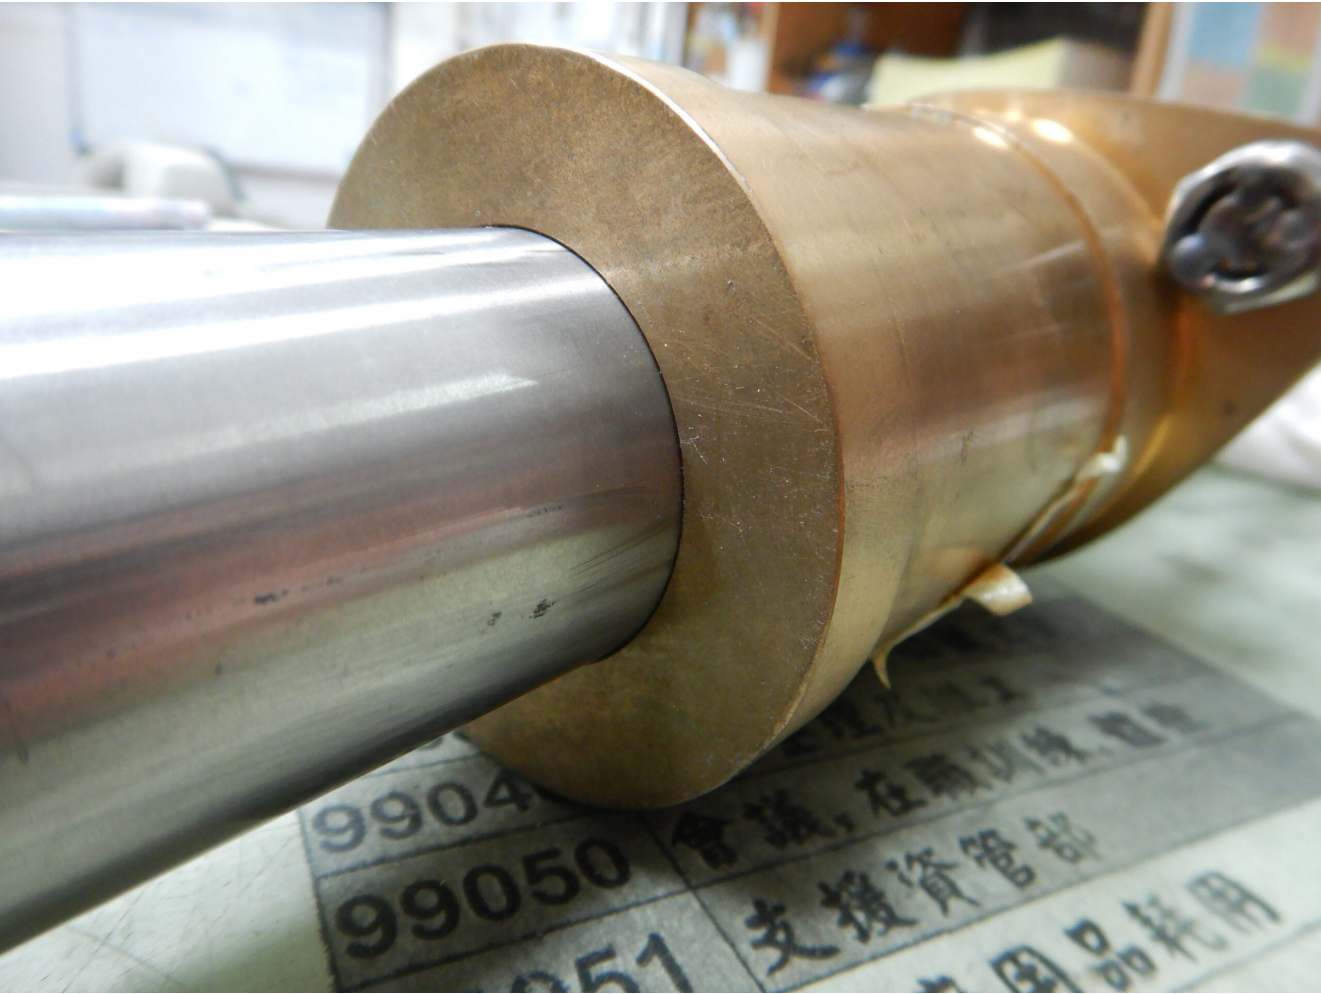
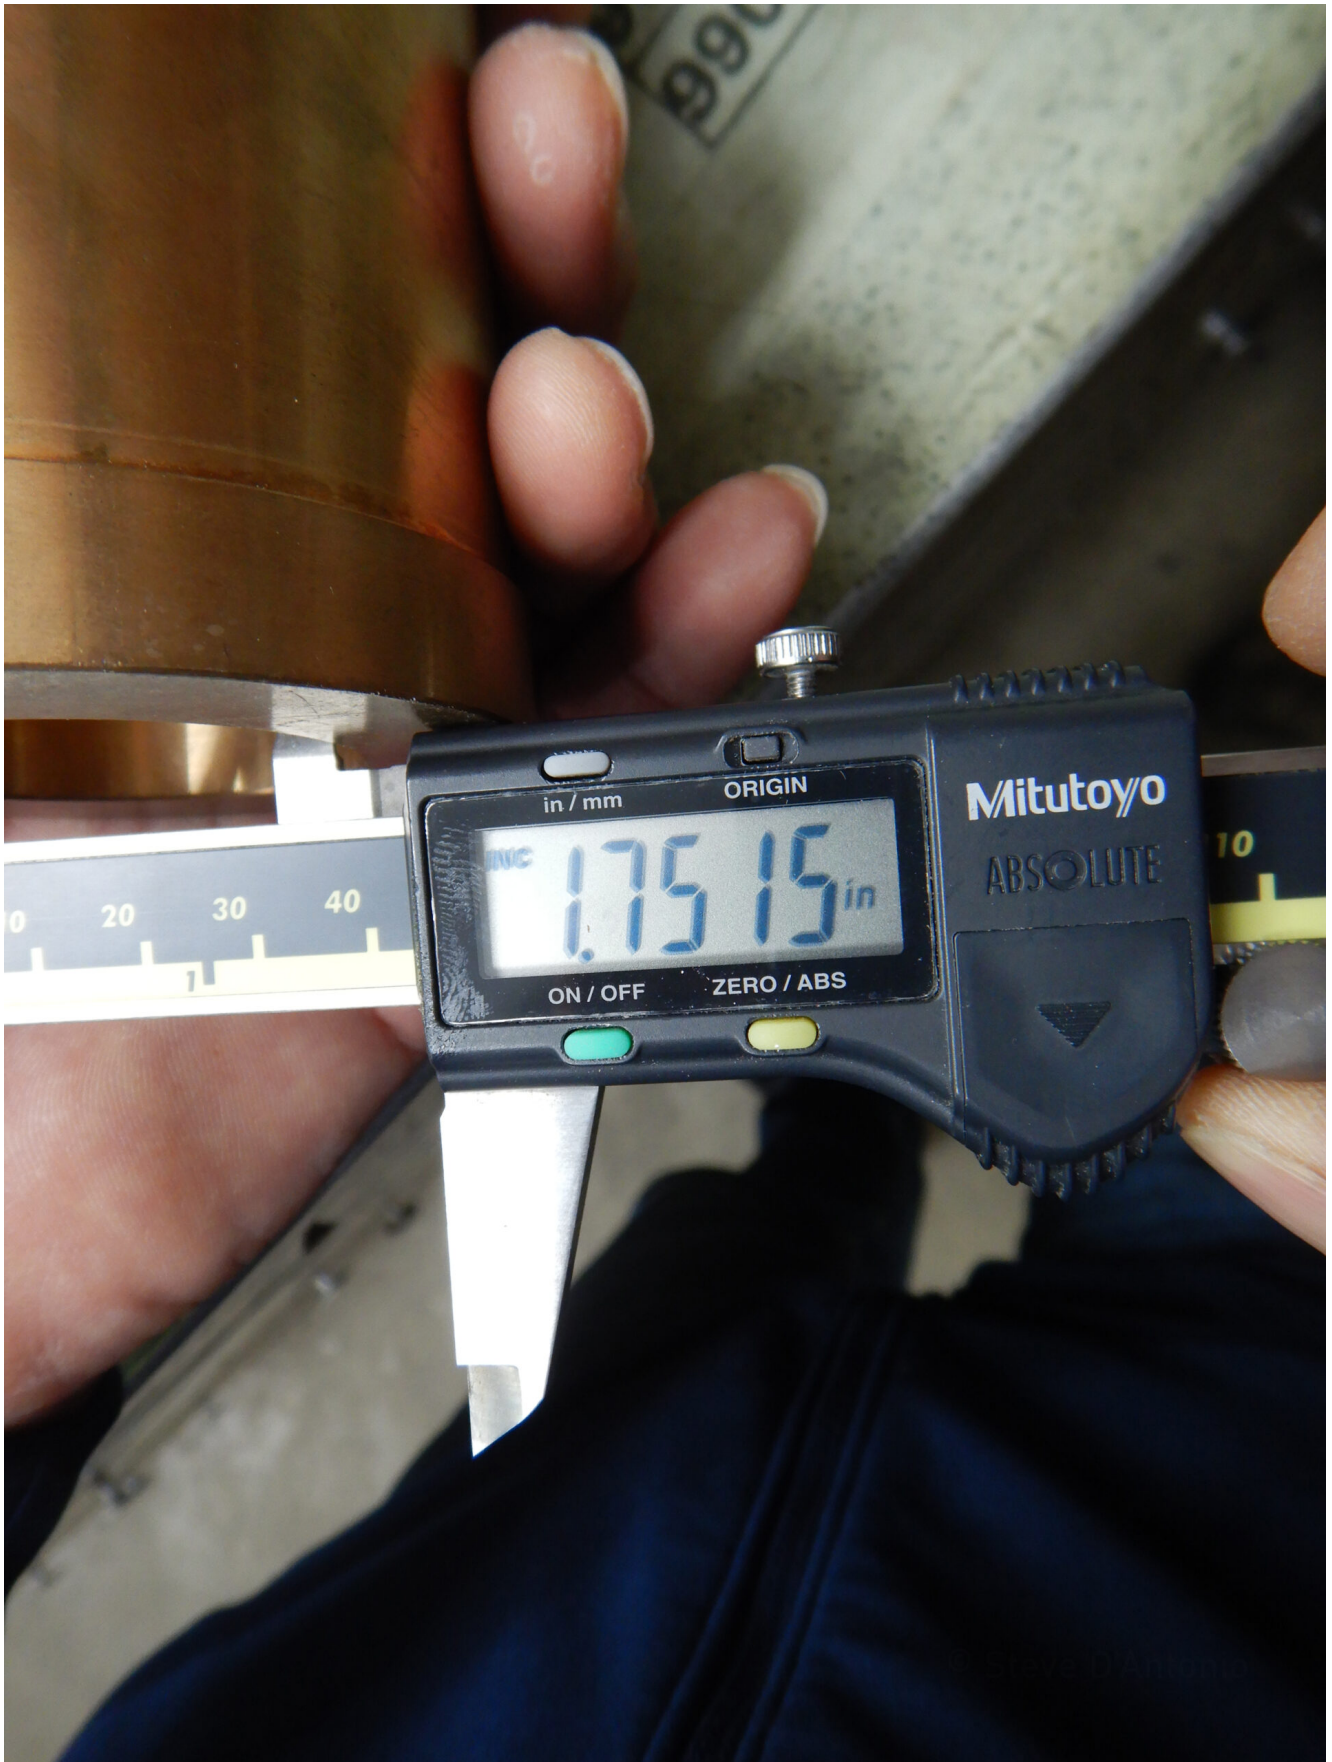
**Clearance between the outside diameter of the shaft and the inside diameter of the stuffing box is critical, too much and packing will be pushed into the gap, limiting its**

**effectiveness, too little and water flow is impeded, which can lead to overheating. One rule of thumb calls for 0.005" clearance, plus an additional 0.005" for every inch of shaft diameter. Thus, a 3" diameter shaft would have 0.020" of clearance.**

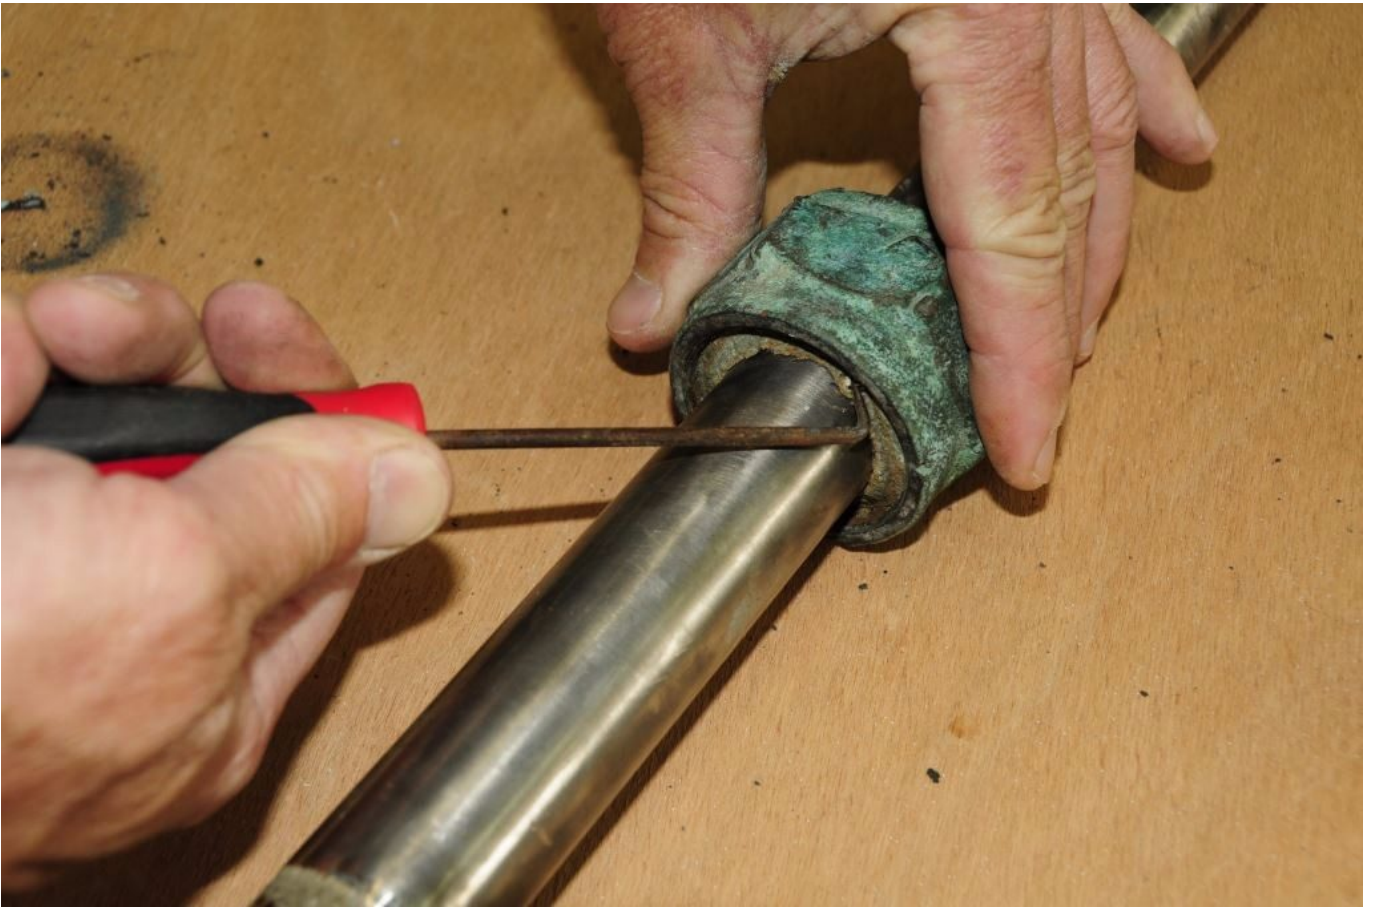
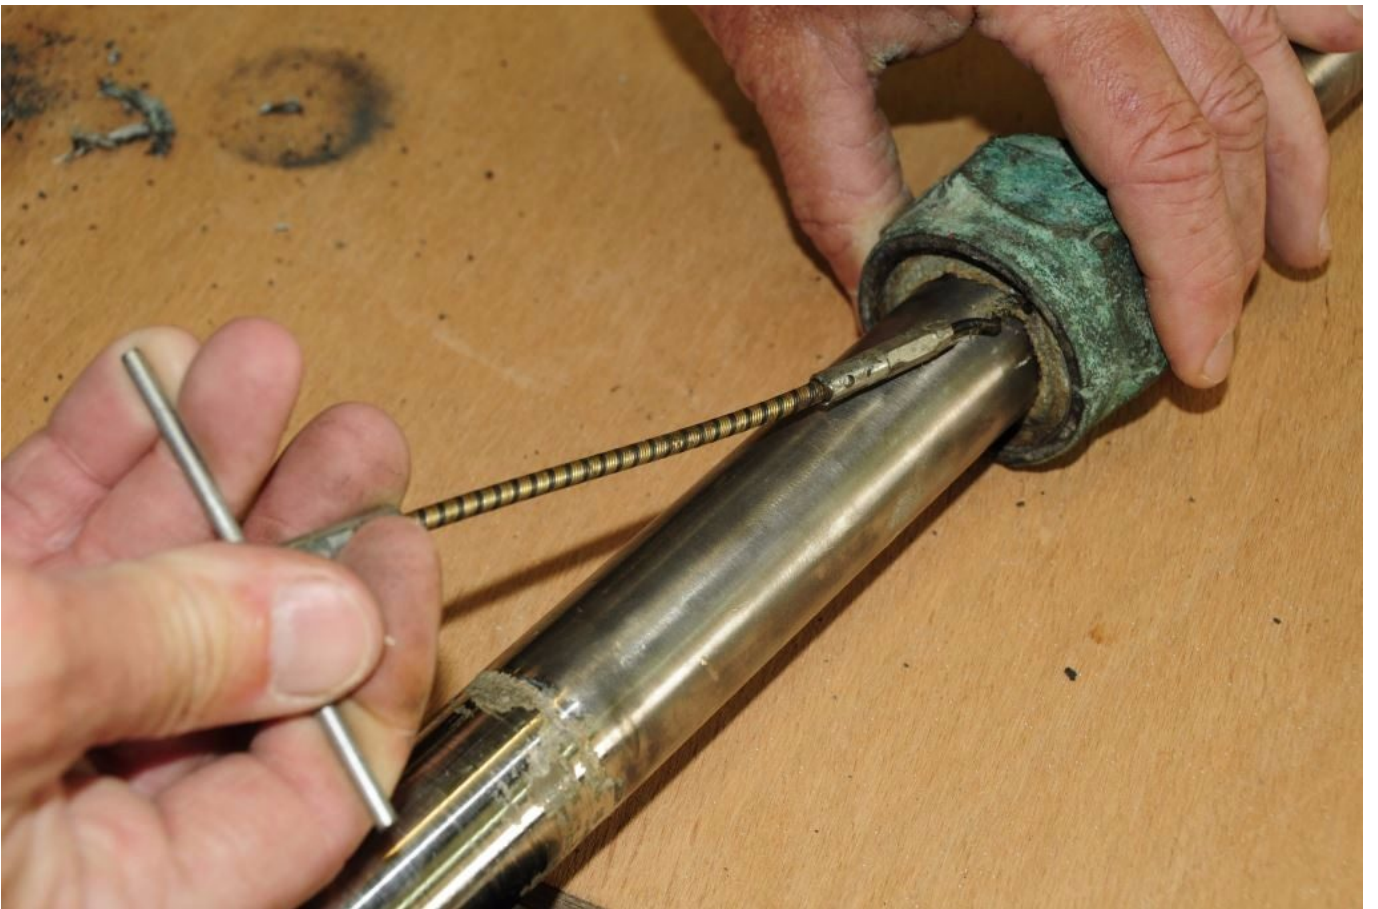
Depending on access, and stuffing box design, removal of the

**old packing can be challenging. Here a cork-screw like packing removal tool(above), as well as a pick (top), are being used.**

Begin by loosening the locking nut(s) and back off the packing carrier nut or tie rod ram. Remove all of the old packing. You can use a pick or a proprietary packing removal tool; it looks a bit like a flexible corkscrew. It's important that all old packing and debris be removed, if you have access to compressed then use it to blow this area out (wear safety glasses). If green and crusty, the threads on the stuffing box body should be cleaned with a non-metallic bristle brush or 3M ScotchBrite pad, and penetrating oil, and then *lightly* lubricated with oil. If they are tie rods and of the stainless steel variety and are discolored or lightly corroded, they too should be cleaned in the same manner; if heavily corroded they should be replaced.

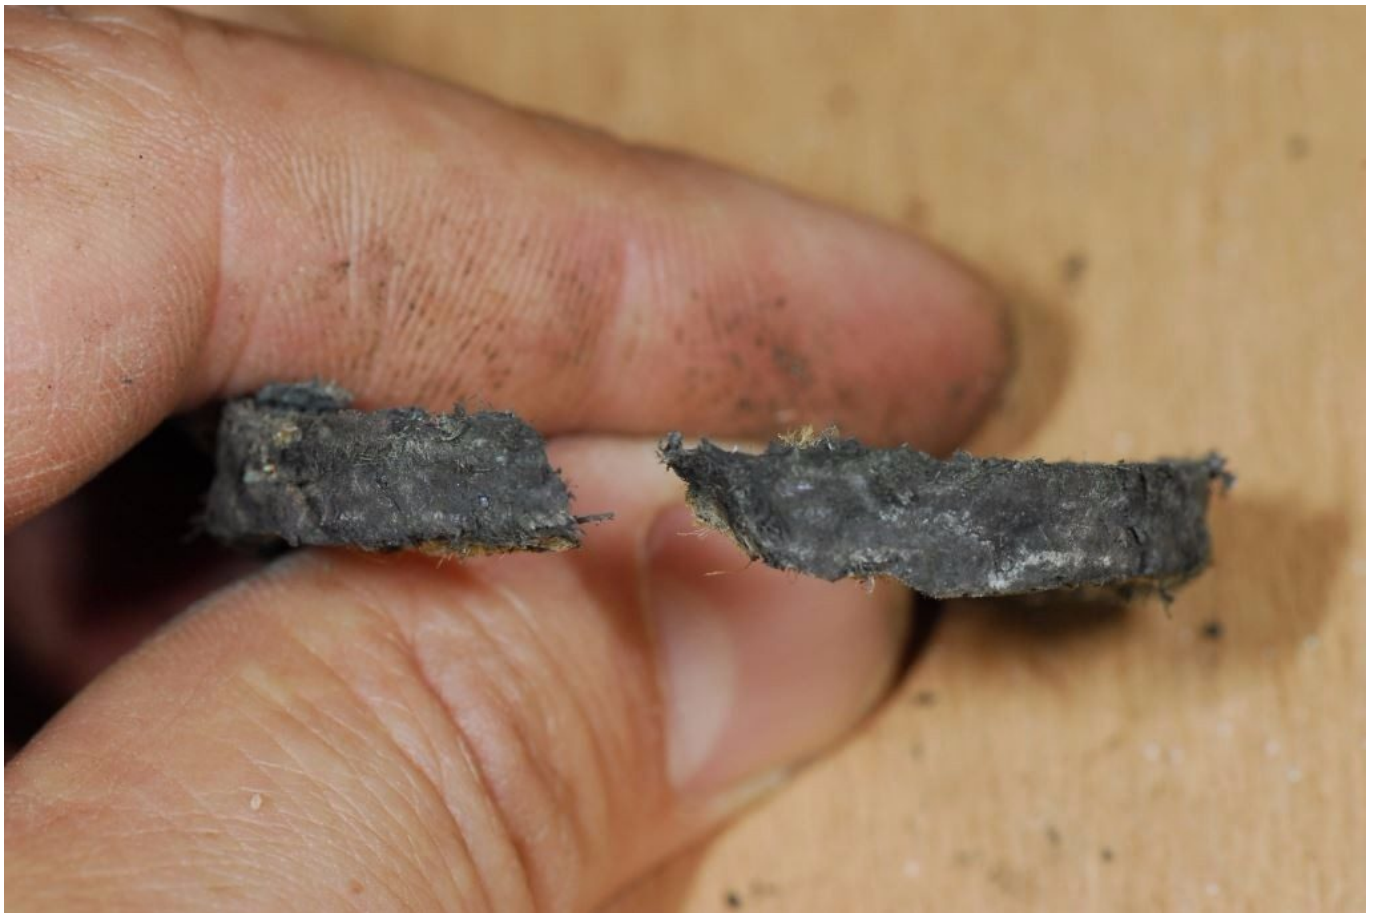
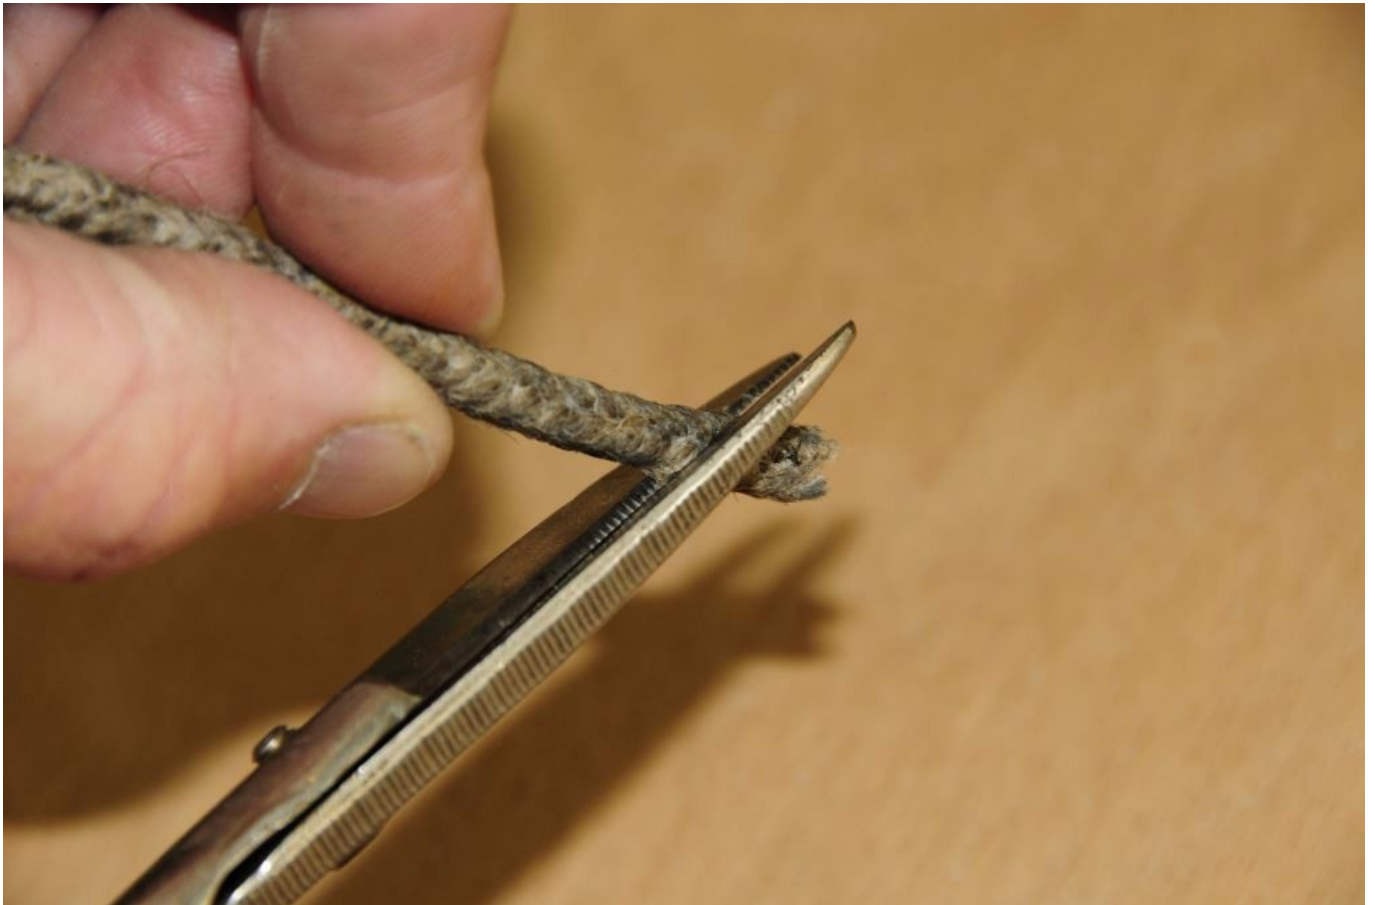
**Packing should be cut at a 45° angle to provide a leak-resistant lap joint.**

Unless instructed otherwise by the stuffing box manufacturer, *three* new rings of packing material should be cut, their inside diameter matching exactly the outside diameter of the shaft; the ends of each piece of packing should be cut on a forty-five degree angle so they mate in an overlapping fashion. I find it helpful to apply a coating of high viscosity grease (I prefer Lubrimatic's green Trailer Wheel Bearing Grease) to the packing sections as I install them, this acts as a lubricant and it helps keep the sections in place as they are inserted into the stuffing box recess or nut carrier. These joints should be spaced 120° apart, or at the 12, 4 and 8 o'clock position.

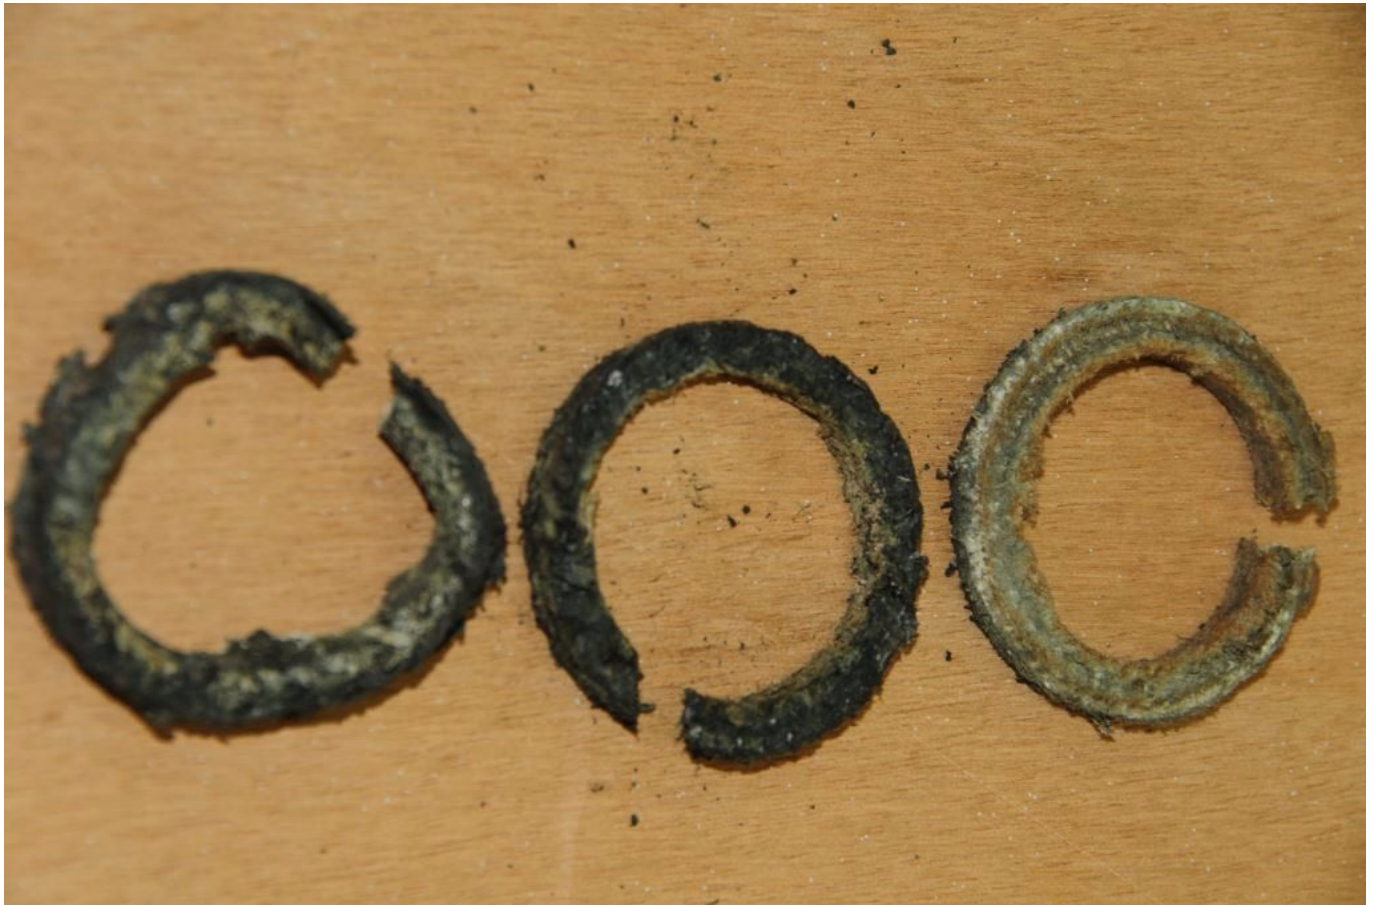
**Most stuffing boxes are designed to accept three rings of packing. The joints should be oriented 120° apart from each other.**

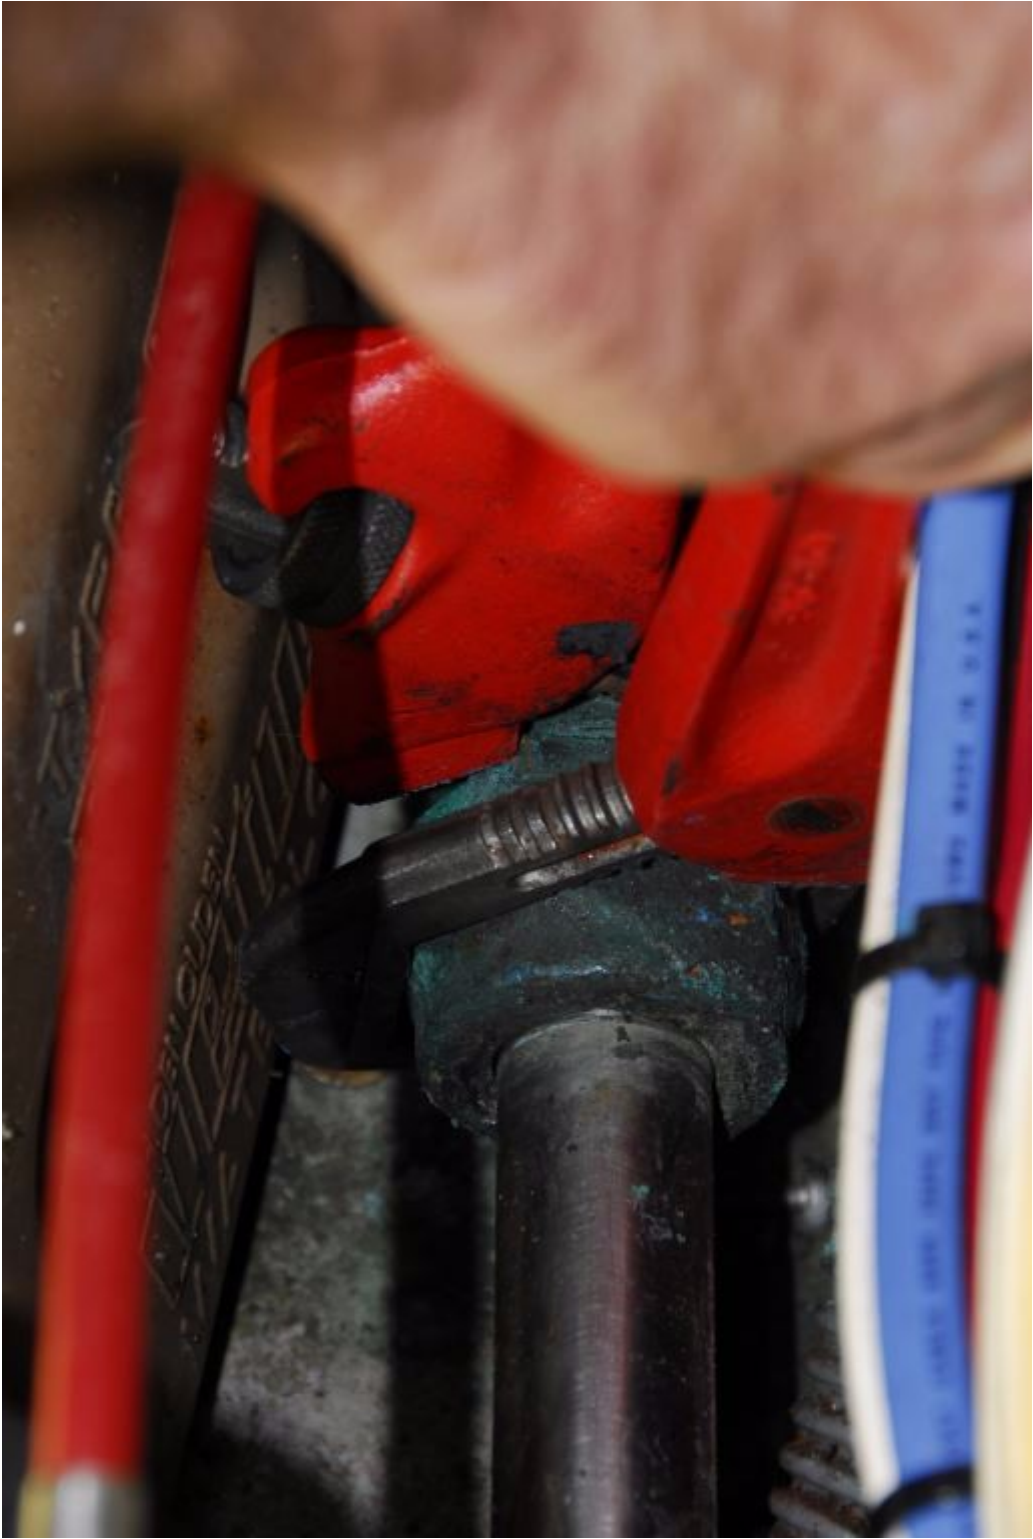
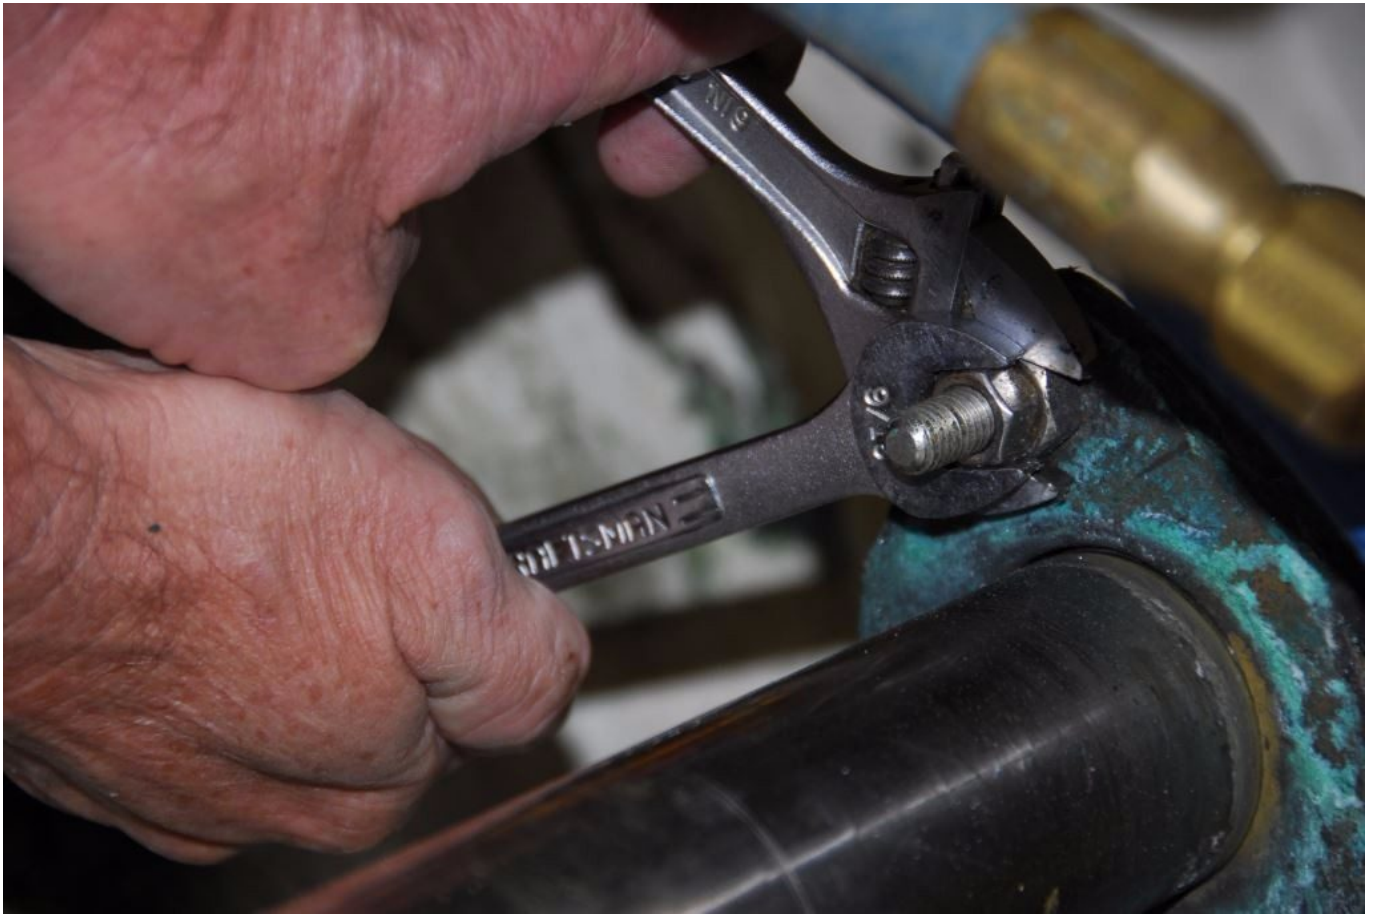
**Two wrenches must be used when tightening packing lock nuts, to ensure adequate tension is developed between the two nuts.**

The packing nut should be made snug, not much more than hand tight initially. How tight is a subjective measure, however, it doesn't matter because it will likely be adjusted once the vessel is launched and the engine run. Initially, it is far better for it to be too loose than too tight. It's critically important that the locking nut(s) be tightened against the packing nut using *two* wrenches, i.e. they need to be tightened to create tension against each other. Tightening one, and then the other, using one wrench, is inadequate and may lead to a loosening and flooding.

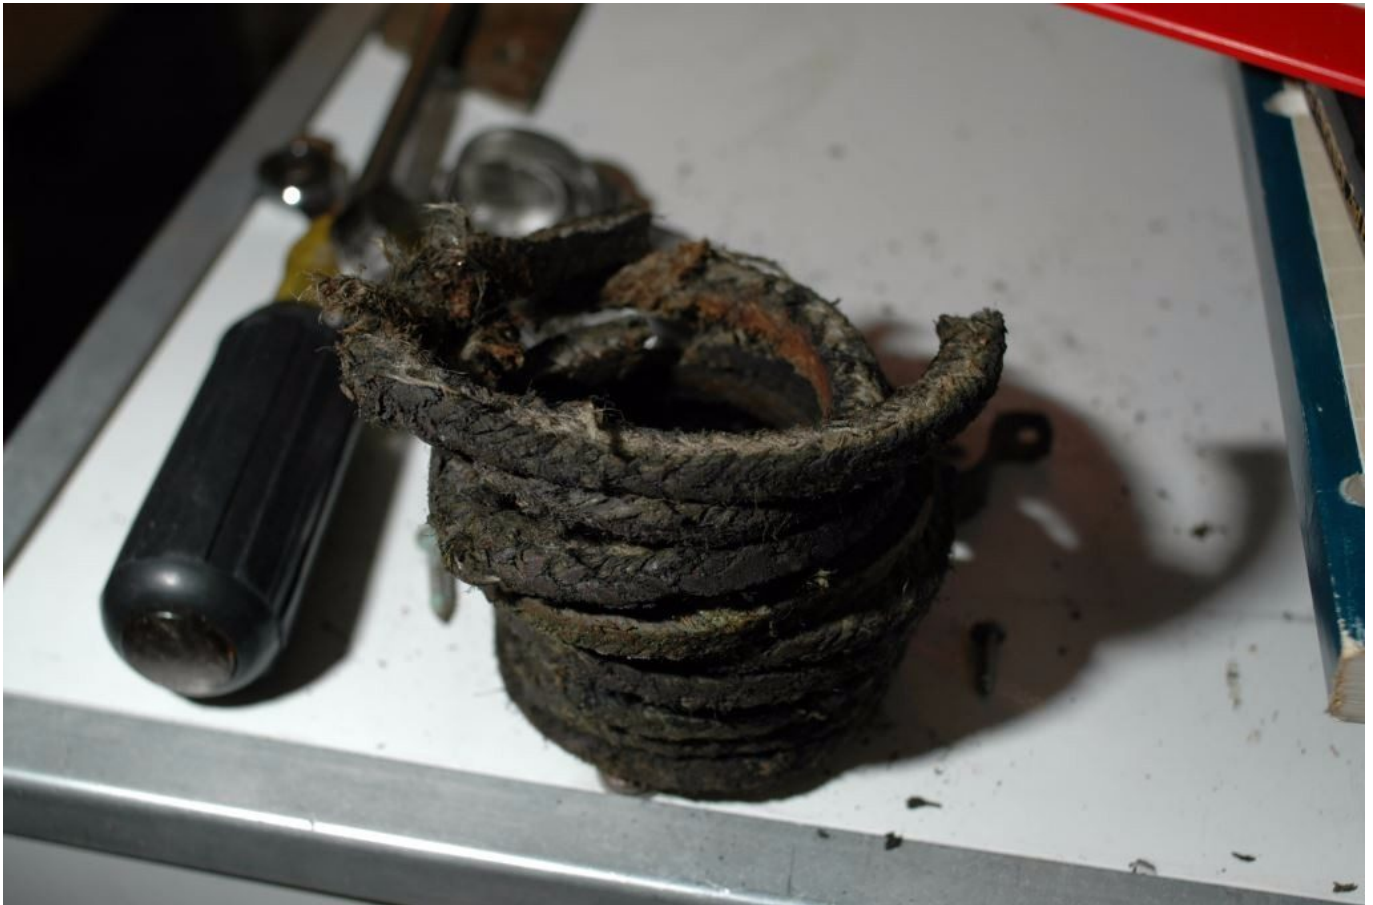
**Too much of a good thing; if three wraps don't stem the flow, another problem is almost certainly present. The stuffing box from which this packing came was clearly over-stuffed.**
