Conventional Wisdom for Conventional Stuffing Boxes

Text and photos by Steve D'Antonio

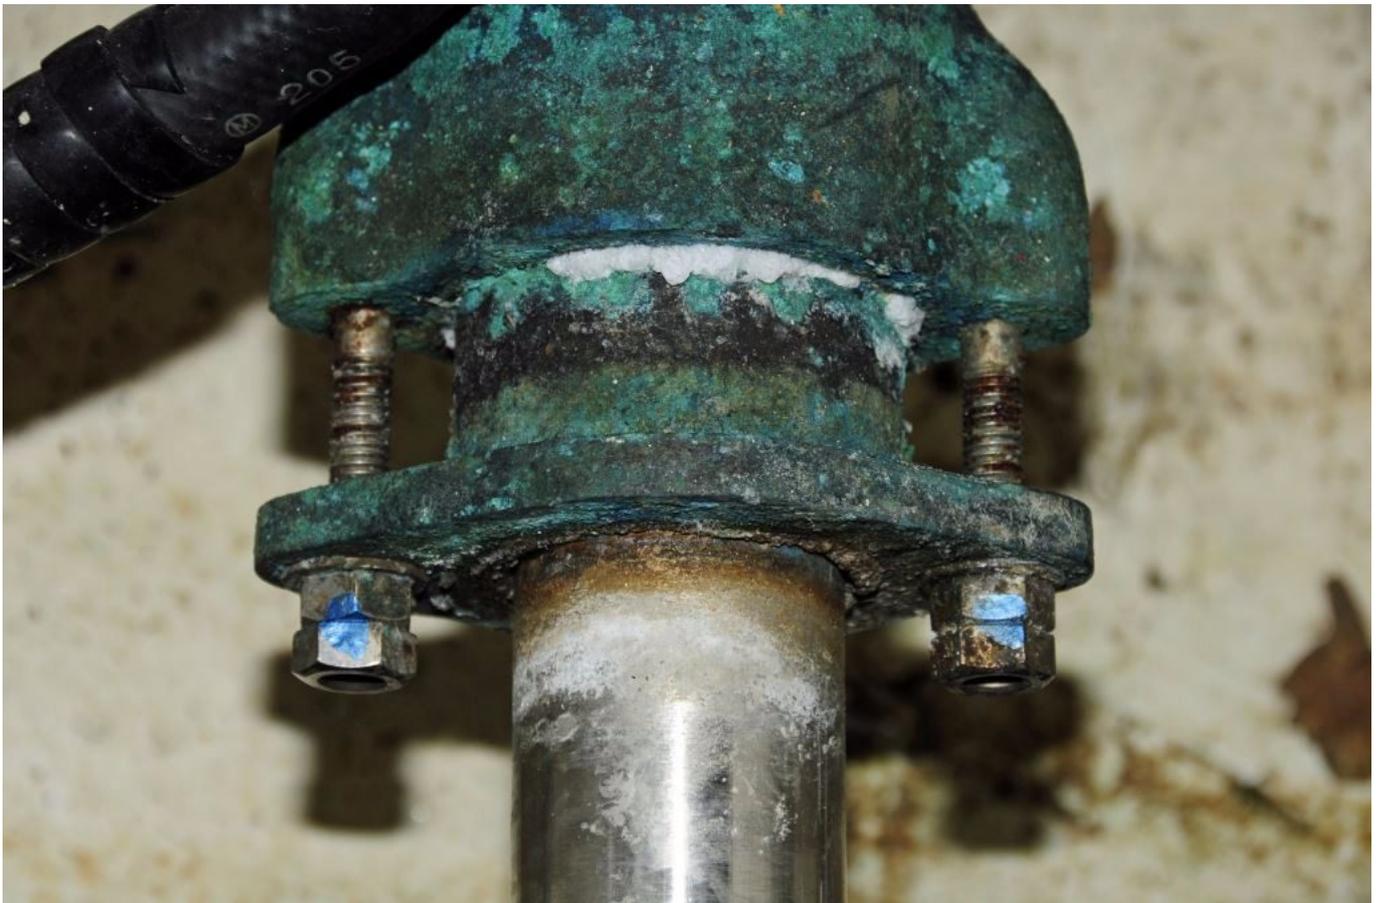
The stainless steel studs used on some stuffing boxes can suffer from corrosion. In many case these can be cleaned, and the studs corrosion inhibited; if extreme, however, these should be replaced. Bronze studs, on the other hand, are virtually immune to this phenomenon.

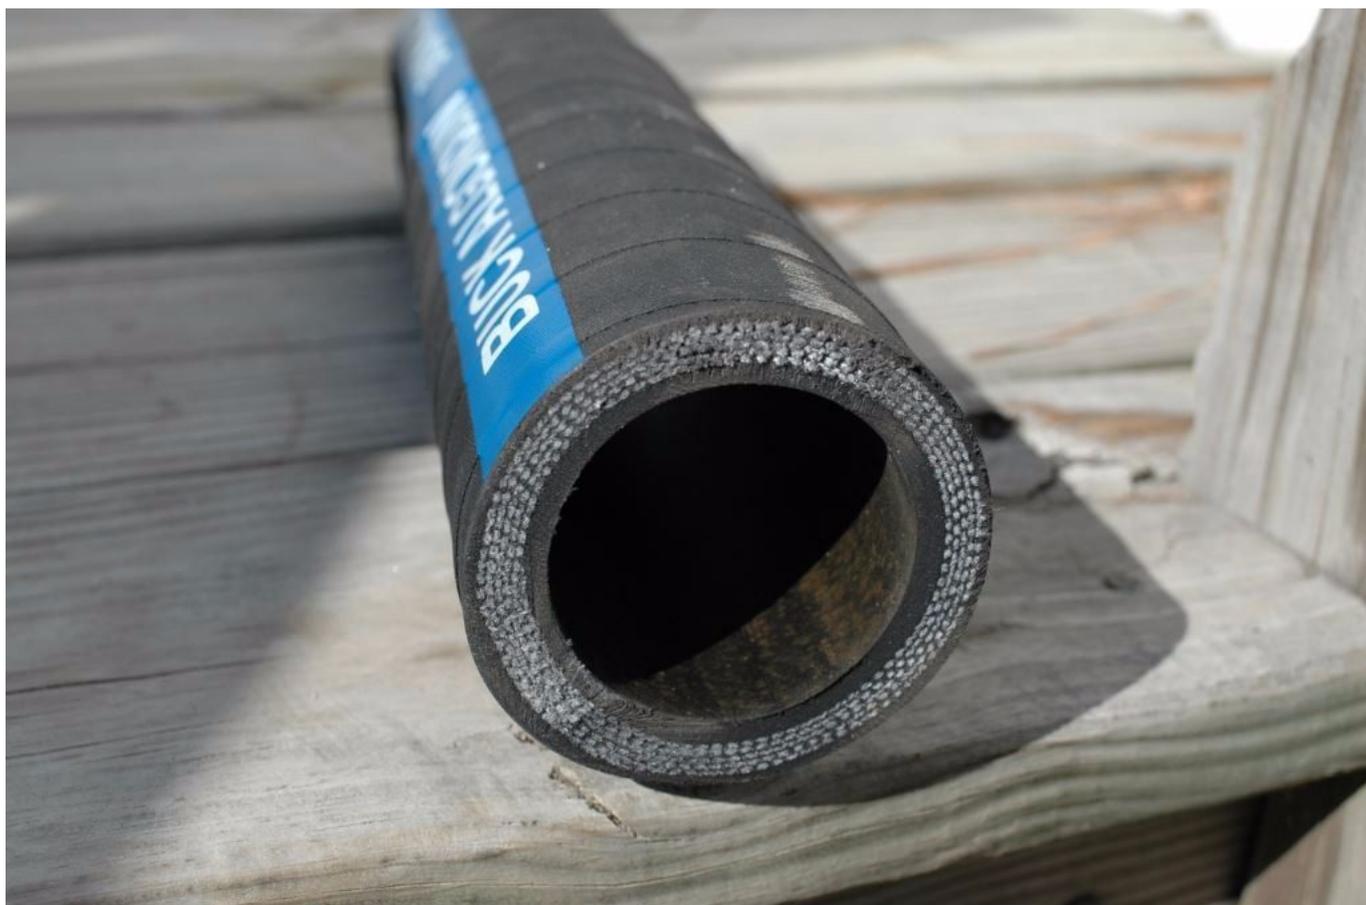
With additional plies, seen here, when compared to ordinary raw water hoses, proprietary stuffing box hose is especially rugged and twist resistant.

While it may look ordinary, the hose used with conventional stuffing boxes is, or should be, proprietary. Ordinary raw water or exhaust hose may utilize two or three plies, while proprietary stuffing box hose incorporates five plies. Because hose used in stuffing box applications lives an especially hard life, it's submerged, vibrated and routinely twisted in forward and reverse, the added heft of five plies is a clear value added, and equates to longer life. Replacement of the stuffing box hose is invariably time consuming in that it requires separation of the propeller shaft from the transmission coupling. It is also, therefore, a task that must be carried out while the vessel is hauled. Conventional, conservative wisdom dictates that stuffing box hoses should be preemptively replaced approximately every five to seven years or when warranted by visible hose deterioration. One critical issue involves hose length, or more importantly, the length of "free hose" between the stuffing box pipe to hose adapter and the shaft log. This free hose length must be long enough to allow the hose to float freely on the shaft, avoiding side-loading, binding, and the overheating it can cause.

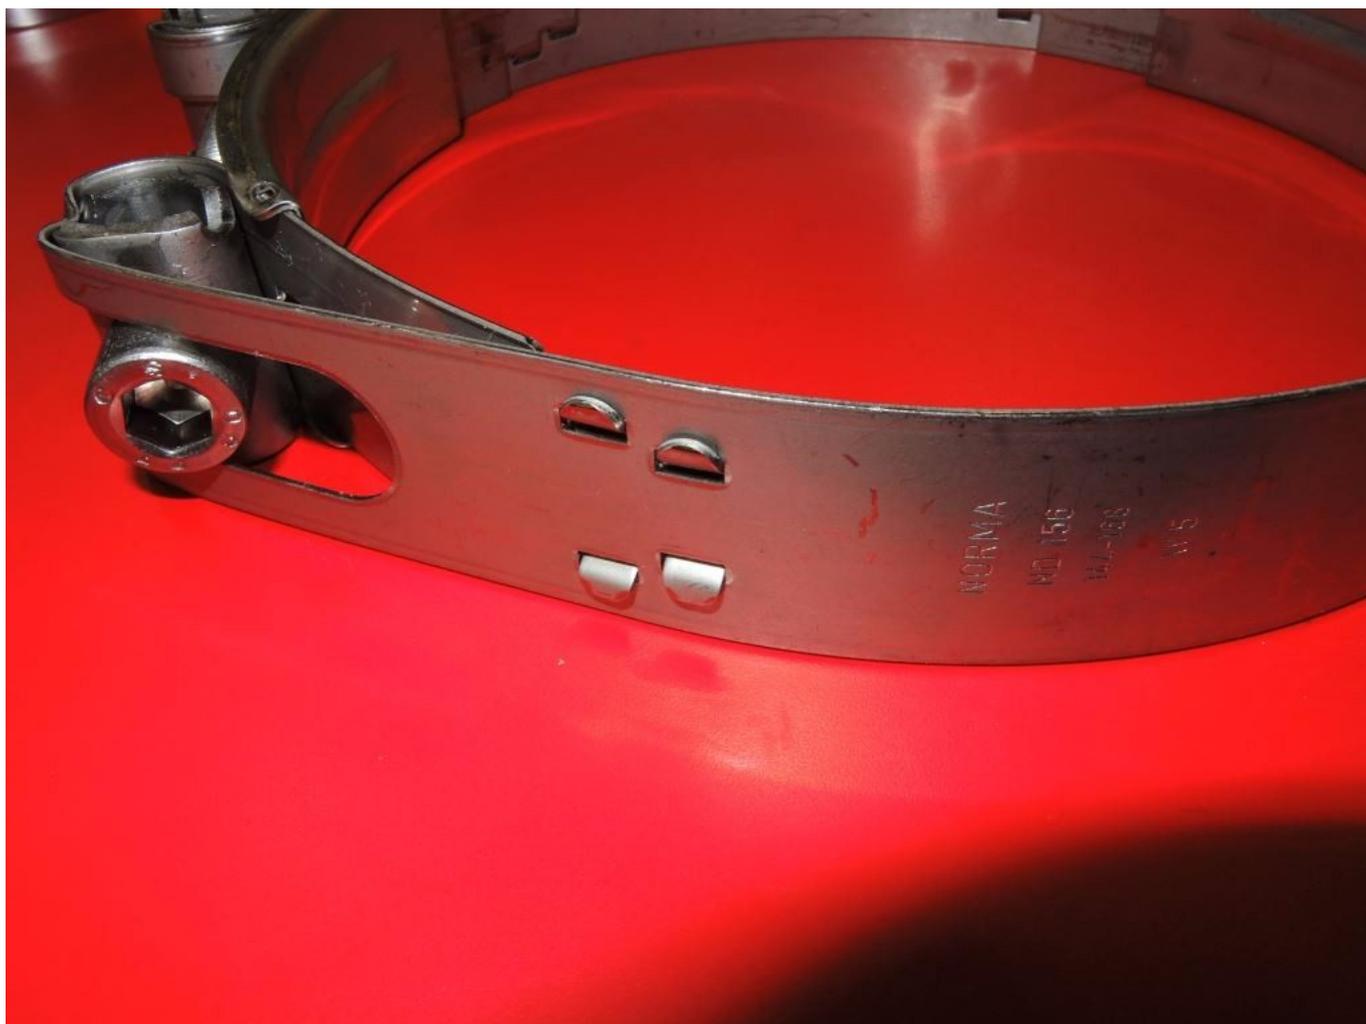
Because of their resistance to corrosion, interlocking, as opposed to spot welded, hose clamps are ideally suited for conventional stuffing box use.

Replacing clamps is straightforward and relatively easy. Replacements should be made from all 316 alloy stainless steel, including the screw, and their bands should be solid rather than perforated (for more on hose clamp selection and

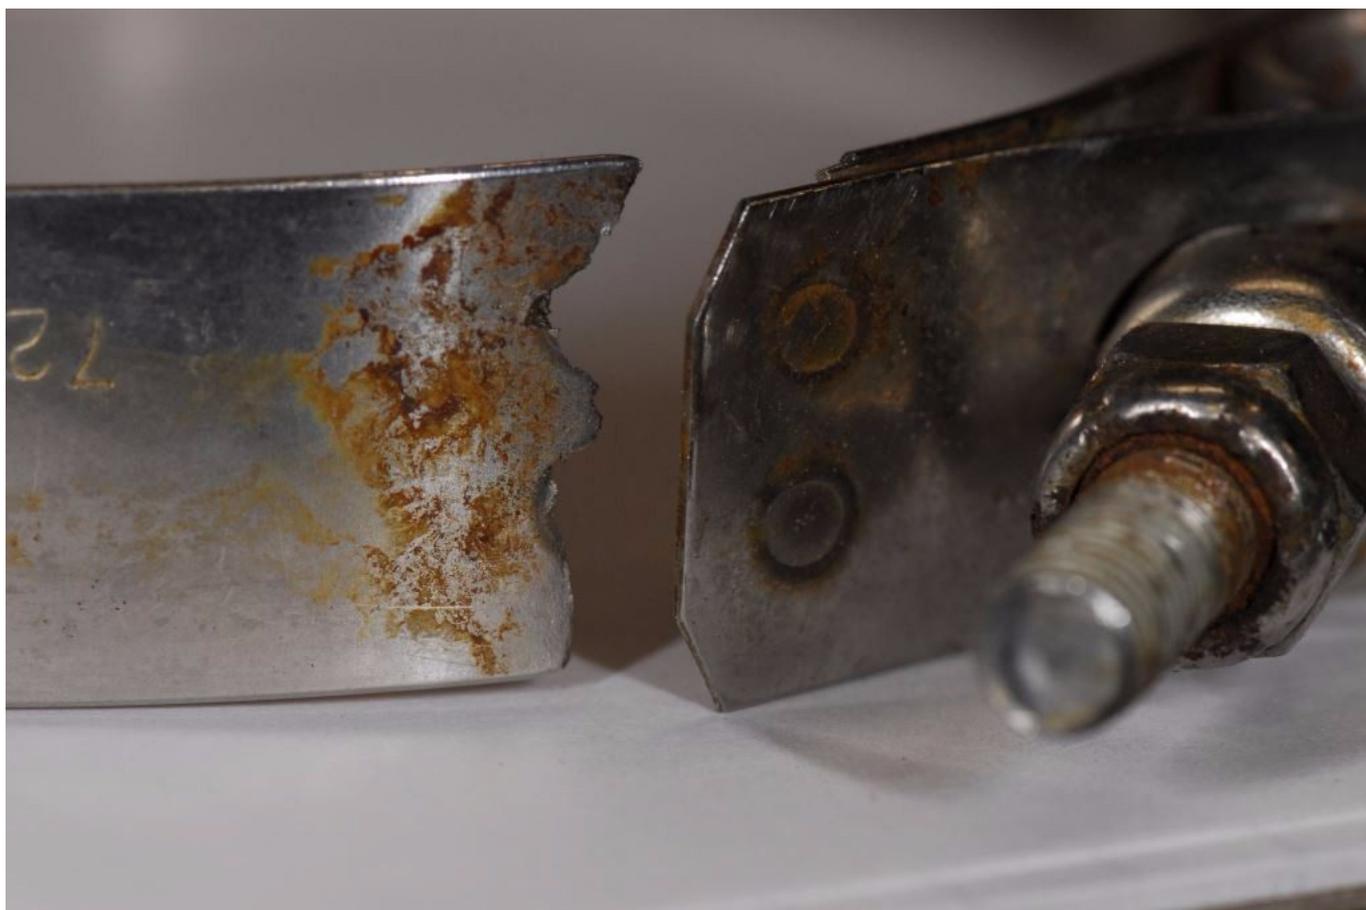
Folded, spot welded T bolt clamps are prone to crevice corrosion. The one shown here, used on a stuffing box, has parted; the fold was oriented along the bottom of the stuffing box hose.

Instead, use clamps that are mechanically interlocked rather than folded and welded. If the spot welded variety is used, ensure the fold is oriented at the top or 12:00 o'clock position on the hose, to prevent it from being continuously exposed to leaking water. Contrary to popular belief, there is no need to alternate fastener position on hose clamps.

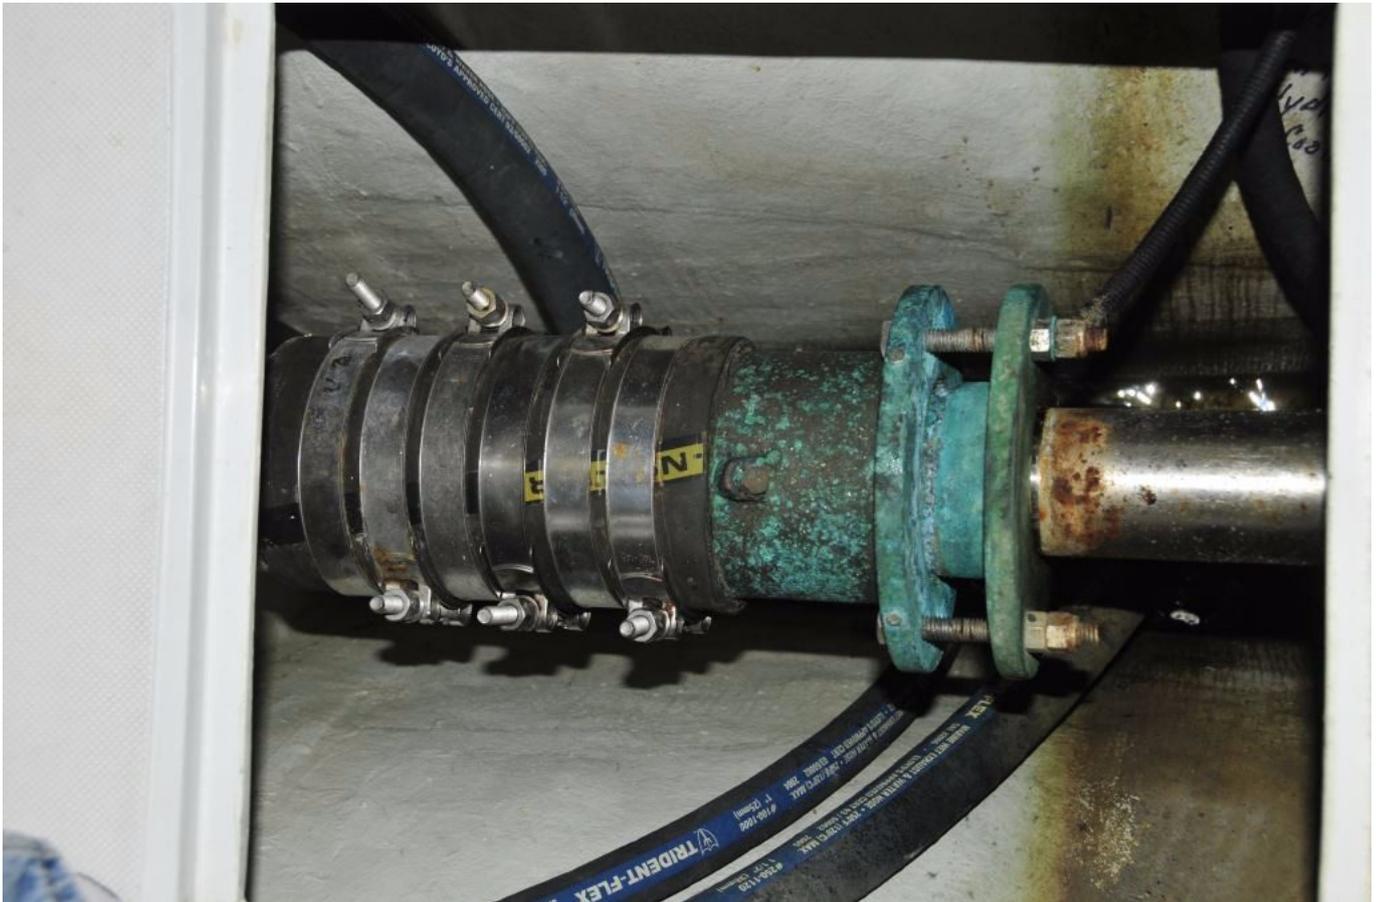
Perhaps this is a case of hose clamp overkill; the additional clamps are of no real value and could be detrimental if they aren't located over the stuffing box or shaft log. Stuffing boxes should be equipped with double, high quality hose clamps at each end. Furthermore, too many clamps, combined with a hose that is too short, could prevent the stuffing box from "floating" on the shaft, and self-aligning.

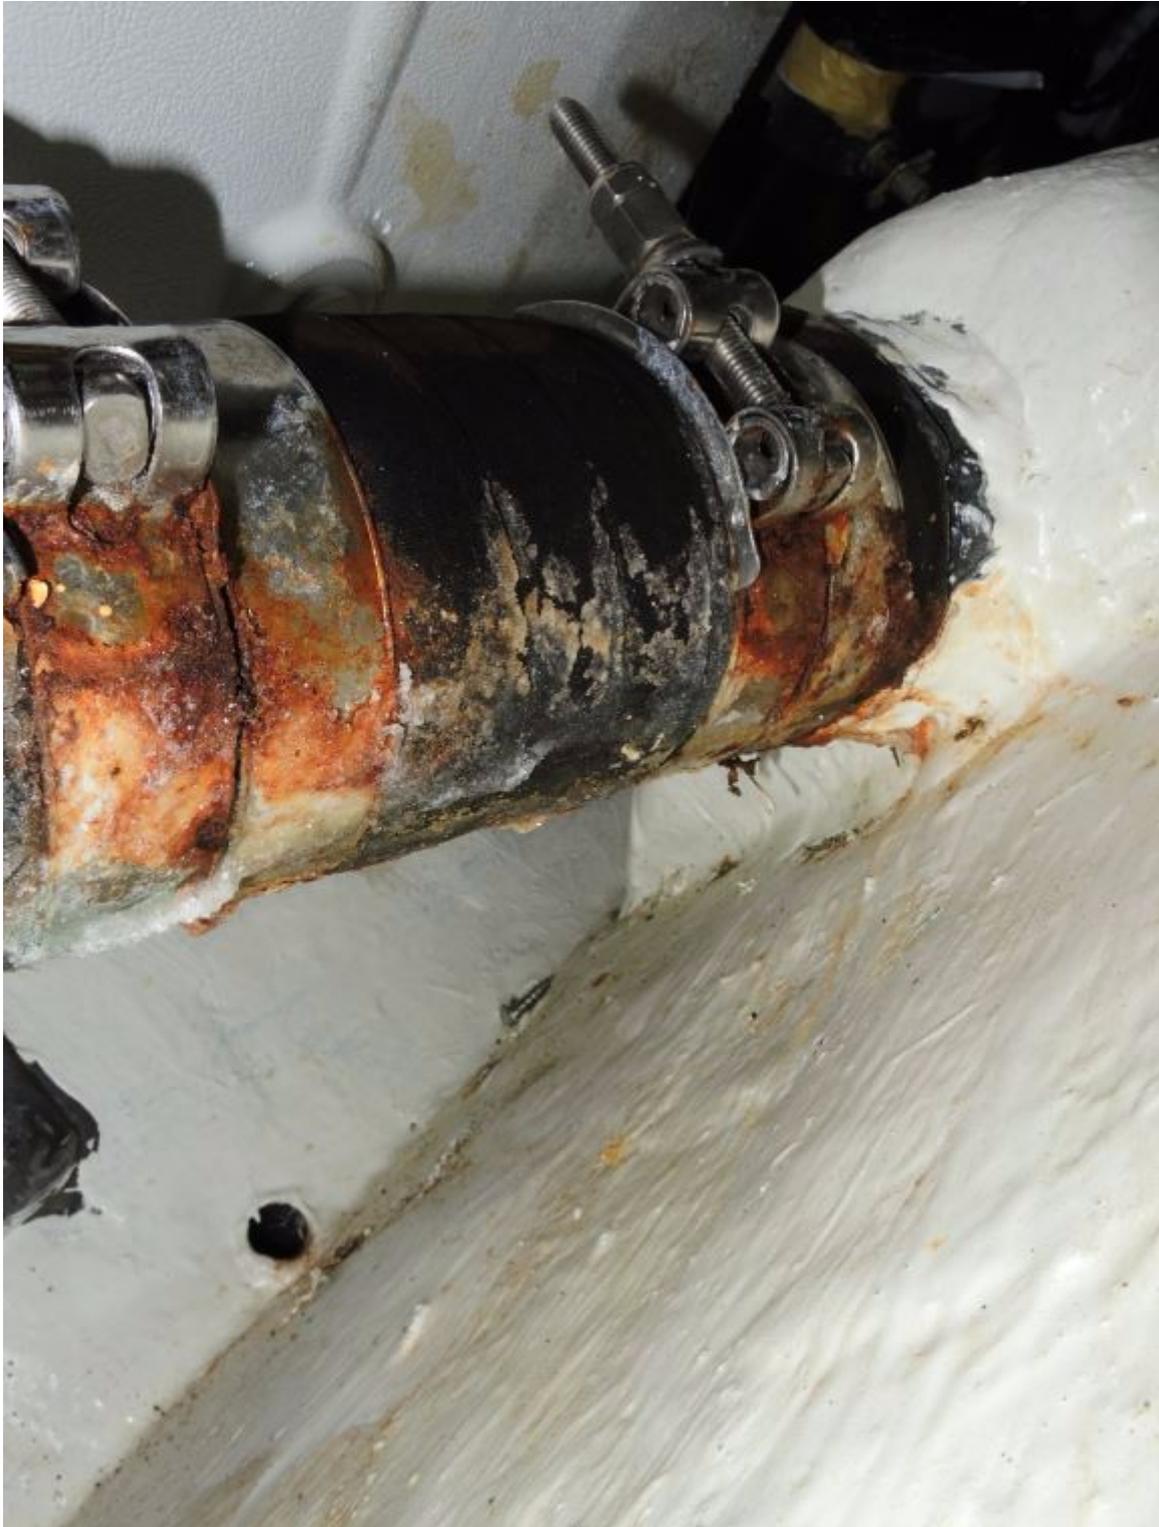
Chronically leaking stuffing boxes lead to more than just wet bilges. These clamps are seriously corroded as a result of

regular exposure to seawater.

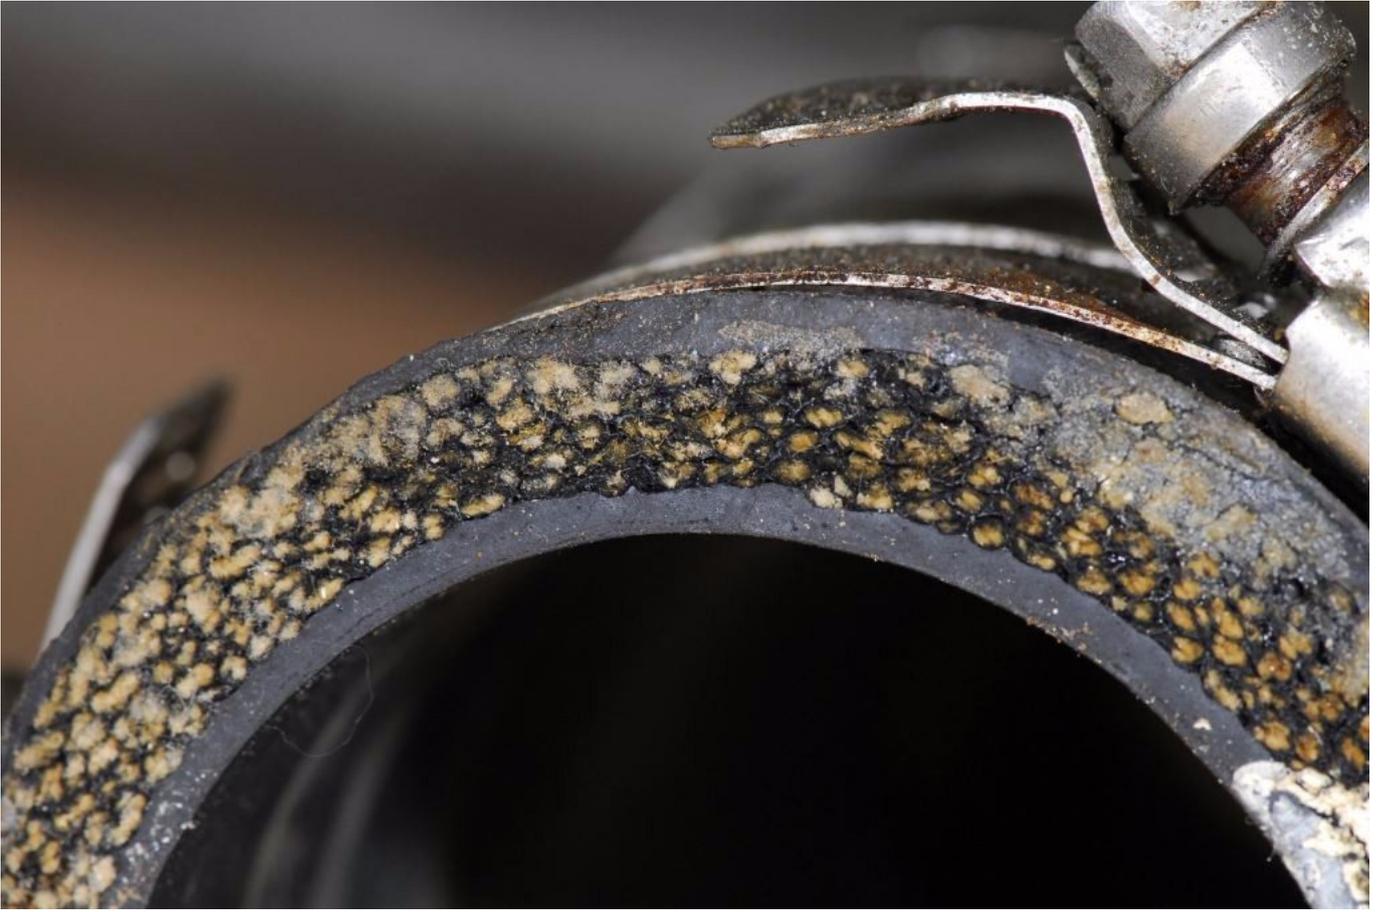
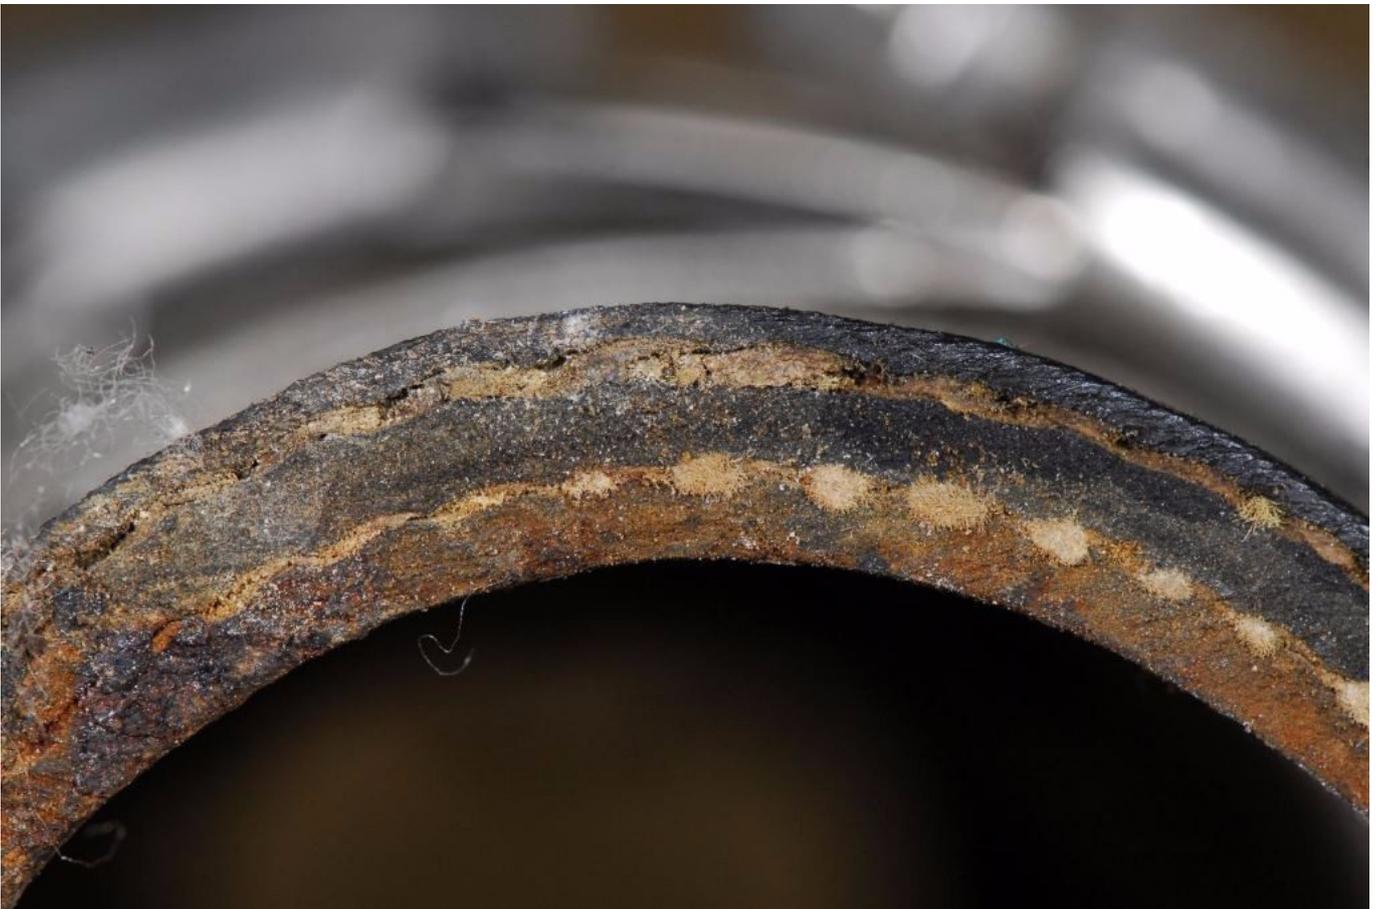
The five plies of a stuffing box hose (top) are clear to see,

compared to ordinary hose's three plies (above).

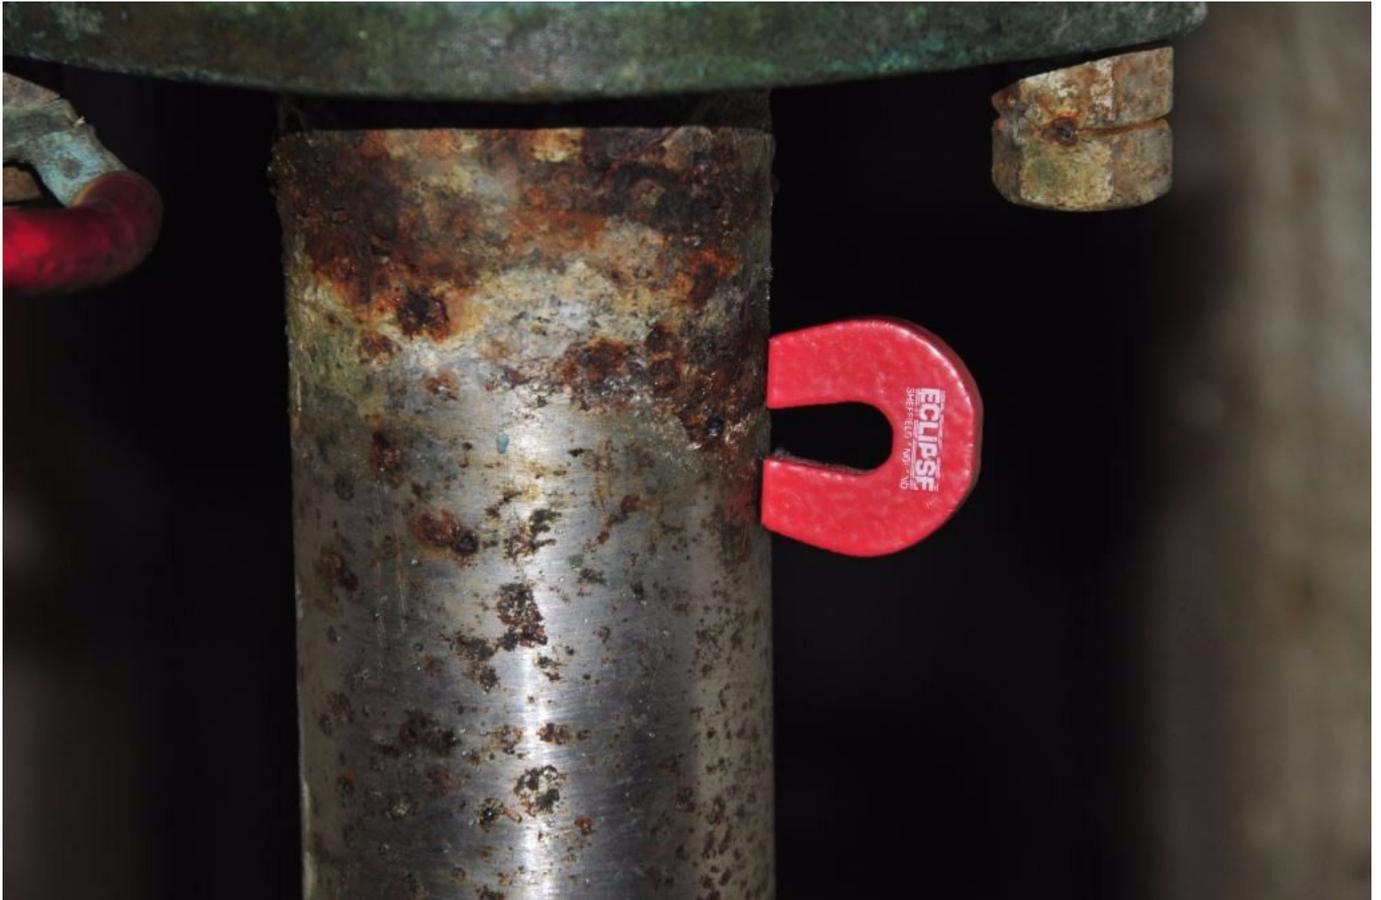
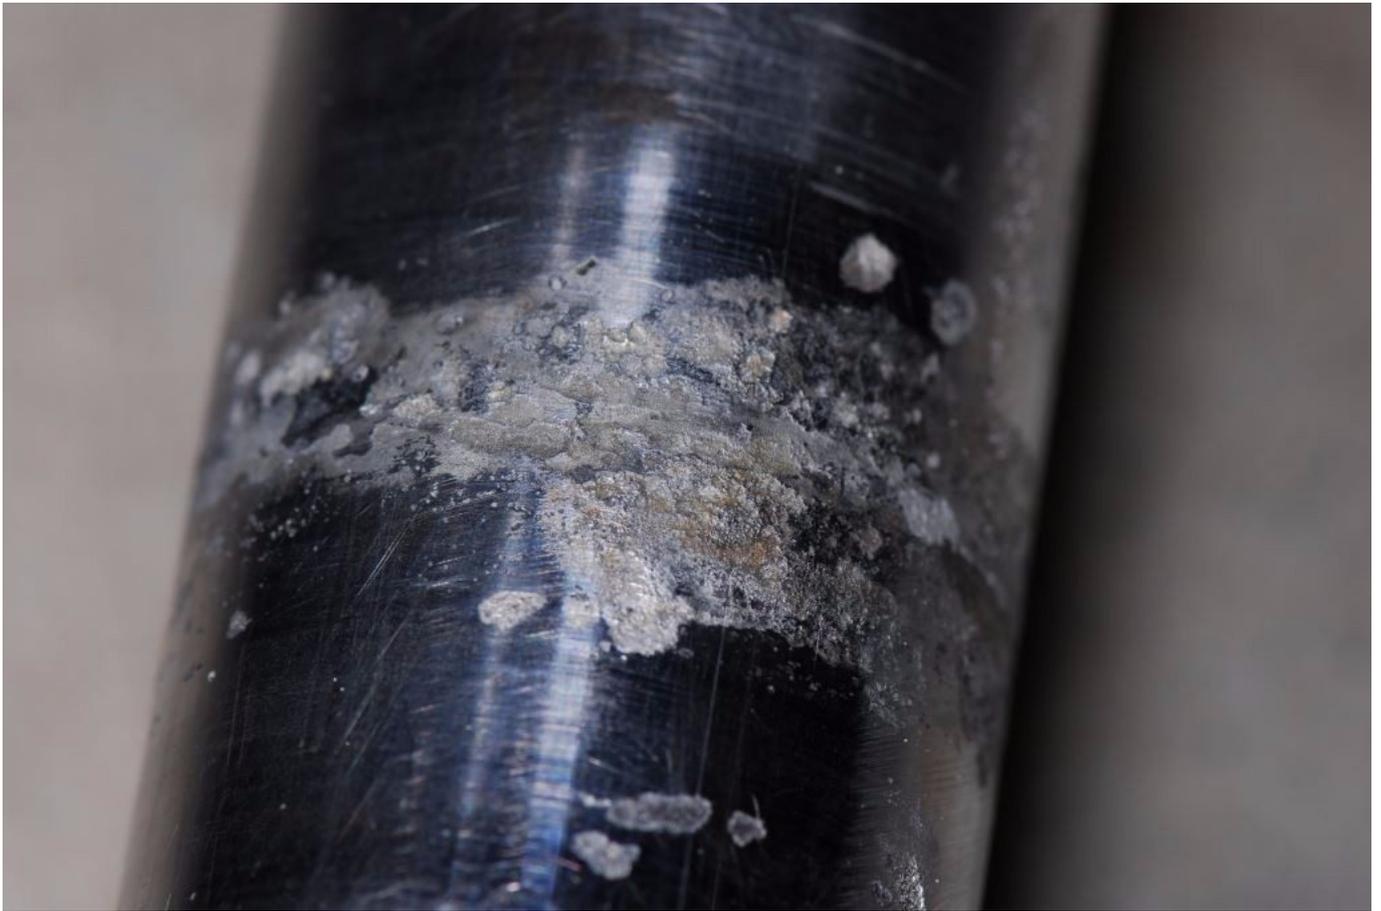
When stuffing boxes leak chronically, even after repacking, there's usually a reason. In many cases it's the result of a pitted shaft (above), which chews into the packing material with each revolution. With a few exceptions, when shafts are magnetic (top), they are also more prone to this sort of corrosion.

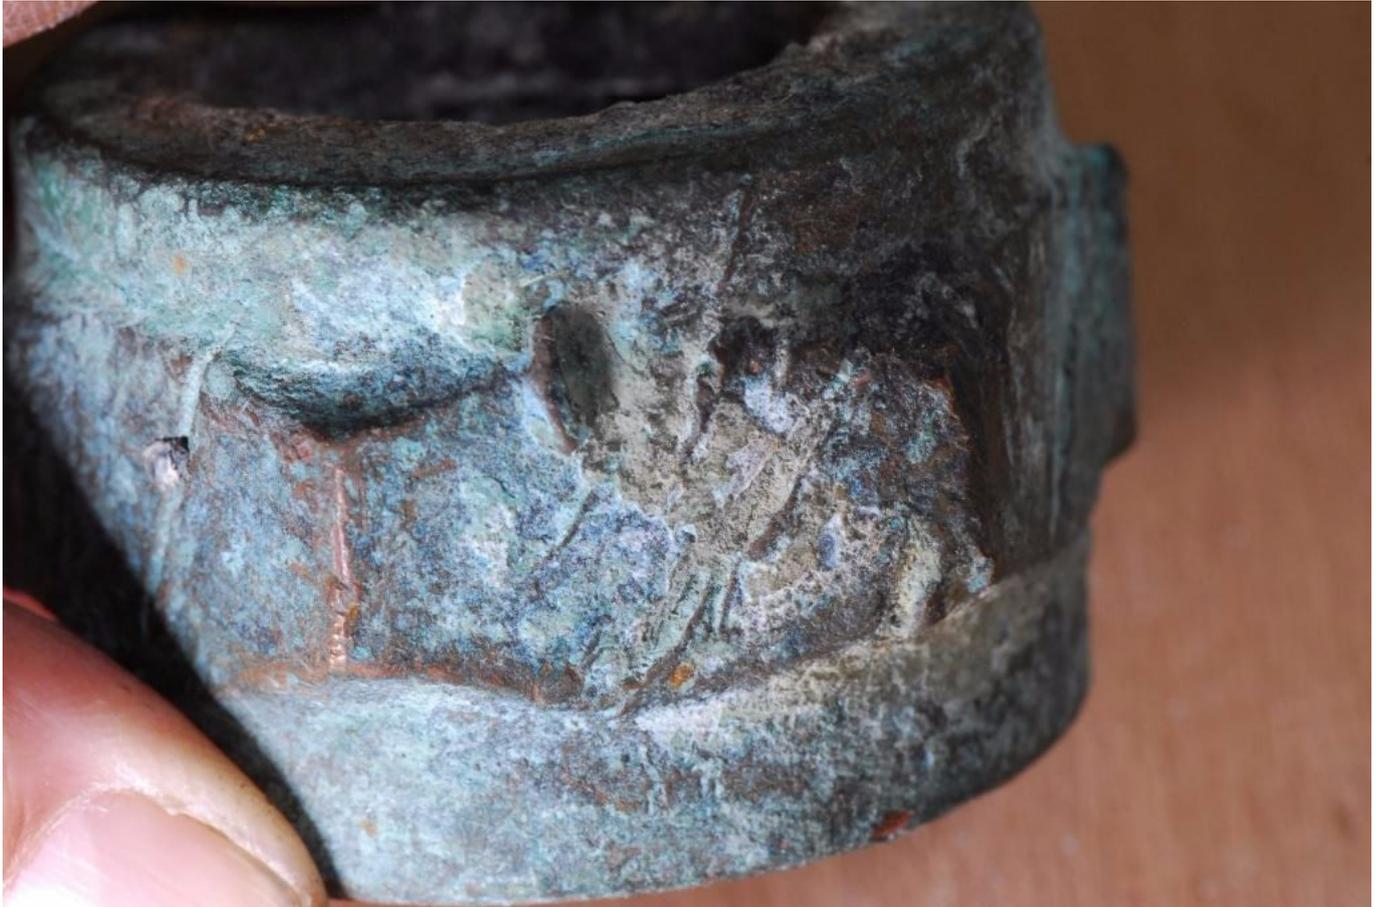
This packing nut has been loosened, and/or tightened using a chisel, damaging the nut's flats. This practice should be avoided, particularly when tightening. Proper, smooth jaw wrenches should always be used.

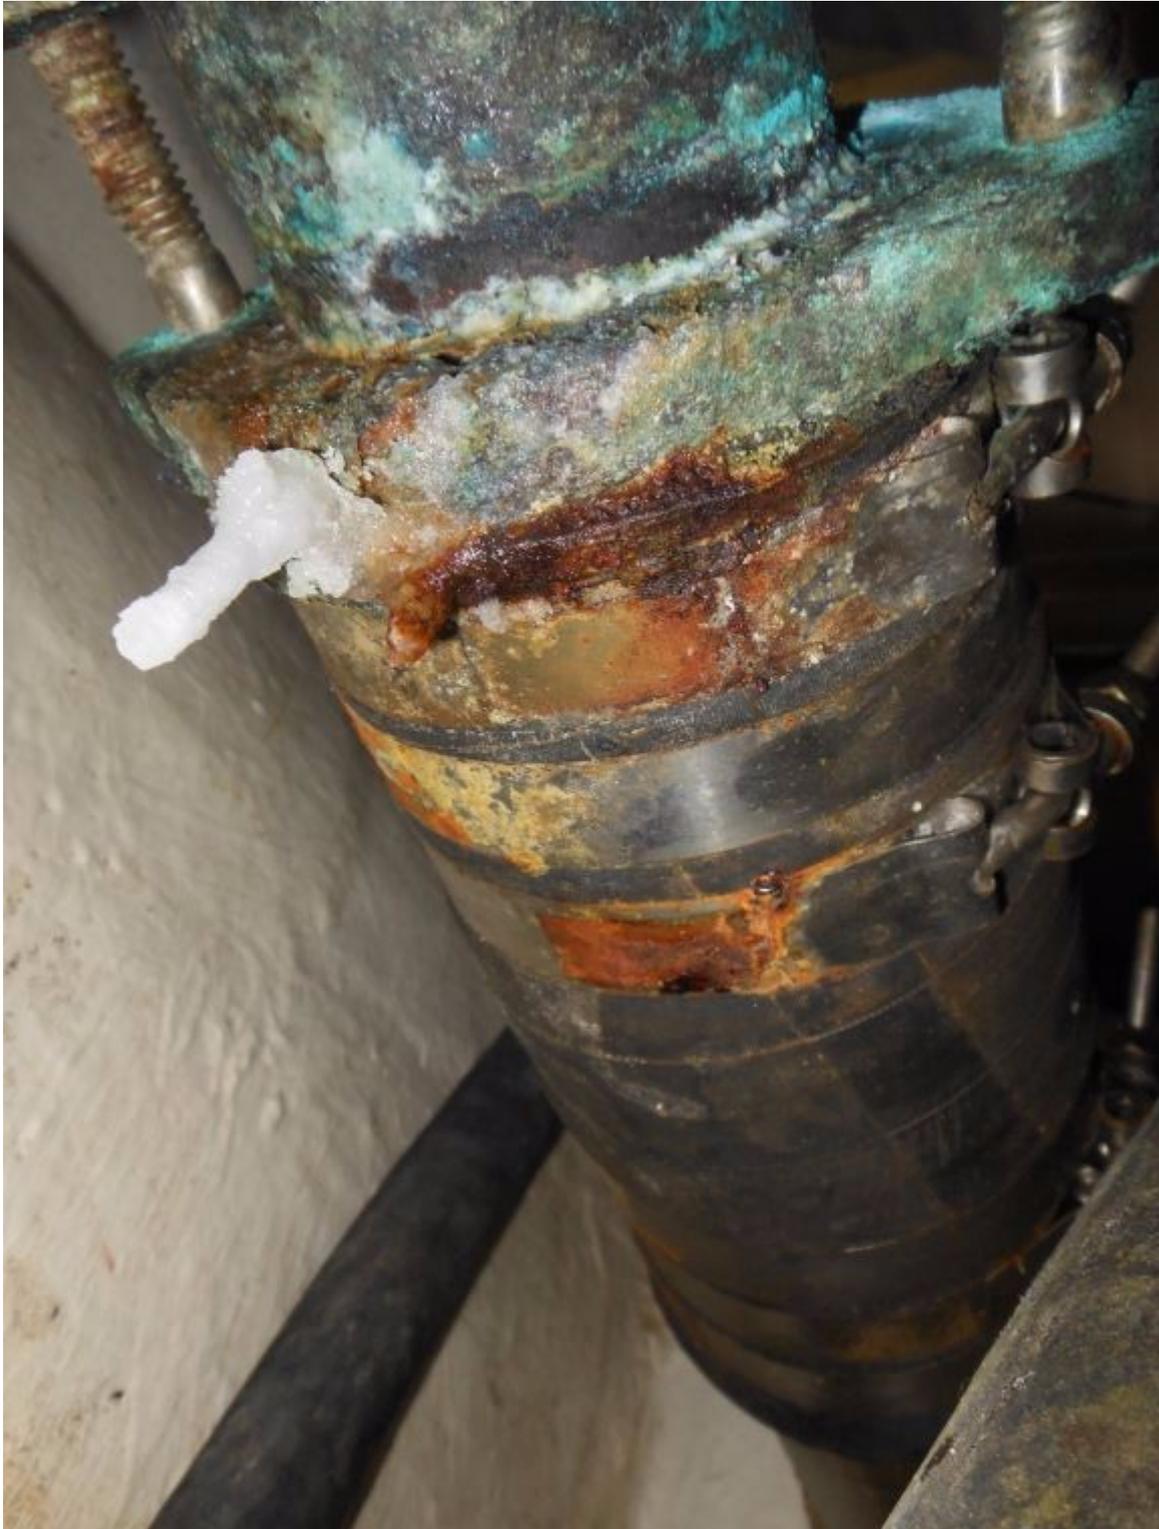
This salt stalactite tells a story, this stuffing box is

almost certainly leaking too much. Anything more than that which is required to keep a stuffing box cool is simply leakage.

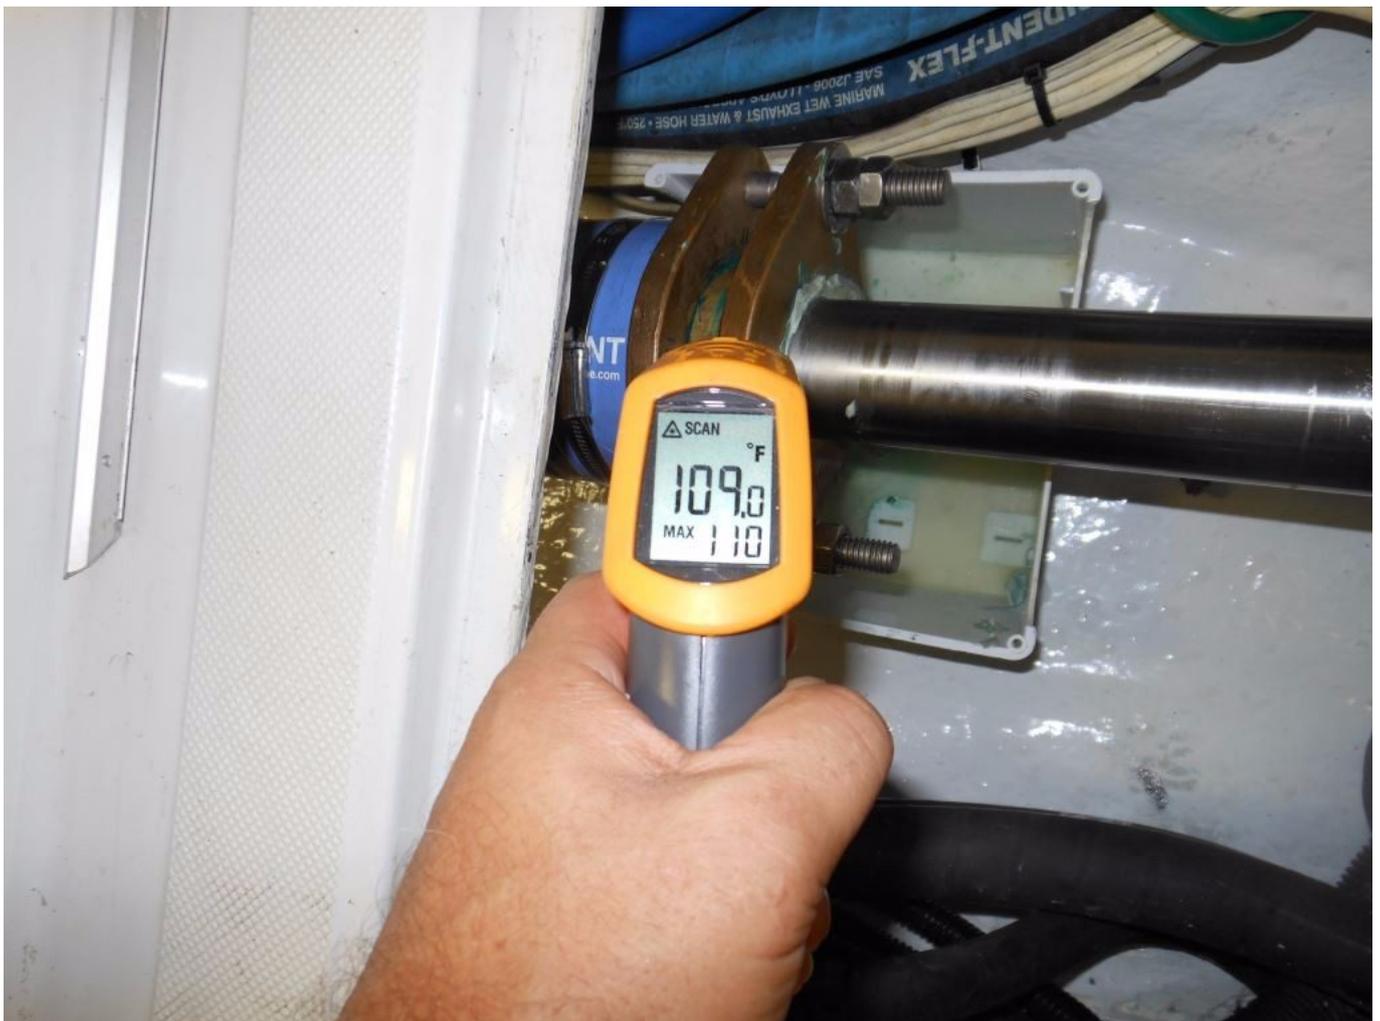
Infrared pyrometers have changed the way stuffing boxes are adjusted, now it's a measurable balance between heat and drip

rate.

The watch phrase when repacking a stuffing box, regardless of the material, is careful monitoring for the first few hours of operation. Using an infra-red pyrometer, the stuffing box temperature should be monitored during this time, shooting the stuffing box and not the shaft (highly reflective surfaces such as shafts and hose clamps will often give erroneous readings); adjustments should be made if necessary. No part of the stuffing box should exceed more than 30°F-40°F above ambient seawater temperature, regardless of drip rate, while at any speed. In fact, with access to an infrared pyrometer, drip rates are much less important than they once were.

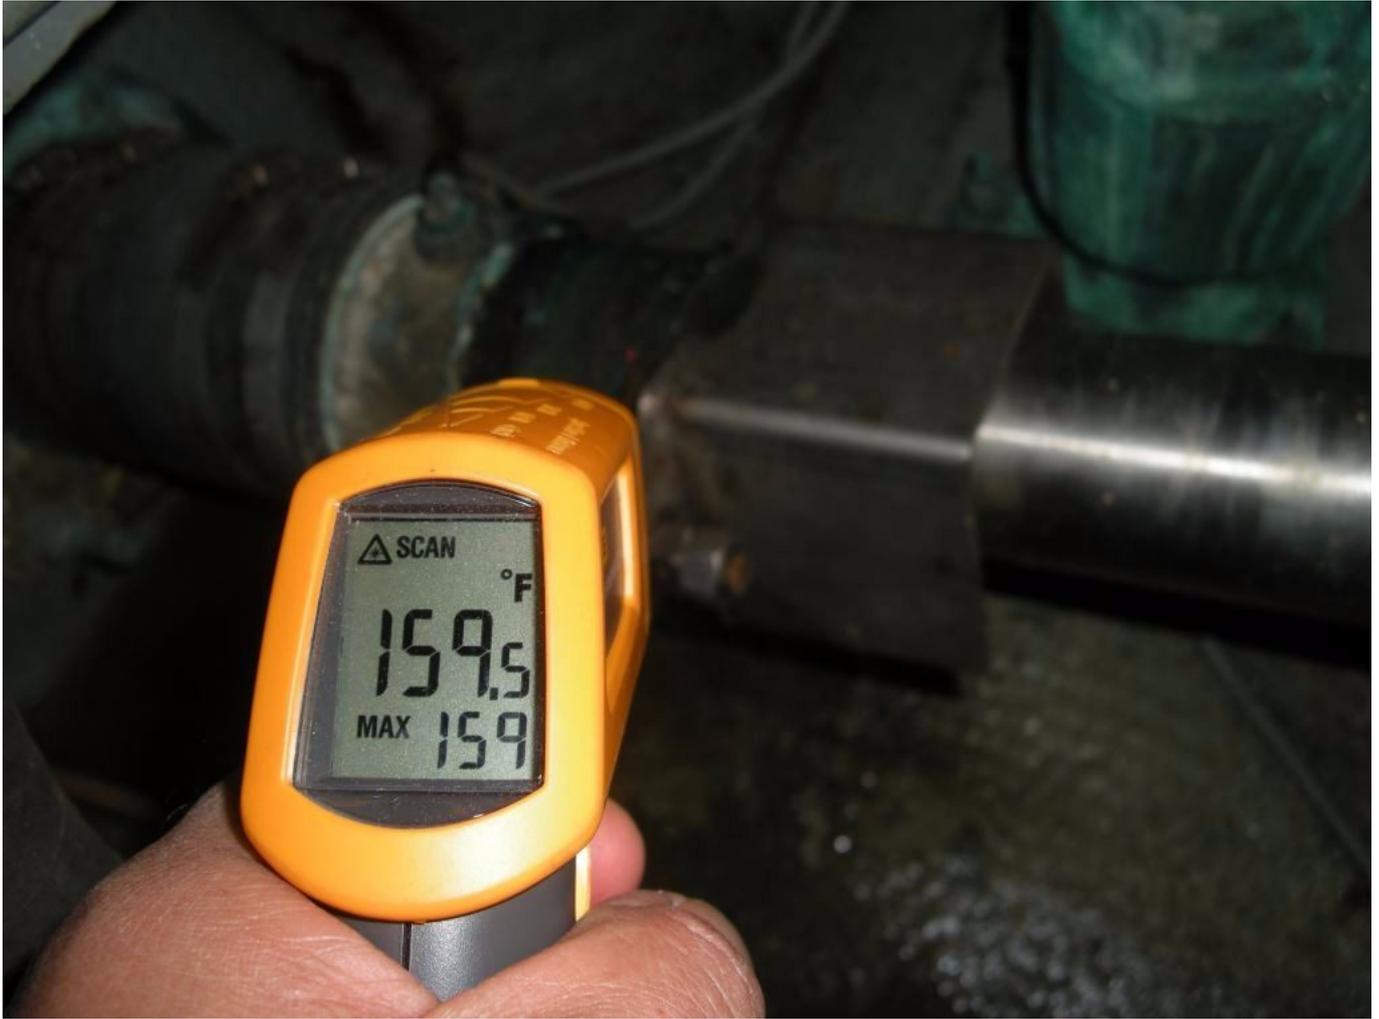
Stuffing box temperature should not exceed that of the water in which the vessel is operating by more than 30°F-40°F. The one shown here is clearly starved for water and is overheating.

Ultimately, the arbiter of correct stuffing box adjustment is temperature rather than drips per minute. Once properly adjusted, the stuffing box should leak little and be no hotter than about 30°F-40°F above ambient water temperature. If it is over tightened the wax in the packing will melt and run out of the stuffing box as a liquid, often accumulating under the stuffing box as a greenish pyramid, after which it will leak copiously. If necessary, this entire procedure can be carried out while the vessel is afloat. Once the packing nut is removed simply secure several wraps of a rag around the stuffing box where the shaft exits to temporarily stem the flow of water. Water will leak during reassembly; however, provided you work quickly it will be comparatively little. Check your stuffing box regularly and provide it with the care it needs. Doing so will yield the dividends in both longevity

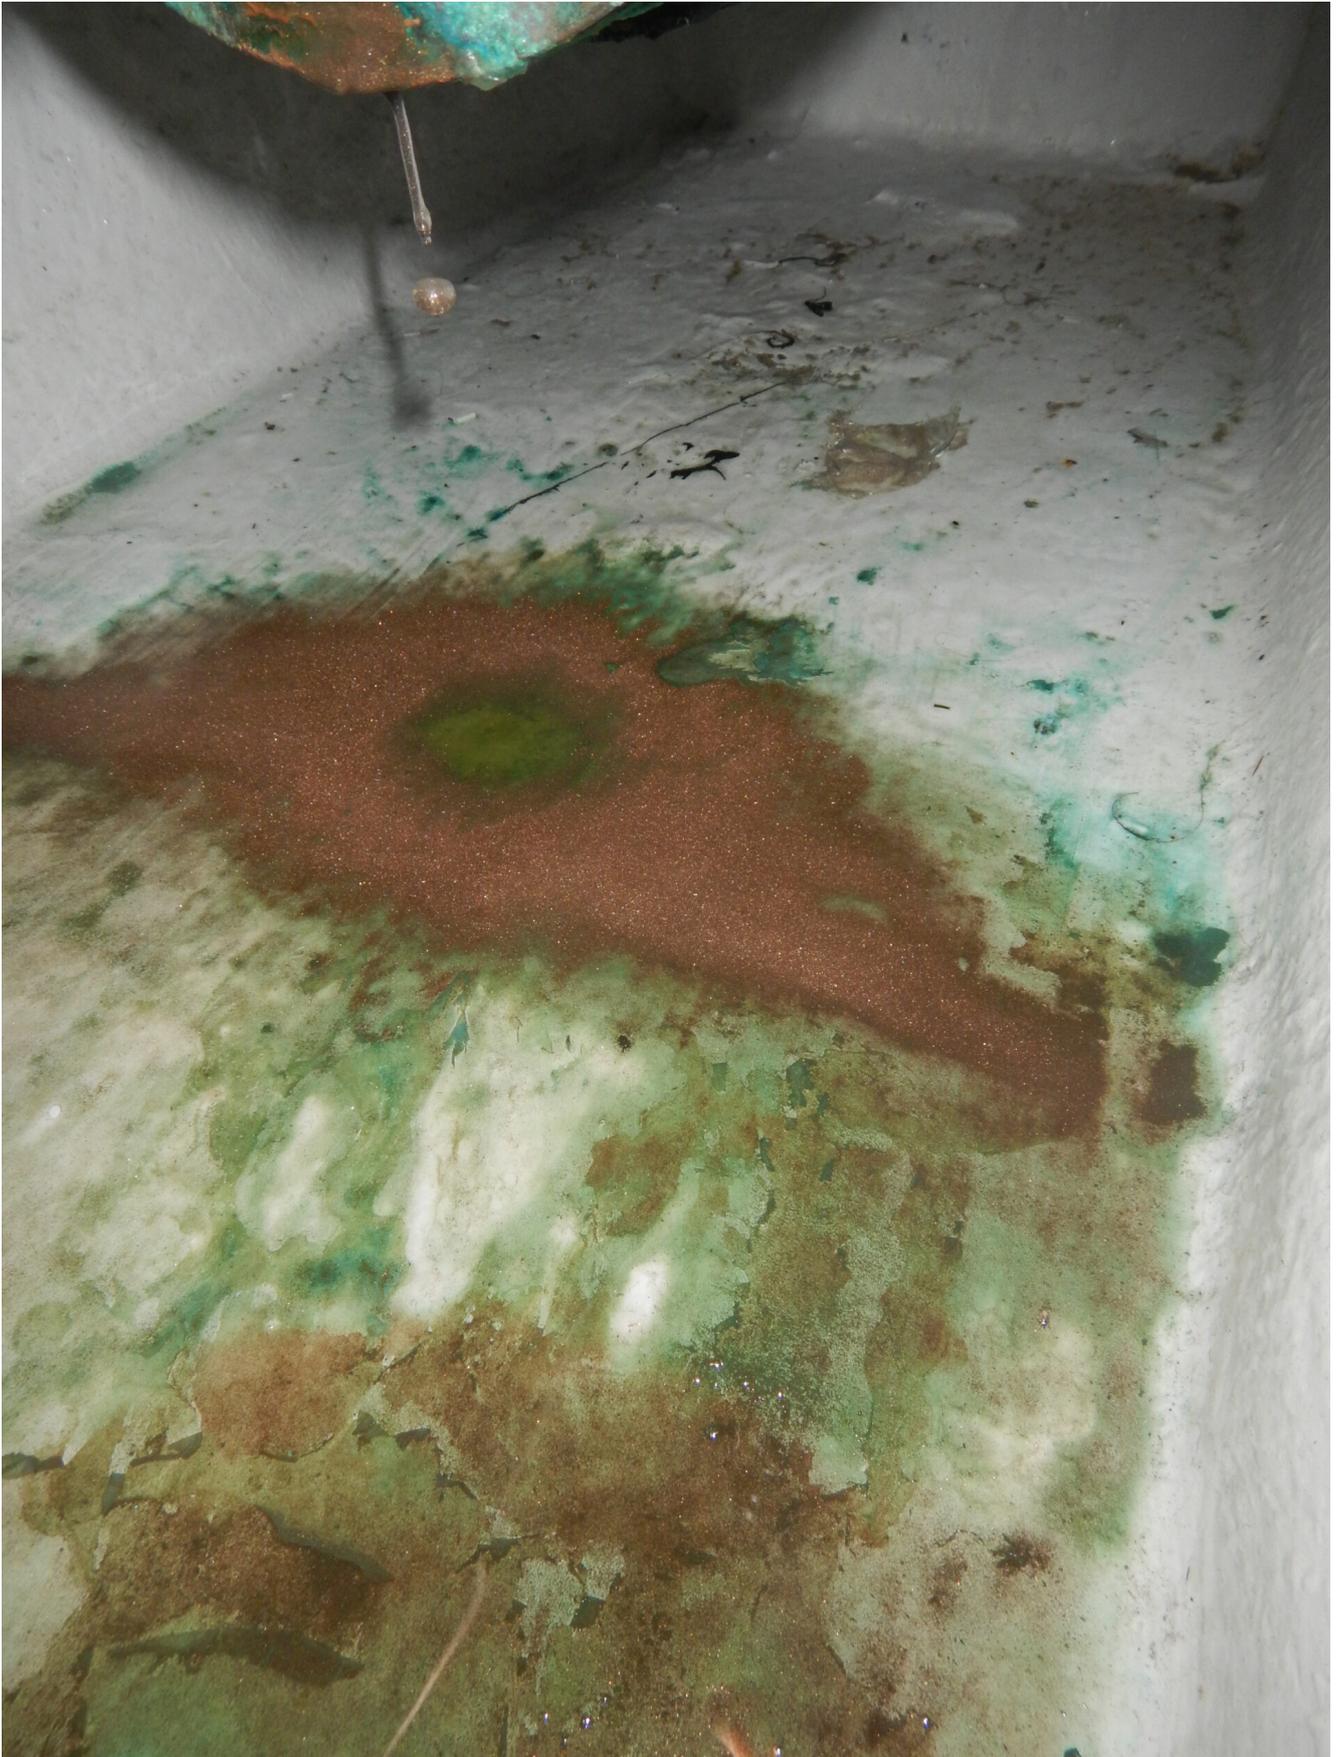
A stuffing box that is side loaded, from overly stiff hose, or a shaft that is not centered in the shaft log, or one whose clearance is inadequate (see images below), can suffer extreme

wear, the result of which is a 'bronze slurry', like that shown here.
