Conventional Wisdom for Conventional Stuffing Boxes

Text and photos by Steve D'Antonio

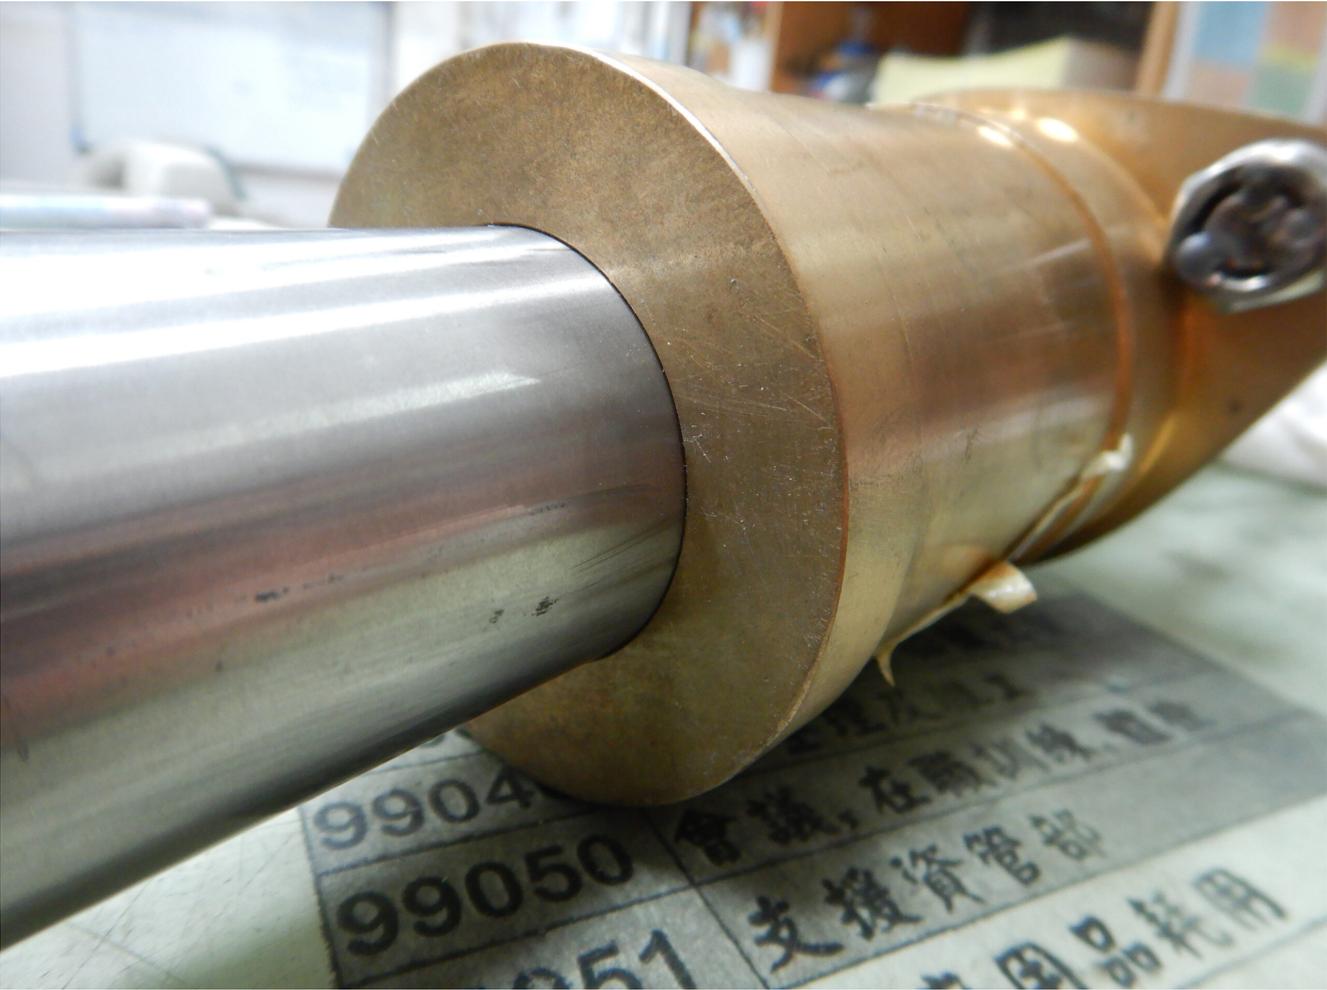
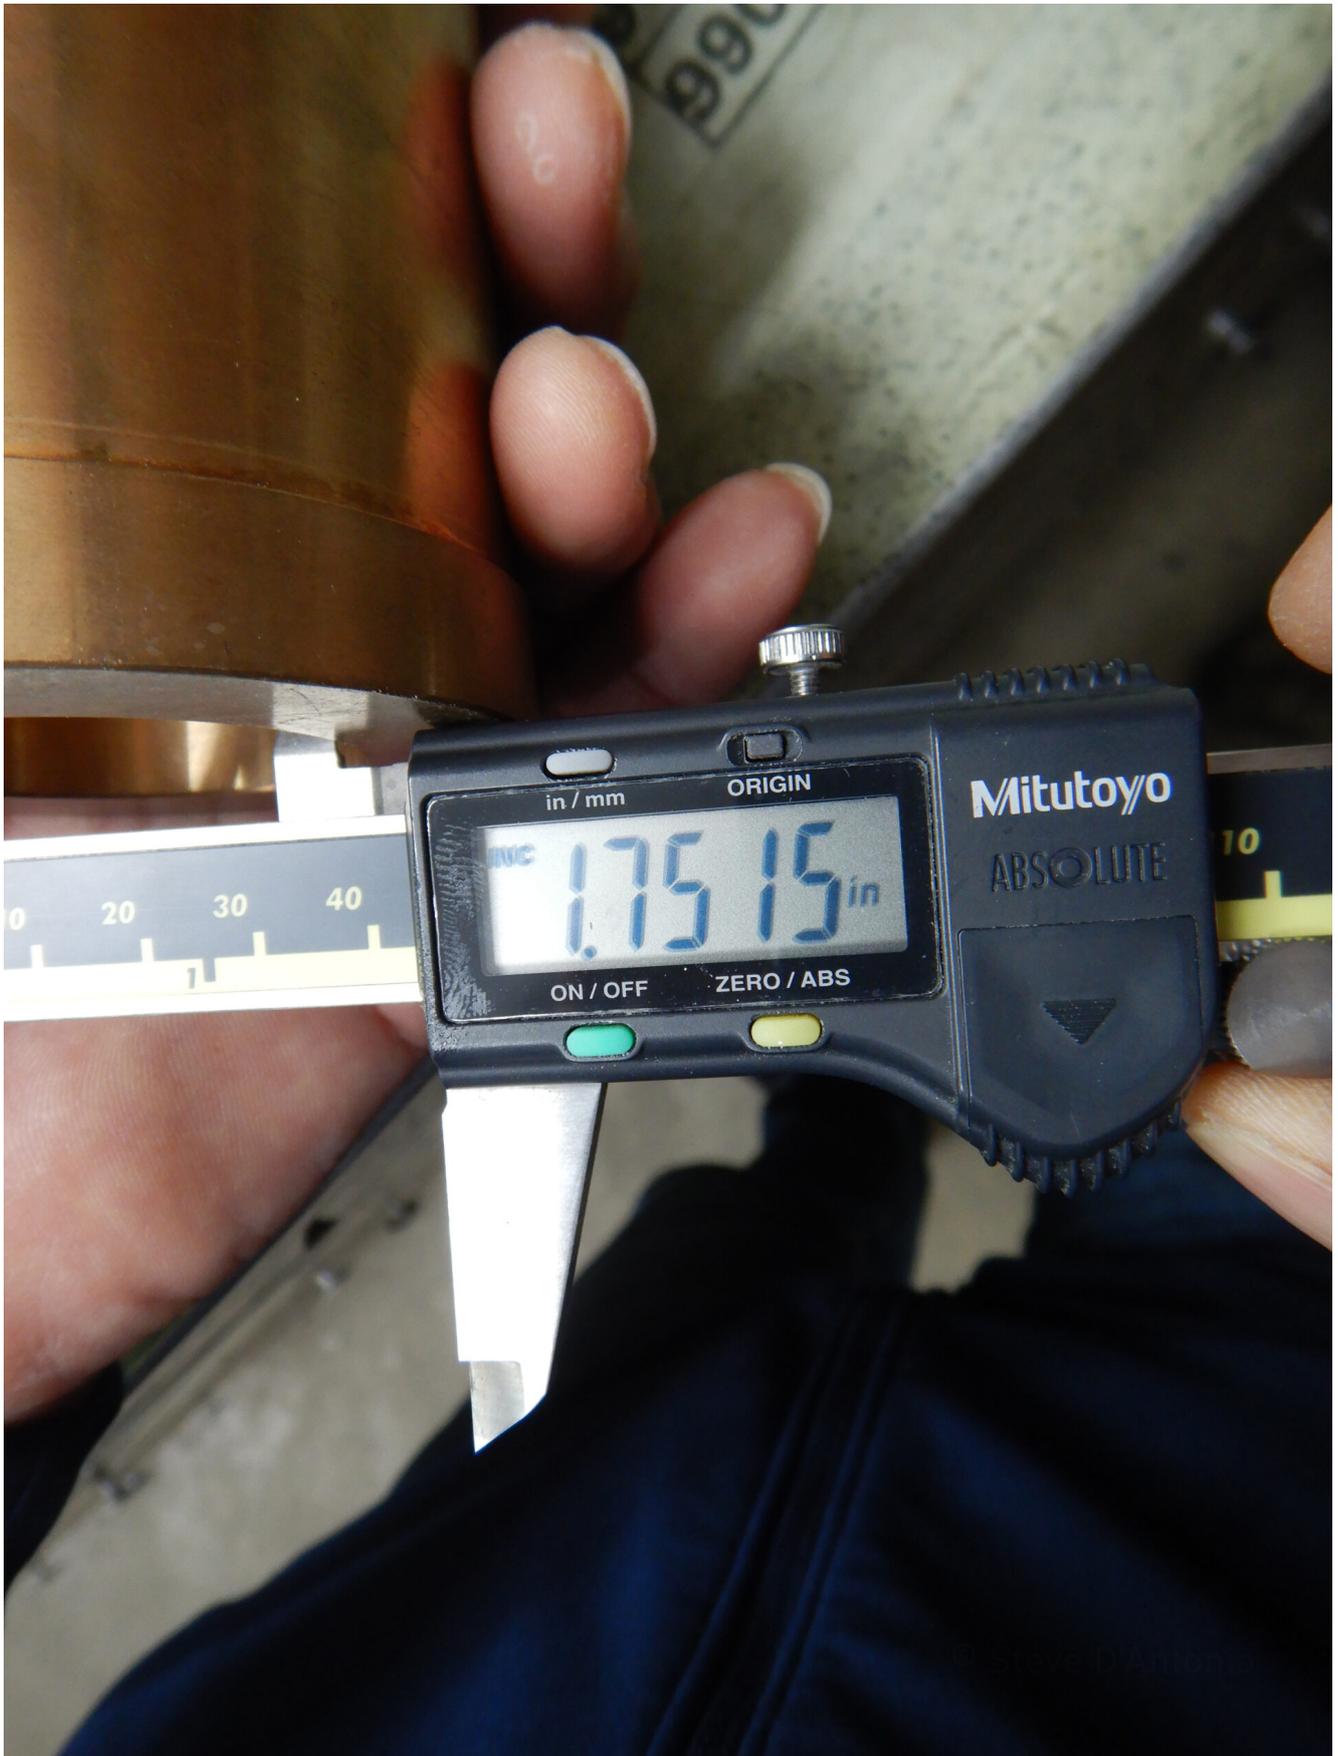
Clearance between the outside diameter of the shaft and the inside diameter of the stuffing box is critical, too much and packing will be pushed into the gap, limiting its

effectiveness, too little and water flow is impeded, which can lead to overheating. One rule of thumb calls for 0.005" clearance, plus an additional 0.005" for every inch of shaft diameter. Thus, a 3" diameter shaft would have 0.020" of clearance.

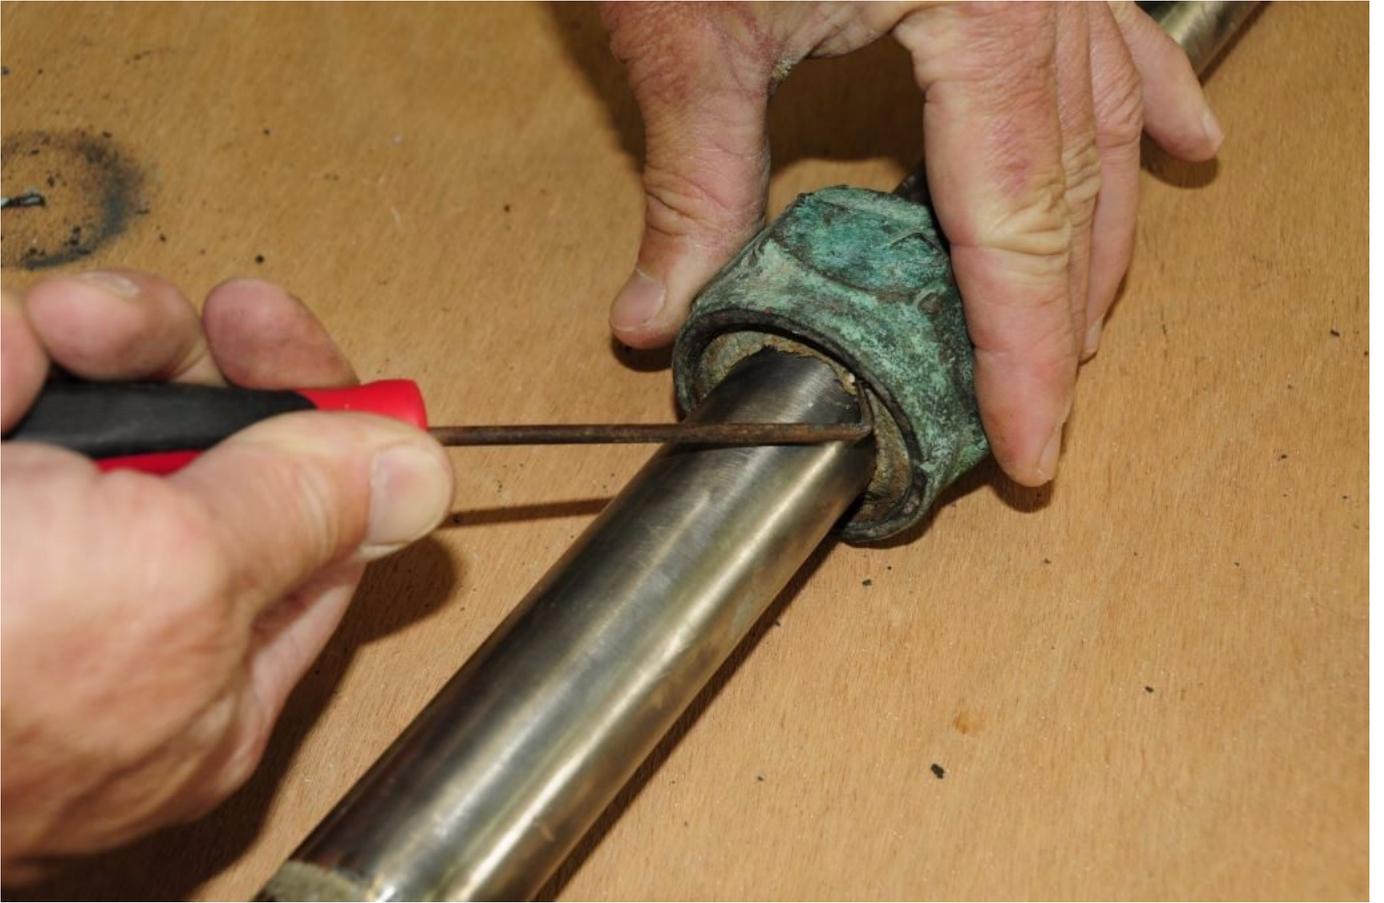
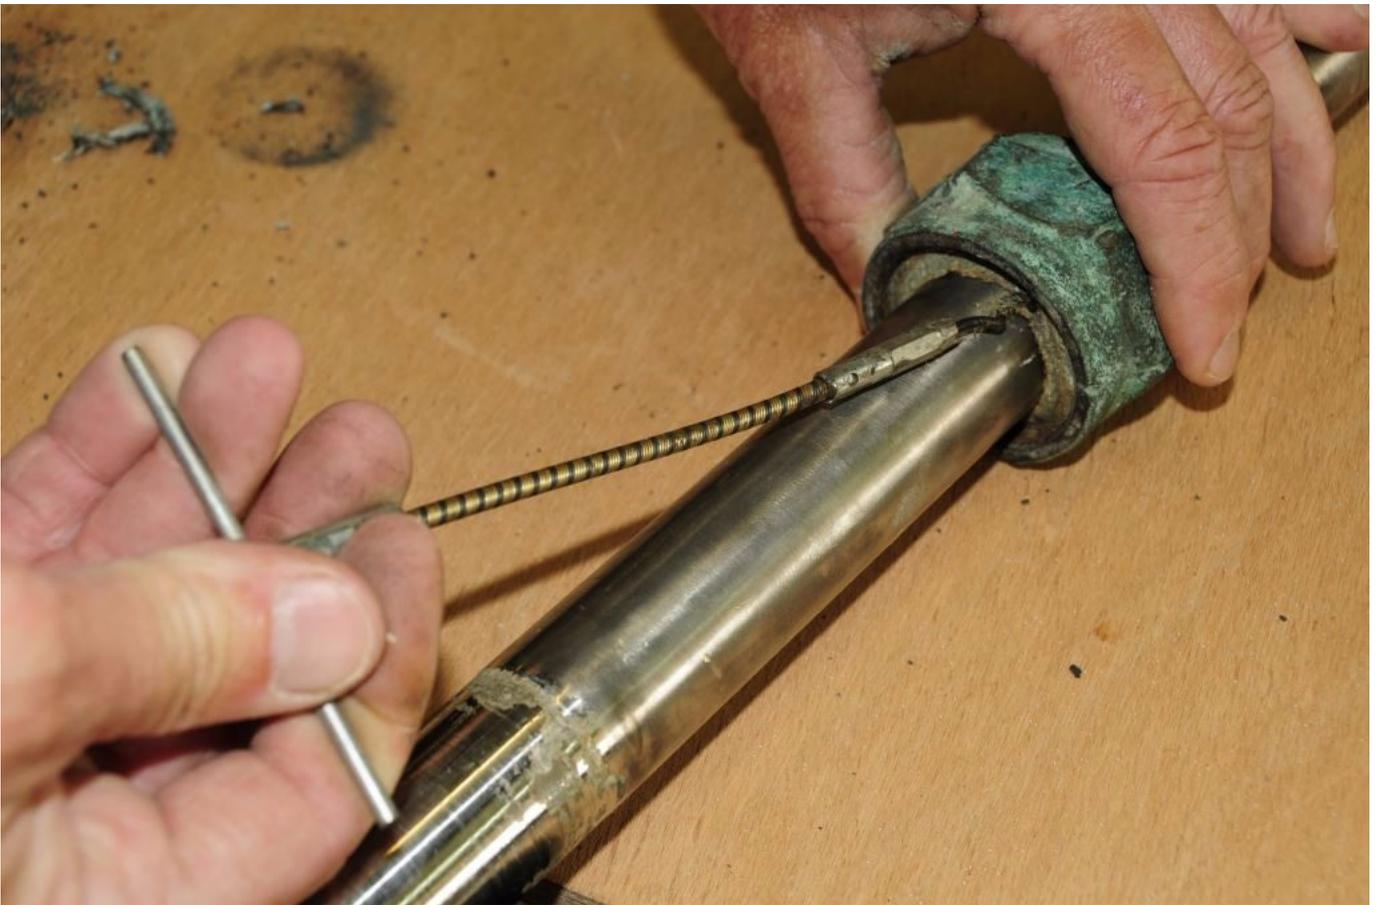
Depending on access, and stuffing box design, removal of the

old packing can be challenging. Here a cork-screw like packing removal tool(above), as well as a pick (top), are being used.

Begin by loosening the locking nut(s) and back off the packing carrier nut or tie rod ram. Remove all of the old packing. You can use a pick or a proprietary packing removal tool; it looks a bit like a flexible corkscrew. It's important that all old packing and debris be removed, if you have access to compressed then use it to blow this area out (wear safety glasses). If green and crusty, the threads on the stuffing box body should be cleaned with a non-metallic bristle brush or 3M ScotchBrite pad, and penetrating oil, and then *lightly* lubricated with oil. If they are tie rods and of the stainless steel variety and are discolored or lightly corroded, they too should be cleaned in the same manner; if heavily corroded they should be replaced.

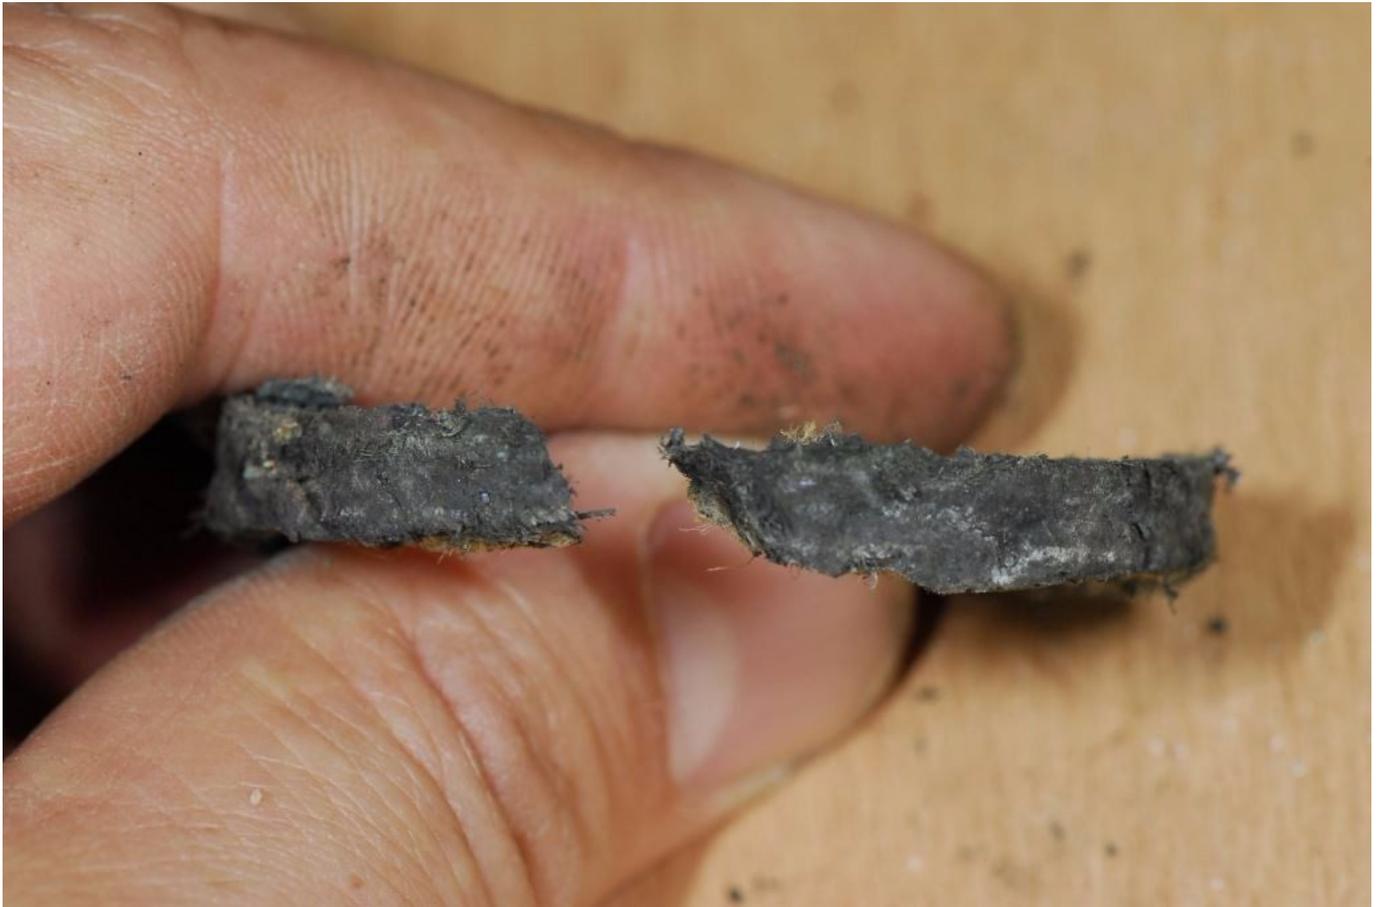
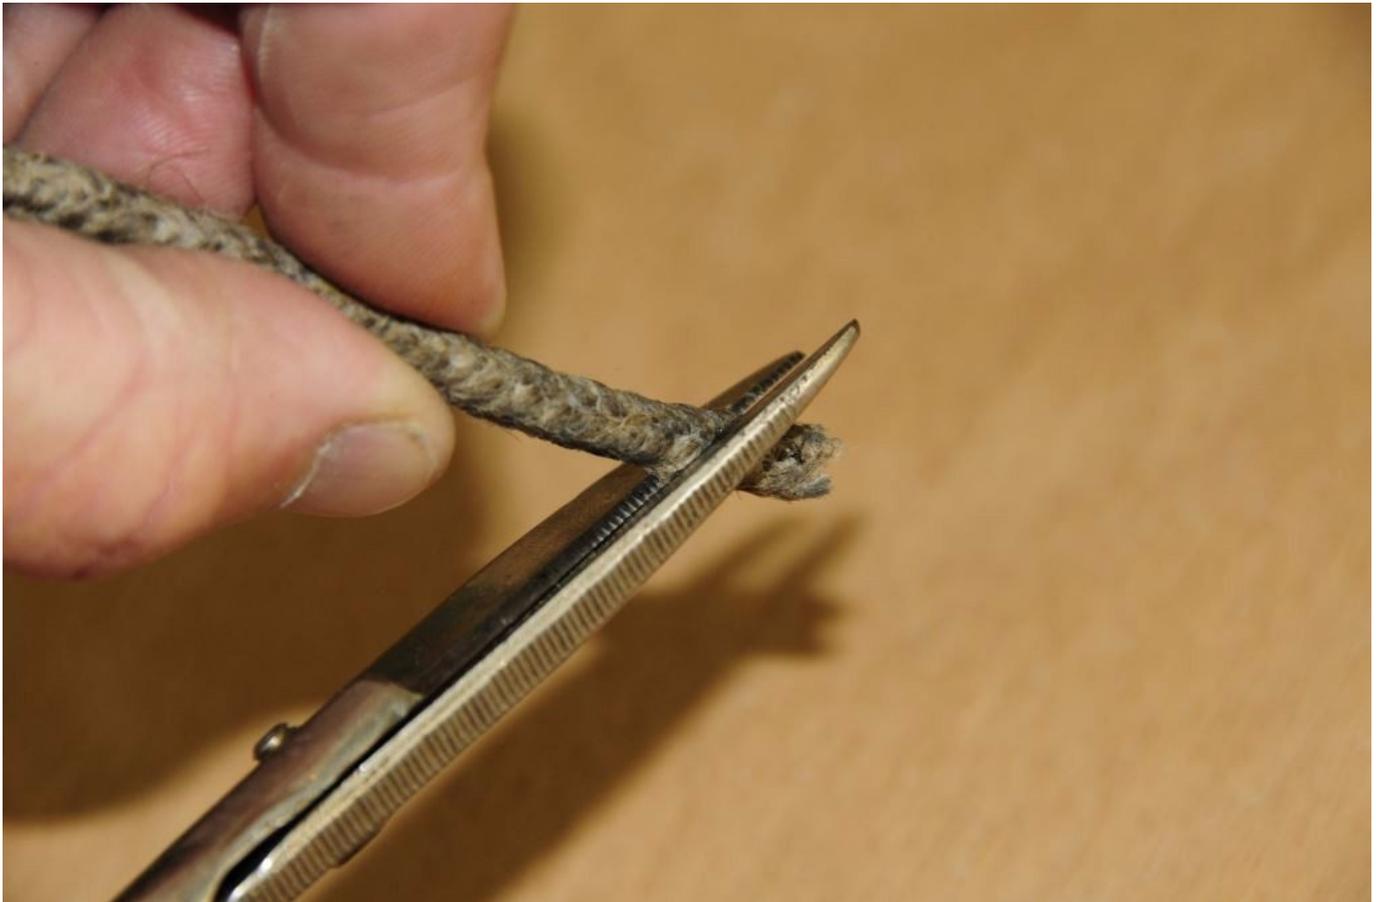
Packing should be cut at a 45° angle to provide a leak-resistant lap joint.

Unless instructed otherwise by the stuffing box manufacturer, *three* new rings of packing material should be cut, their inside diameter matching exactly the outside diameter of the shaft; the ends of each piece of packing should be cut on a forty-five degree angle so they mate in an overlapping fashion. I find it helpful to apply a coating of high viscosity grease (I prefer Lubrimatic's green Trailer Wheel Bearing Grease; and adding a stainless steel or Monel (never ordinary steel) grease or Zerk fitting to a stuffing box will allow you to inject grease any time, especially when leaving the boat, which will reduce dripping, potentially to zero) to the packing sections as I install them, this acts as a lubricant and it helps keep the sections in place as they are inserted into the stuffing box recess or nut carrier. These joints should be spaced 120° apart, or at the 12, 4 and 8 o'clock position.

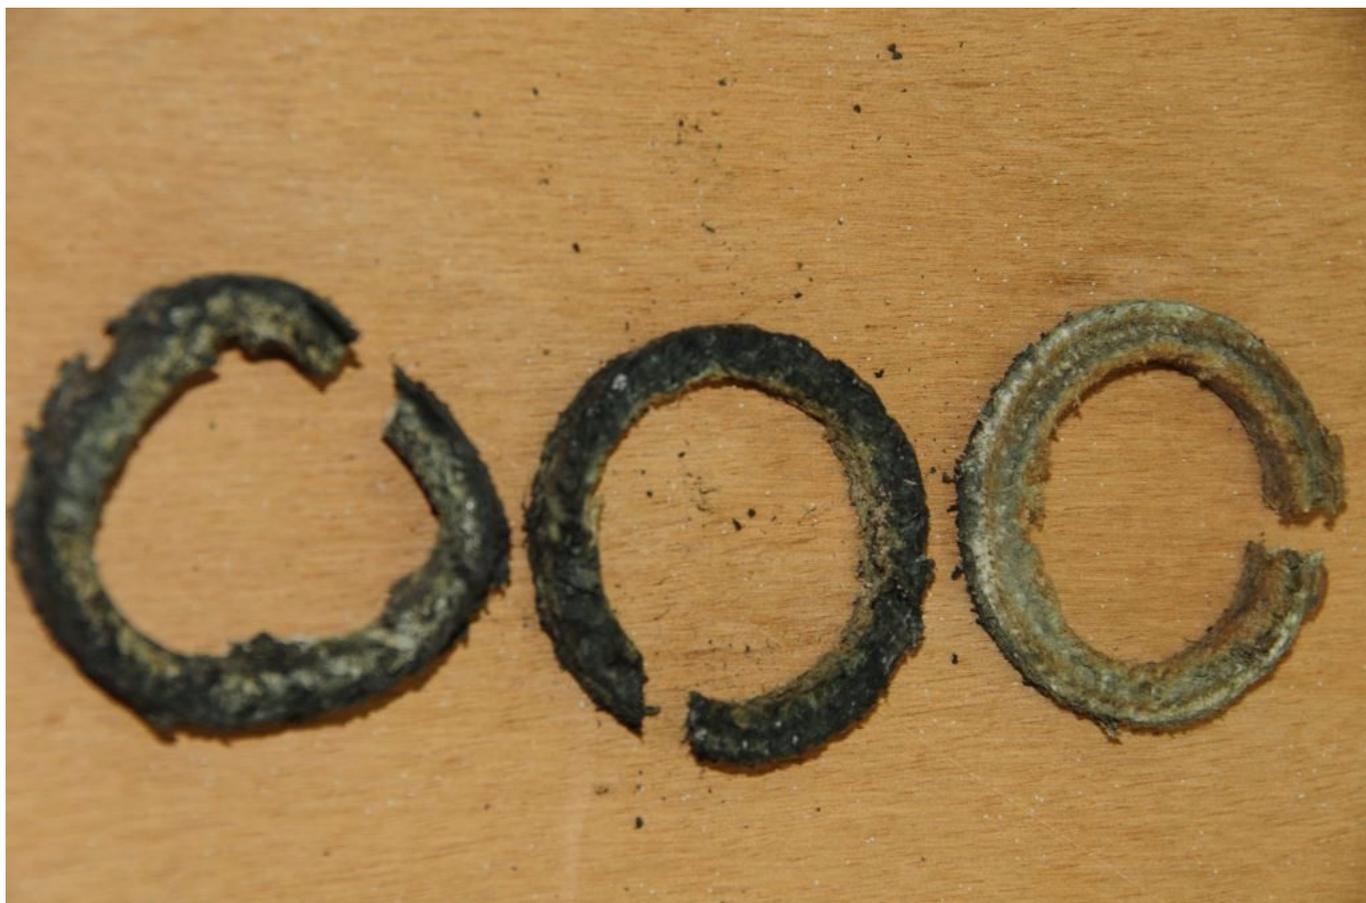
Most stuffing boxes are designed to accept three rings of packing. The joints should be oriented 120° apart from each other.

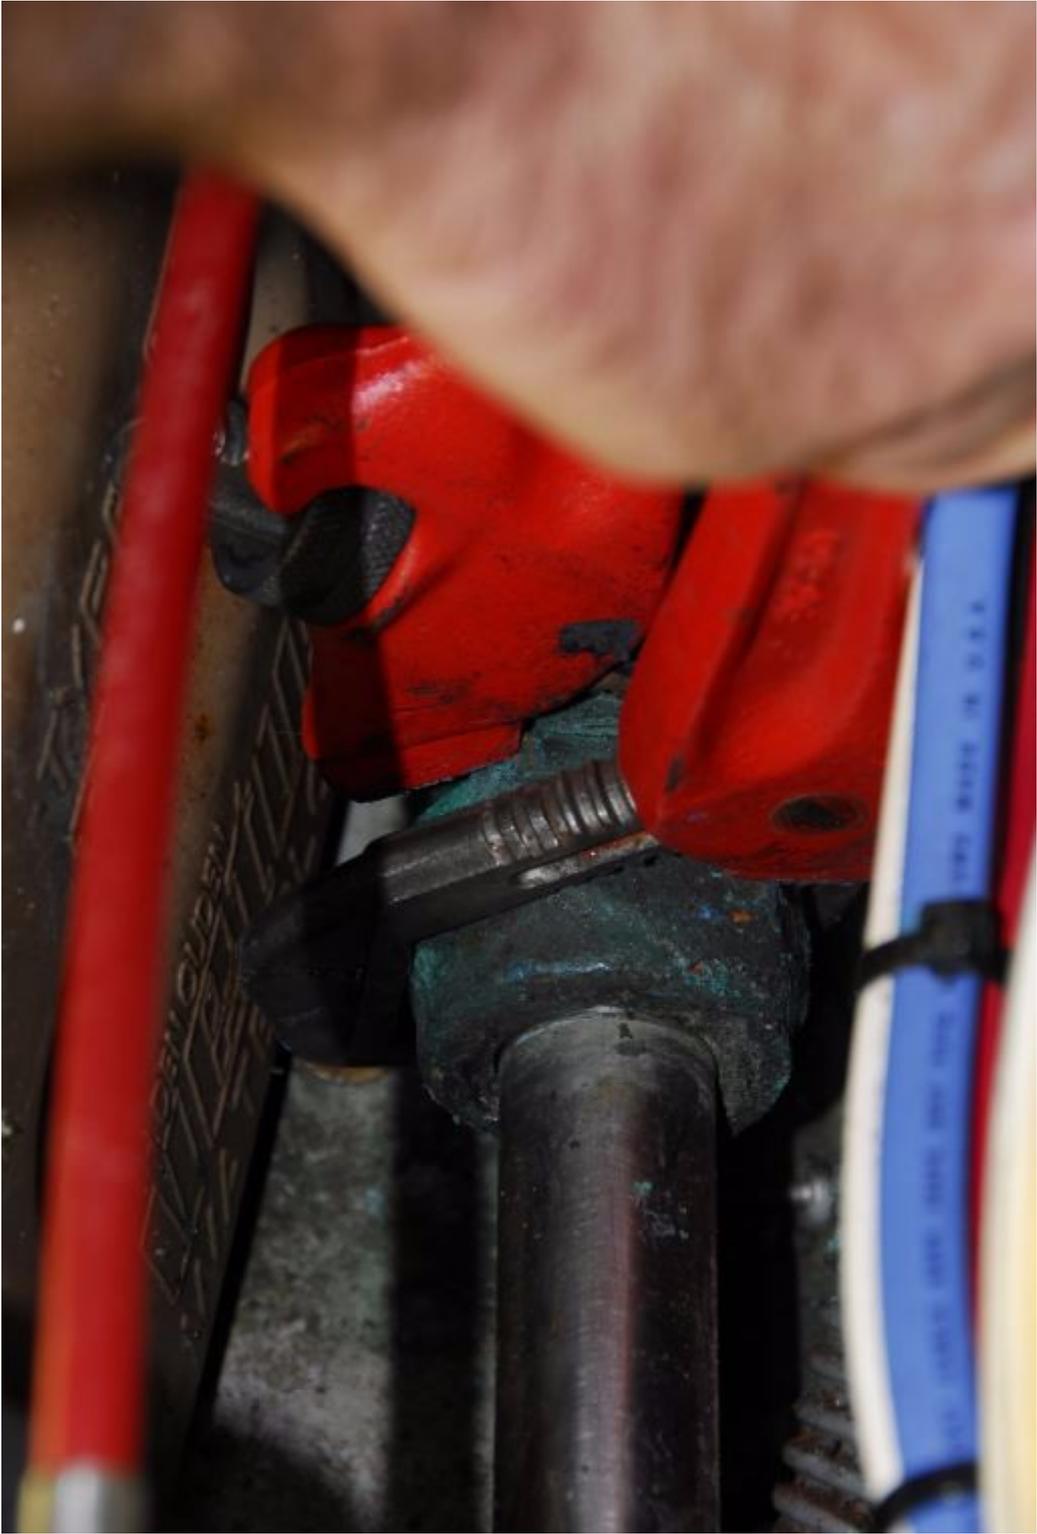
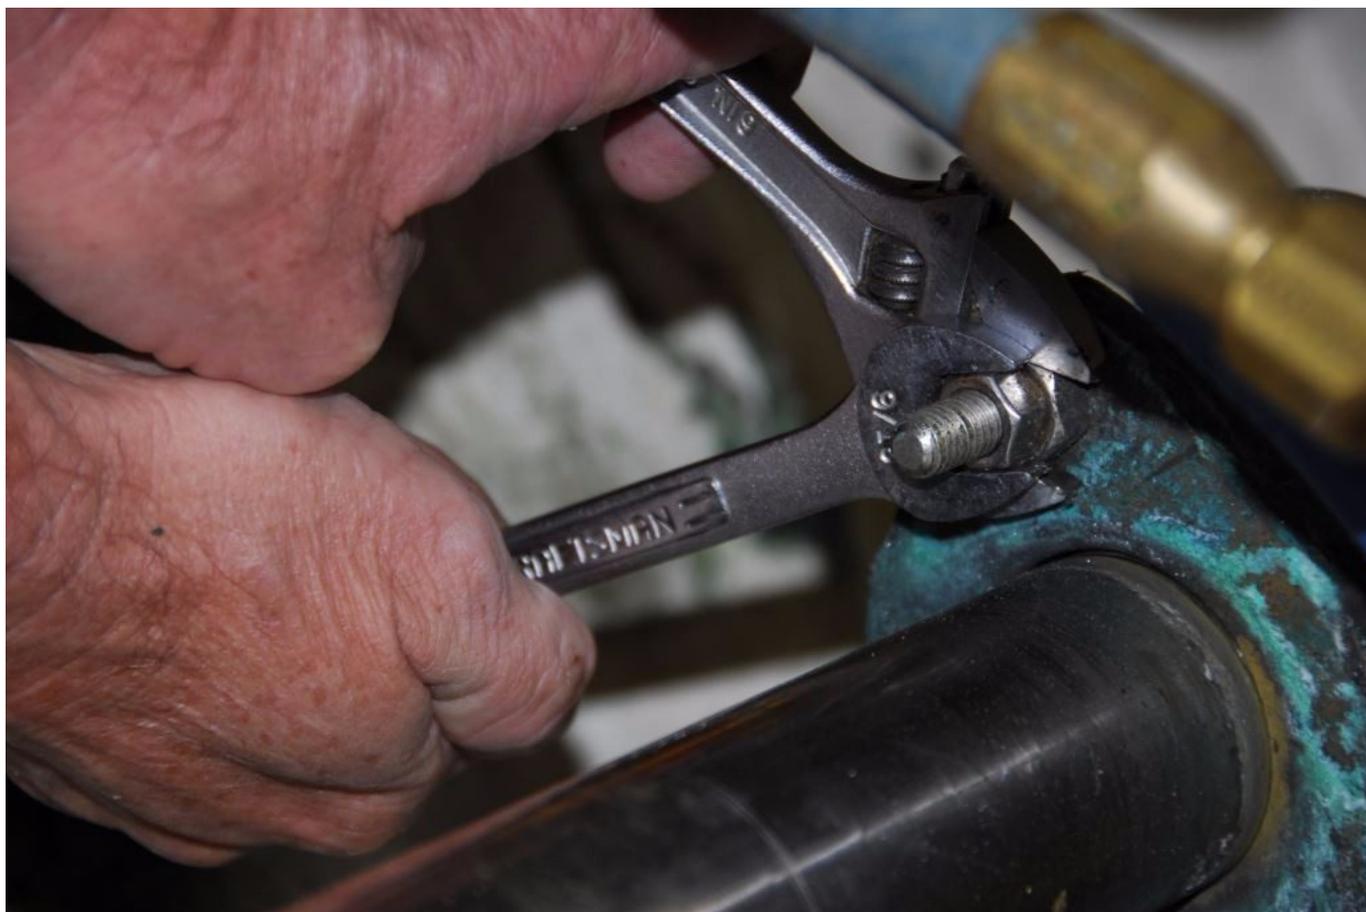
Two wrenches must be used when tightening twin packing lock nuts, to ensure adequate tension is developed between the two nuts. The style shown at the top should be avoided where access is poor. The adjustment method shown above, using twin studs, is better suited to limited access locations. If Nyloc rather than double nuts are used, loosening is virtually eliminated and adjustment can be accomplished with a single wrench.

The packing nut should be made snug, not much more than hand tight initially. How tight is a subjective measure, however, it doesn't matter because it will likely be adjusted once the vessel is launched and the engine run. Initially, it is far better for it to be too loose than too tight. It's critically important that the locking nut(s) be tightened against the packing nut using *two* wrenches, i.e. they need to be tightened to create tension against each other. Tightening one, and then the other, using one wrench, is inadequate and may lead to a loosening and flooding.

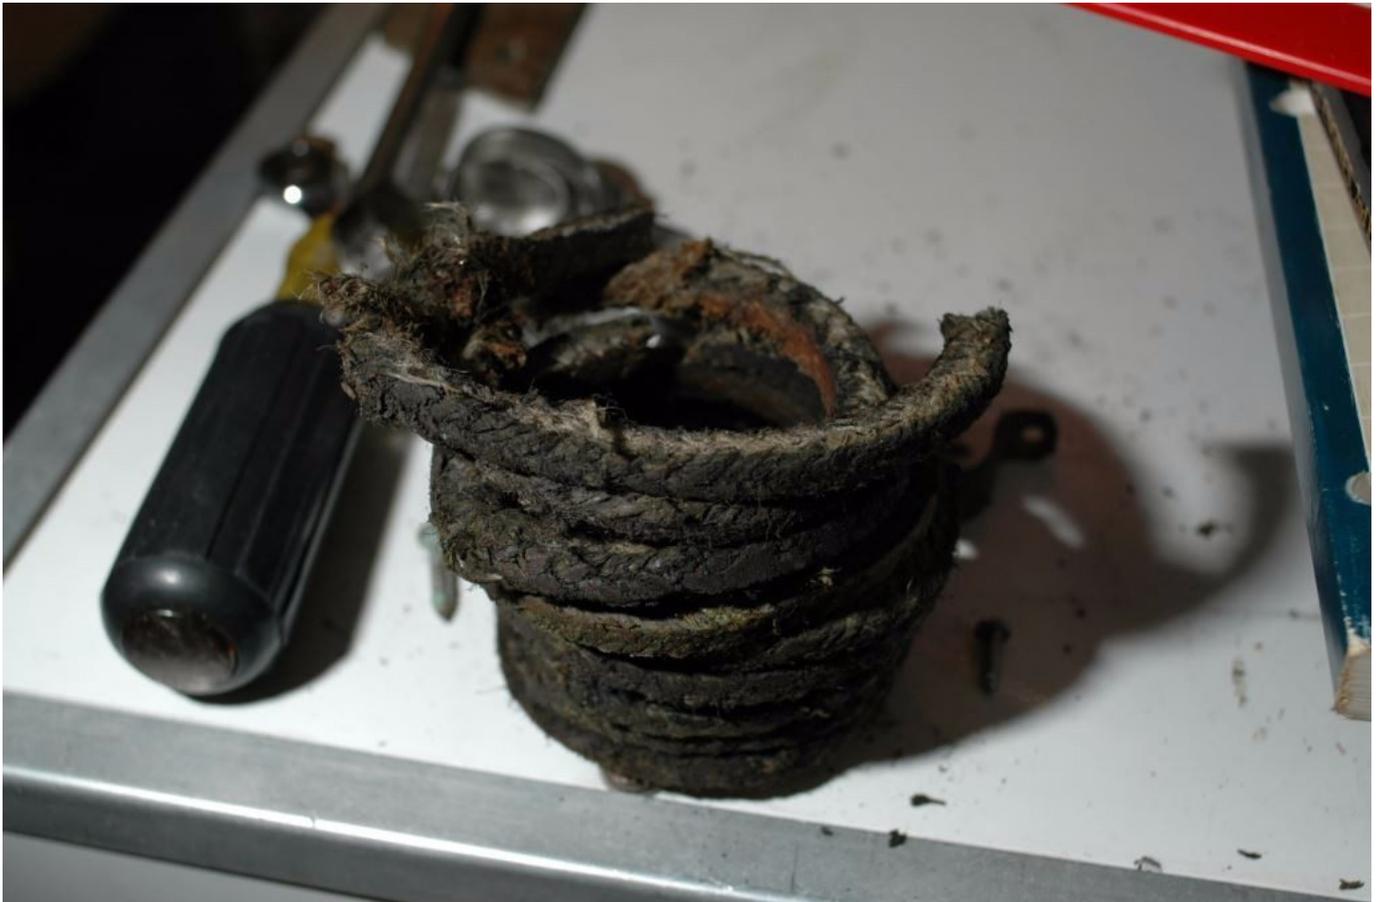
Too much of a good thing; if three wraps don't stem the flow, another problem is almost certainly present. The stuffing box from which this packing came was clearly over-stuffed.
