Conventional Wisdom for Conventional Stuffing Boxes

Text and photos by Steve D'Antonio

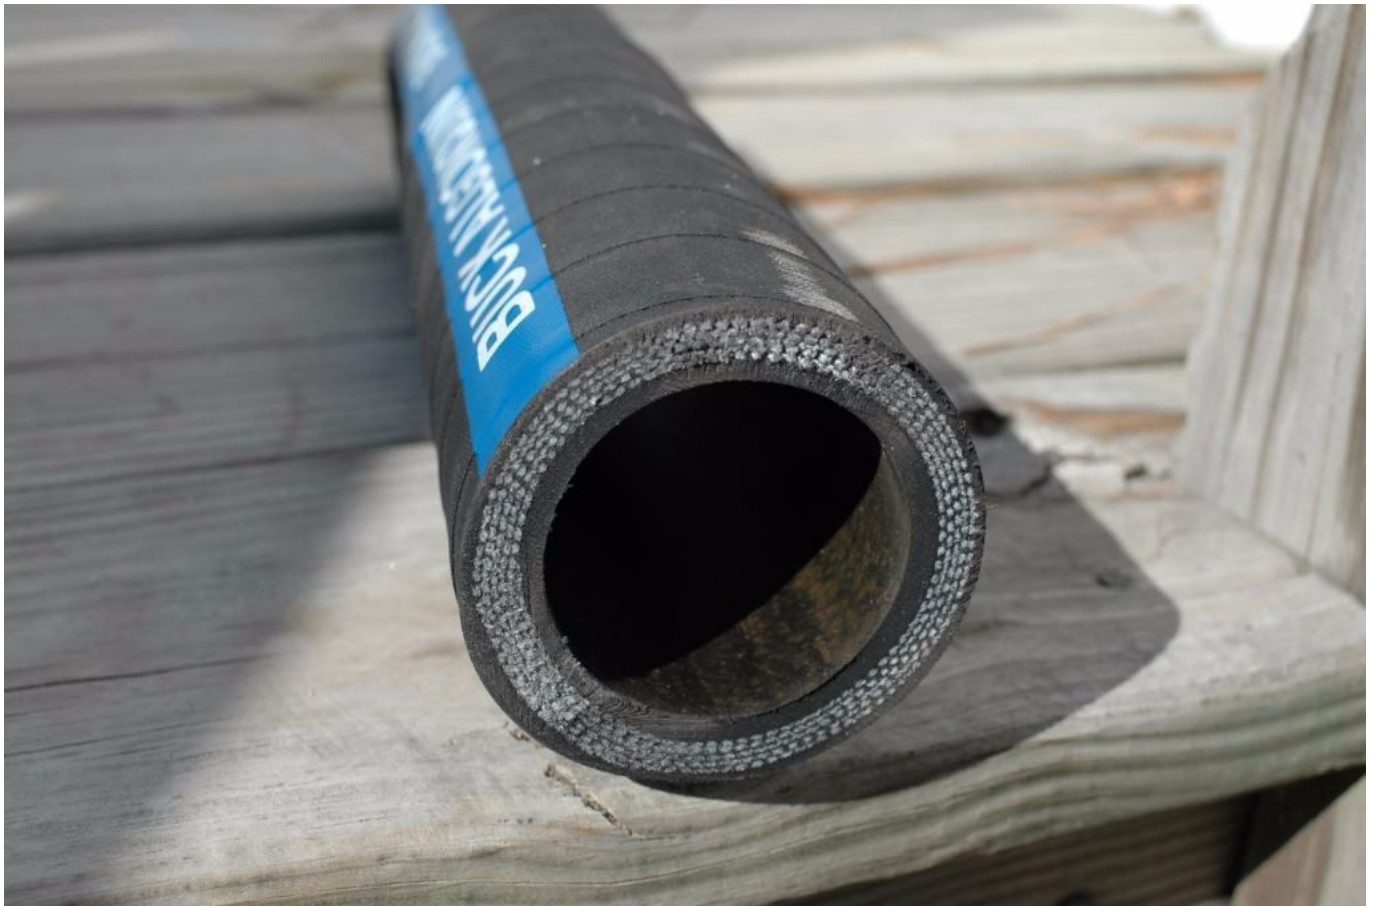
With additional plies, seen here, when compared to ordinary raw water hoses, proprietary stuffing box hose is especially rugged and twist resistant.

While it may look ordinary, the hose used with conventional stuffing boxes is, or should be, proprietary. Ordinary raw water or exhaust hose may utilize two or three plies, while proprietary stuffing box hose incorporates five plies. Because hose used in stuffing box applications lives an especially hard life, it's submerged, vibrated and routinely twisted in forward and reverse, the added heft of five plies is a clear value added, and equates to longer life. Replacement of the stuffing box hose is invariably time consuming in that it requires separation of the propeller shaft from the transmission coupling. It is also, therefore, a task that must be carried out while the vessel is hauled. Conventional, conservative wisdom dictates that stuffing box hoses should be preemptively replaced approximately every five to seven years or when warranted by visible hose deterioration. One critical issue involves hose length, or more importantly, the length of "free hose" between the stuffing box pipe to hose adapter and the shaft log. This free hose length must be long enough to allow the hose to float freely on the shaft, avoiding side-loading, binding, and the overheating it can cause.

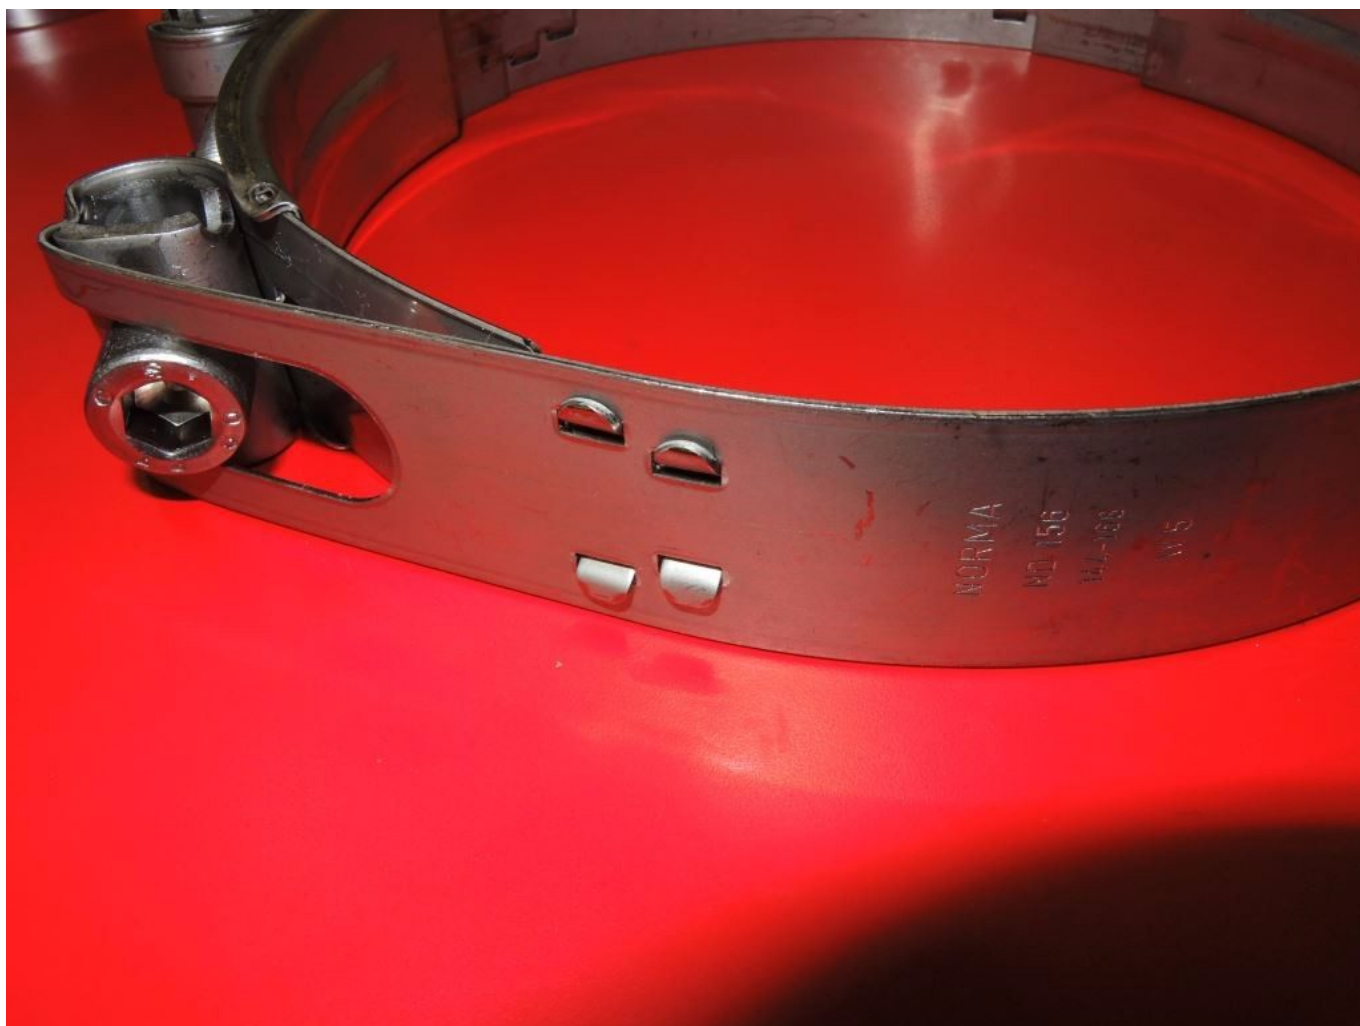
Because of their resistance to corrosion, interlocking, as opposed to spot welded, hose clamps are ideally suited for conventional stuffing box use.

Replacing clamps is straightforward and relatively easy. Replacements should be made from all 316 alloy stainless steel, including the screw, and their bands should be solid rather than perforated (for more on hose clamp selection and

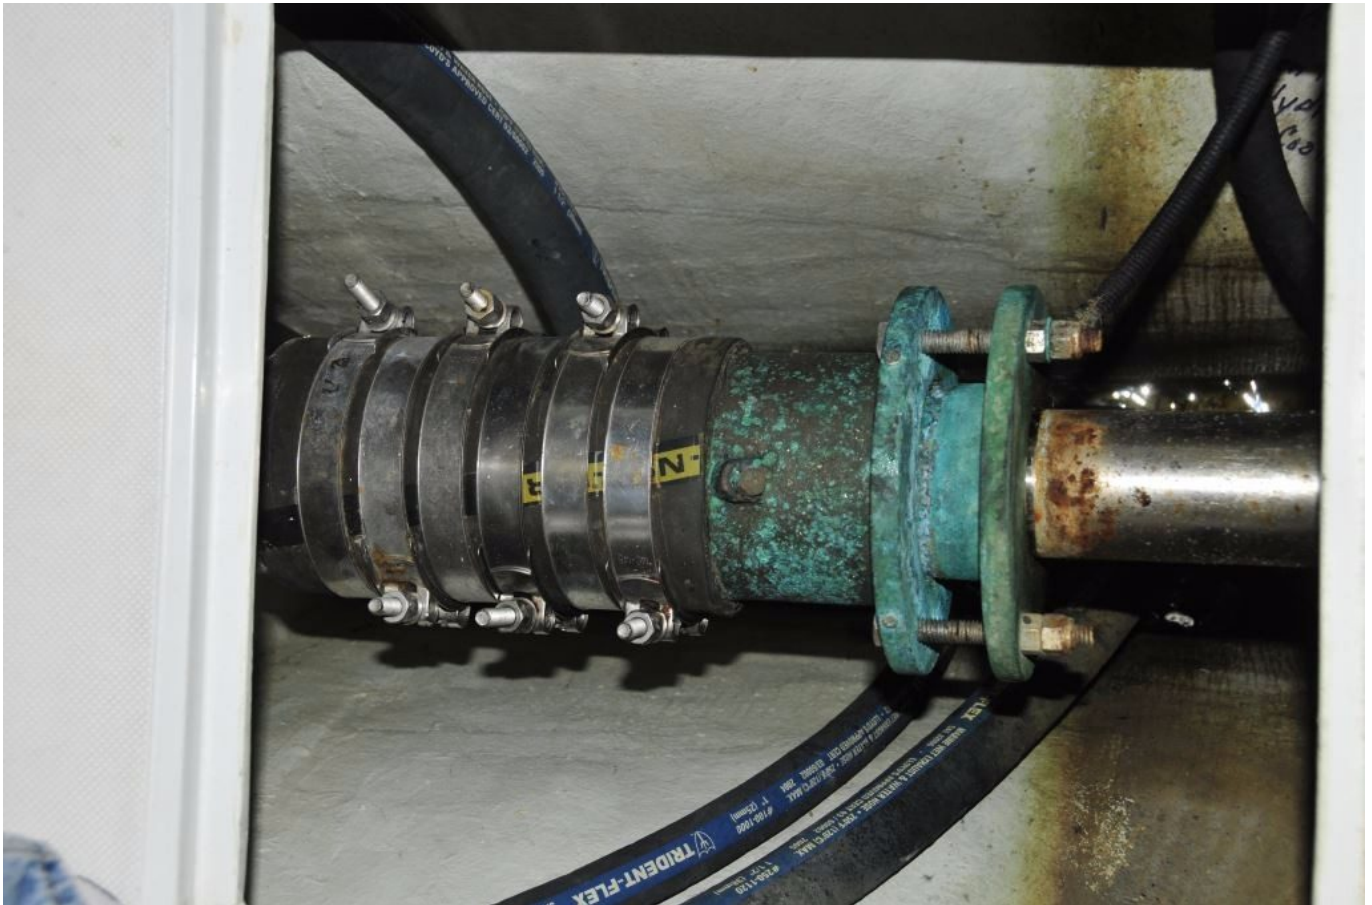
Perhaps this is a case of hose clamp overkill; the additional clamps are of no real value and could be detrimental if they aren't located over the stuffing box or shaft log. Stuffing boxes should be equipped with double, high quality hose clamps at each end. Furthermore, too many clamps, combined with a hose that is too short, could prevent the stuffing box from "floating" on the shaft, and self-aligning.

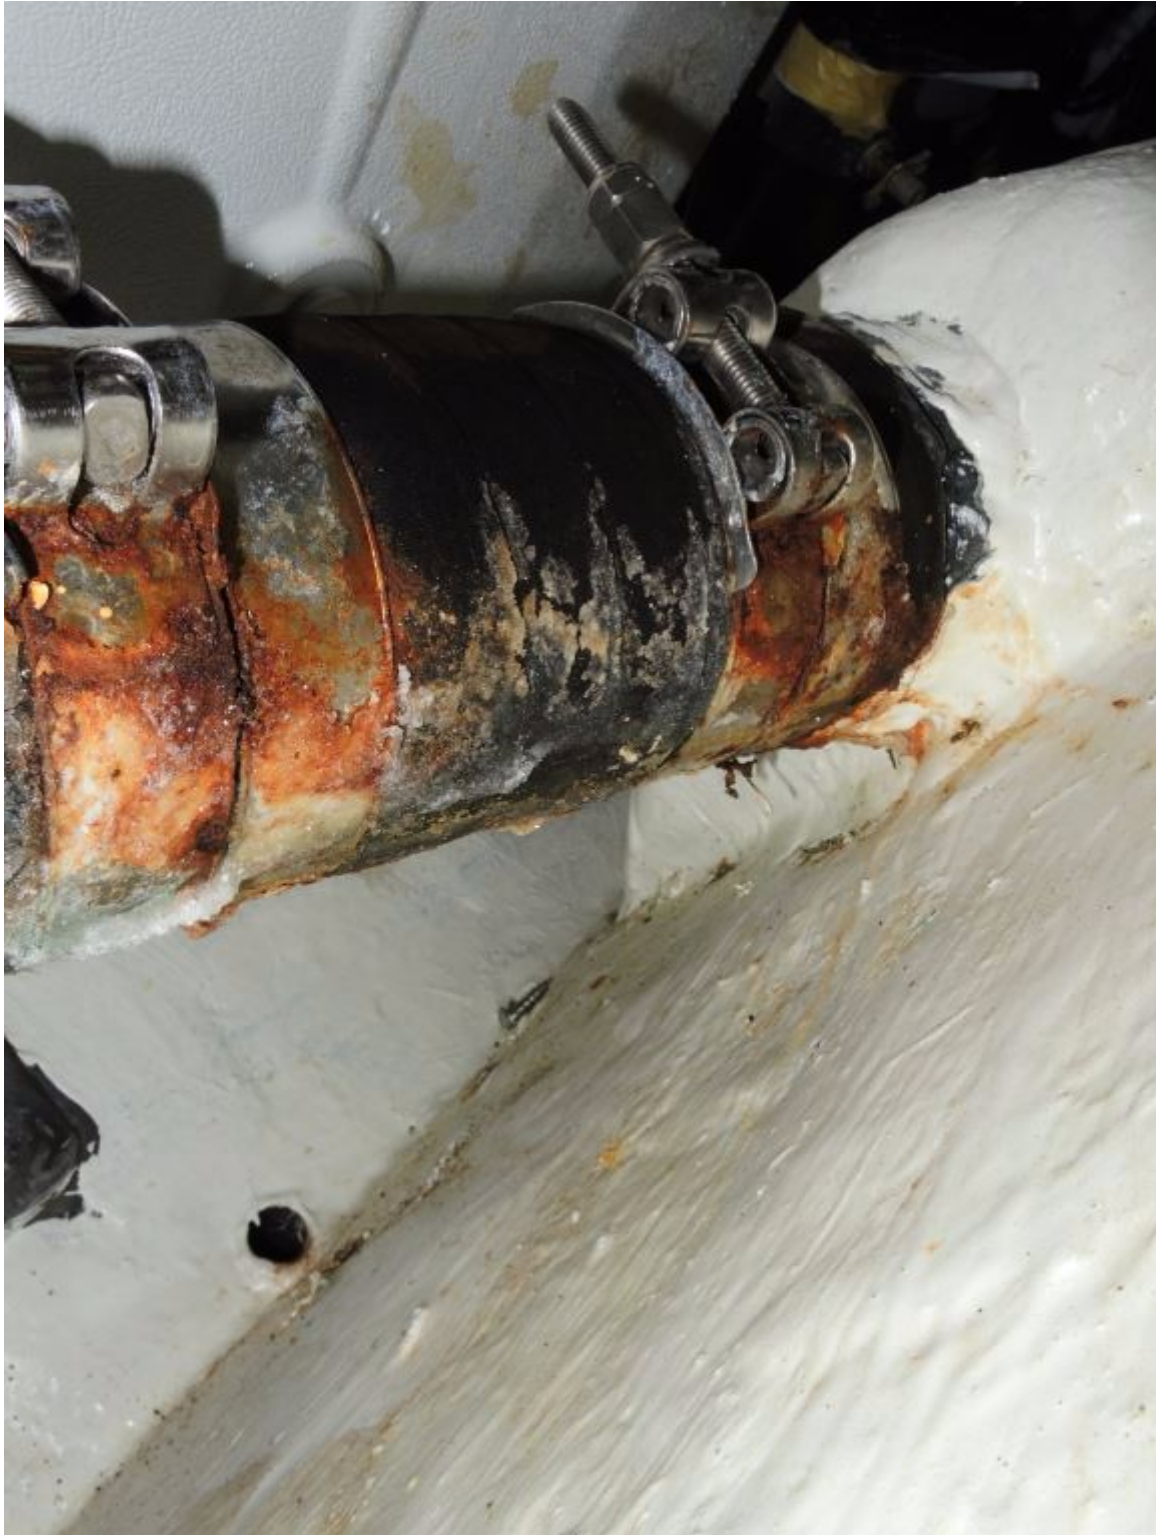
Chronically leaking stuffing boxes lead to more than just wet bilges. These clamps are seriously corroded as a result of

regular exposure to seawater.

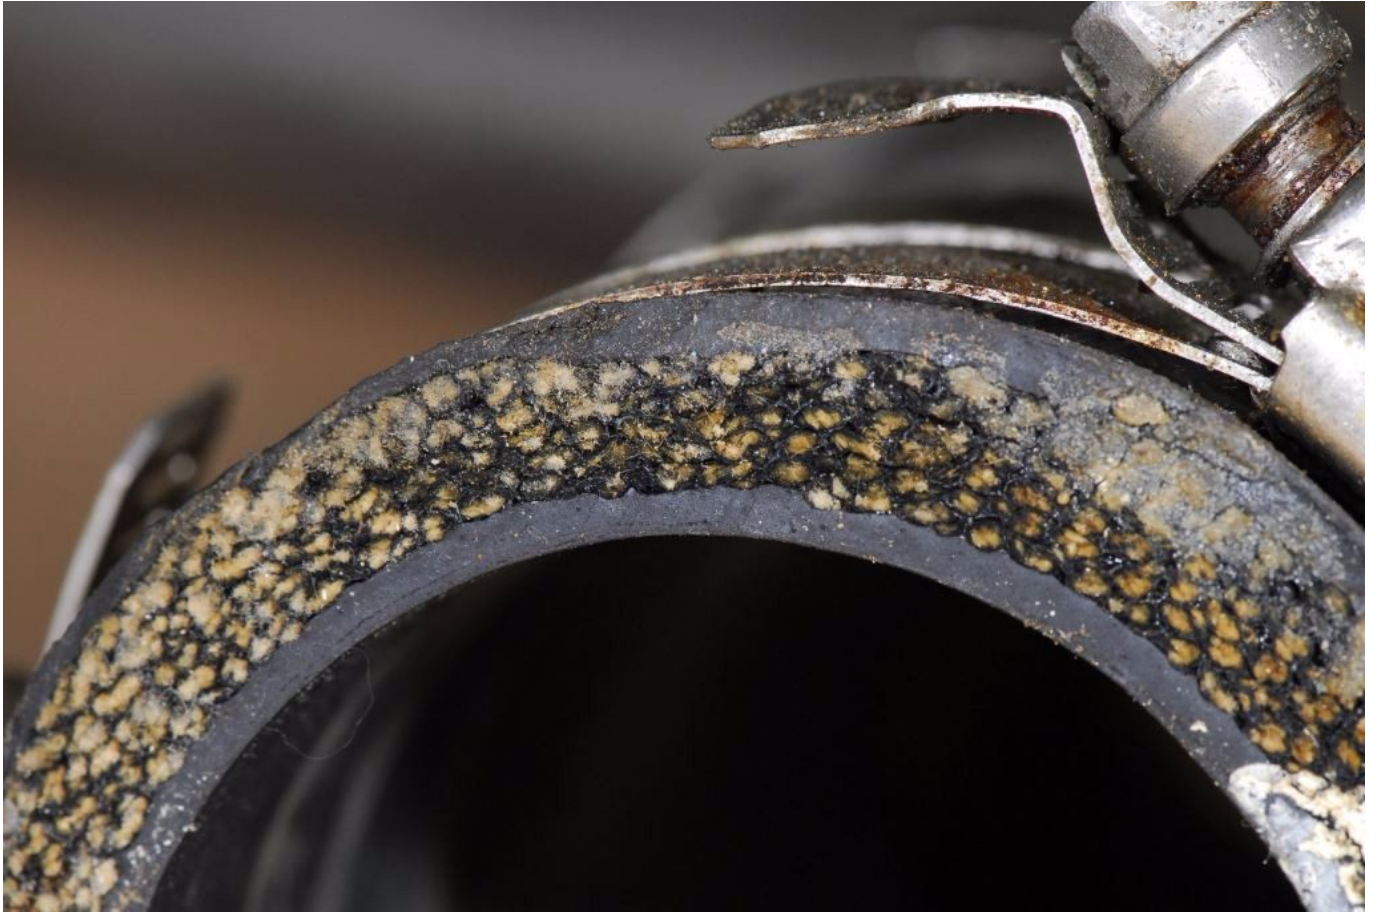
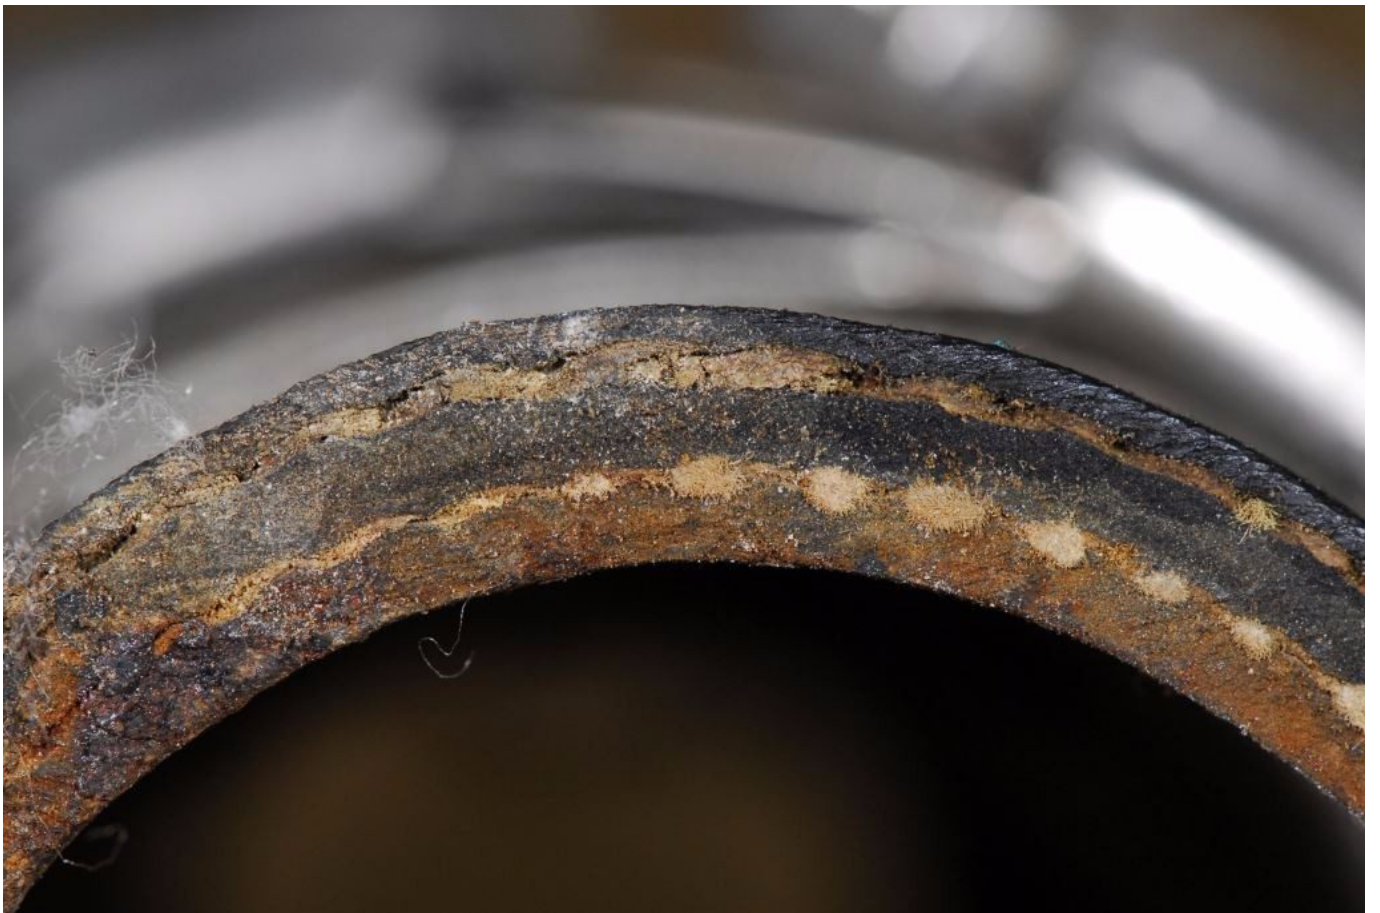
The five plies of a stuffing box hose (top) are clear to see,

compared to ordinary hose's three plies (above).

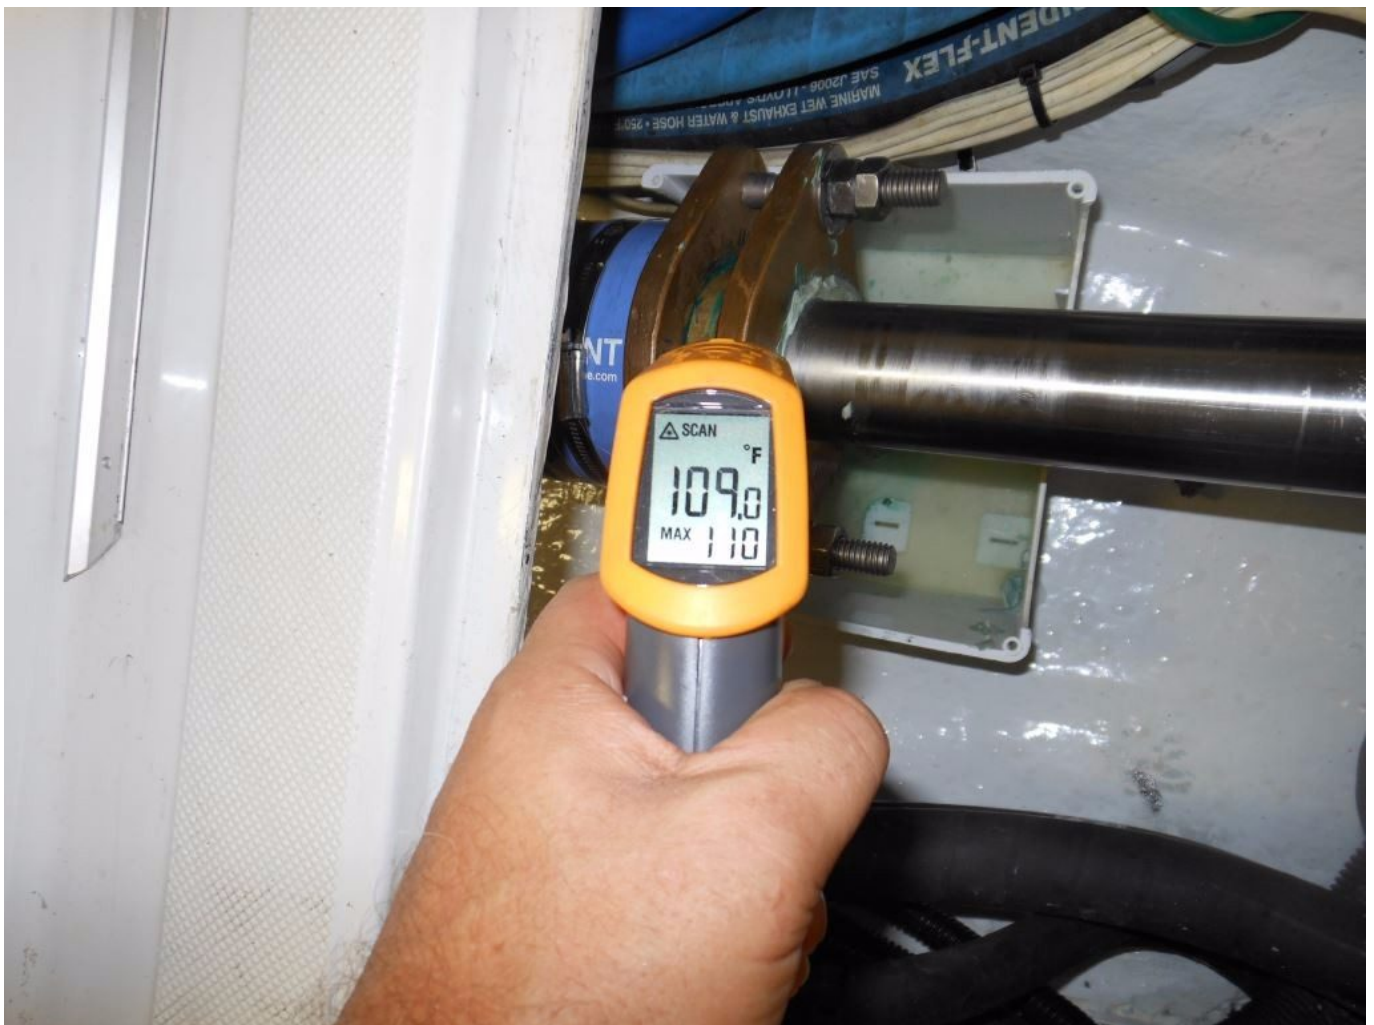
Infrared pyrometers have changed the way stuffing boxes are adjusted, now it's a measurable balance between heat and drip

rate.

The watch phrase when repacking a stuffing box, regardless of the material, is careful monitoring for the first few hours of operation. Using an infra-red pyrometer, the stuffing box temperature should be monitored during this time, shooting the stuffing box and not the shaft (highly reflective surfaces such as shafts and hose clamps will often give erroneous readings); adjustments should be made if necessary. No part of the stuffing box should exceed more than 30°F-40°F above ambient seawater temperature, regardless of drip rate, while at any speed. In fact, with access to an infrared pyrometer, drip rates are much less important than they once were.

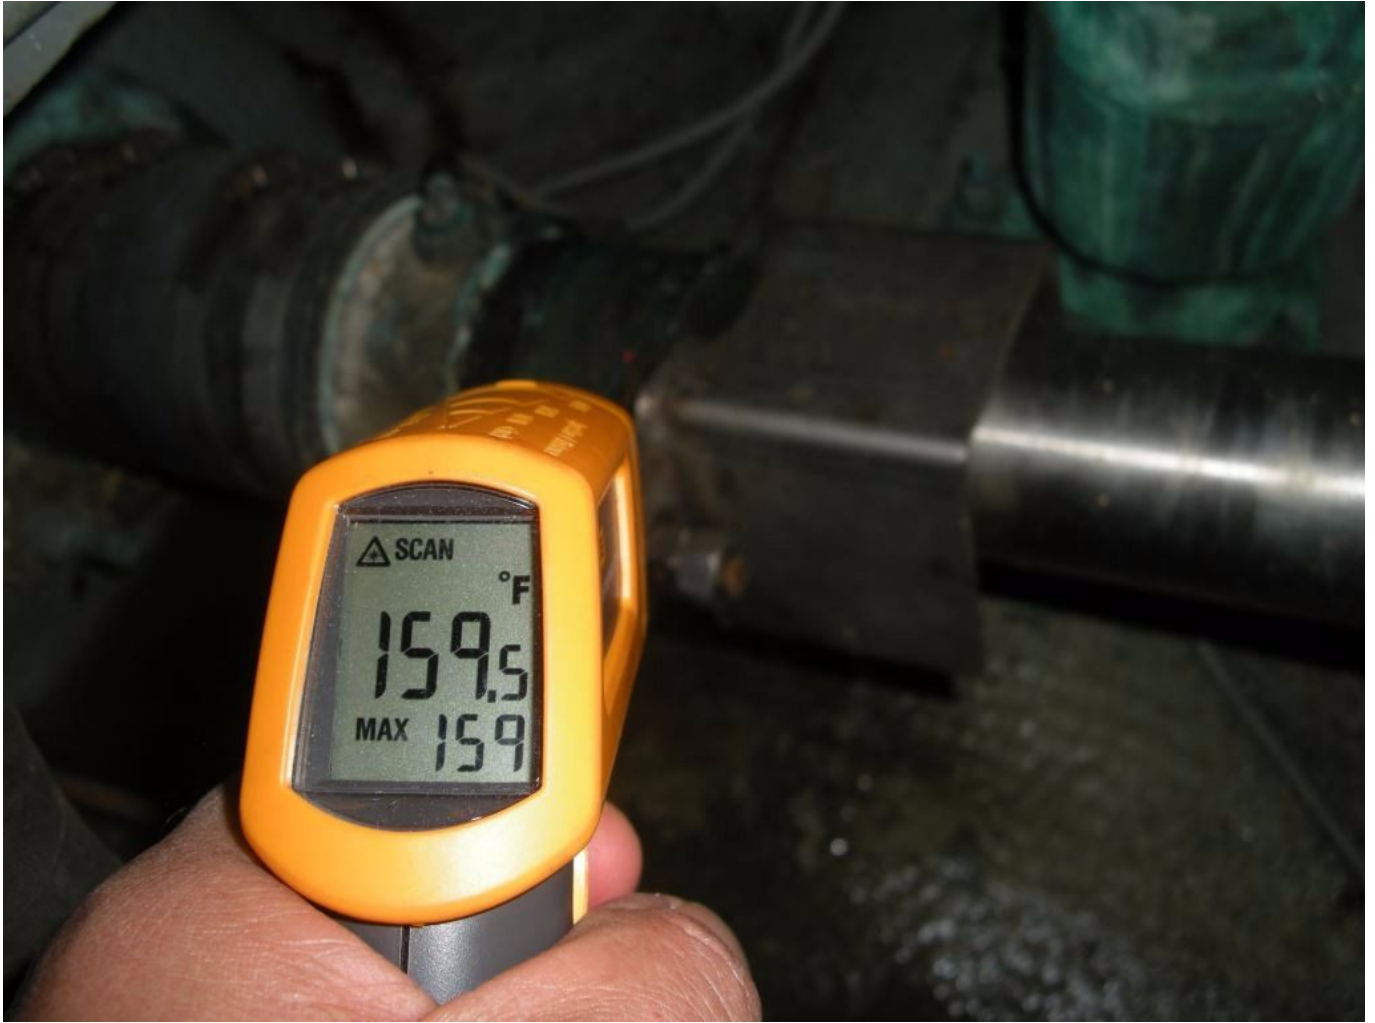
Stuffing box temperature should not exceed that of the water in which the vessel is operating by more than 30°F-40°F. The one shown here is clearly starved for water and is overheating.

Ultimately, the arbiter of correct stuffing box adjustment is temperature rather than drips per minute. Once properly adjusted, the stuffing box should leak little and be no hotter than about 30°F-40°F above ambient water temperature. If it is over tightened the wax in the packing will melt and run out of the stuffing box as a liquid, often accumulating under the stuffing box as a greenish pyramid, after which it will leak copiously. If necessary, this entire procedure can be carried out while the vessel is afloat. Once the packing nut is removed simply secure several wraps of a rag around the stuffing box where the shaft exits to temporarily stem the flow of water. Water will leak during reassembly; however, provided you work quickly it will be comparatively little. Check your stuffing box regularly and provide it with the care it needs. Doing so will yield the dividends in both longevity

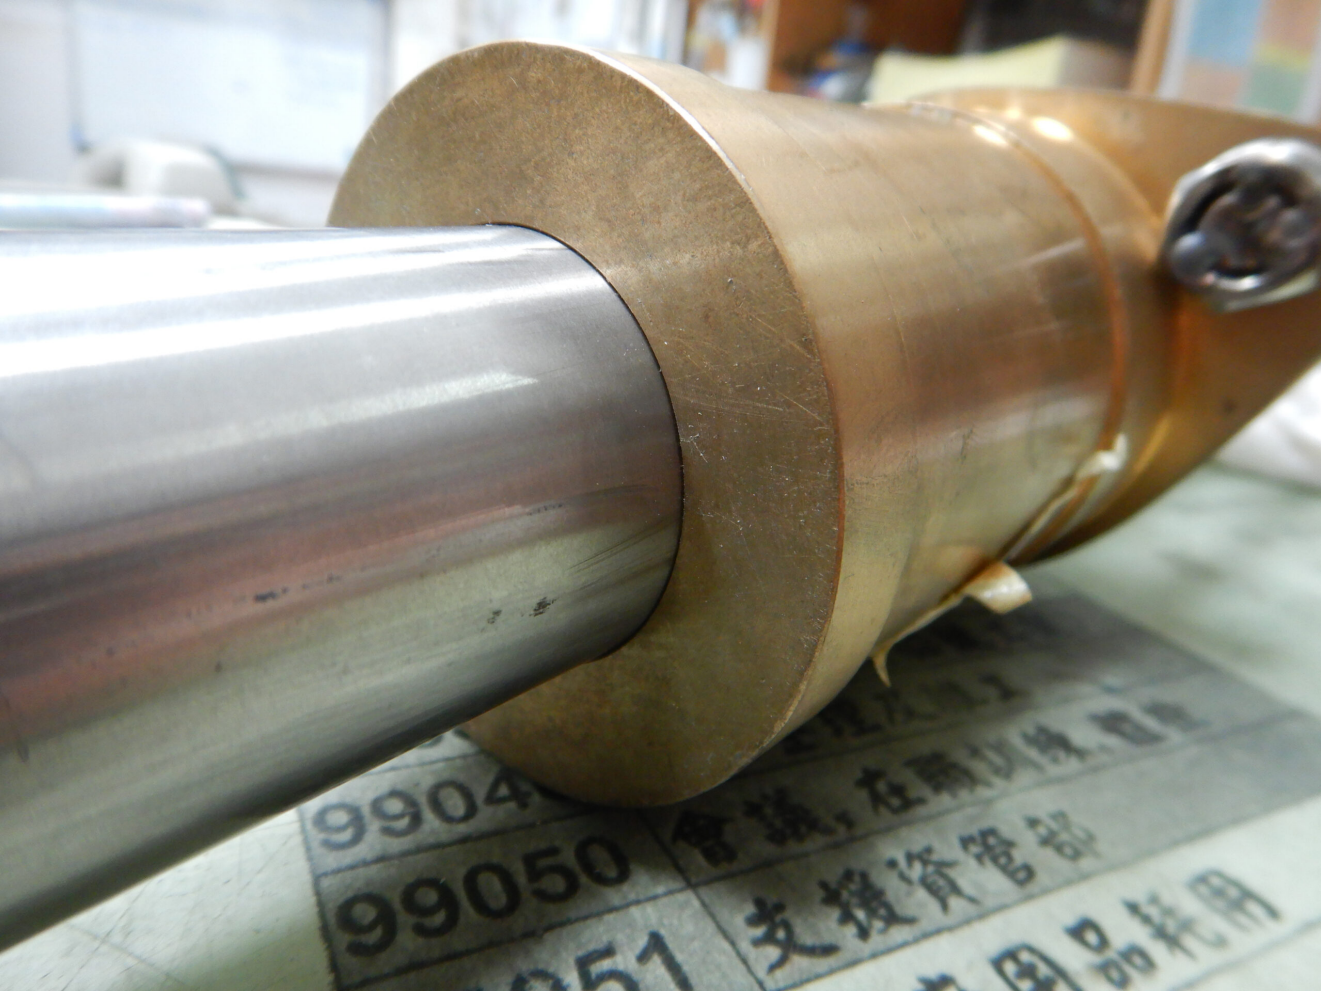
Clearance between the outside diameter of the shaft and the inside diameter of the stuffing box is critical, too much and packing will be pushed into the gap, limiting its

effectiveness, too little and water flow is impeded, which can lead to overheating. One rule of thumb calls for 0.005" clearance, plus an additional 0.005" for every inch of shaft diameter. Thus, a 3" diameter shaft would have 0.020" of clearance.

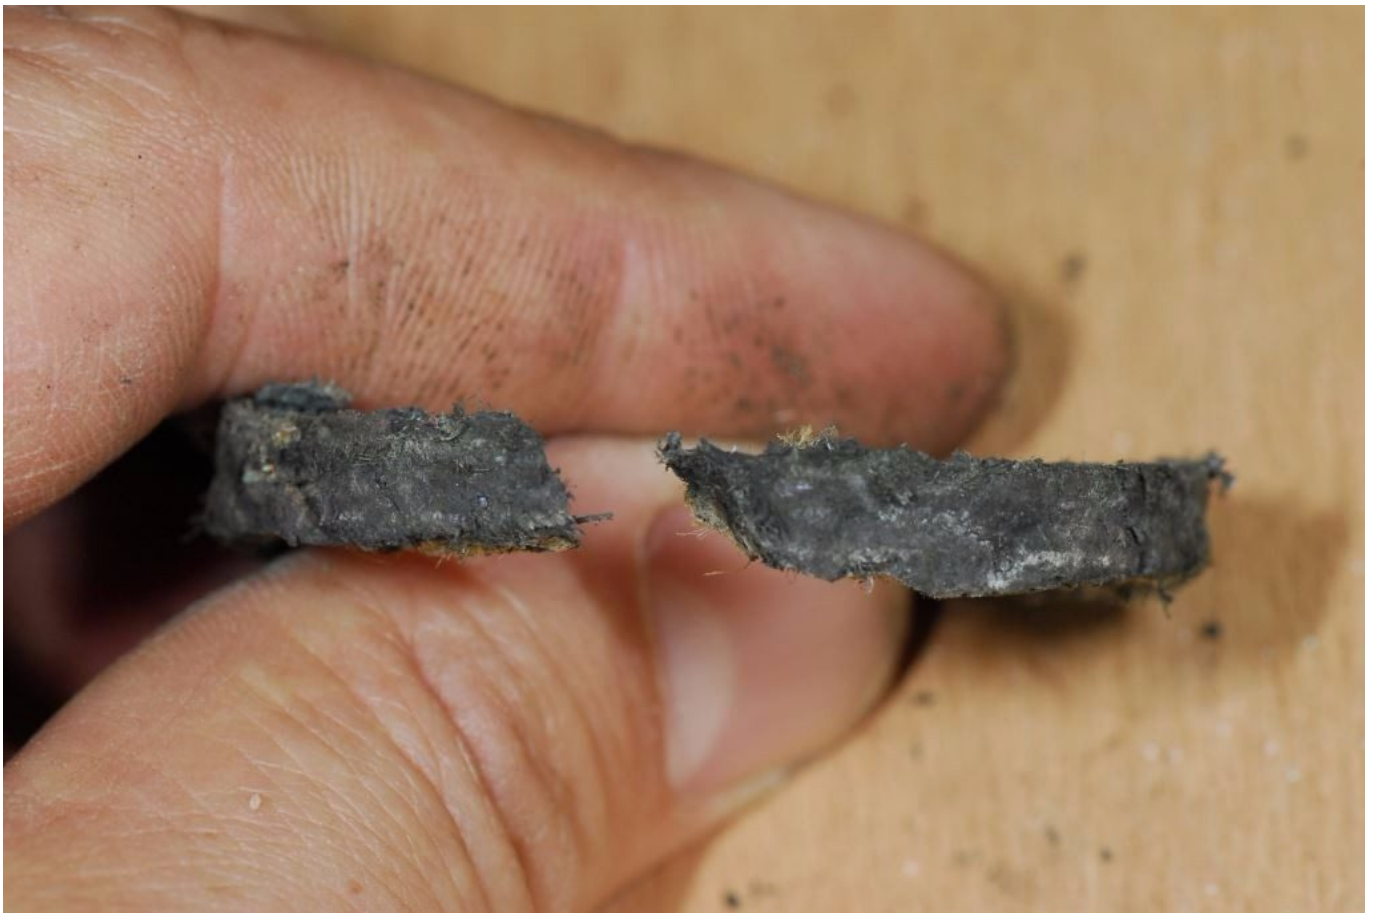
Packing should be cut at a 45° angle to provide a leak-resistant lap joint.

Unless instructed otherwise by the stuffing box manufacturer, *three* new rings of packing material should be cut, their inside diameter matching exactly the outside diameter of the shaft; the ends of each piece of packing should be cut on a forty-five degree angle so they mate in an overlapping fashion. I find it helpful to apply a coating of high viscosity grease (I prefer Lubrimatec's green Trailer Wheel Bearing Grease) to the packing sections as I install them, this acts as a lubricant and it helps keep the sections in place as they are inserted into the stuffing box recess or nut carrier. These joints should be spaced 120° apart, or at the 12, 4 and 8 o'clock position.

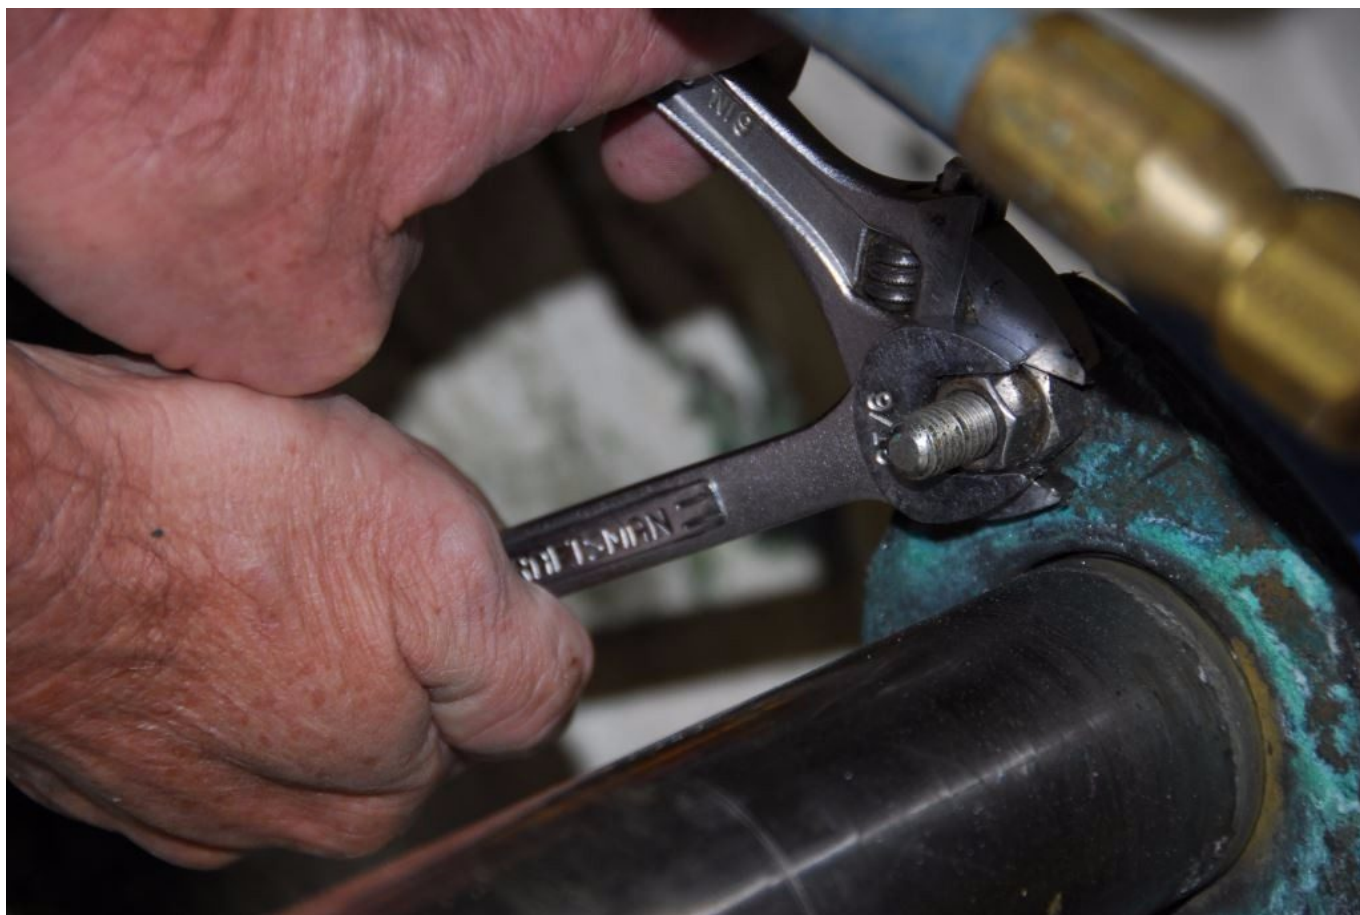
Two wrenches must be used when tightening packing lock nuts, to ensure adequate tension is developed between the two nuts.

The packing nut should be made snug, not much more than hand tight initially. How tight is a subjective measure, however, it doesn't matter because it will likely be adjusted once the vessel is launched and the engine run. Initially, it is far better for it to be too loose than too tight. It's critically important that the locking nut(s) be tightened against the packing nut using *two* wrenches, i.e. they need to be tightened to create tension against each other. Tightening one, and then the other, using one wrench, is inadequate and may lead to a loosening and flooding.

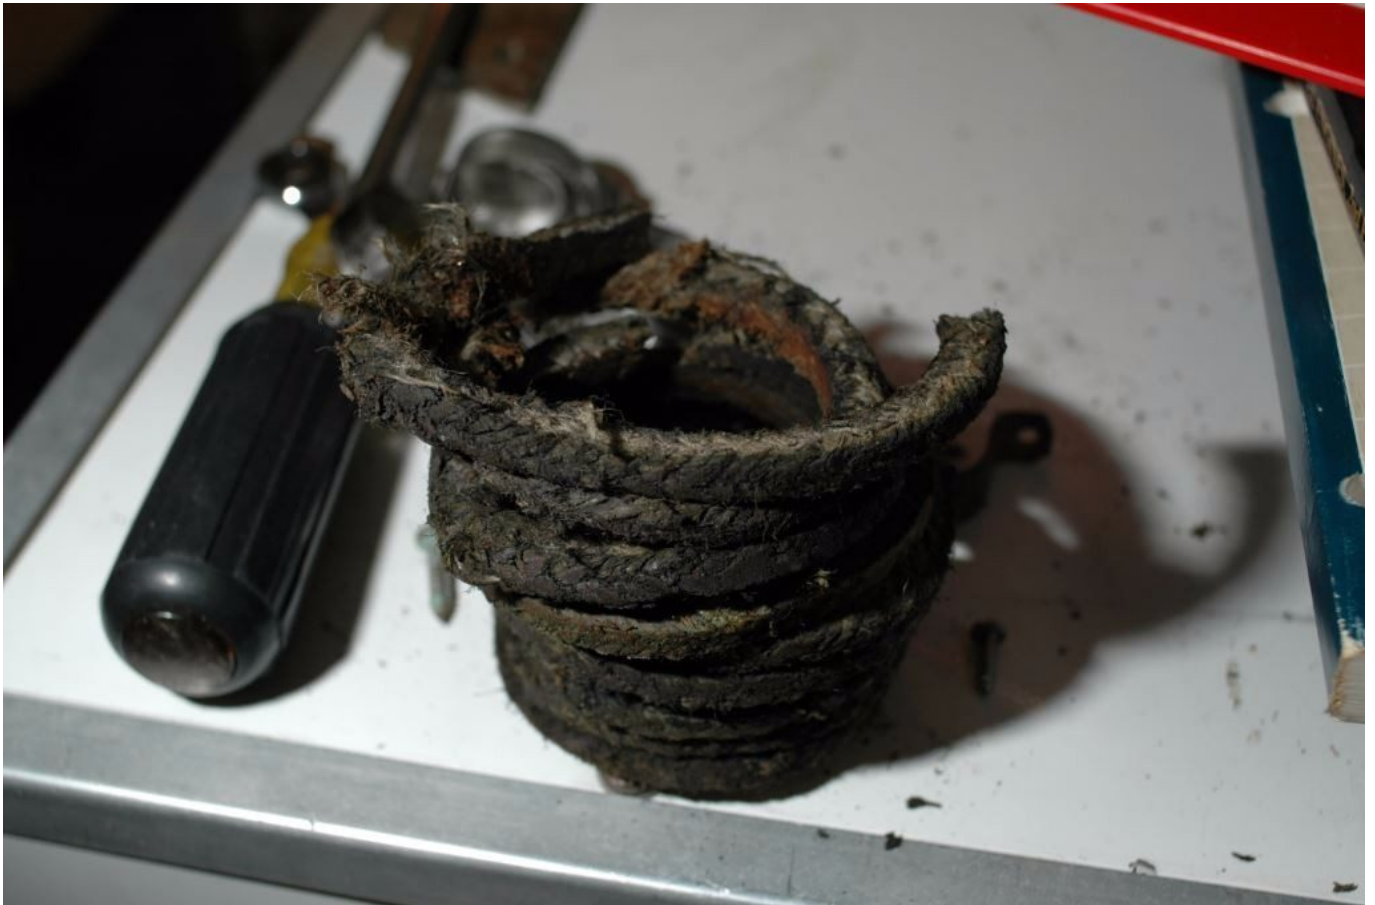
Too much of a good thing; if three wraps don't stem the flow, another problem is almost certainly present. The stuffing box from which this packing came was clearly over-stuffed.
