Conventional Wisdom for Conventional Stuffing Boxes

Text and photos by Steve D'Antonio

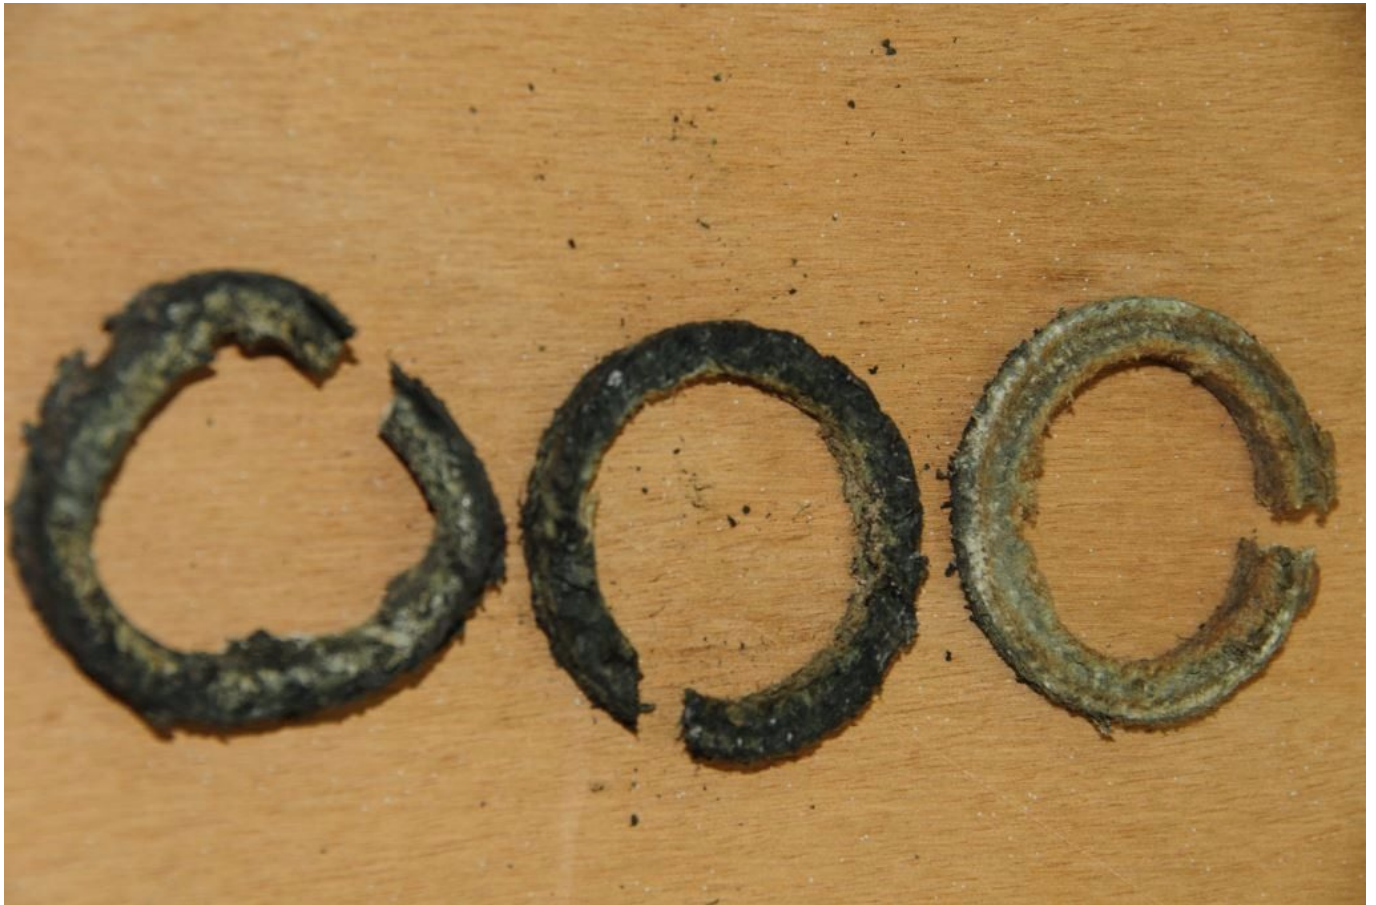
Most stuffing boxes are designed to accept three rings of packing. The joints should be oriented 120° apart from each other.

Unless instructed otherwise by the stuffing box manufacturer, *three* new rings of packing material should be cut, their inside diameter matching exactly the outside diameter of the shaft; the ends of each piece of packing should be cut on a forty-five degree angle so they mate in an overlapping fashion. I find it helpful to apply a coating of high viscosity grease (I prefer Lubrimatic's green Trailer Wheel Bearing Grease) to the packing sections as I install them, this acts as a lubricant and it helps keep the sections in place as they are inserted into the stuffing box recess or nut carrier. These joints should be spaced 120° apart, or at the 12, 4 and 8 o'clock position.
