Conventional Wisdom for Conventional Stuffing Boxes

Text and photos by Steve D'Antonio

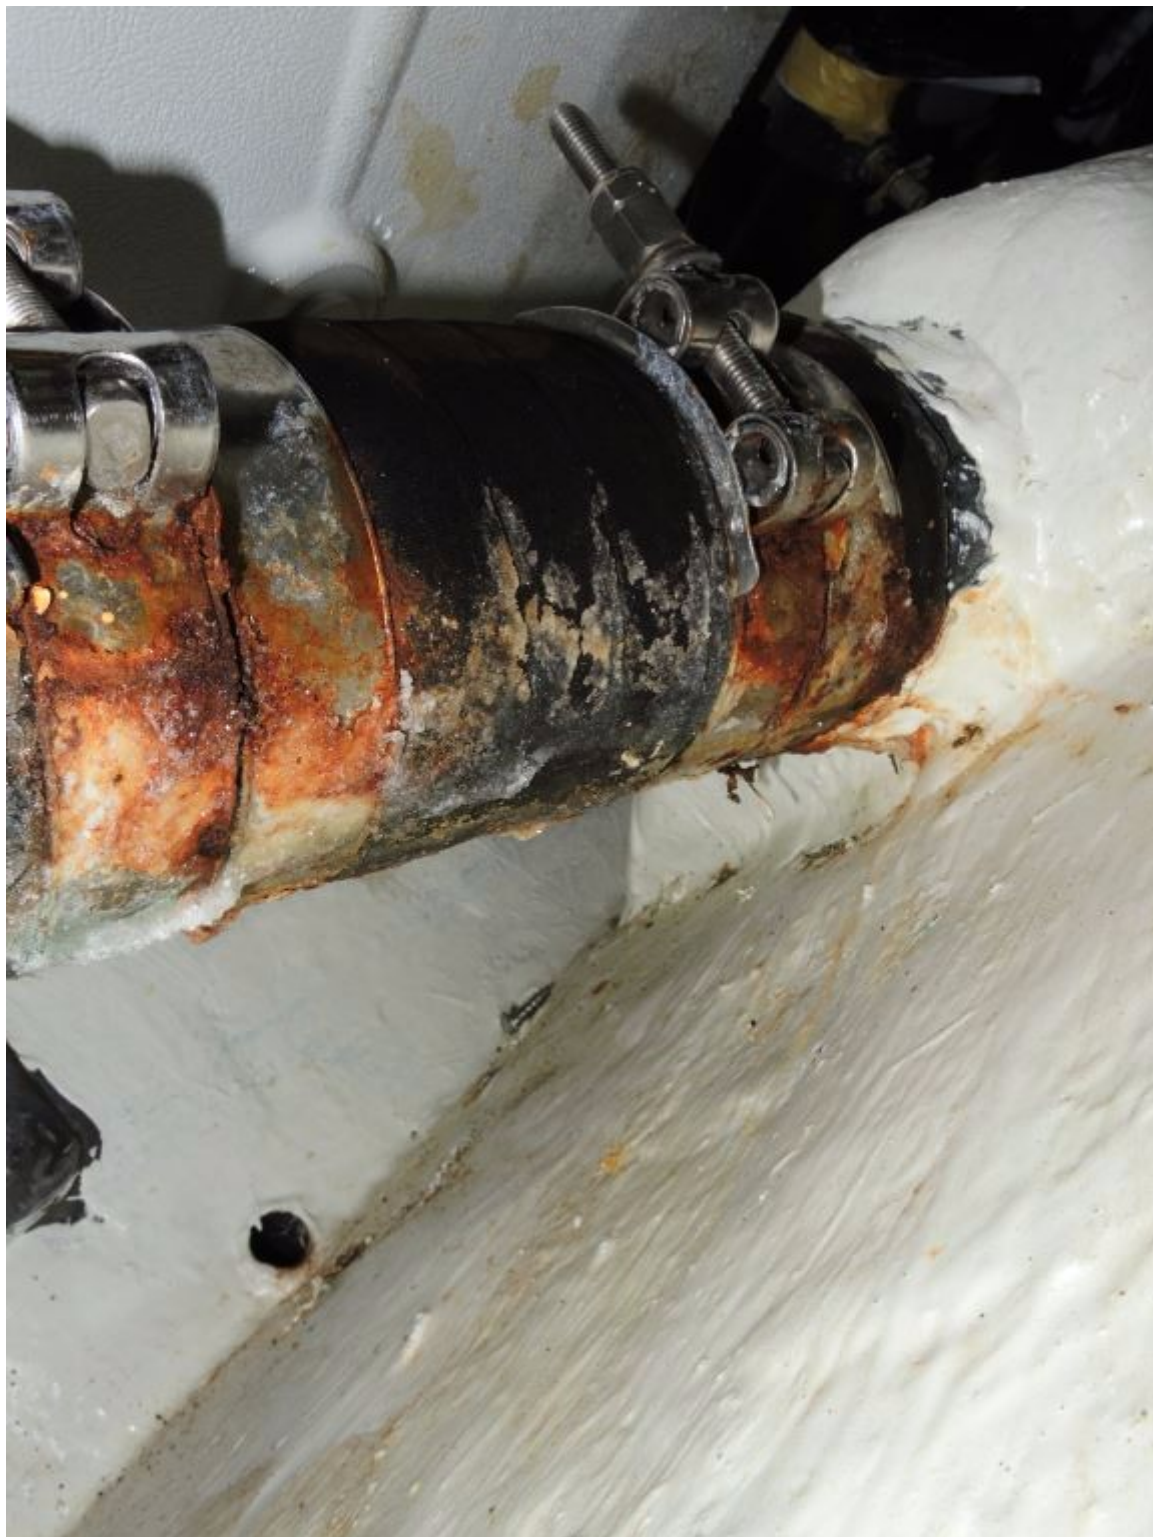
Chronically leaking stuffing boxes lead to more than just wet bilges. These clamps are seriously corroded as a result of

regular exposure to seawater.
