# Conventional Wisdom for Conventional Stuffing Boxes

Text and photos by Steve D'Antonio

## Conventional Wisdom for Conventional Stuffing Boxes

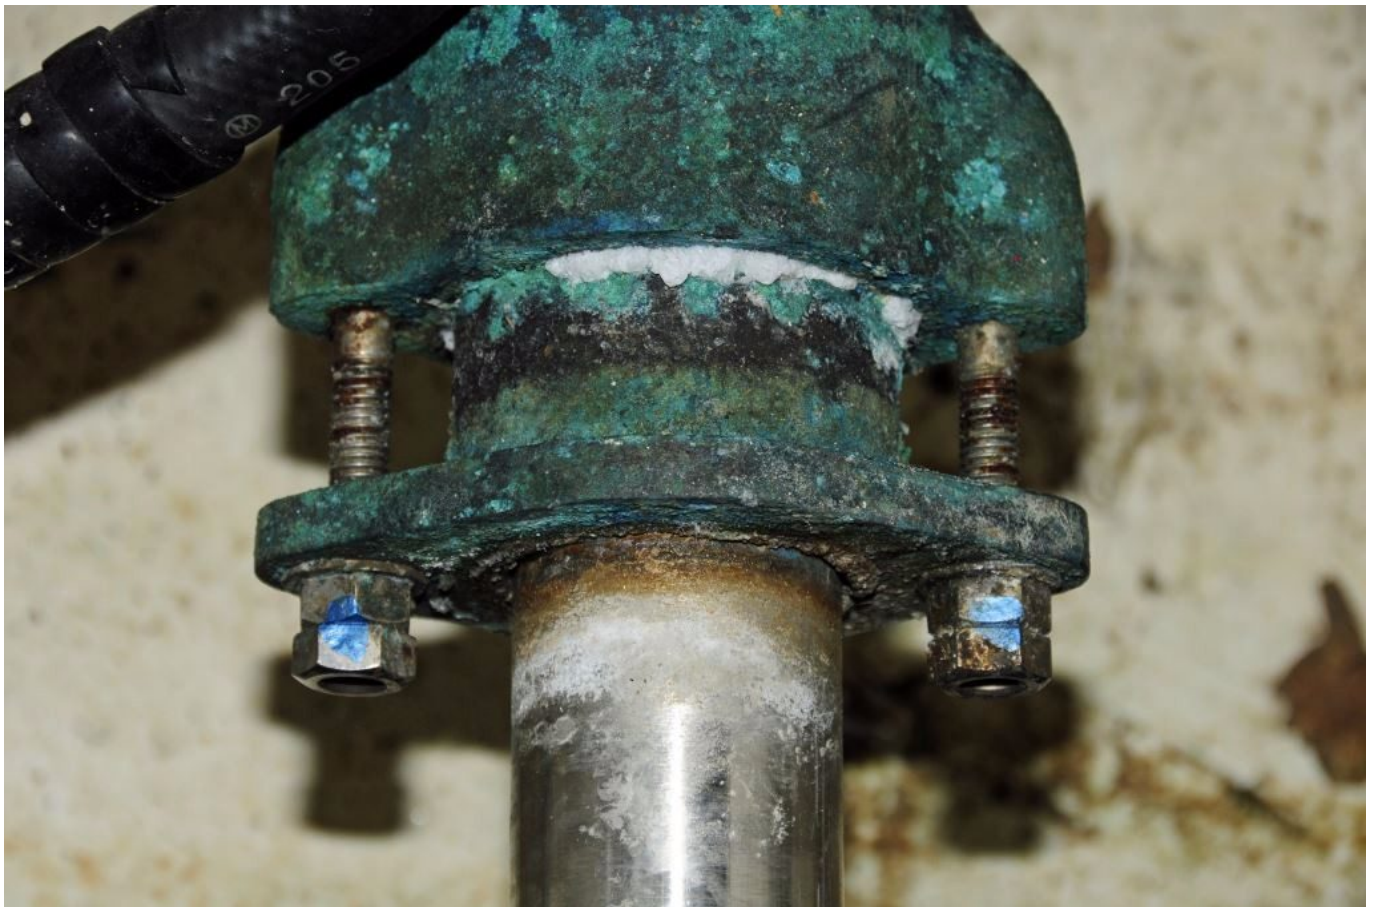
**The stainless steel studs used on some stuffing boxes can suffer from corrosion. In many case these can be cleaned, and the studs corrosion inhibited; if extreme, however, these should be replaced. Bronze studs, on the other hand, are virtually immune to this phenomenon.**

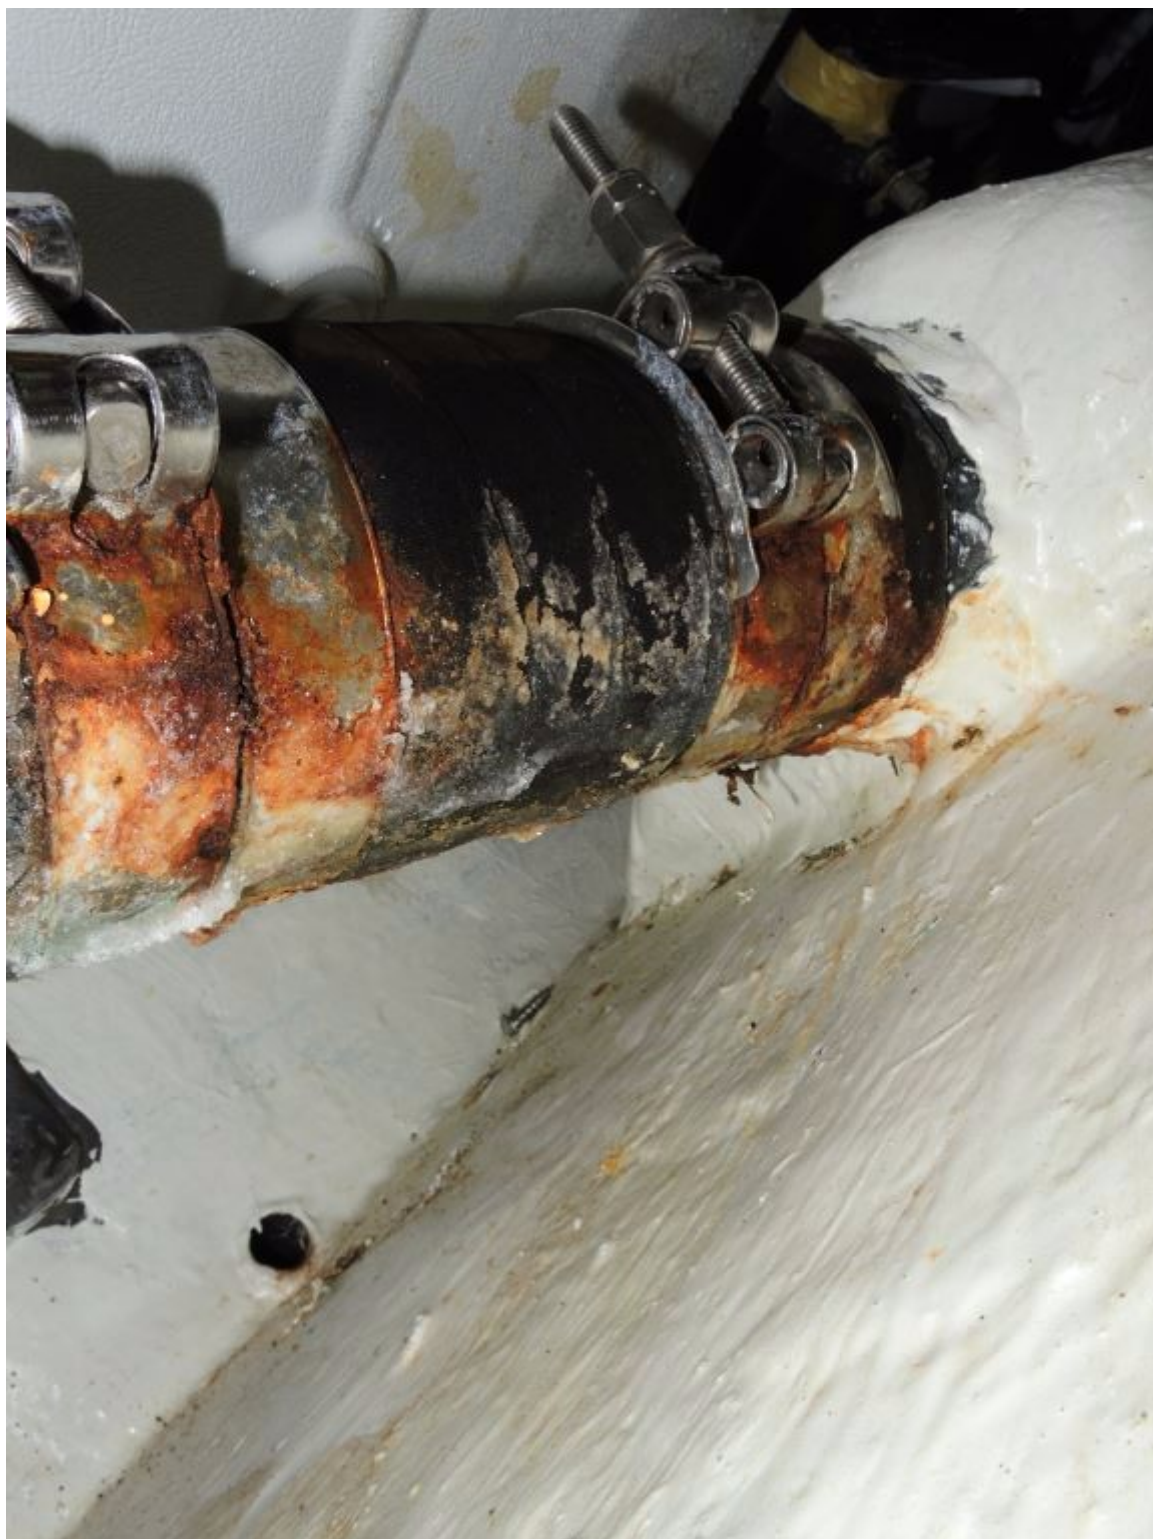
**Chronically leaking stuffing boxes lead to more than just wet bilges. These clamps are seriously corroded as a result of**

## **regular exposure to seawater.**

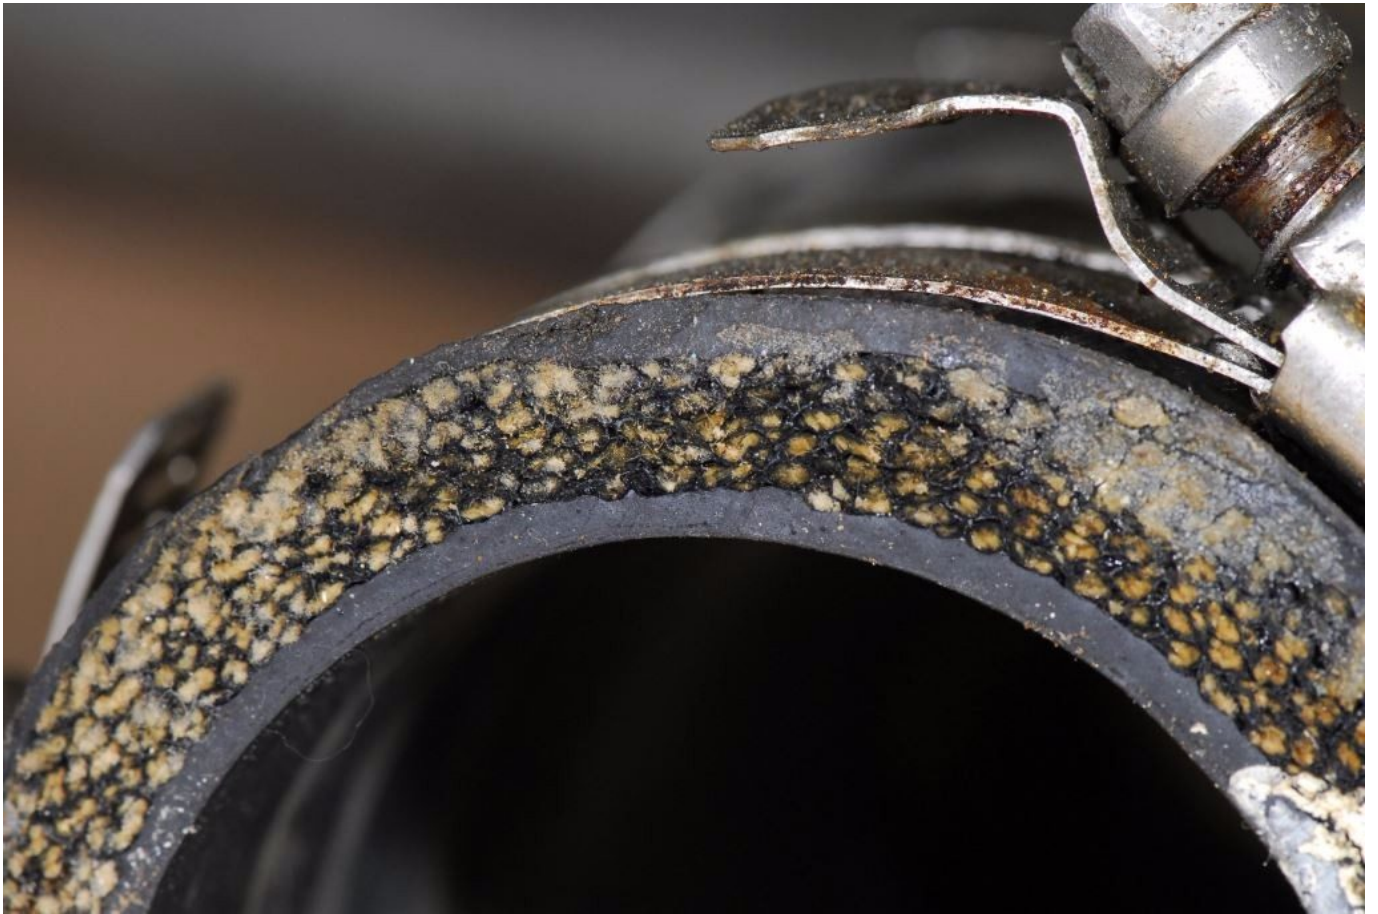
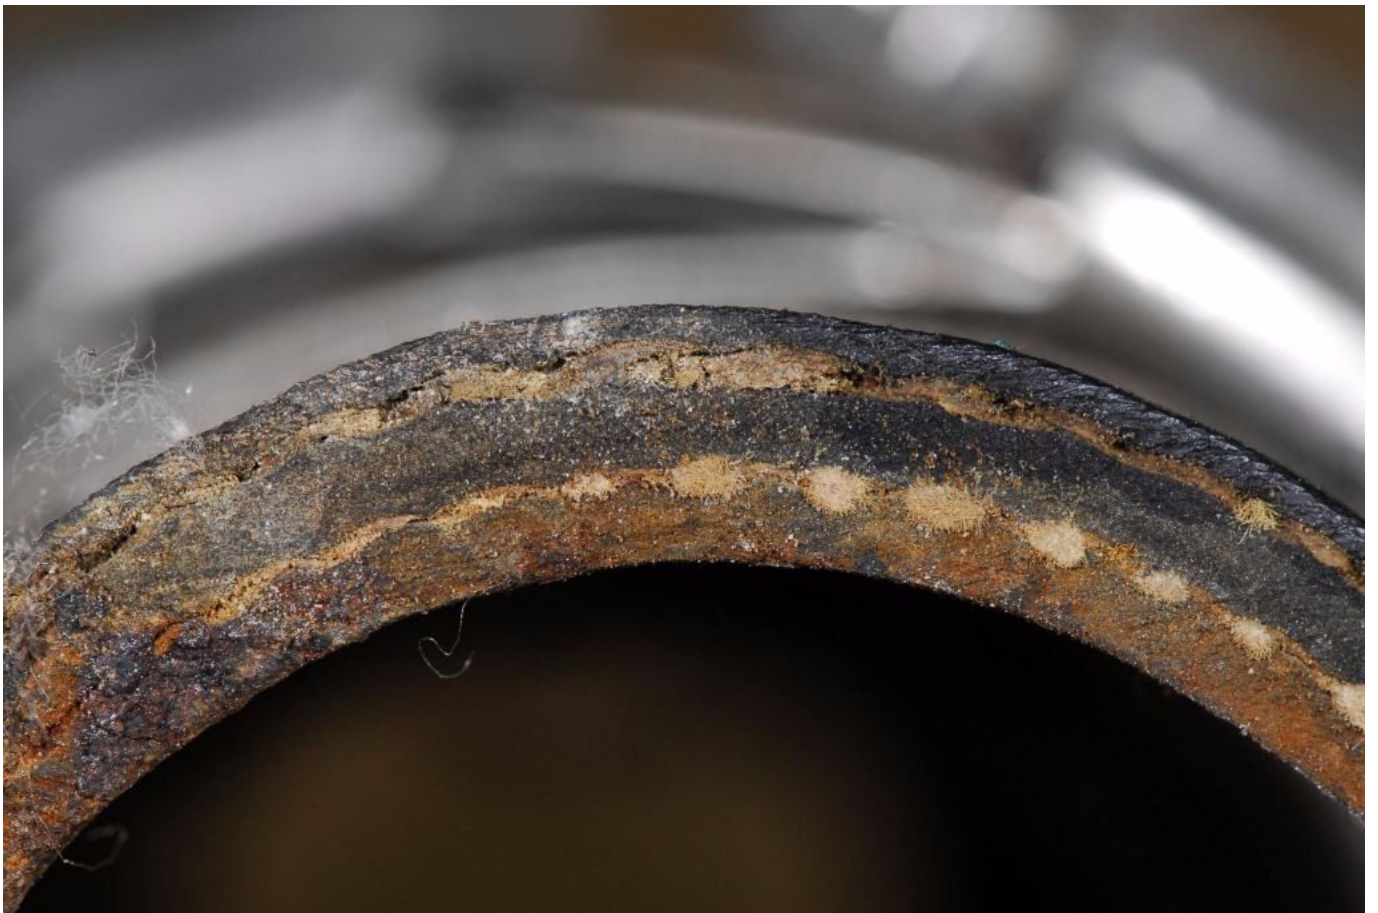
The five plies of a stuffing box hose (top) are clear to see,

**compared to ordinary hose's three plies (above).**

While it may look ordinary, the hose used with conventional stuffing boxes is, or should be, proprietary. Ordinary raw water or exhaust hose may utilize two or three plies, while proprietary stuffing box hose incorporates five plies. Because hose used in stuffing box applications lives an especially hard life, it's submerged, vibrated and routinely twisted in forward and reverse, the added heft of five plies is a clear value added, and equates to longer life. Replacement of the stuffing box hose is invariably time consuming in that it requires separation of the propeller shaft from the transmission coupling. It is also, therefore, a task that must be carried out while the vessel is hauled. Conventional, conservative wisdom dictates that stuffing box hoses should be preemptively replaced approximately every five to seven years or when warranted by visible hose deterioration. One critical issue involves hose length, or more importantly, the length of "free hose" between the stuffing box pipe to hose adapter and the shaft log. This free hose length must be long enough to allow the hose to float freely on the shaft, avoiding side-loading, binding, and the overheating it can cause.

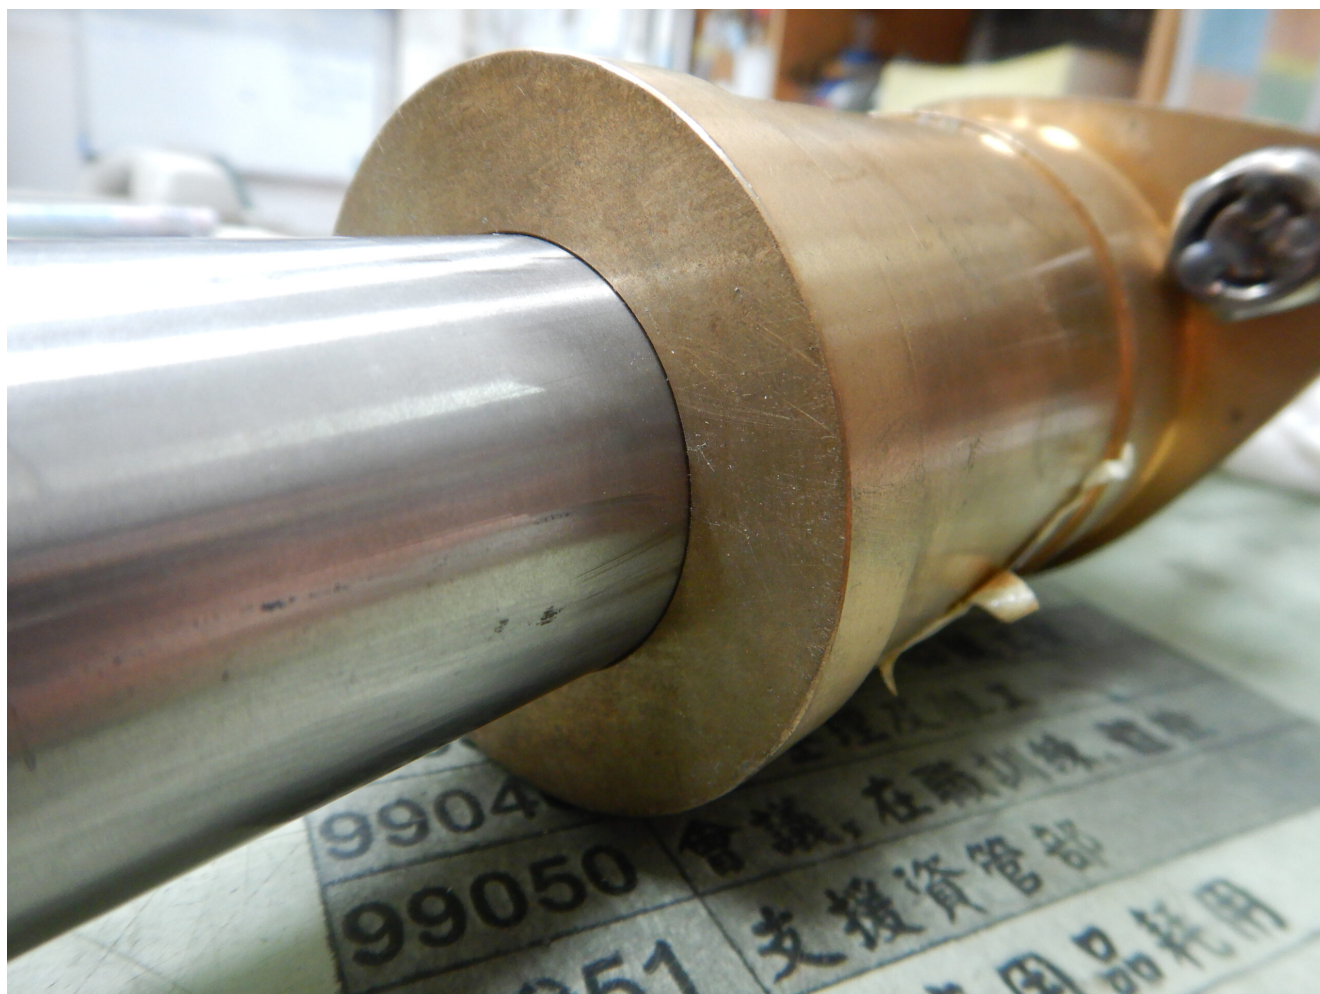
**Clearance between the outside diameter of the shaft and the inside diameter of the stuffing box is critical, too much and packing will be pushed into the gap, limiting its**

effectiveness, too little and water flow is impeded, which can lead to overheating. One rule of thumb calls for 0.005" clearance, plus an additional 0.005" for every inch of shaft diameter. Thus, a 3" diameter shaft would have 0.020" of clearance.

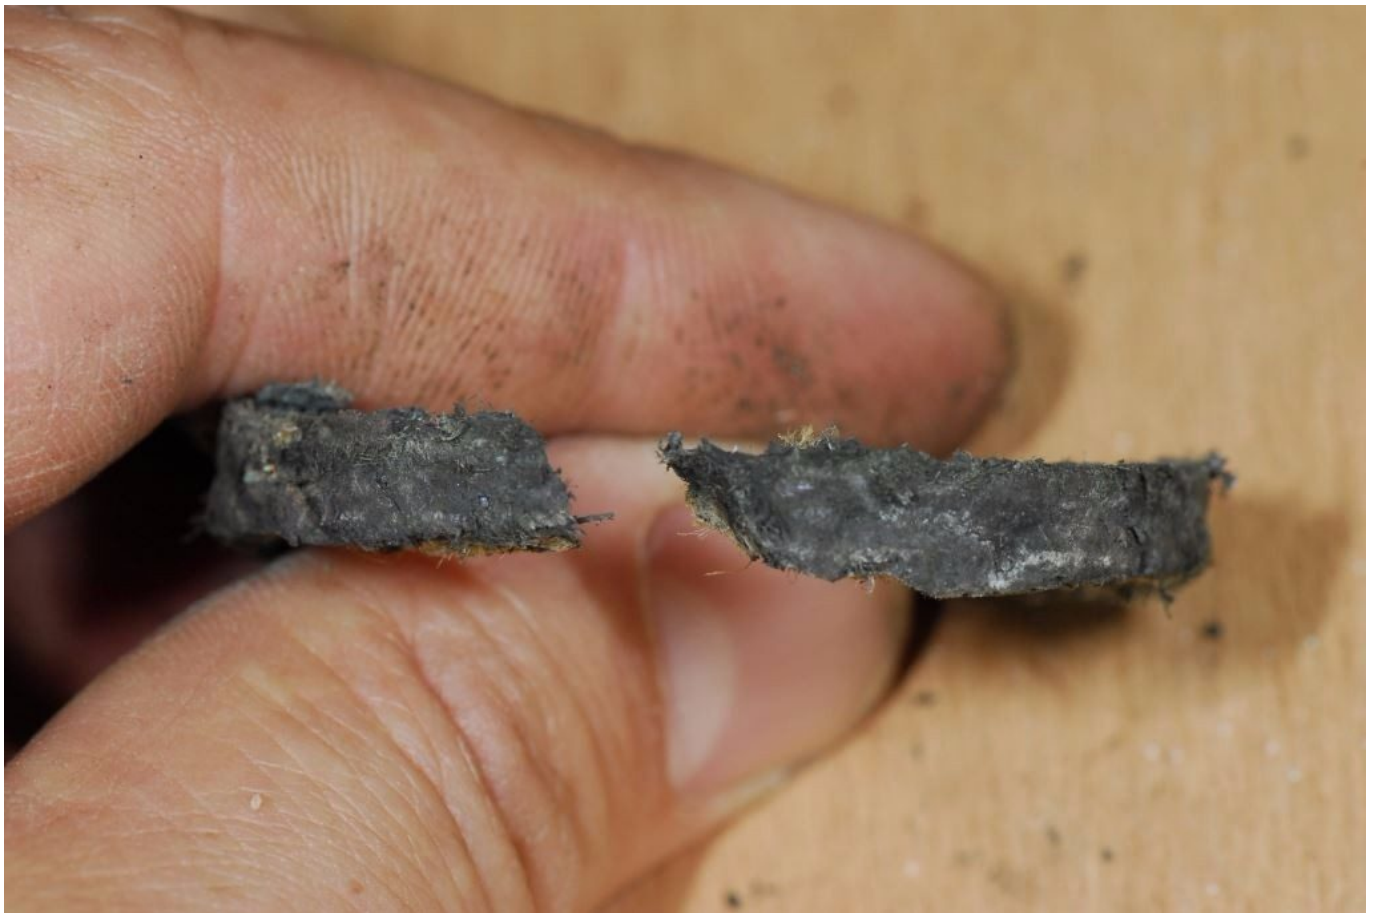
**Packing should be cut at a 45° angle to provide a leak-resistant lap joint.**

Unless instructed otherwise by the stuffing box manufacturer, *three* new rings of packing material should be cut, their inside diameter matching exactly the outside diameter of the shaft; the ends of each piece of packing should be cut on a forty-five degree angle so they mate in an overlapping fashion. I find it helpful to apply a coating of high viscosity grease (I prefer Lubrimatic's green Trailer Wheel Bearing Grease) to the packing sections as I install them, this acts as a lubricant and it helps keep the sections in place as they are inserted into the stuffing box recess or nut carrier. These joints should be spaced 120° apart, or at the 12, 4 and 8 o'clock position.

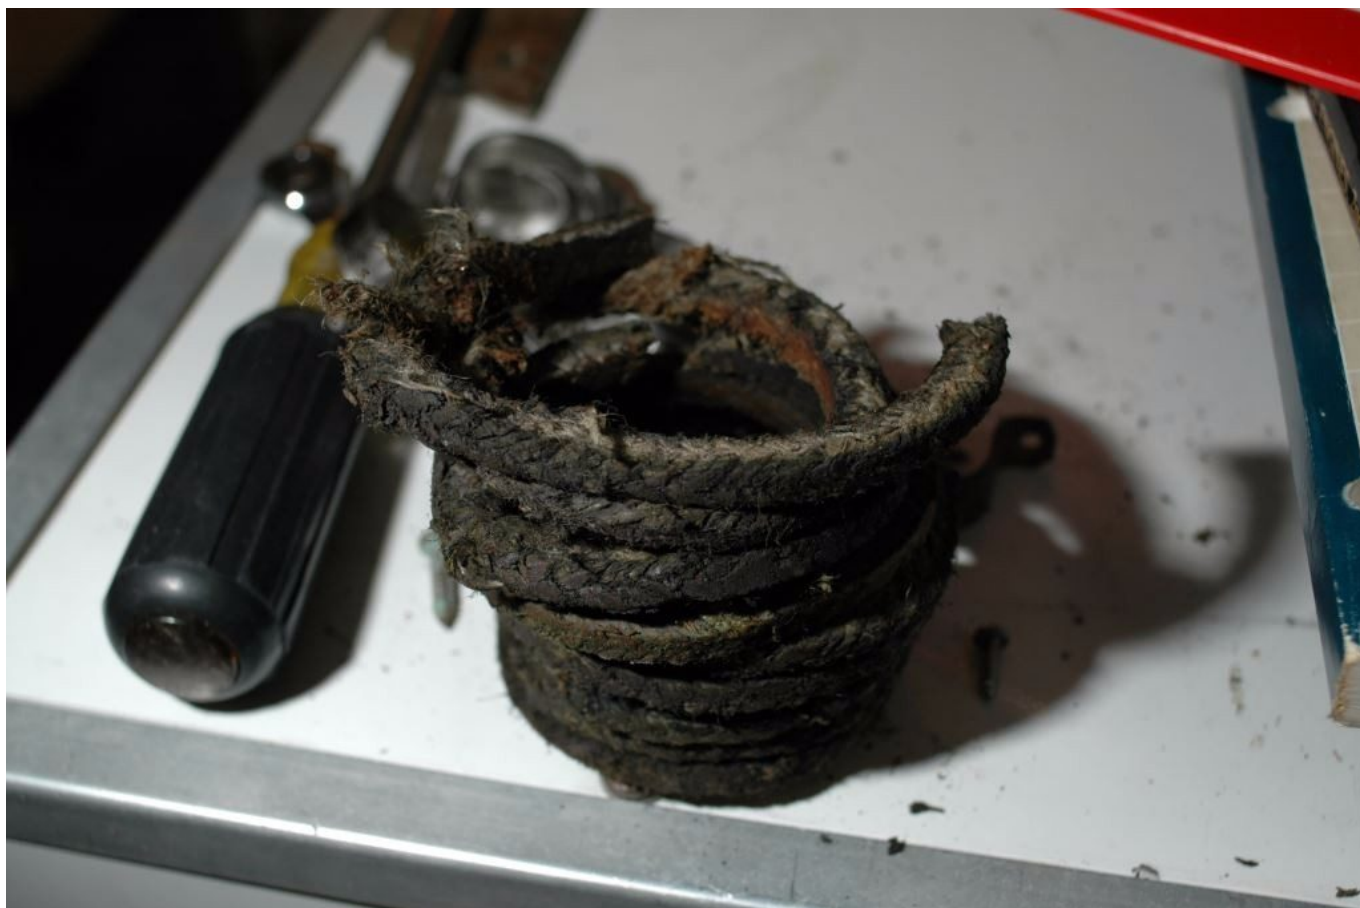
**Too much of a good thing; if three wraps don't stem the flow, another problem is almost certainly present. The stuffing box from which this packing came was clearly over-stuffed.**
