# Conventional Wisdom for Conventional Stuffing Boxes

Text and photos by Steve D'Antonio

## Conventional Wisdom for Conventional Stuffing Boxes

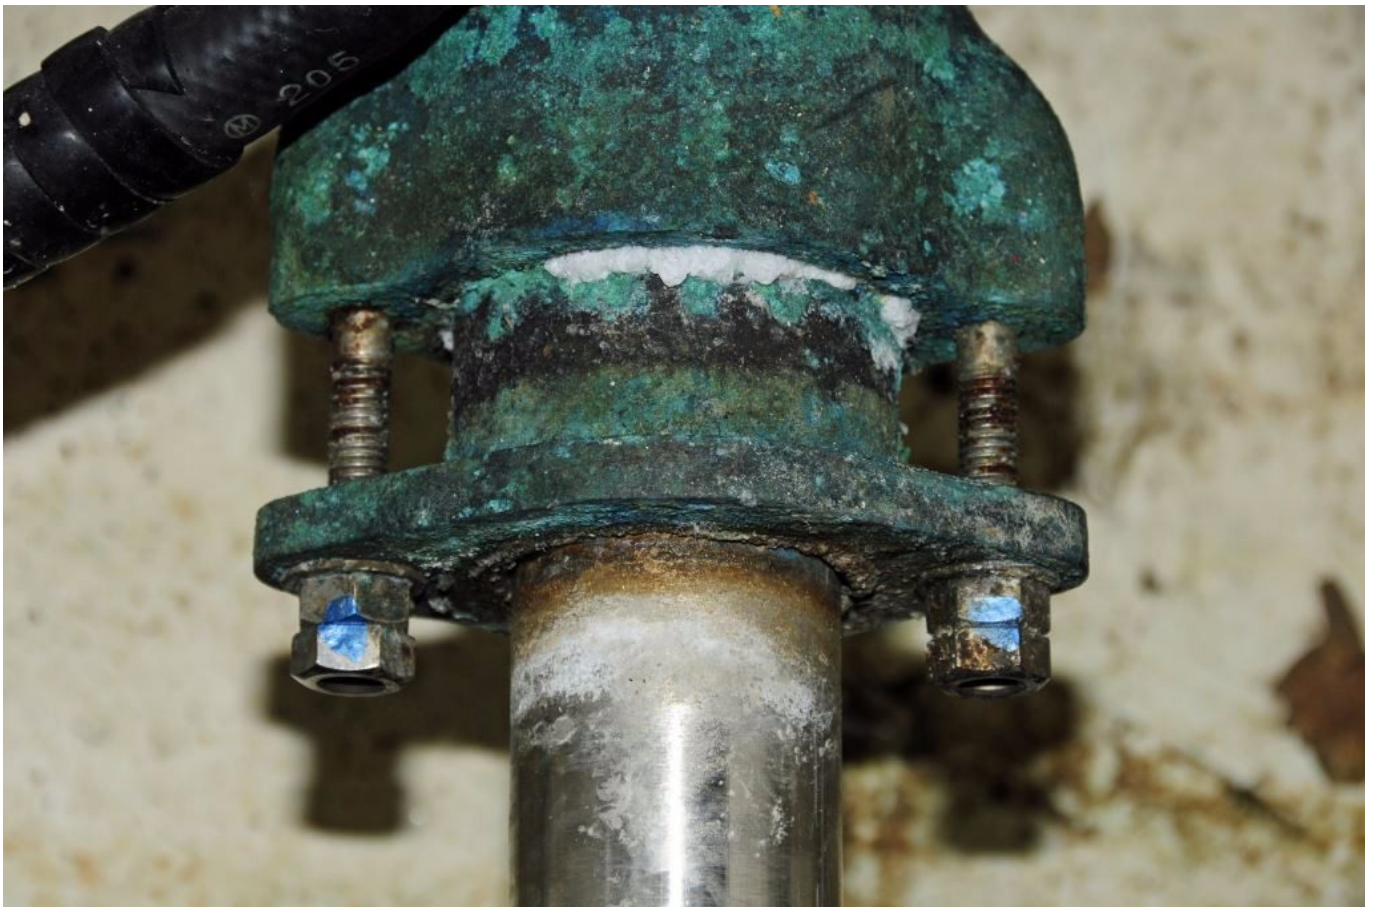
**The stainless steel studs used on some stuffing boxes can suffer from corrosion. In many case these can be cleaned, and the studs corrosion inhibited; if extreme, however, these should be replaced. Bronze studs, on the other hand, are virtually immune to this phenomenon.**

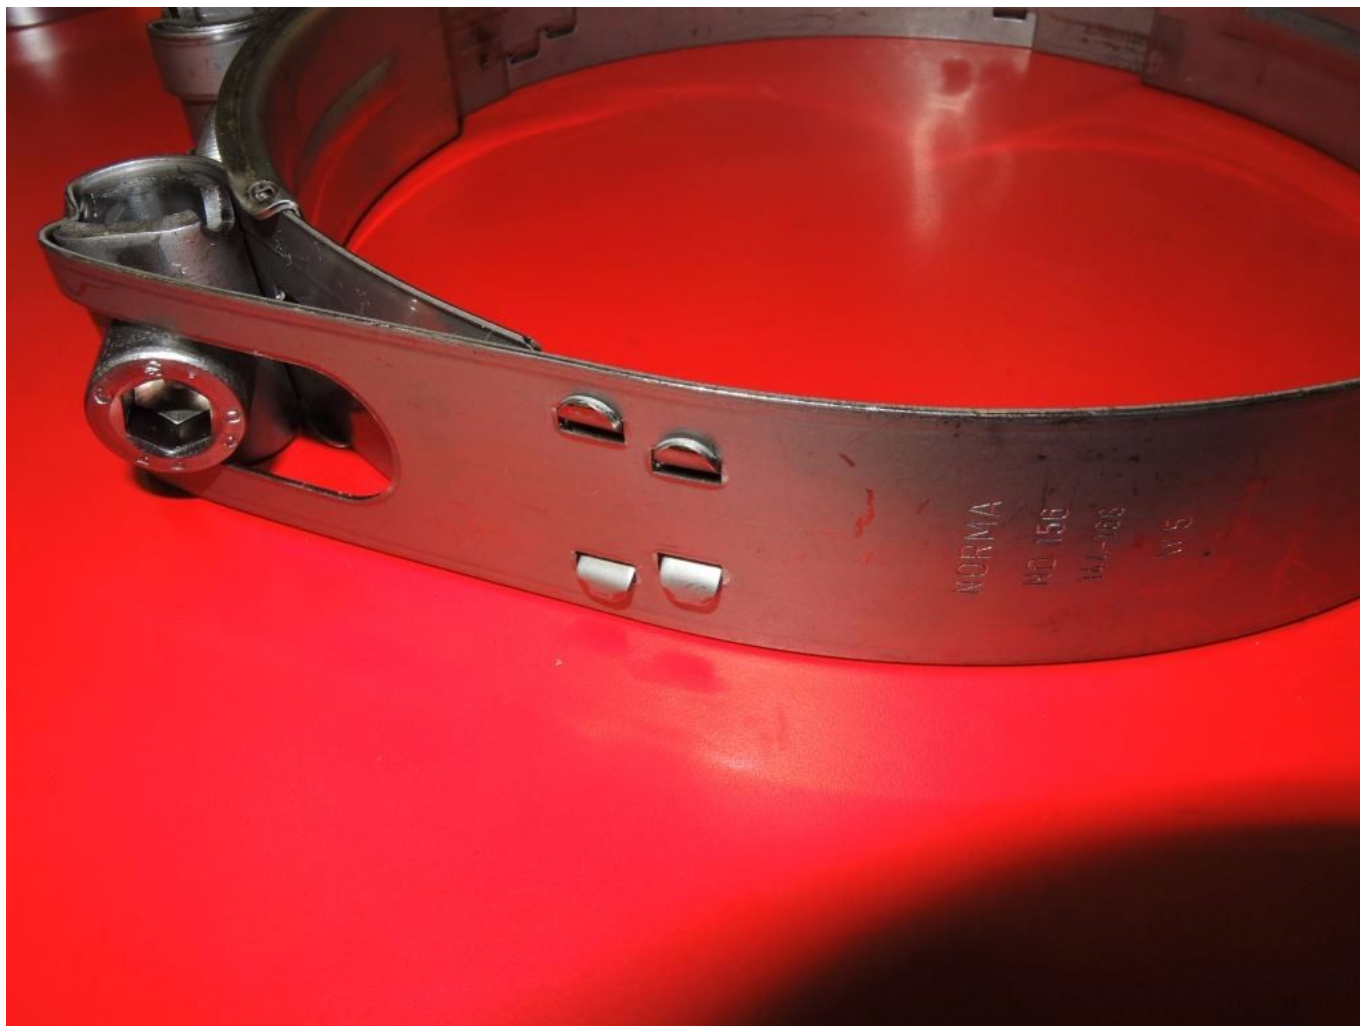
**Because of their resistance to corrosion, interlocking, as opposed to spot welded, hose clamps are ideally suited for conventional stuffing box use.**

Replacing clamps is straightforward and relatively easy. Replacements should be made from all 316 alloy stainless steel, including the screw, and their bands should be solid rather than perforated (for more on hose clamp selection and

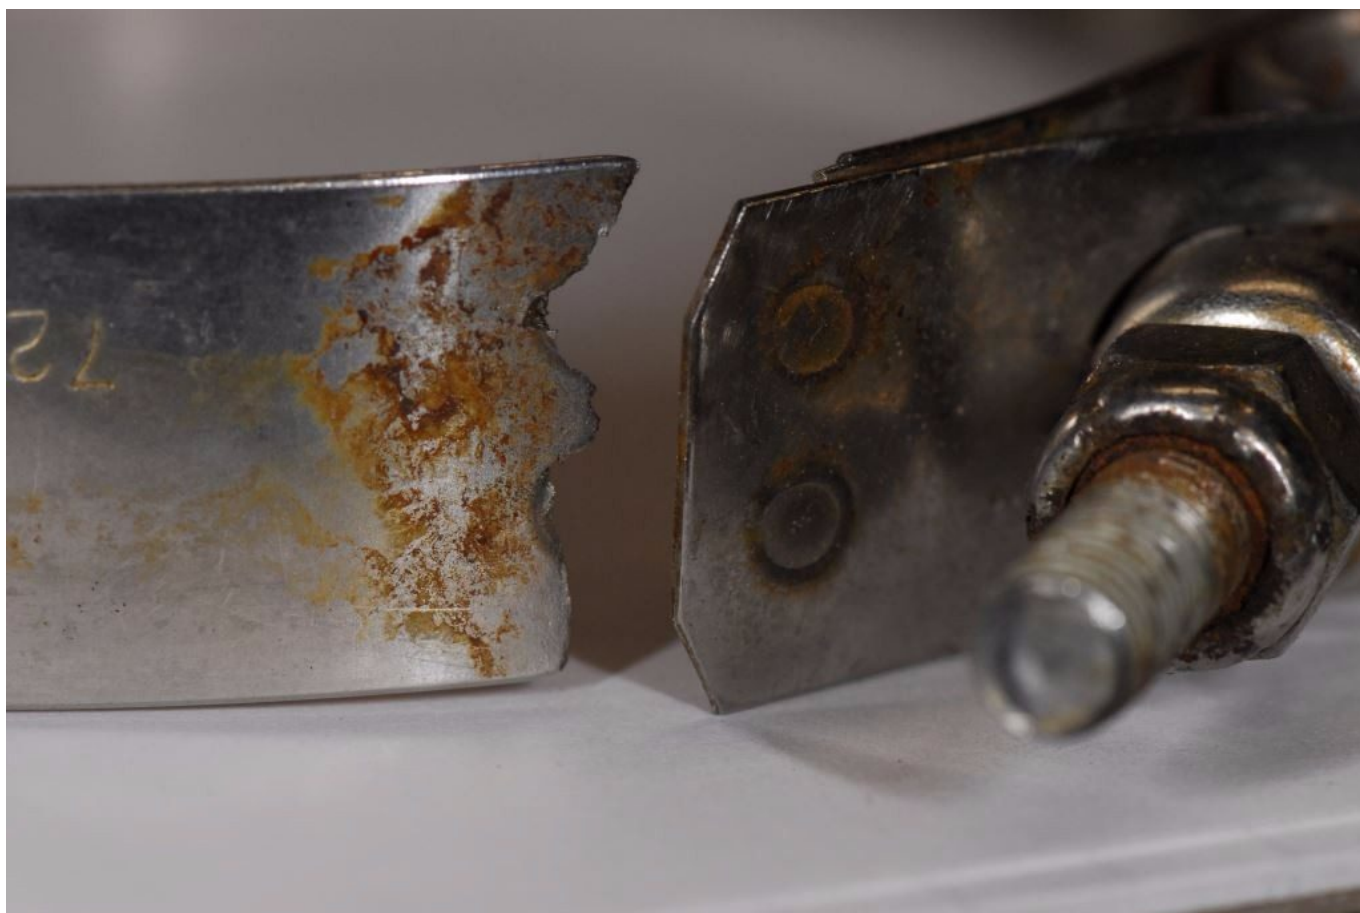
**Folded, spot welded T bolt clamps are prone to crevice corrosion. The one shown here, used on a stuffing box, has parted; the fold was oriented along the bottom of the stuffing box hose.**

Instead, use clamps that are mechanically interlocked rather than folded and welded. If the spot welded variety is used, ensure the fold is oriented at the top or 12:00 o'clock position on the hose, to prevent it from being continuously exposed to leaking water. Contrary to popular belief, there is no need to alternate fastener position on hose clamps.

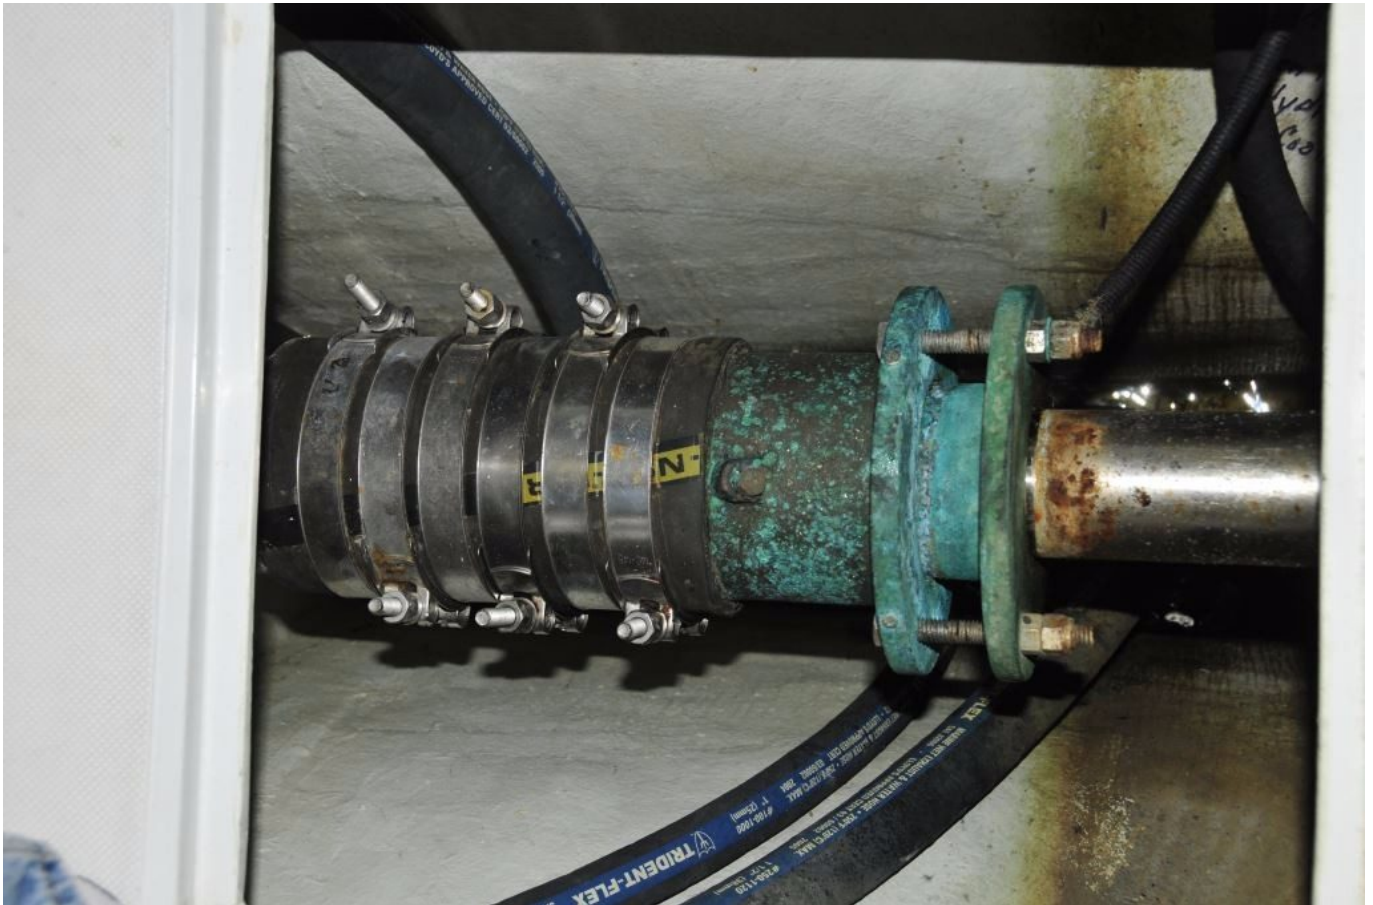
Perhaps this is a case of hose clamp overkill; the additional clamps are of no real value and could be detrimental if they aren't located over the stuffing box or shaft log. Stuffing boxes should be equipped with double, high quality hose clamps at each end. Furthermore, too many clamps, combined with a hose that is too short, could prevent the stuffing box from "floating" on the shaft, and self-aligning.

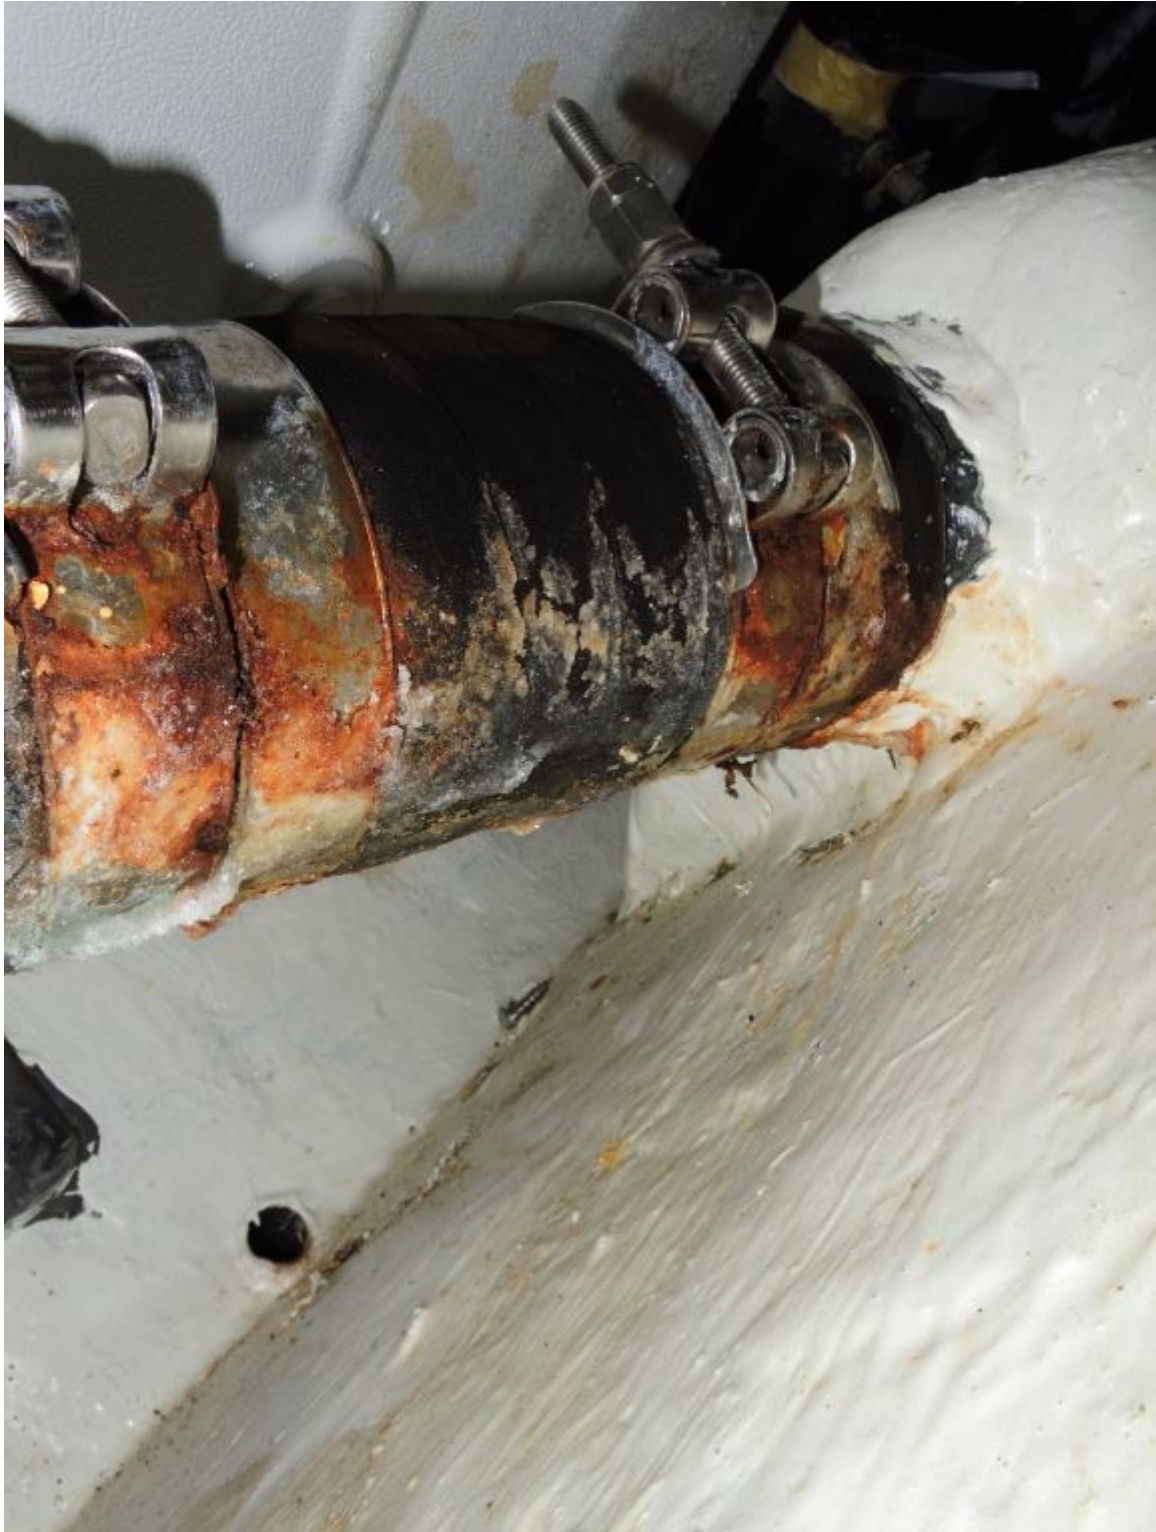
**Chronically leaking stuffing boxes lead to more than just wet bilges. These clamps are seriously corroded as a result of**

## **regular exposure to seawater.**

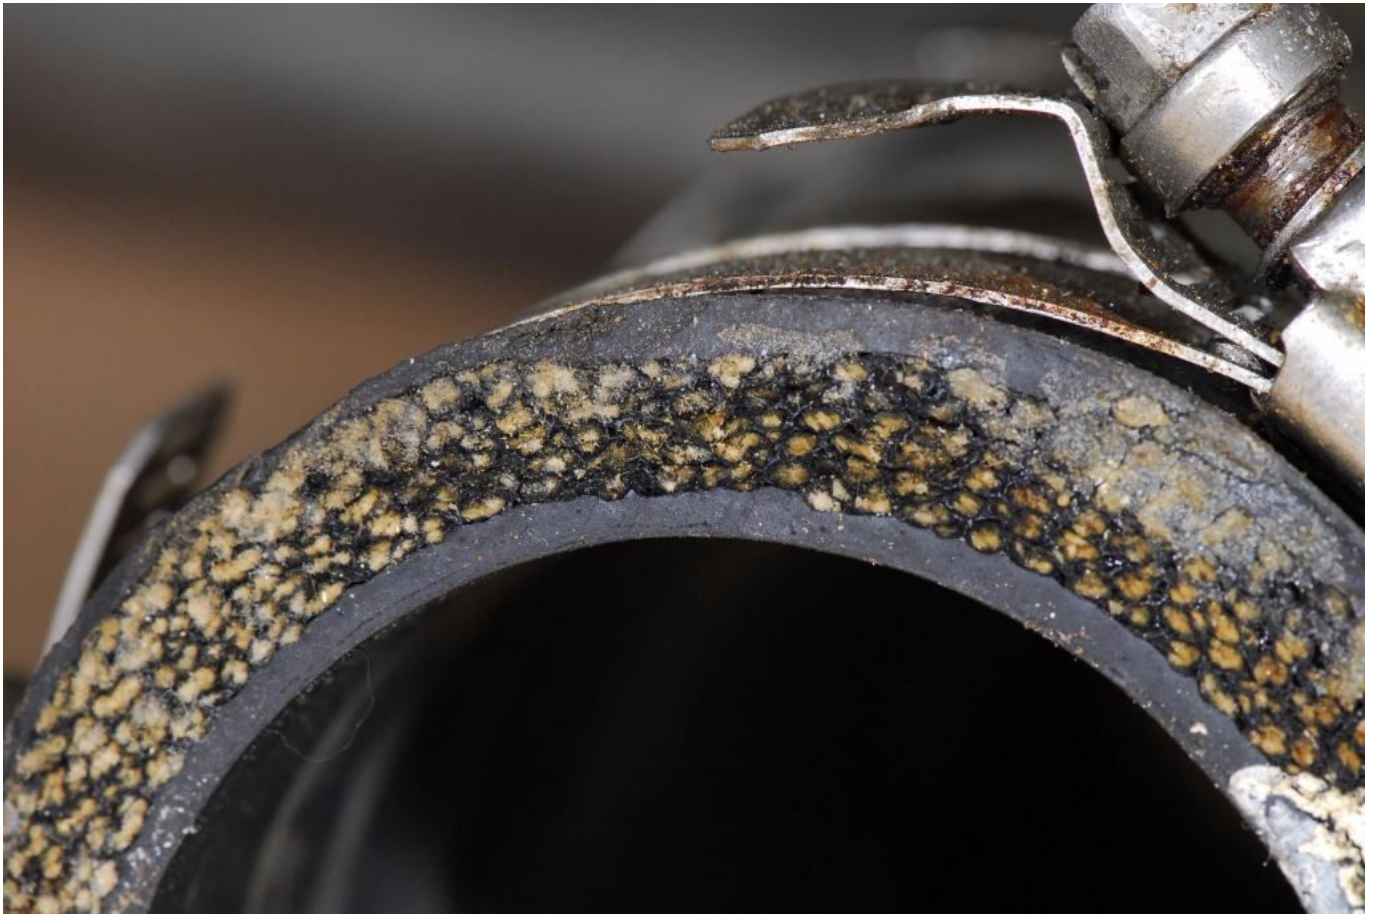
The five plies of a stuffing box hose (top) are clear to see,

**compared to ordinary hose's three plies (above).**

While it may look ordinary, the hose used with conventional stuffing boxes is, or should be, proprietary. Ordinary raw water or exhaust hose may utilize two or three plies, while proprietary stuffing box hose incorporates five plies. Because hose used in stuffing box applications lives an especially hard life, it's submerged, vibrated and routinely twisted in forward and reverse, the added heft of five plies is a clear value added, and equates to longer life. Replacement of the stuffing box hose is invariably time consuming in that it requires separation of the propeller shaft from the transmission coupling. It is also, therefore, a task that must be carried out while the vessel is hauled. Conventional, conservative wisdom dictates that stuffing box hoses should be preemptively replaced approximately every five to seven years or when warranted by visible hose deterioration. One critical issue involves hose length, or more importantly, the length of "free hose" between the stuffing box pipe to hose adapter and the shaft log. This free hose length must be long enough to allow the hose to float freely on the shaft, avoiding side-loading, binding, and the overheating it can cause.

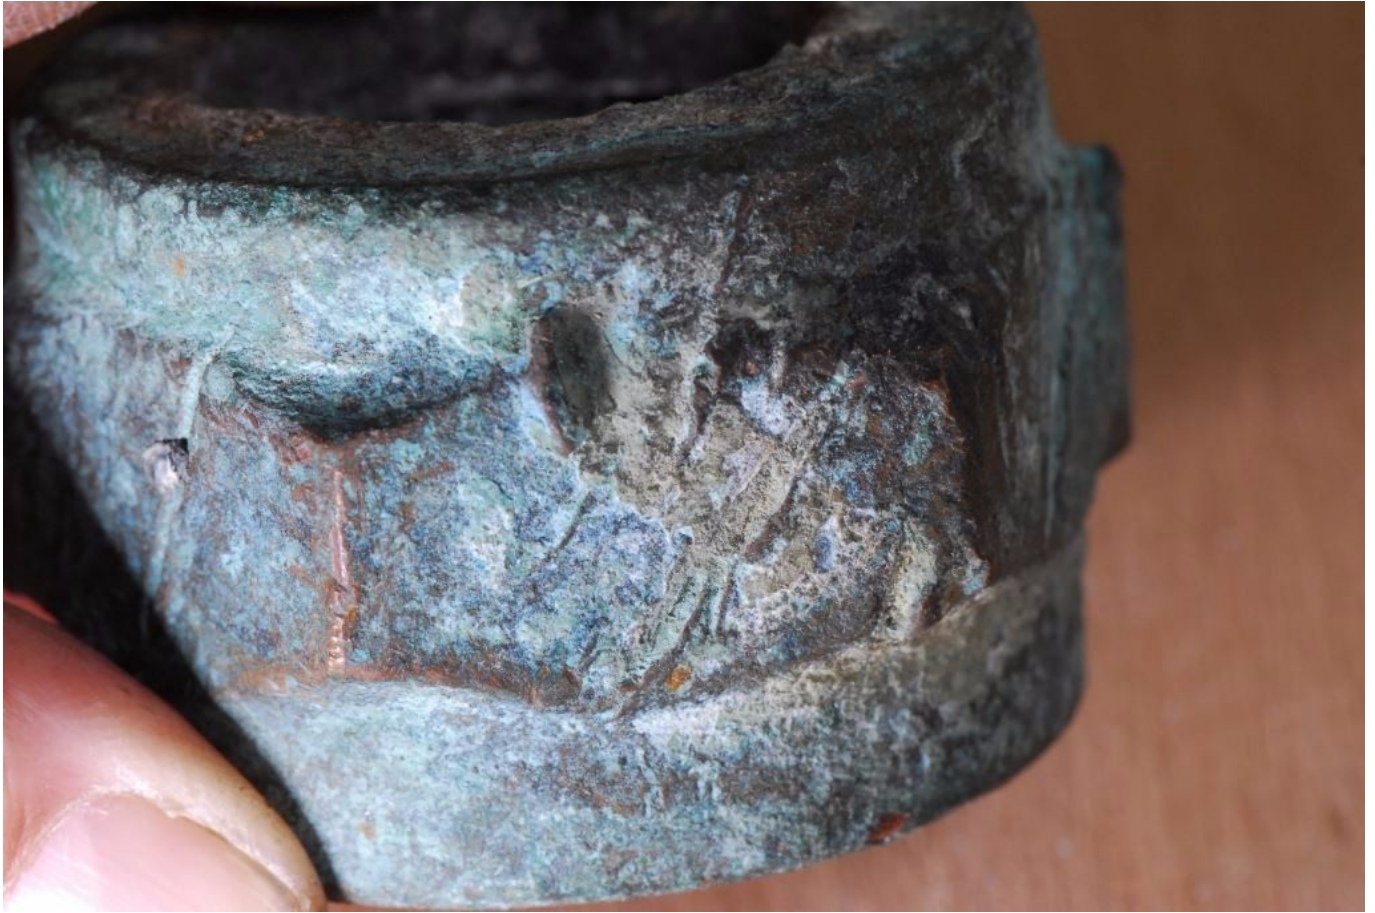
**This packing nut has been loosened, and/or tightened using a chisel, damaging the nut's flats. This practice should be avoided, particularly when tightening. Proper wrenches should be used.**

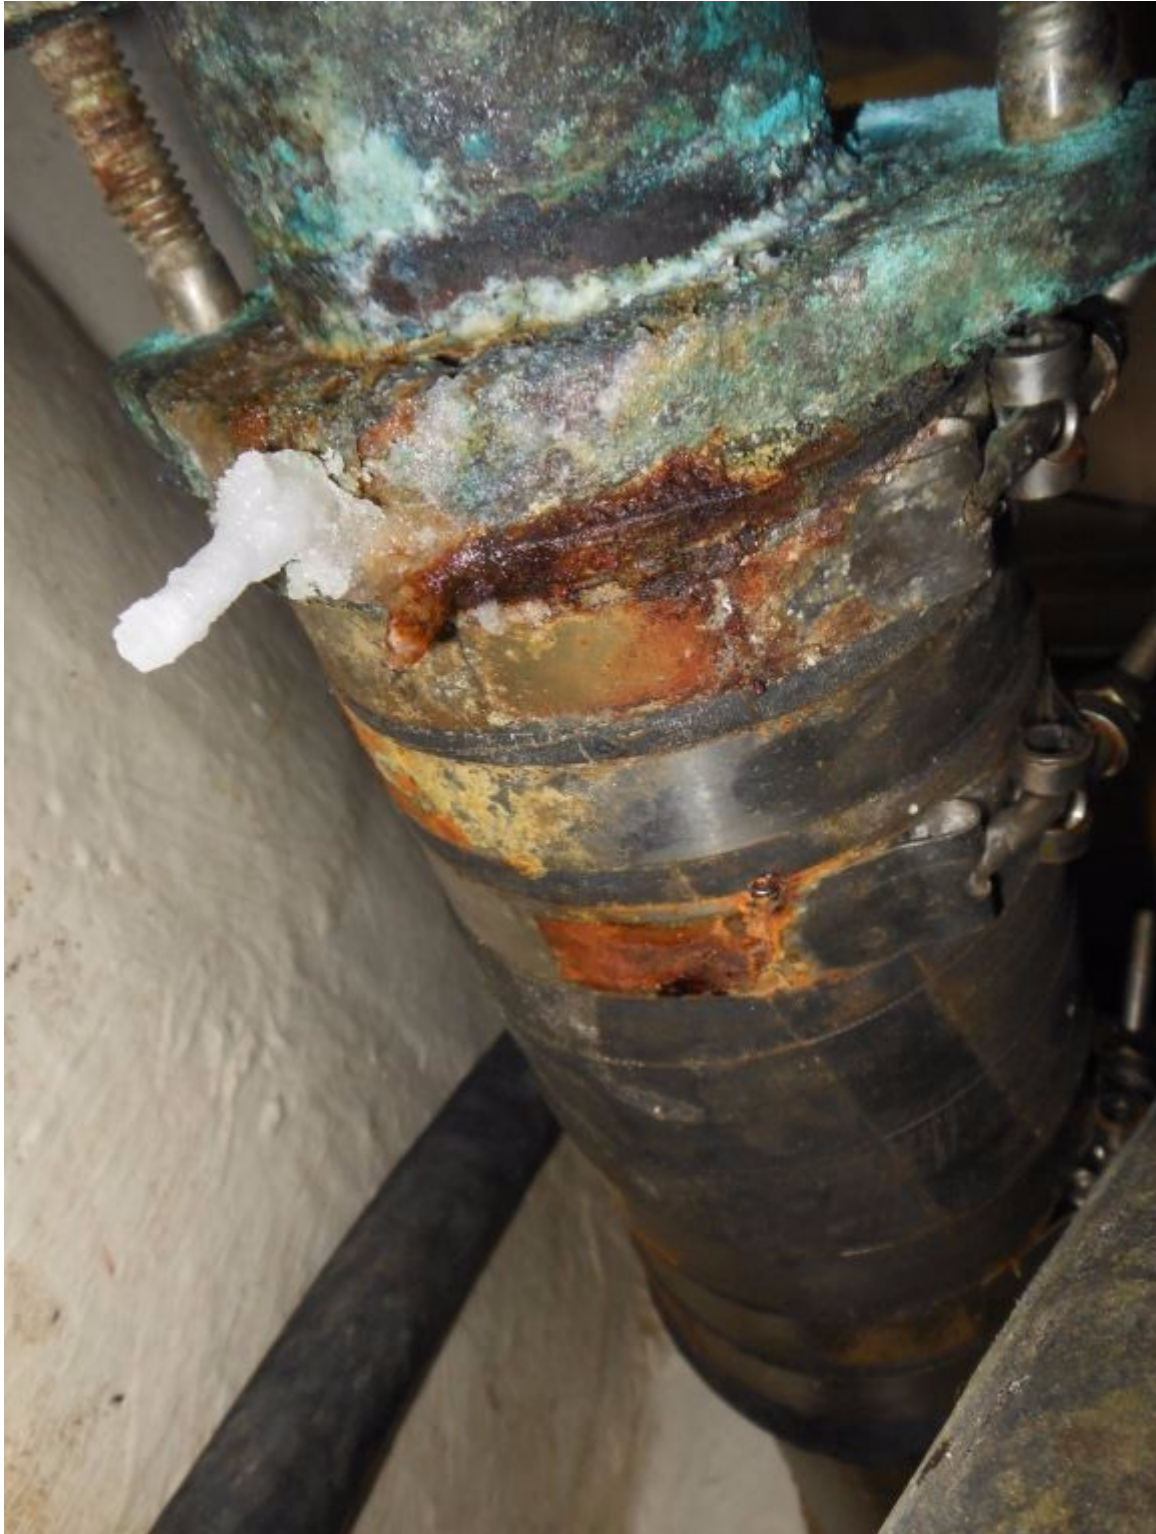
**This salt stalactite tells a story, this stuffing box is**

which is required to keep a stuffing box cool is simply leakage.

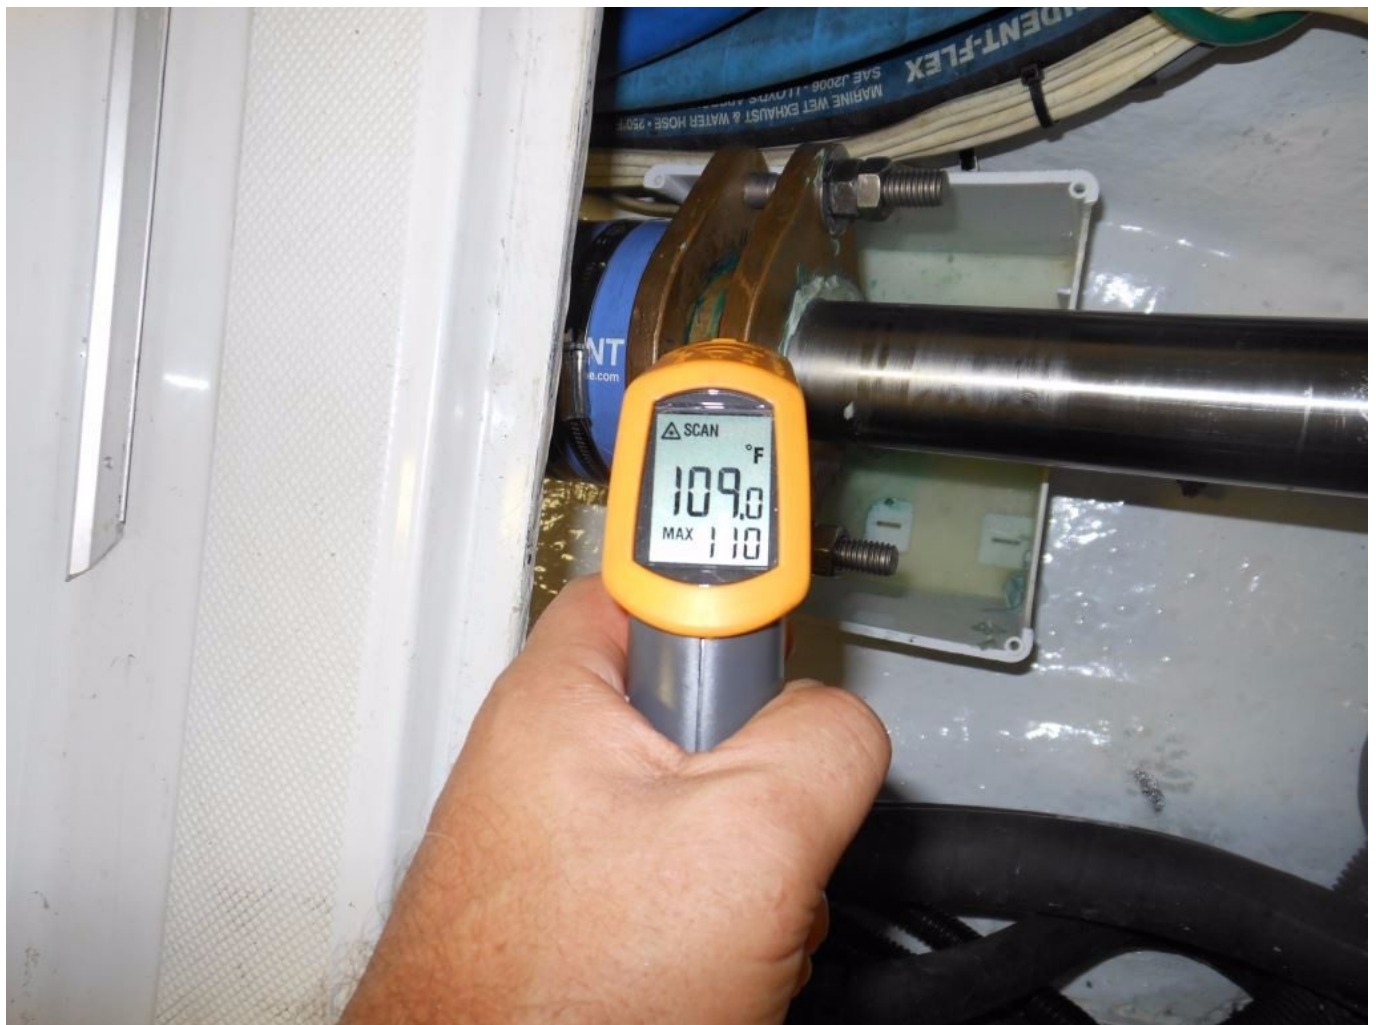
Infrared pyrometers have changed the way stuffing boxes are adjusted, now it's a measurable balance between heat and drip

rate.

The watch phrase when repacking a stuffing box, regardless of the material, is careful monitoring for the first few hours of operation. Using an infra-red pyrometer, the stuffing box temperature should be monitored during this time, shooting the stuffing box and not the shaft (highly reflective surfaces such as shafts and hose clamps will often give erroneous readings); adjustments should be made if necessary. No part of the stuffing box should exceed more than 30°F-40°F above ambient seawater temperature, regardless of drip rate, while at any speed. In fact, with access to an infrared pyrometer, drip rates are much less important than they once were.

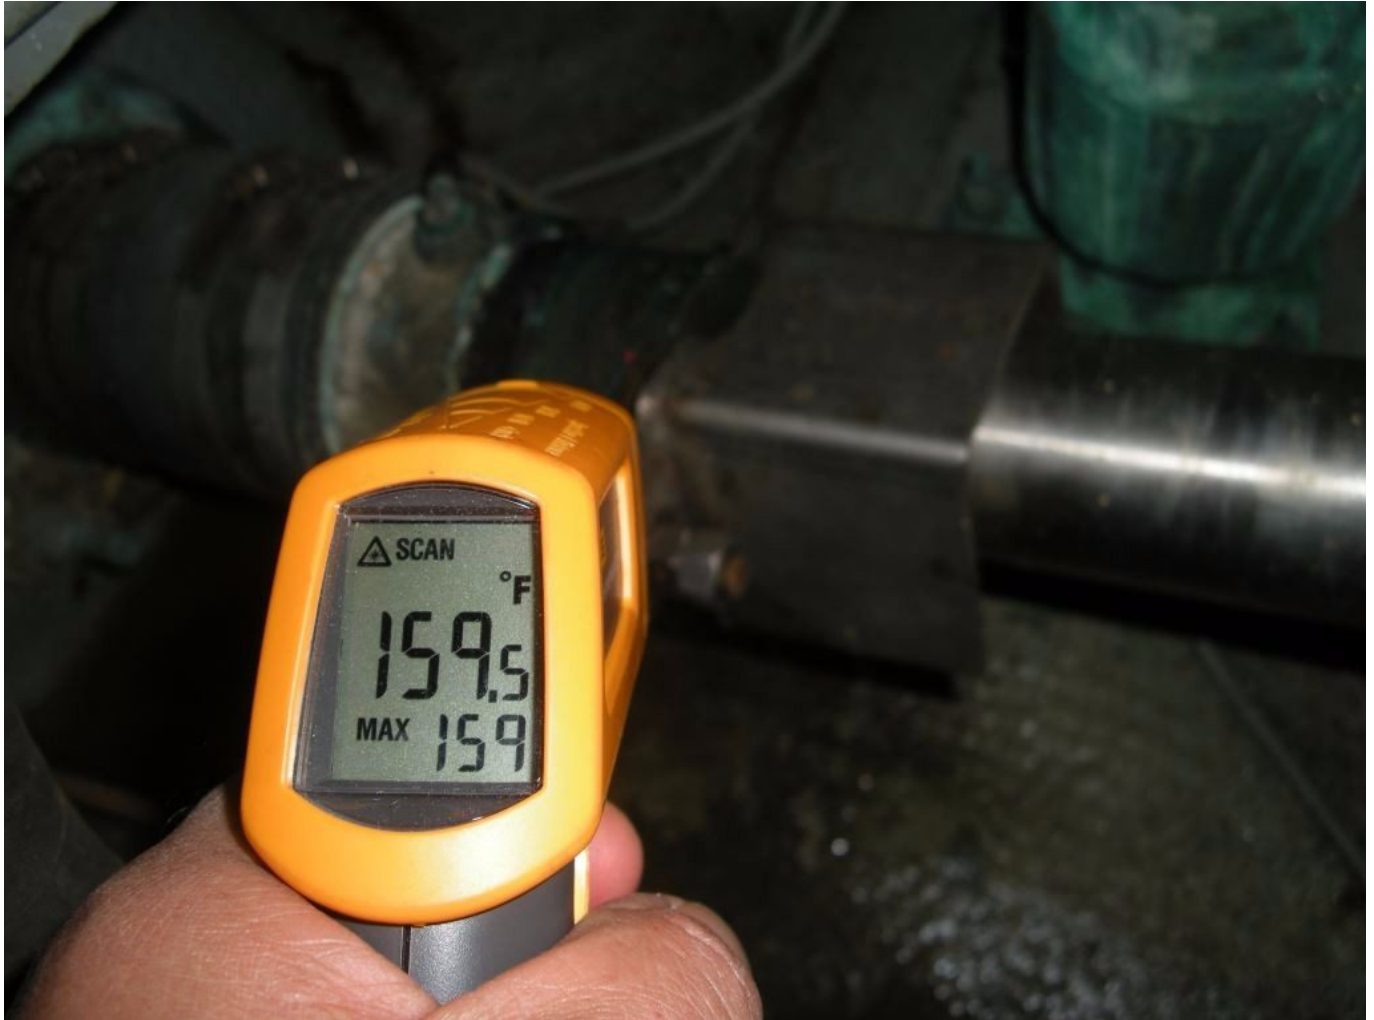
Stuffing box temperature should not exceed that of the water in which the vessel is operating by more than 30°F-40°F. The one shown here is clearly starved for water and is overheating.

Ultimately, the arbiter of correct stuffing box adjustment is temperature rather than drips per minute. Once properly adjusted, the stuffing box should leak little and be no hotter than about 30°F-40°F above ambient water temperature. If it is over tightened the wax in the packing will melt and run out of the stuffing box as a liquid, often accumulating under the stuffing box as a greenish pyramid, after which it will leak copiously. If necessary, this entire procedure can be carried out while the vessel is afloat. Once the packing nut is removed simply secure several wraps of a rag around the stuffing box where the shaft exits to temporarily stem the flow of water. Water will leak during reassembly; however, provided you work quickly it will be comparatively little. Check your stuffing box regularly and provide it with the care it needs. Doing so will yield the dividends in both longevity

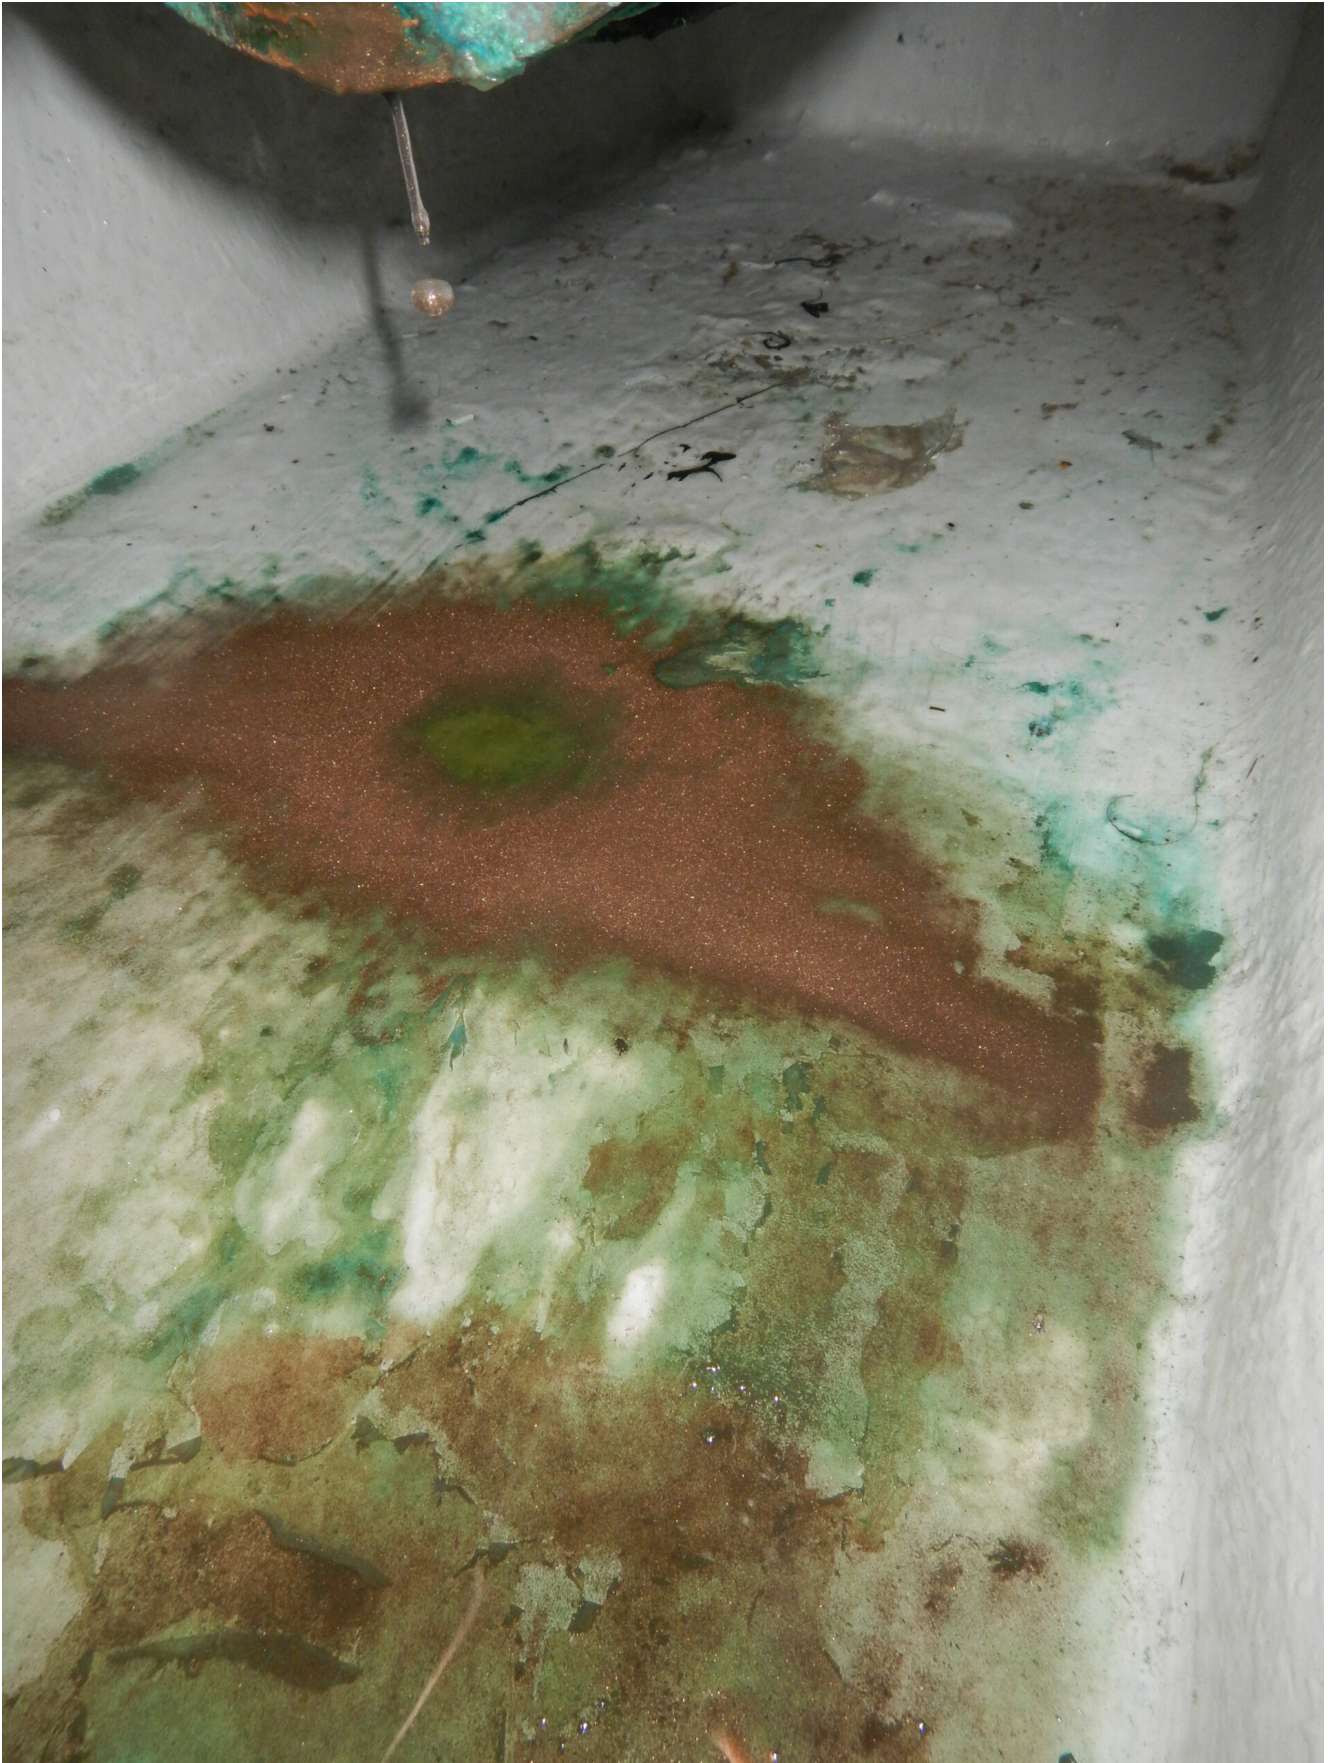
**A stuffing box that is side loaded, from overly stiff hose, or a shaft that is not centered in the shaft log, or one whose clearance is inadequate (see images below), can suffer extreme**

wear, the result of which is a 'bronze slurry', like that shown here.

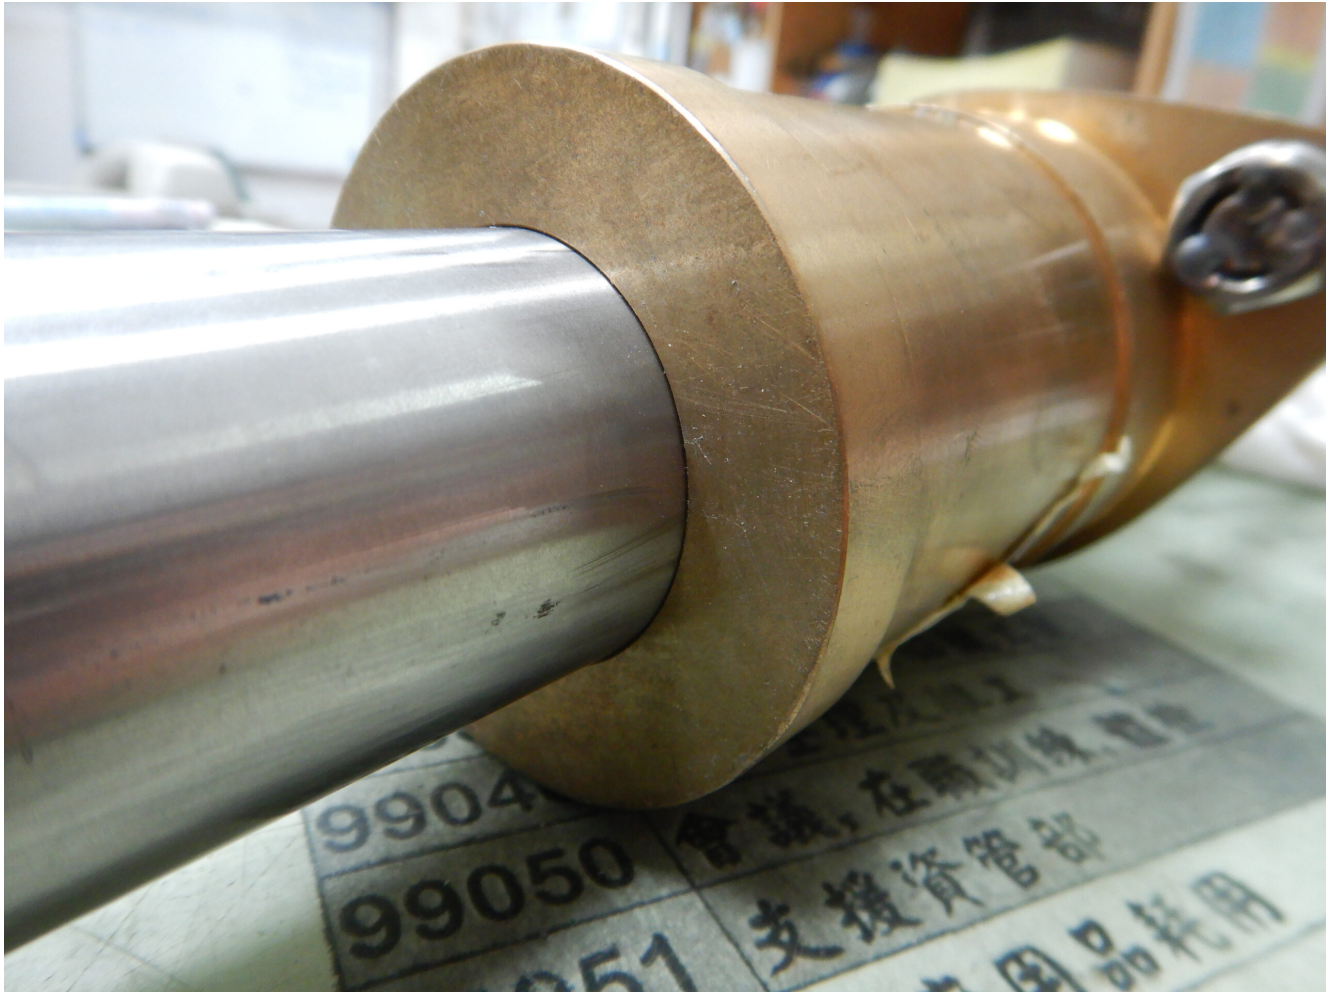
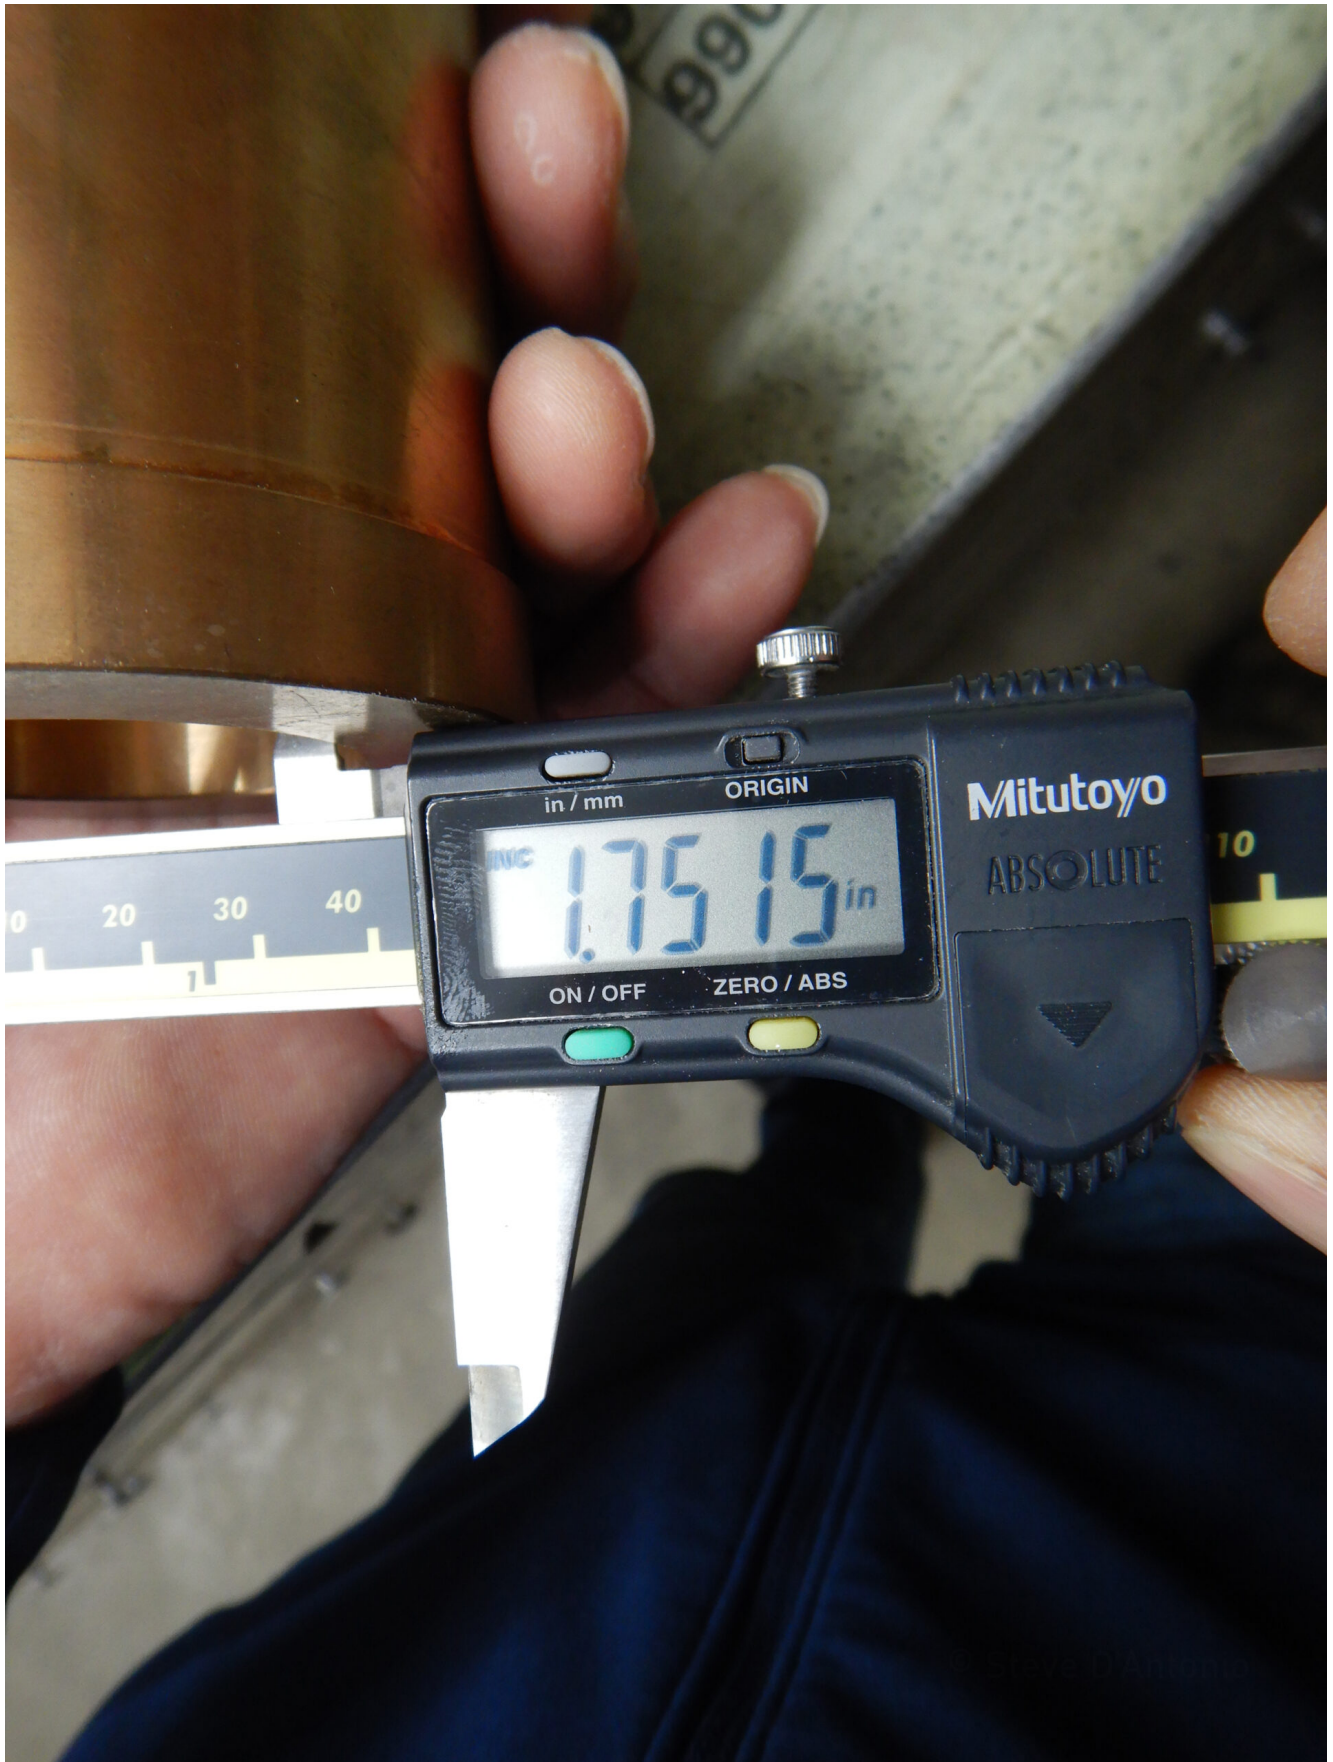
**Clearance between the outside diameter of the shaft and the inside diameter of the stuffing box is critical, too much and packing will be pushed into the gap, limiting its**

effectiveness, too little and water flow is impeded, which can lead to overheating. One rule of thumb calls for 0.005" clearance, plus an additional 0.005" for every inch of shaft diameter. Thus, a 3" diameter shaft would have 0.020" of clearance.
