# Conventional Wisdom for Conventional Stuffing Boxes

Text and photos by Steve D'Antonio

## Conventional Wisdom for Conventional Stuffing Boxes

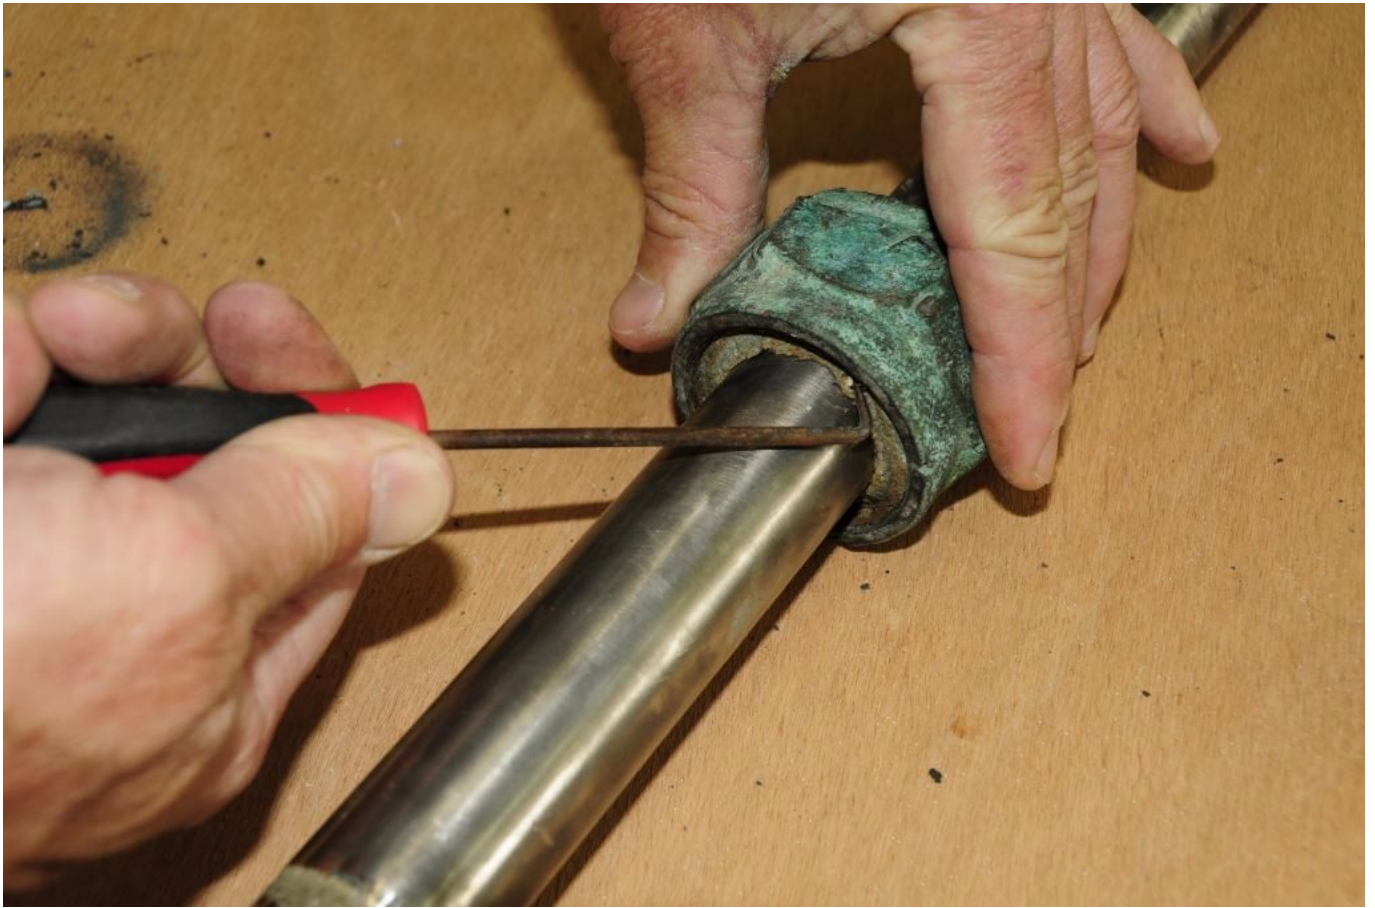
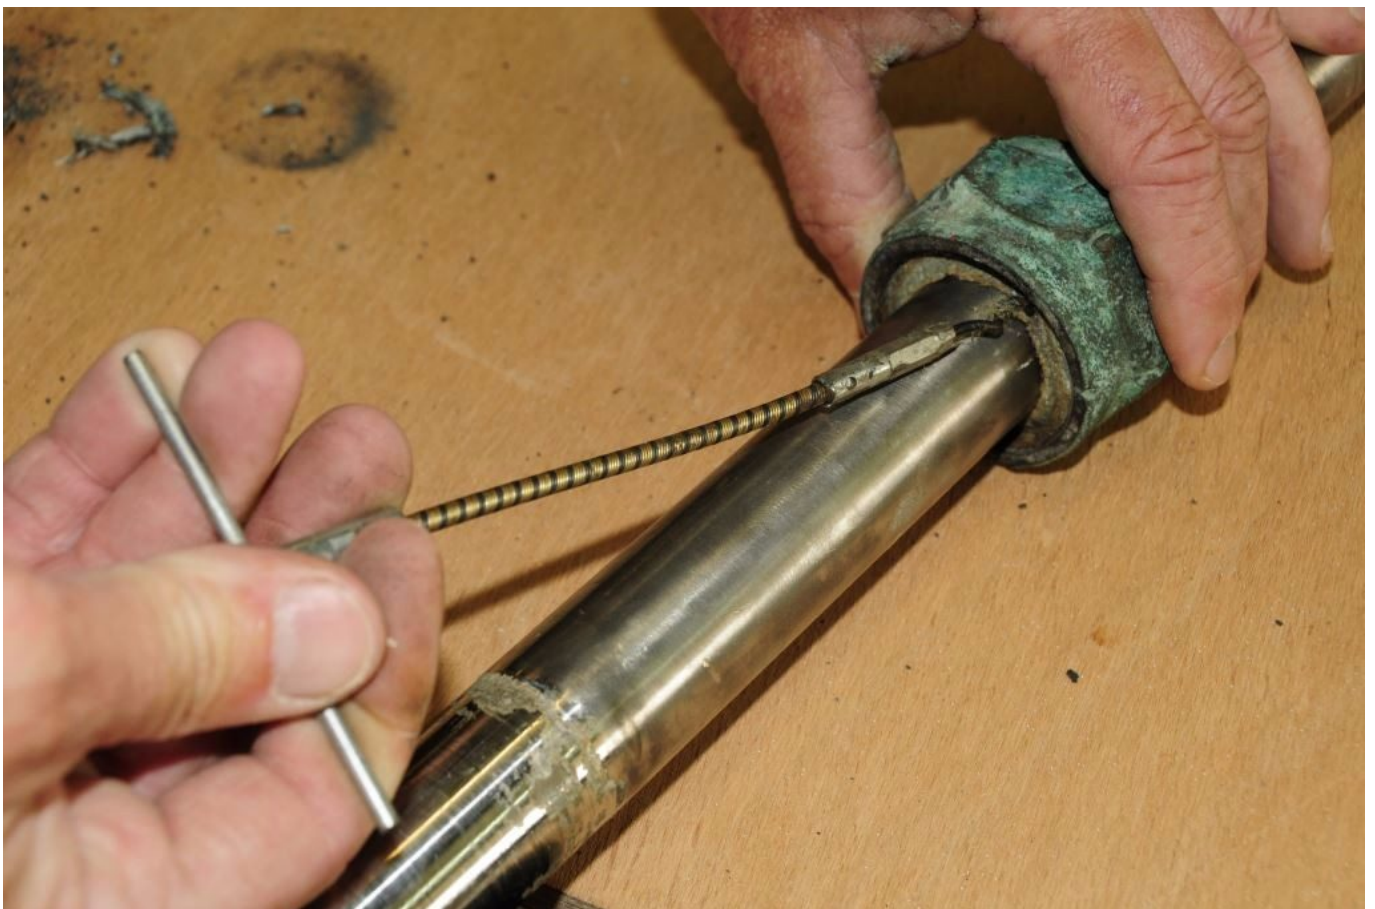
Depending on access, and stuffing box design, removal of the

**old packing can be challenging. Here a cork-screw like packing removal tool(above), as well as a pick (top), are being used.**

Begin by loosening the locking nut(s) and back off the packing carrier nut or tie rod ram. Remove all of the old packing. You can use a pick or a proprietary packing removal tool; it looks a bit like a flexible corkscrew. It's important that all old packing and debris be removed, if you have access to compressed then use it to blow this area out (wear safety glasses). If green and crusty, the threads on the stuffing box body should be cleaned with a non-metallic bristle brush or 3M ScotchBrite pad, and penetrating oil, and then *lightly* lubricated with oil. If they are tie rods and of the stainless steel variety and are discolored or lightly corroded, they too should be cleaned in the same manner; if heavily corroded they should be replaced.

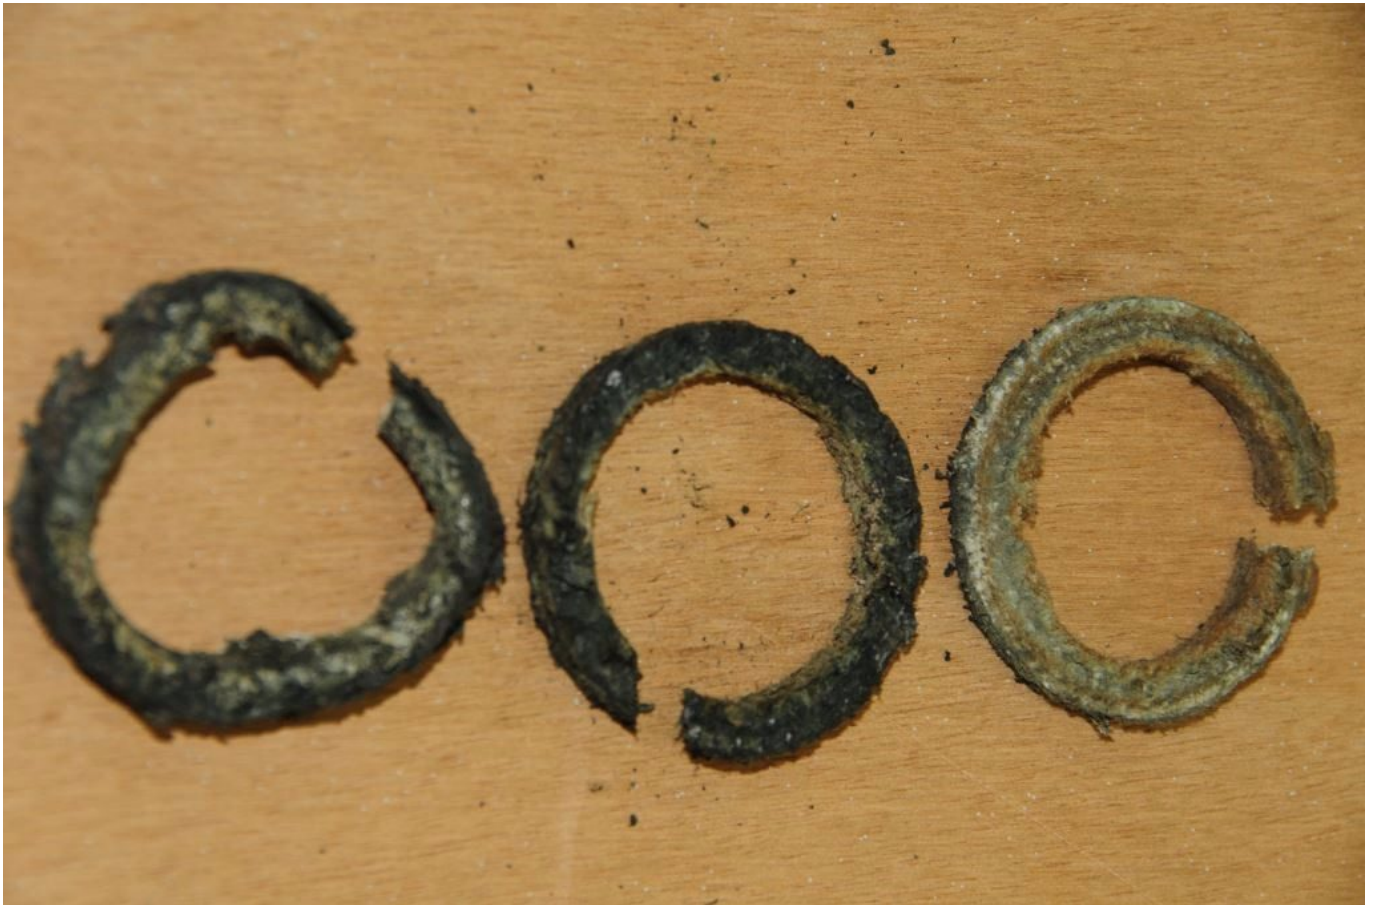
**Most stuffing boxes are designed to accept three rings of packing. The joints should be oriented  $120^\circ$  apart from each other.**

Unless instructed otherwise by the stuffing box manufacturer, *three* new rings of packing material should be cut, their inside diameter matching exactly the outside diameter of the shaft; the ends of each piece of packing should be cut on a forty-five degree angle so they mate in an overlapping fashion. I find it helpful to apply a coating of high viscosity grease (I prefer Lubrimatic's green Trailer Wheel Bearing Grease) to the packing sections as I install them, this acts as a lubricant and it helps keep the sections in place as they are inserted into the stuffing box recess or nut carrier. These joints should be spaced 120° apart, or at the 12, 4 and 8 o'clock position.

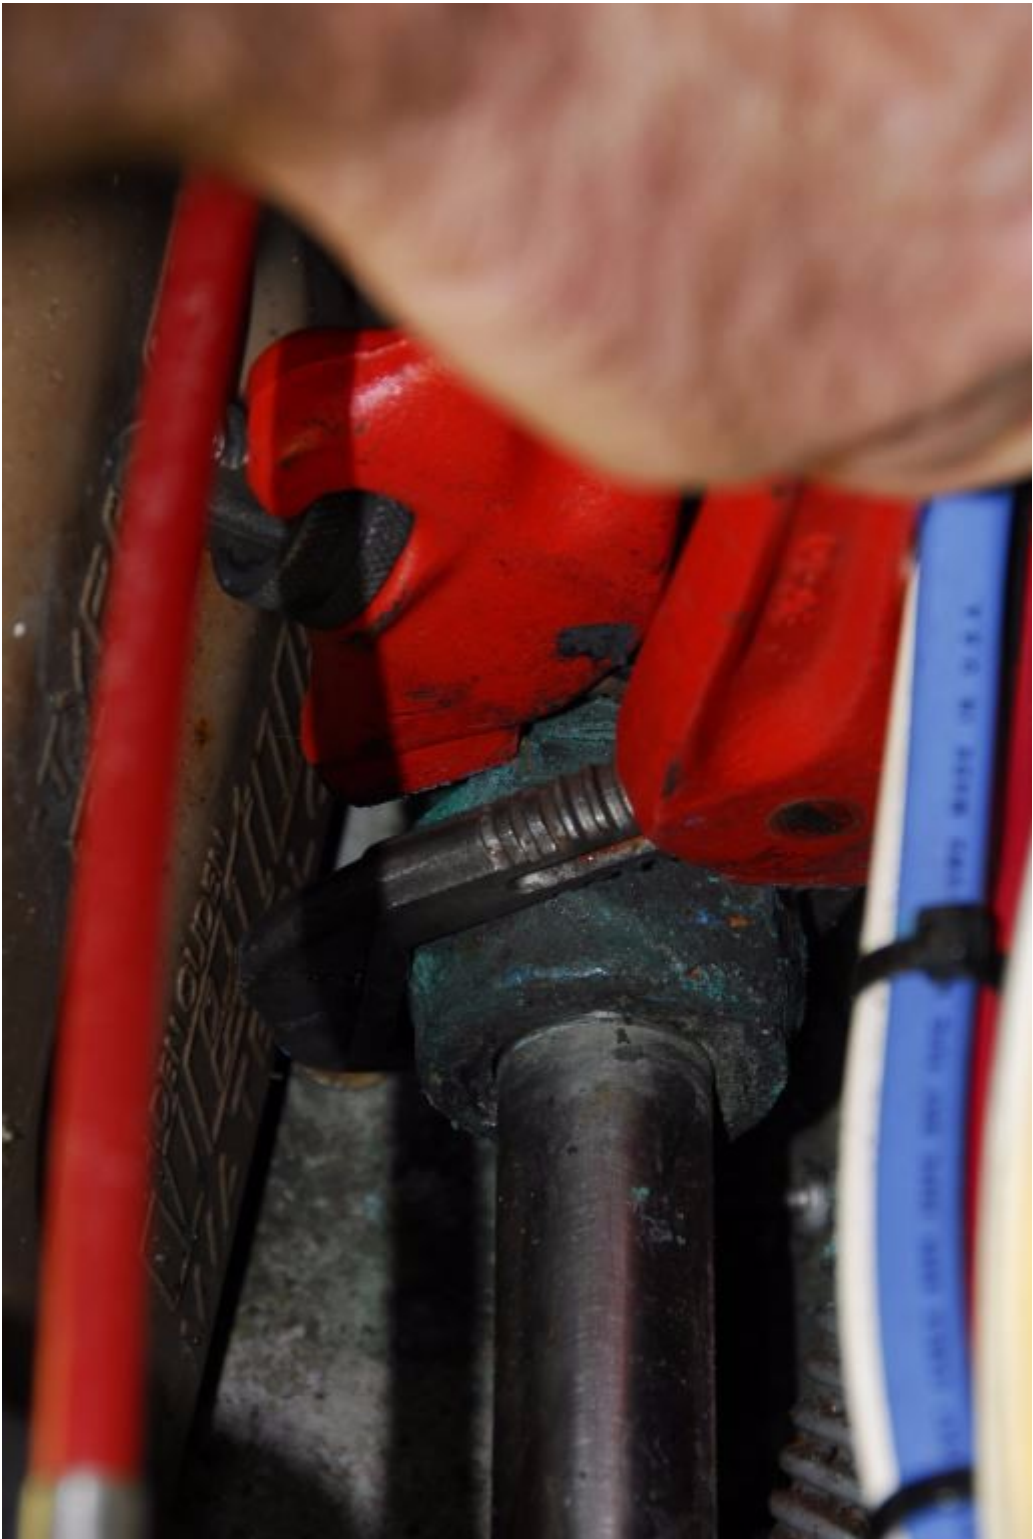
**Two wrenches must be used when tightening packing lock nuts, to ensure adequate tension is developed between the two nuts.**

The packing nut should be made snug, not much more than hand tight initially. How tight is a subjective measure, however, it doesn't matter because it will likely be adjusted once the vessel is launched and the engine run. Initially, it is far better for it to be too loose than too tight. It's critically important that the locking nut(s) be tightened against the packing nut using two wrenches, i.e. they need to be tightened to create tension against each other. Tightening one, and then the other, using one wrench, is inadequate and may lead to a loosening and flooding.

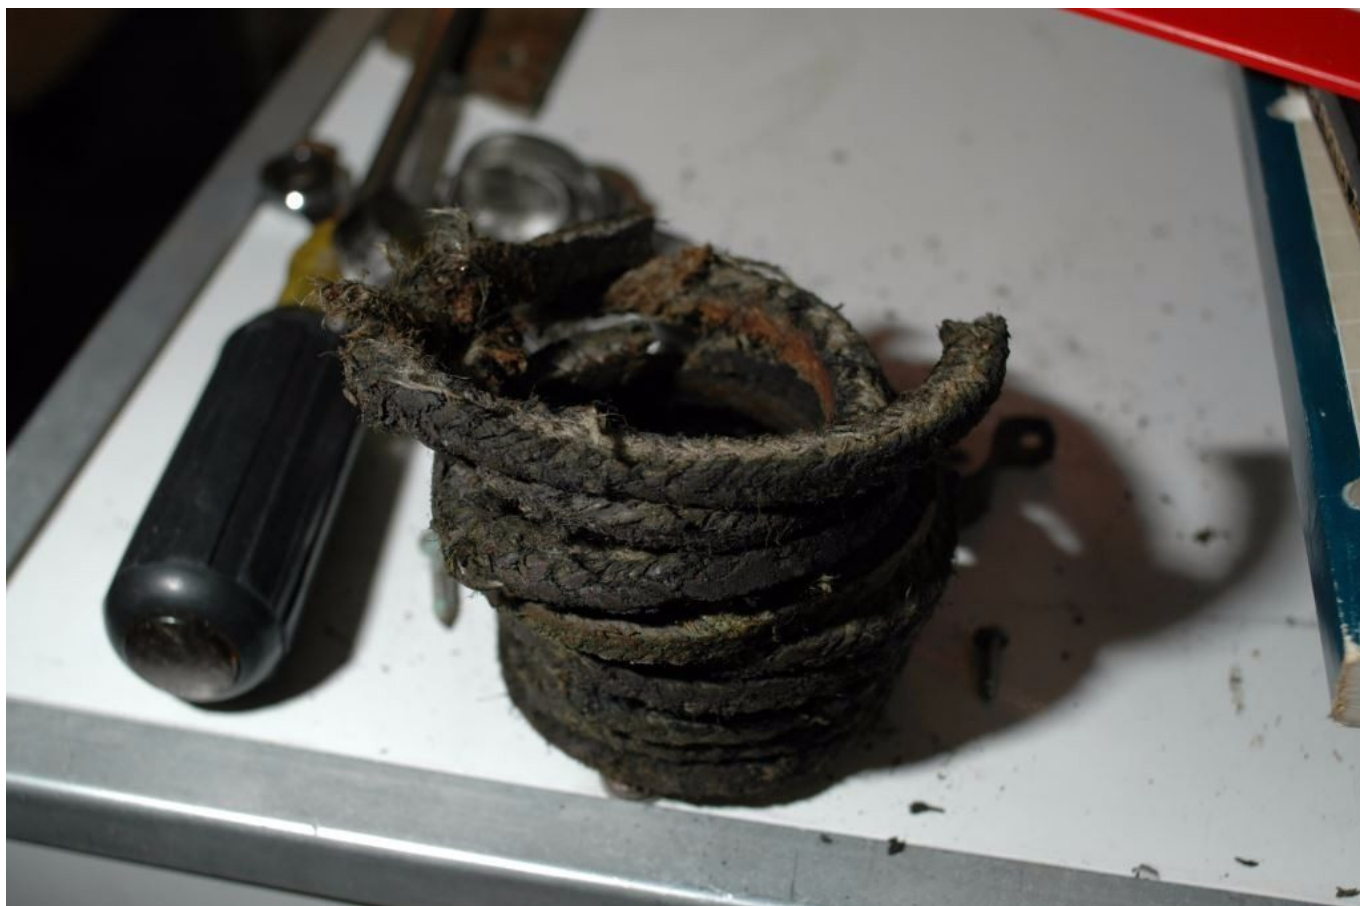
**Too much of a good thing; if three wraps don't stem the flow, another problem is almost certainly present. The stuffing box from which this packing came was clearly over-stuffed.**
