Don't Underestimate the Importance of High-Water Alarms – Crossing the Bar, Tim Caruso

Don't Underestimate the Importance of High-Water Alarms

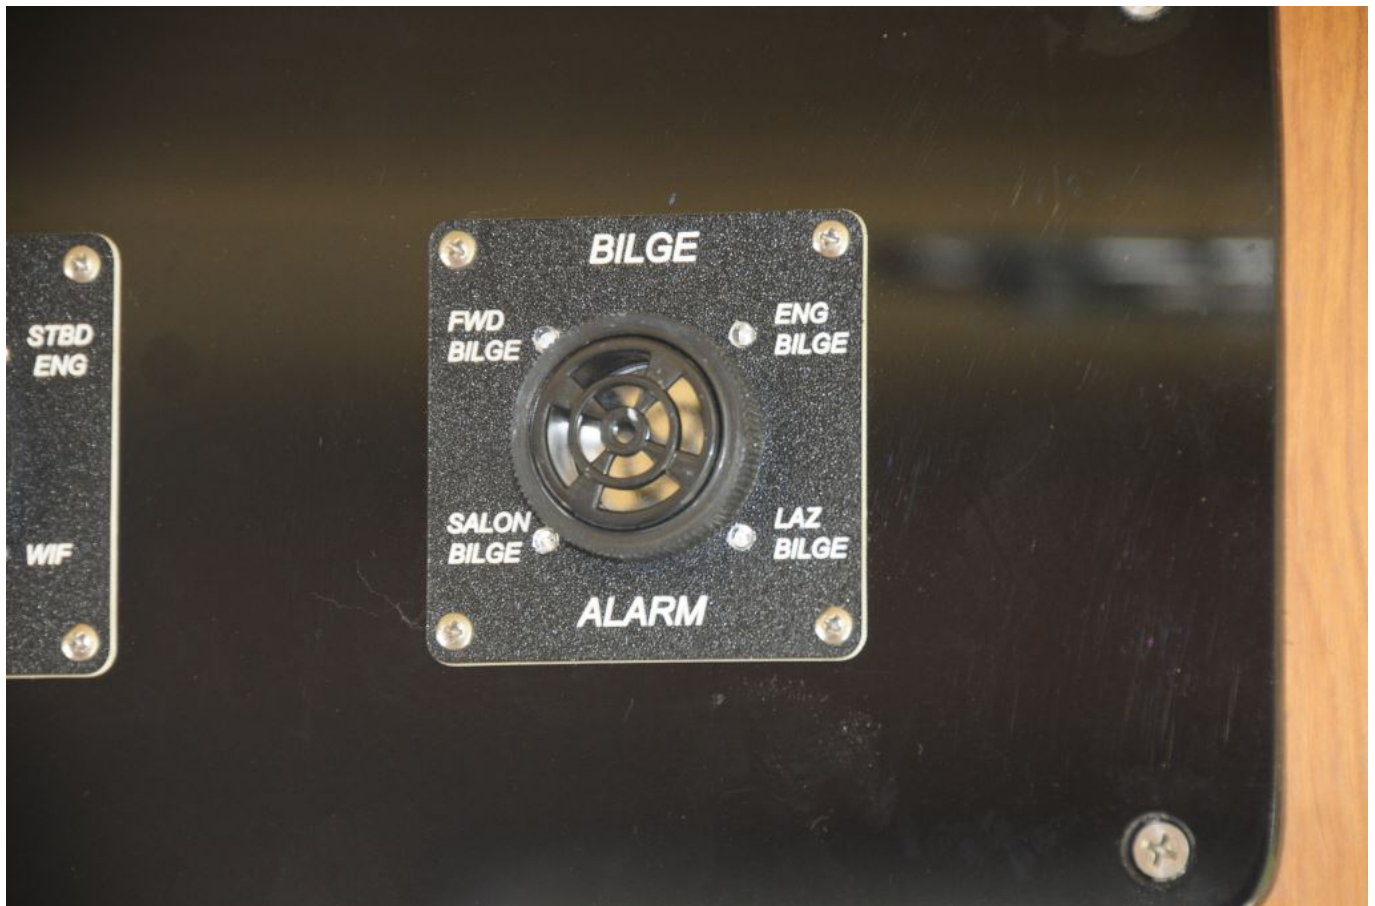
This high water alarm annunciator is well-designed, it includes a single audible horn, and indicator lights to show which compartment is flooding.

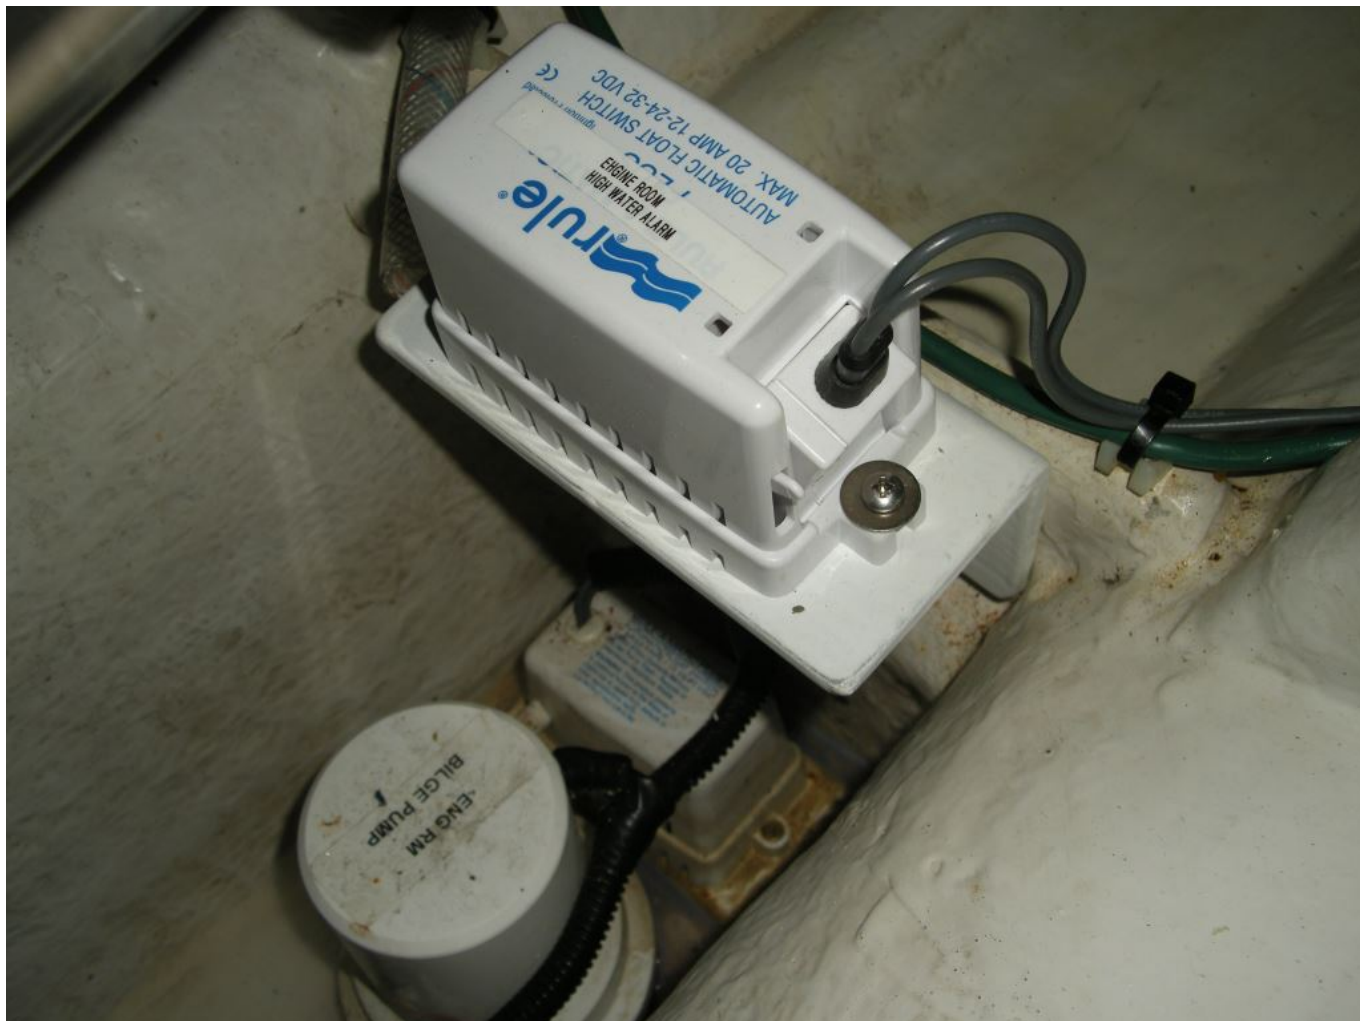
High water alarm switches must be located so that they provide the earliest possible indication of flooding; that usually means no more than just a couple of inches above the primary pump's switch. The one shown here is, once again, too high.

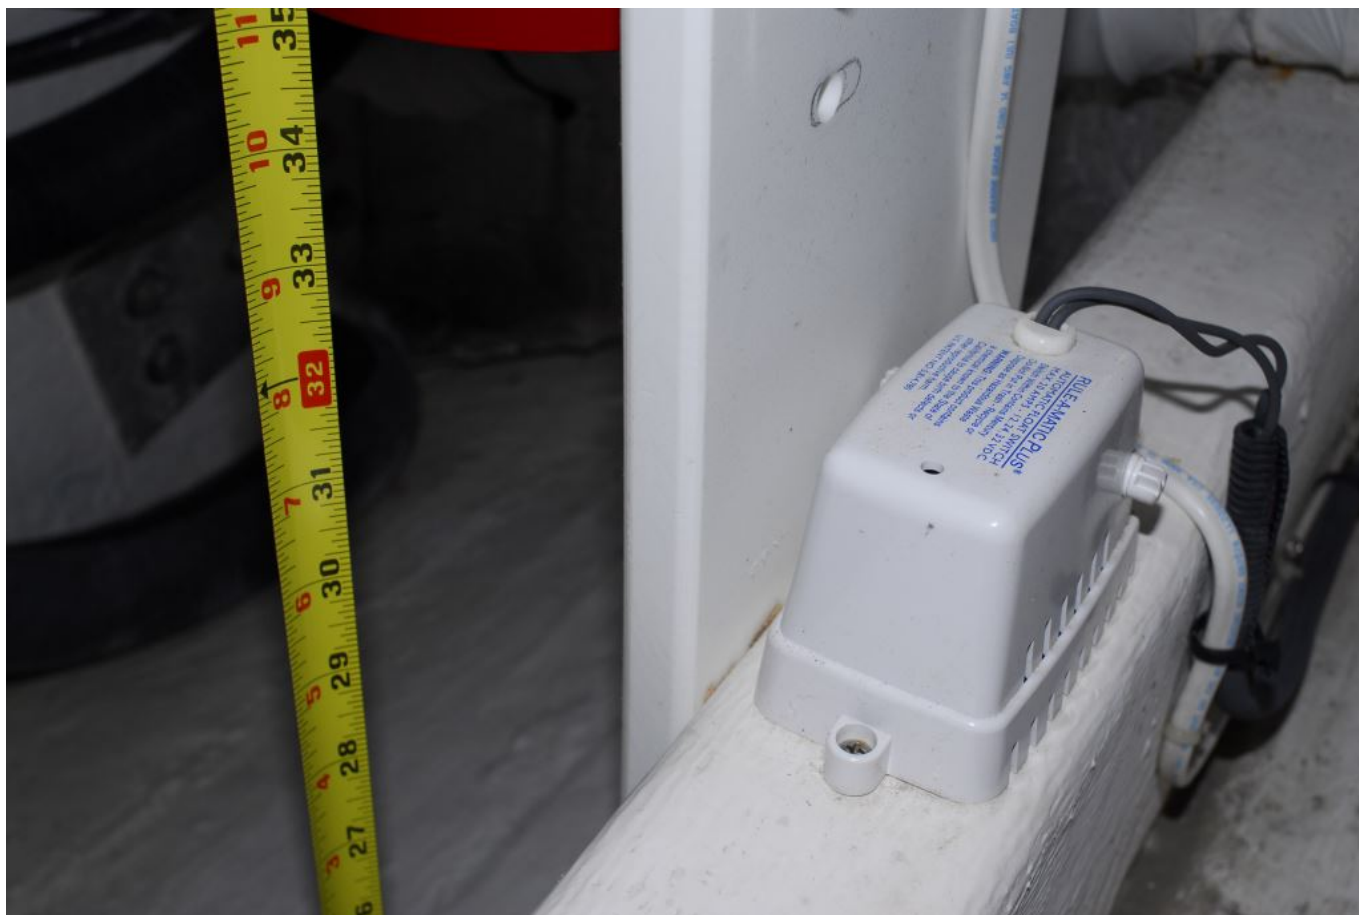
This high water alarm, located on an engine bed stringer, is over 30-inches above the bilge pump, and above the bottom of the engine.
