# Don't Underestimate the Importance of High-Water Alarms – Crossing the Bar, Tim Caruso

## **Don't Underestimate the Importance of High-Water Alarms**

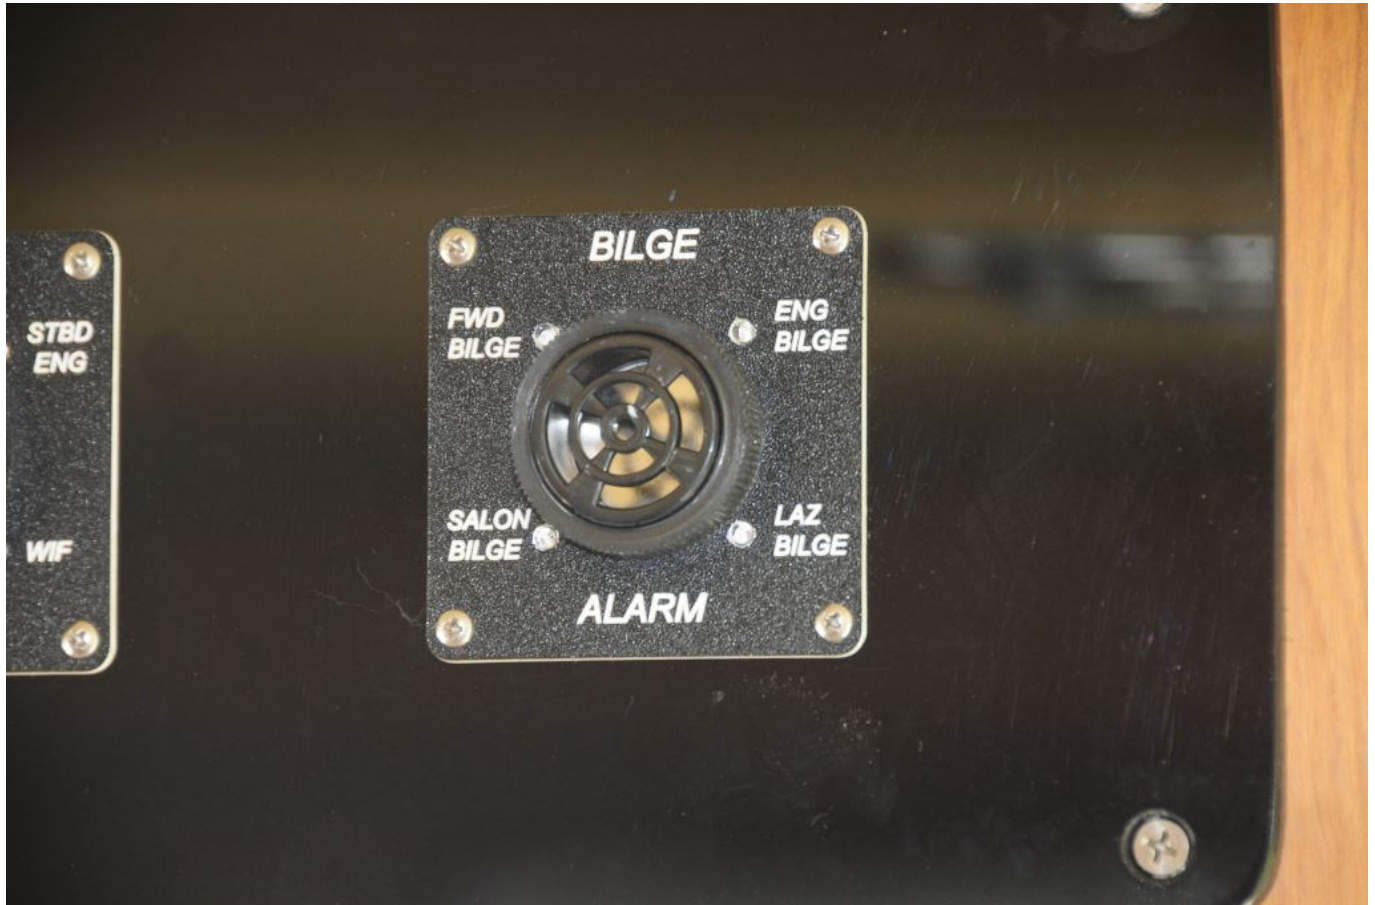
**This high water alarm annunciator is well-designed, it includes a single audible horn, and indicator lights to show which compartment is flooding.**

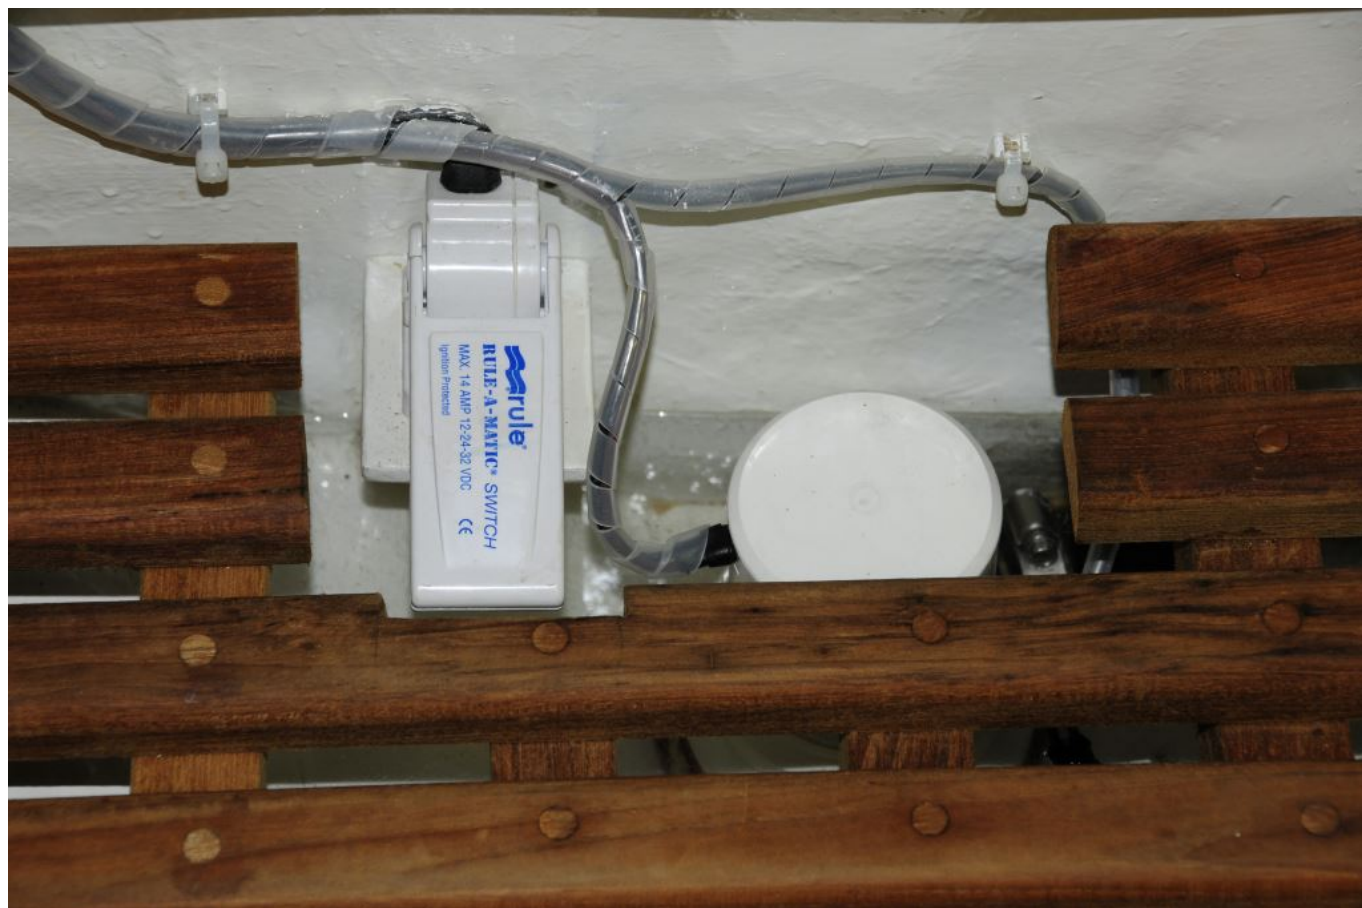
**This high water alarm switch is located above the bilge pump, it’s too high and in this case vulnerable to being stepped on.**

Alarm switches should be mounted no more than 2-inches above bilge pump float switches (I’ve seen them as many as 18-inches above the primary pump, well above the level of critical equipment, including batteries and the bottom of the engine, I sometimes refer to those as, “it’s time to deploy the life raft” alarms). Additionally, whenever a bilge pump runs, it should be accompanied by the illumination of an indicator light, or monitoring system display, one that can be seen at the helm, nav station, or in the cockpit.

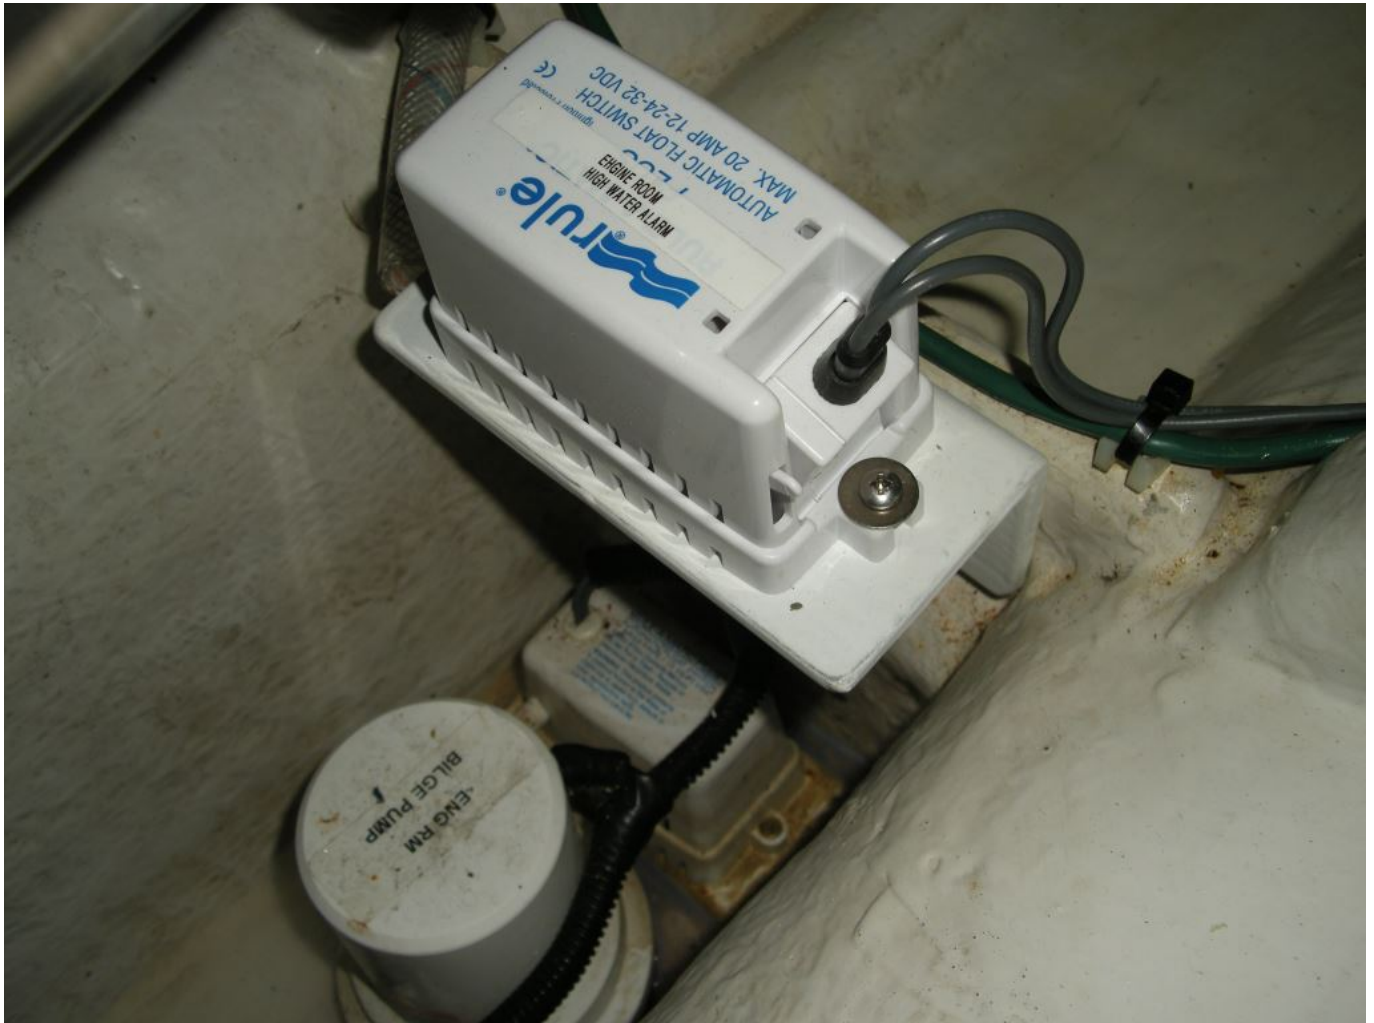
**High water alarm switches must be located so that they provide the earliest possible indication of flooding; that usually means no more than just a couple of inches above the primary pump's switch. The one shown here is, once again, too high.**

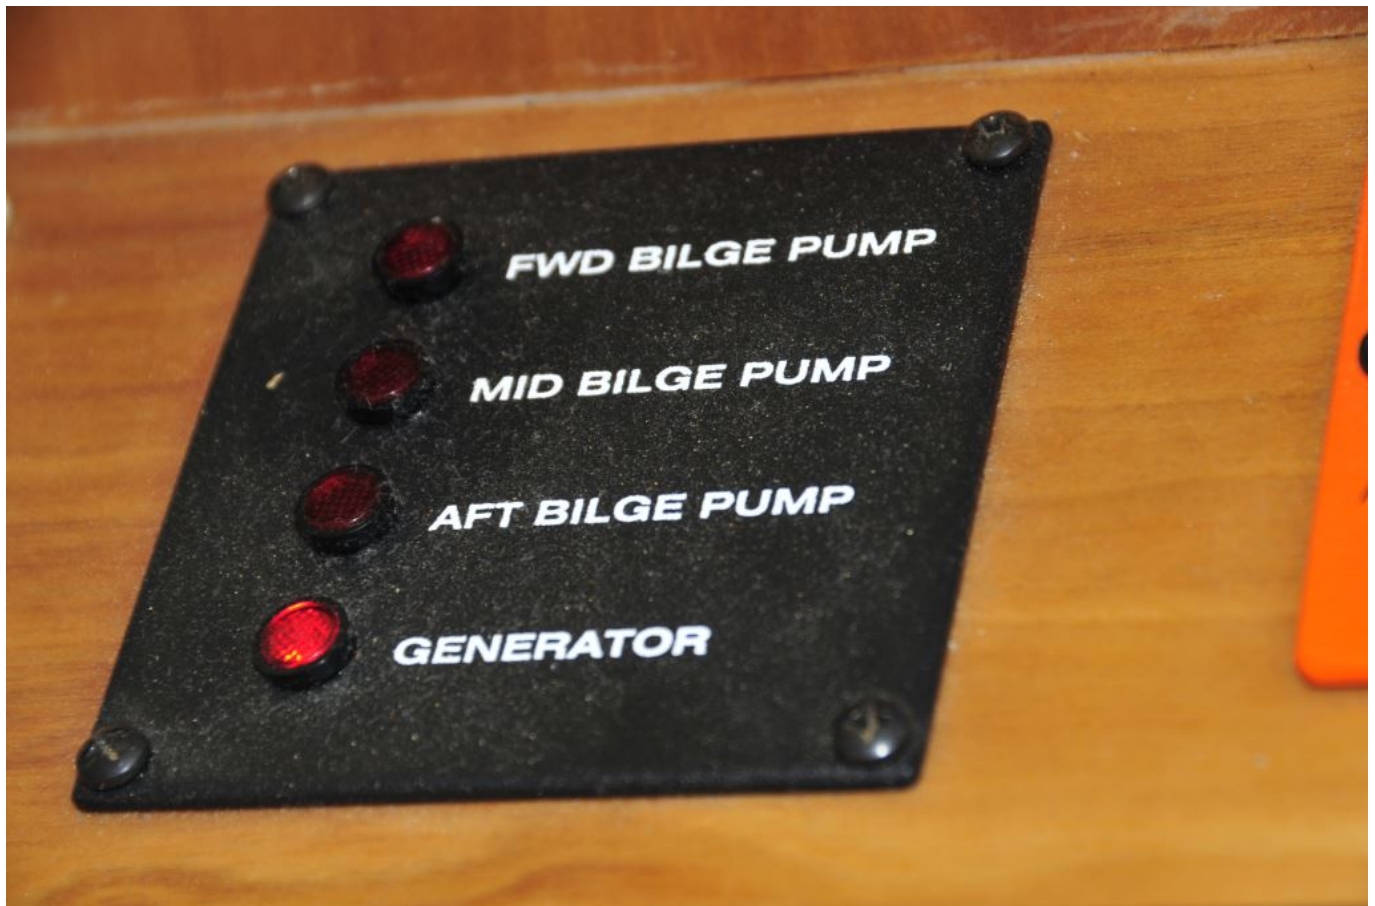
**A light should illuminate every time a bilge pump runs.**

Some vessels include an audible indicator as well, not necessarily an alarm, but a chirp or soft buzzer, something that will tell the crew know the pump is running without waking the off watch, although high water alarms should be ear-splitting and impossible to ignore or sleep through.

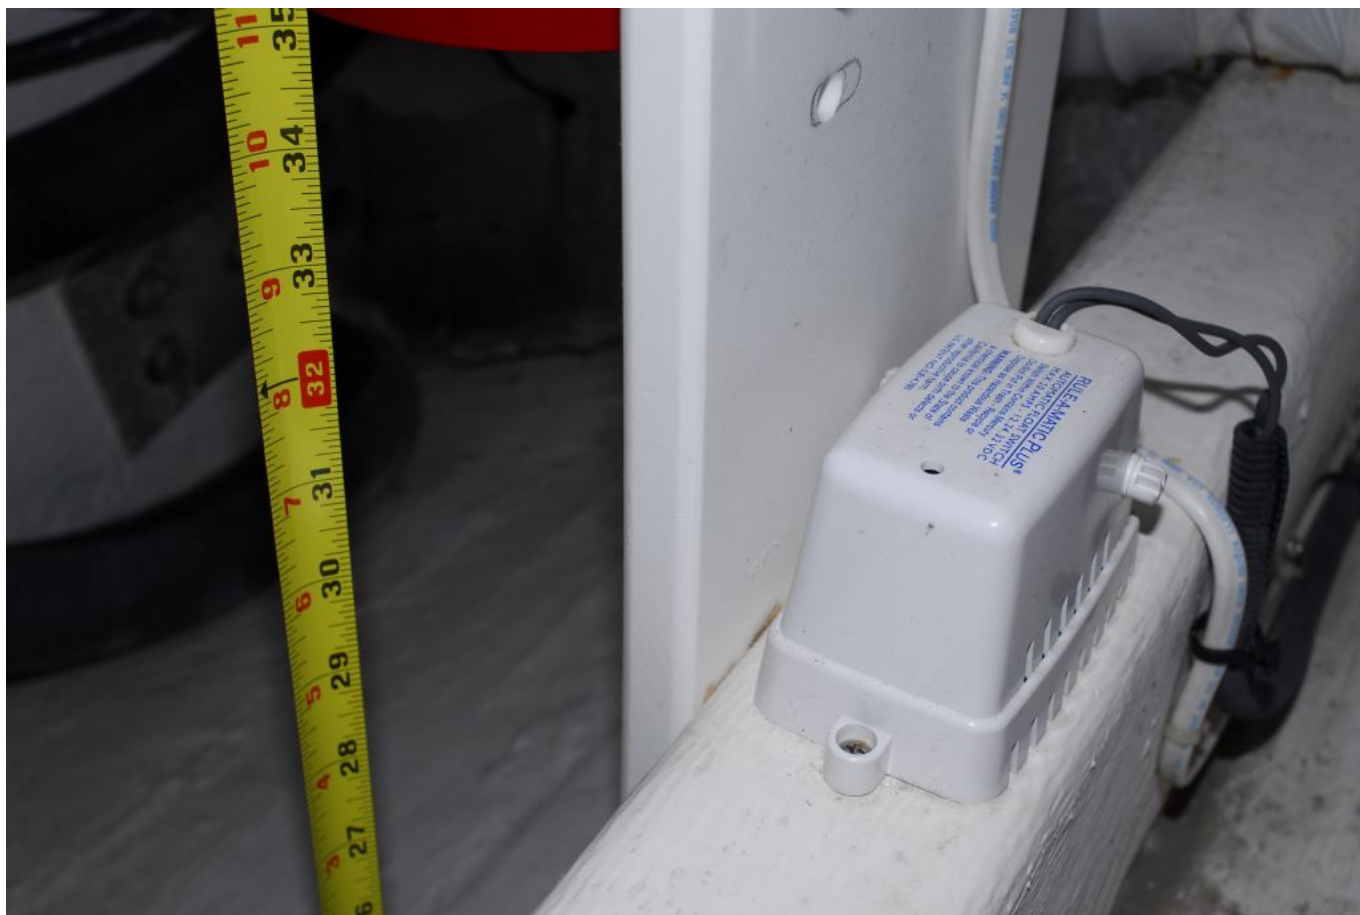
**This high water alarm, located on an engine bed stringer, is over 30-inches above the bilge pump, and above the bottom of the engine.**

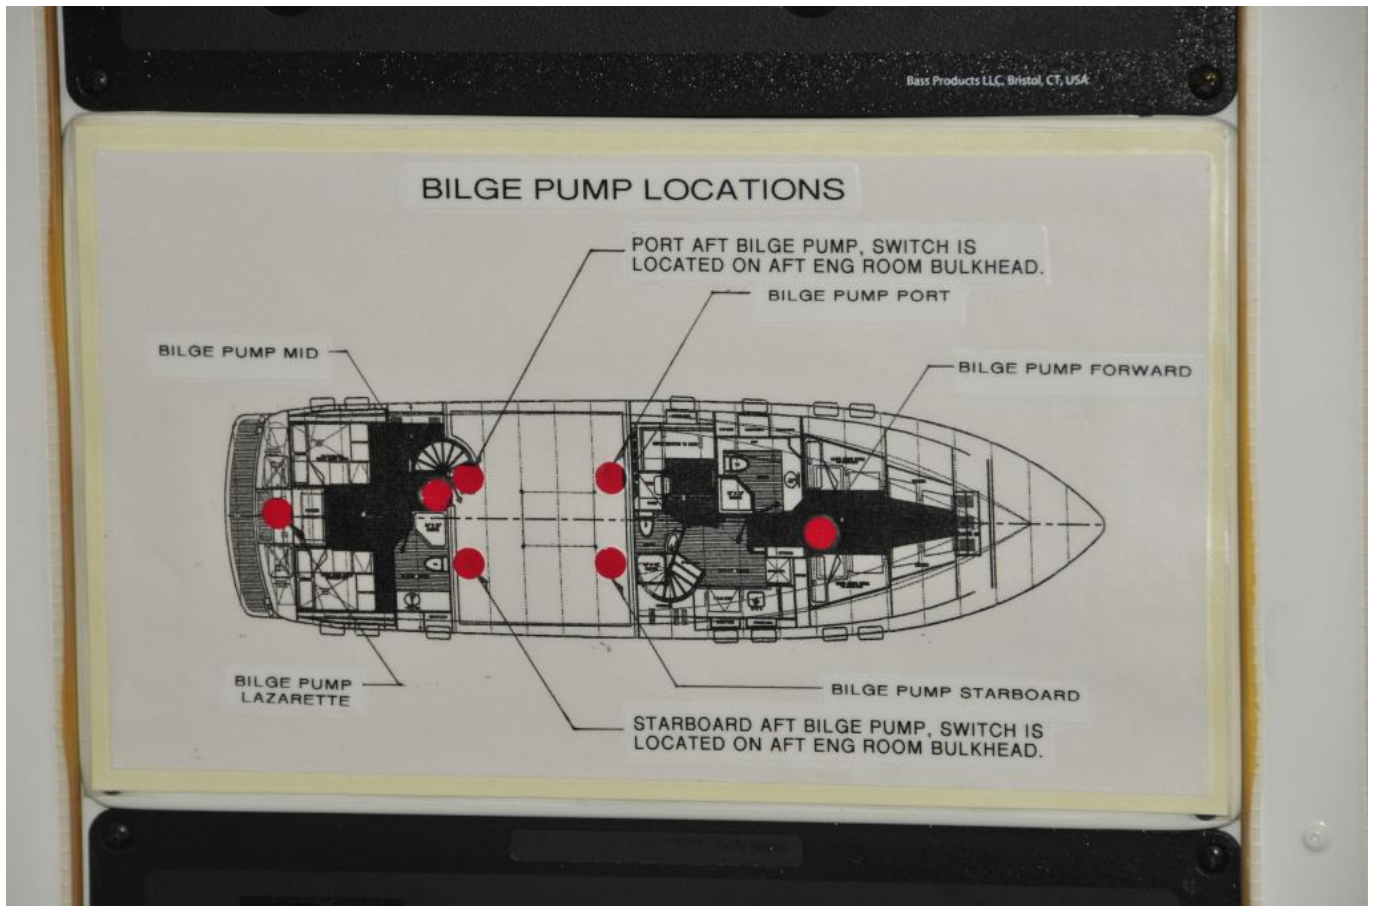
**A chart showing seacock and bilge pump locations makes good sense, make certain the font can be easily read in a low-light, emergency scenario.**

The crew of the stricken vessel searched for the source of the water ingress with no success, so they wisely shut all the below the waterline seacocks. The owner had posted a diagram showing the location, however, it was noted the font indicating locations was very small. Not only should this be as clear as possible, each seacock *and hull penetration* on the chart should be clearly identified, so it's clear none have been missed in a scenario such as this.

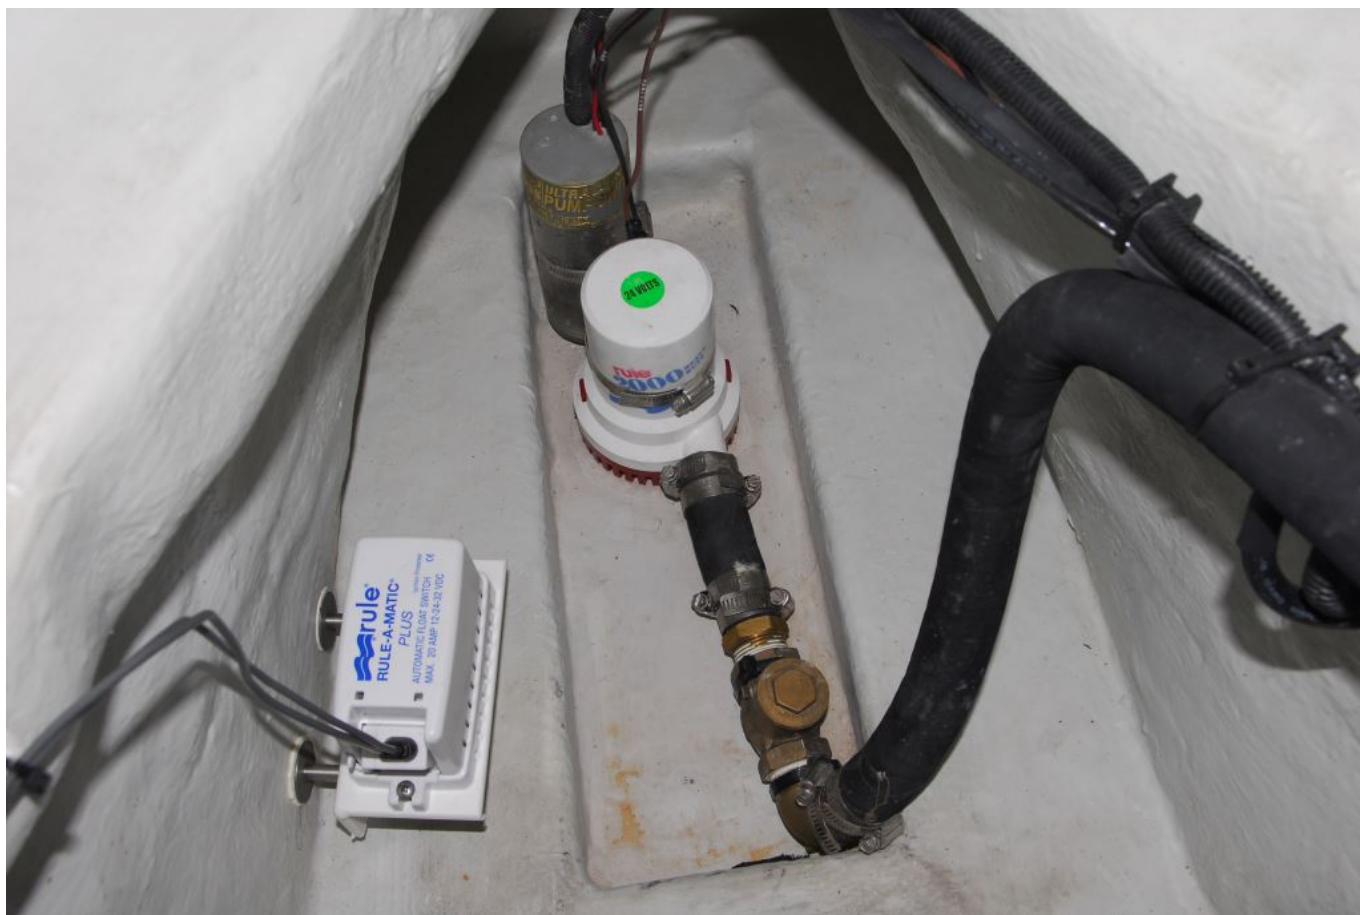
**Located only slightly above the switch for the pump, this high water alarm float switch is properly located.**
