Don't Underestimate the Importance of High-Water Alarms – Crossing the Bar, Tim Caruso

Don't Underestimate the Importance of High-Water Alarms

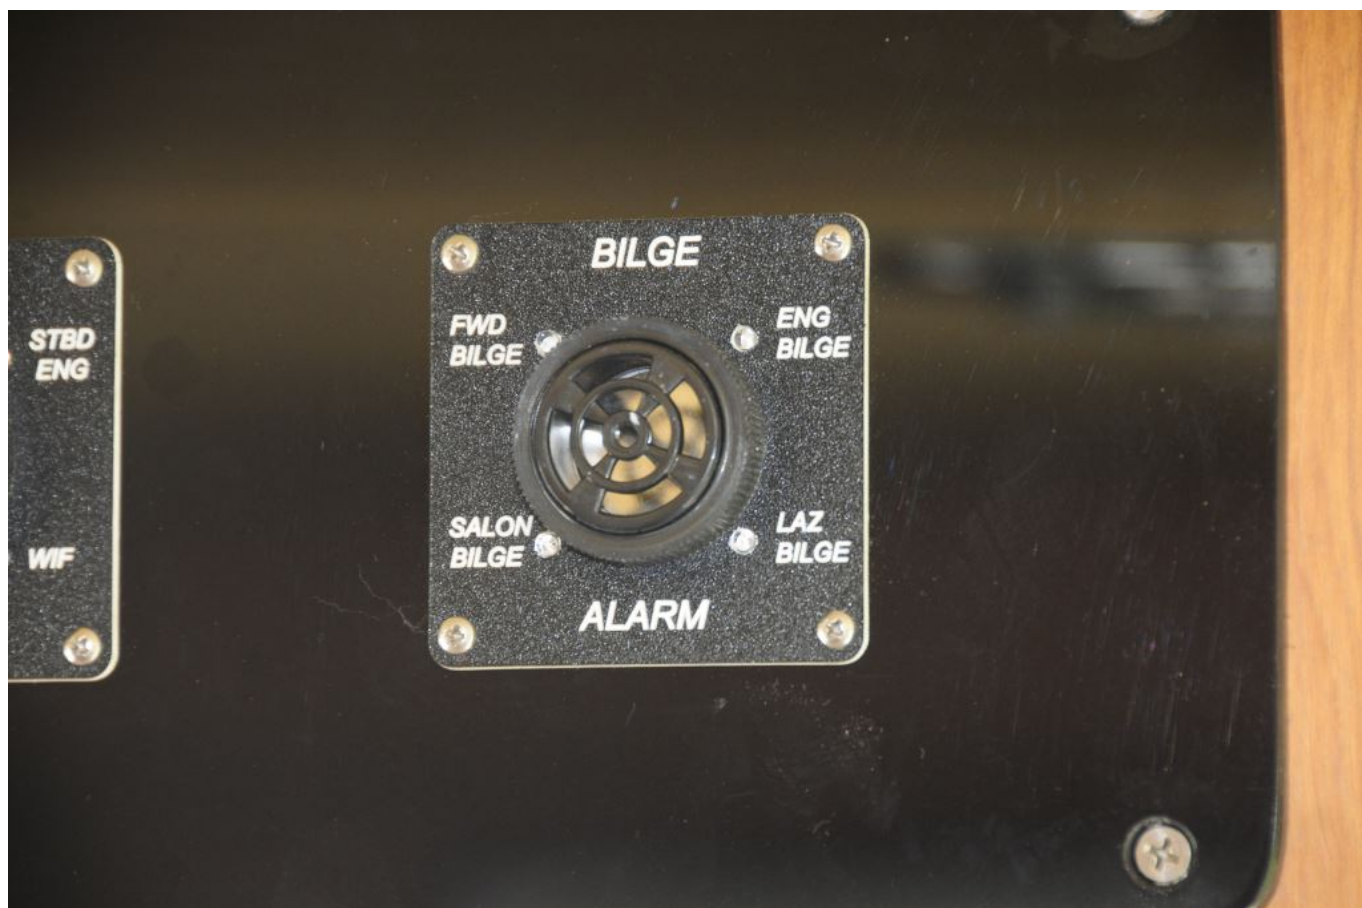
This high water alarm annunciator is well-designed, it includes a single audible horn, and indicator lights to show which compartment is flooding.

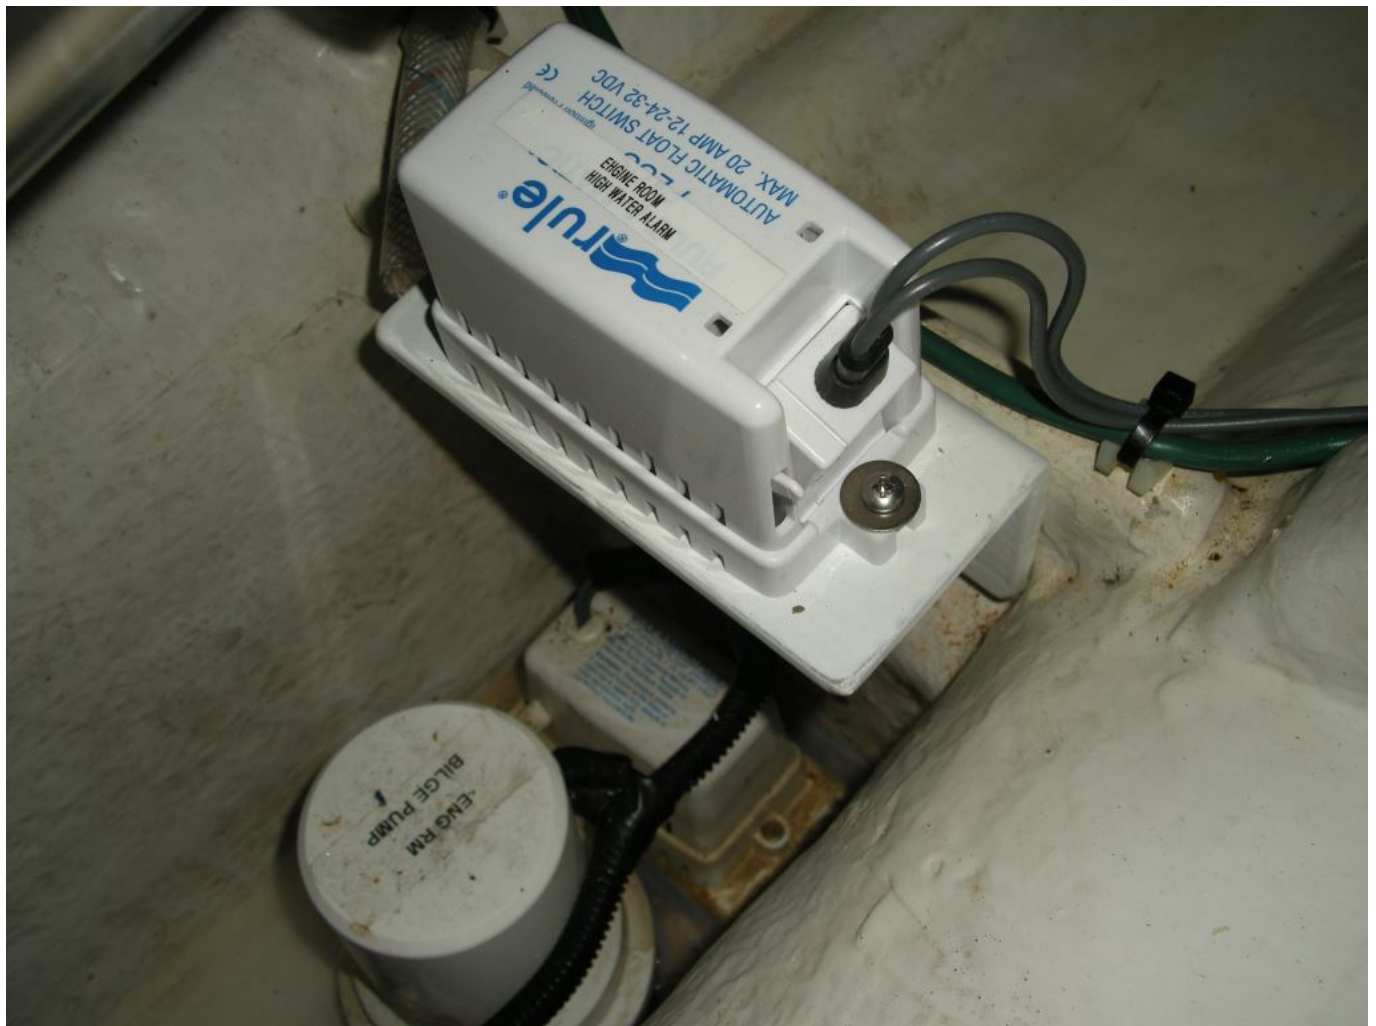
High water alarm switches must be located so that they provide the earliest possible indication of flooding; that usually means no more than just a couple of inches above the primary pump's switch. The one shown here is, once again, too high.

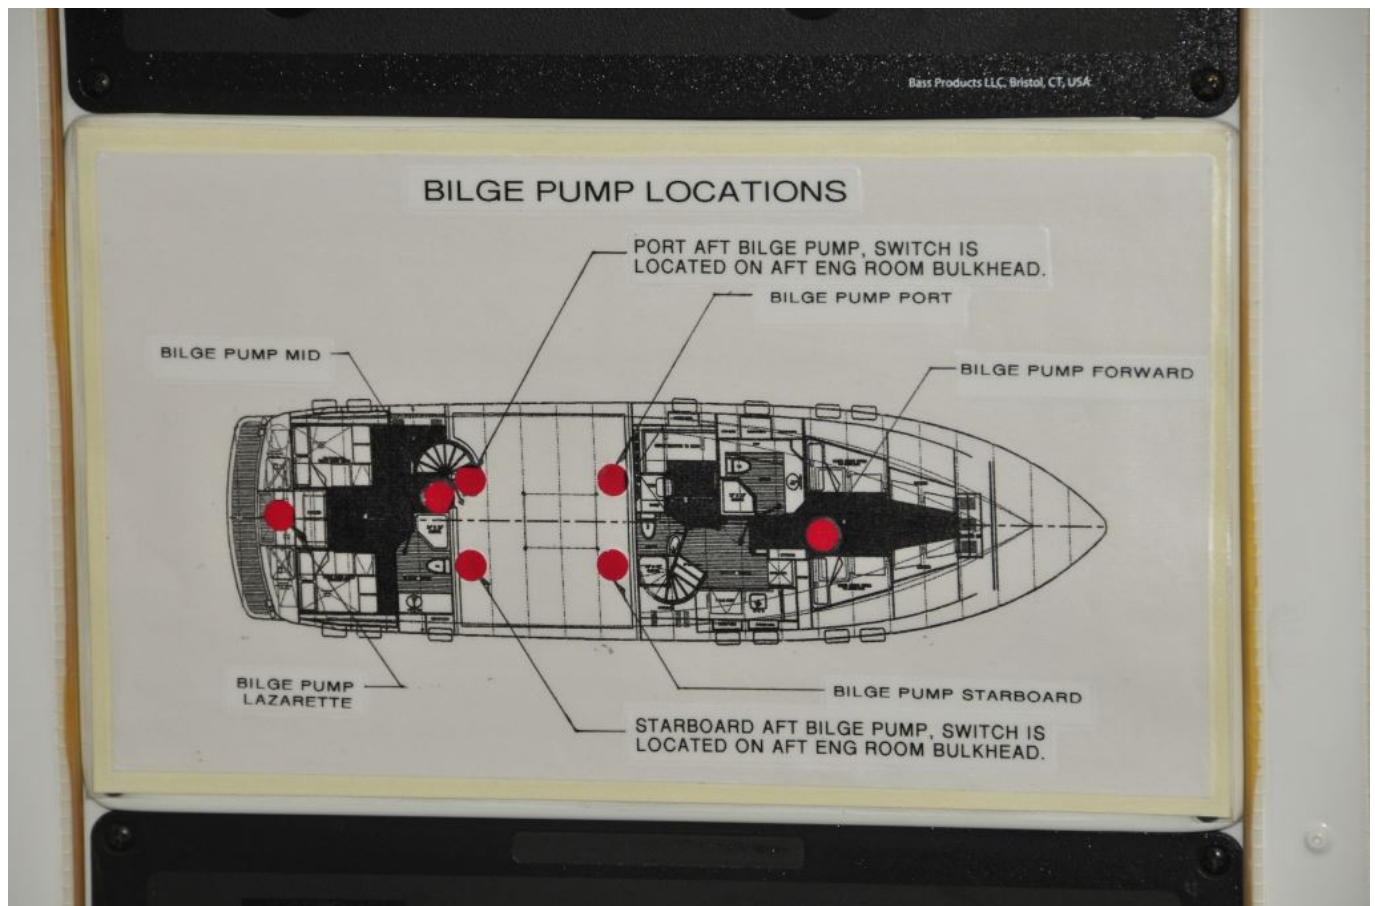
A chart showing seacock and bilge pump locations makes good sense, make certain the font can be easily read in a low-light, emergency scenario.

The crew of the stricken vessel searched for the source of the water ingress with no success, so they wisely shut all the below the waterline seacocks. The owner had posted a diagram showing the location, however, it was noted the font indicating locations was very small. Not only should this be as clear as possible, each seacock *and hull penetration* on the chart should be clearly identified, so it's clear none have been missed in a scenario such as this.
