Editorial: Visiting the USS SAGINAW's Gig- Feature: Buying a Metal Boat

Metal Boats

Buying, Owning and Selling Metal Boats

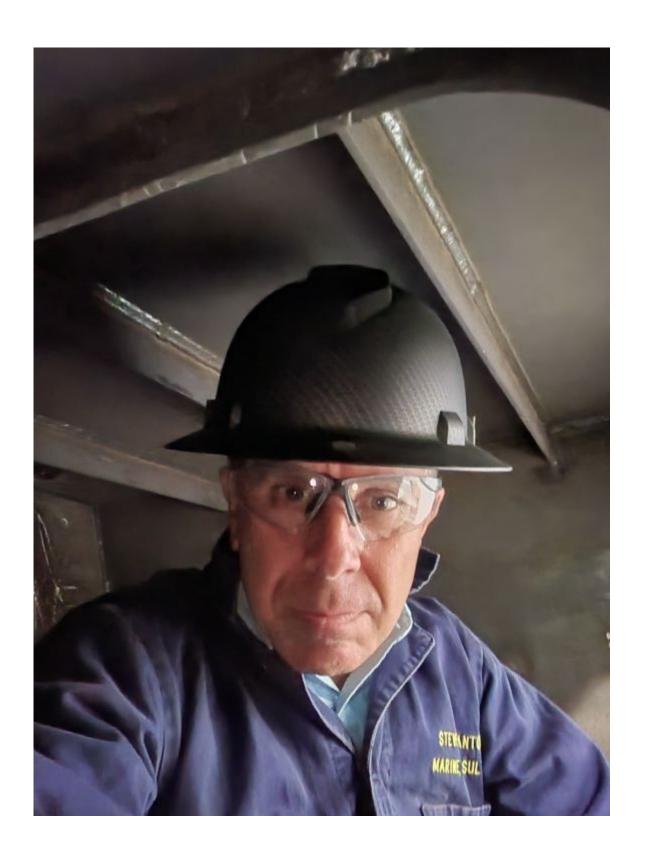
The author inside the fuel tank of a steel vessel under construction.

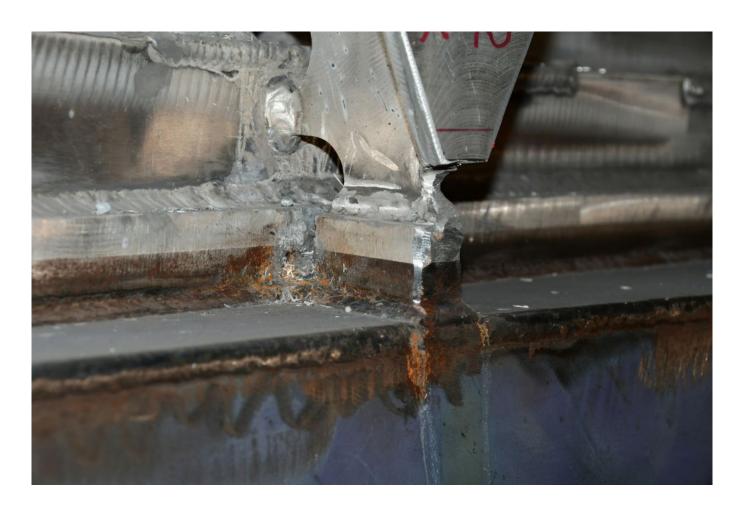
Many steel vessels utilize aluminum for cabins and other above deck structures. Joining these two metals typically relies on specialized products that act as an interface between the two.

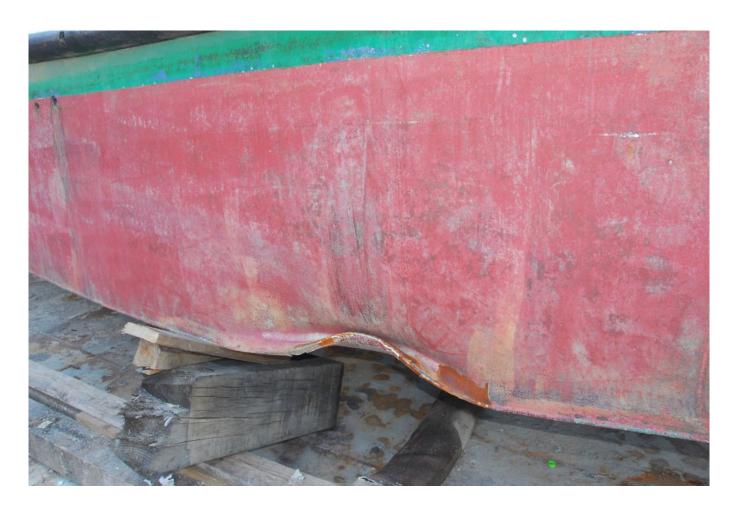
One advantage of steel and aluminum is their ability to deform significantly before being breached.

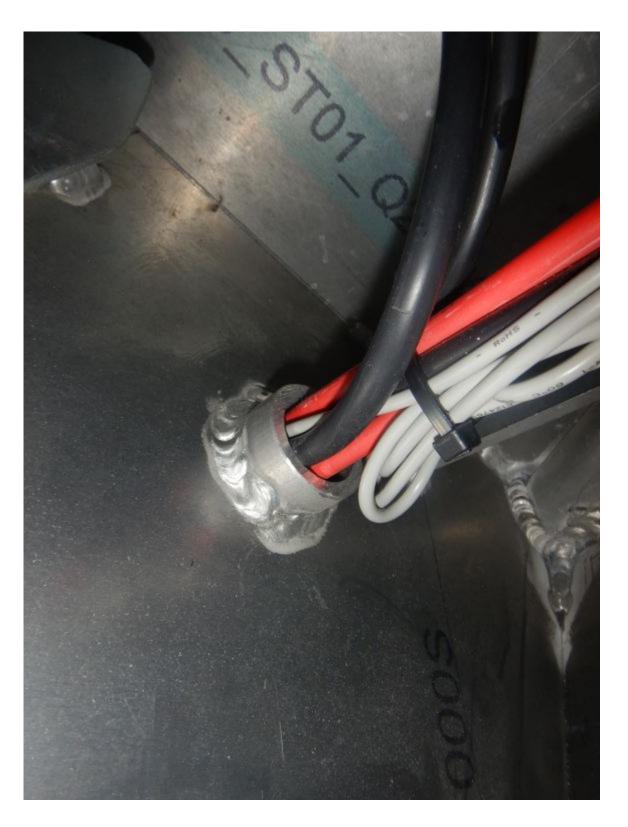
Because of the risk of chafe and short circuits, additional caution must be used when installing wiring on metal vessels.

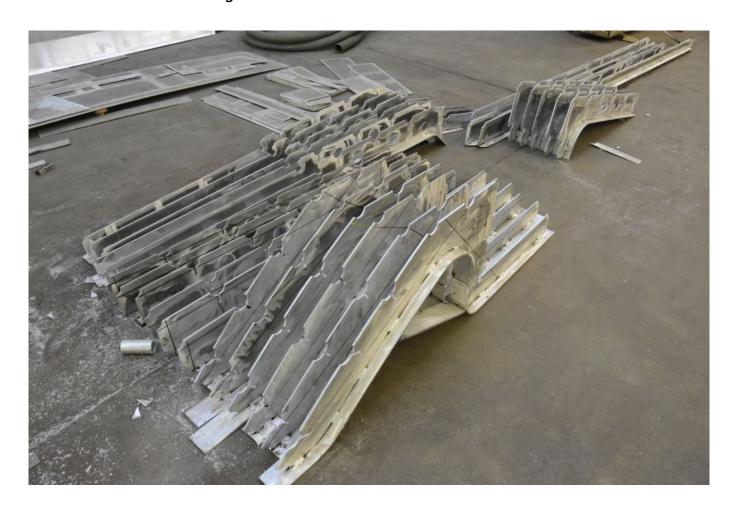
Steel and aluminum are versatile materials that lend themselves to custom designs. In most cases metal is automatically pre-cut using digital design software.

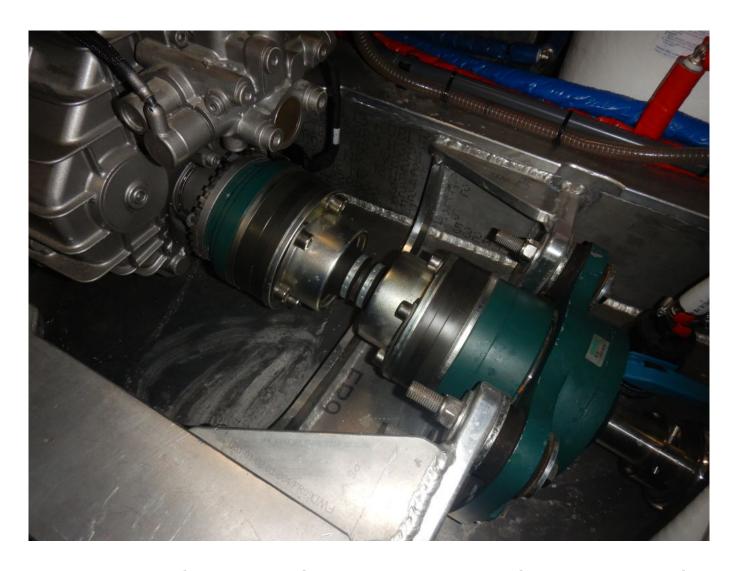
A thrust bearing system installed on an aluminum vessel; this transmits all propeller thrust to the hull, rather than through the engine's mounts. Heavily loaded installations of this are relatively easy to install on metal vessels.

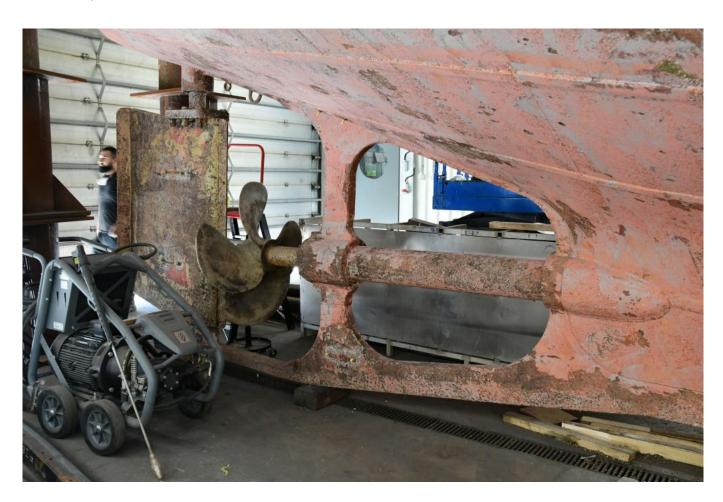
In contrast to aluminum, steel requires thorough preparation, priming and coating, on a regular basis, in order to remain rust-free.

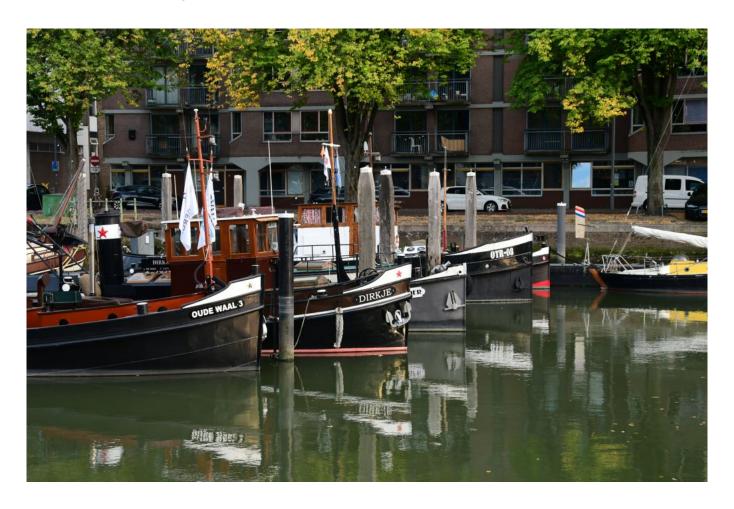
Steel water and waste tanks' interiors are typically epoxy coated, which in theory should prevent corrosion, however, because the shapes are complex and sharp, with stiffeners, frames and gussets, it is very difficult to prep and reliably coat the inside of a metal tank, and this is especially true

of aluminum. Aluminum is particularly susceptible to corrosion that thrives between coatings and the metals surface. Known as poultice corrosion, mentioned elsewhere in this article, it is very much at home in this environment.

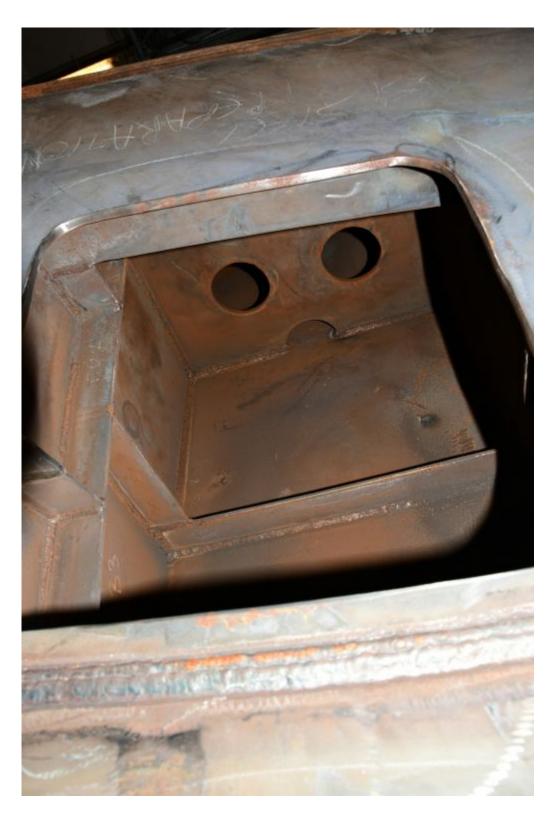
Most steel vessels utilize this alloy for integral tanks. For fuel, no treatment or coating is necessary, however, for potable water and waste, tank interiors must be thoroughly coated to prevent rusting. Additionally, while the inside of most steel fuel tanks are not coated, every effort must be made to prevent the accumulation of water, as it can lead to rusting. Of course, this is also true for aluminum integral tanks, where stagnant water can lead to poultice corrosion.

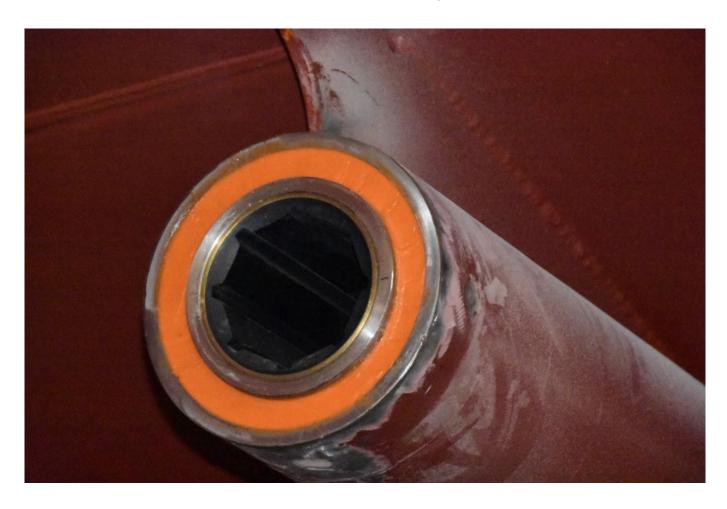
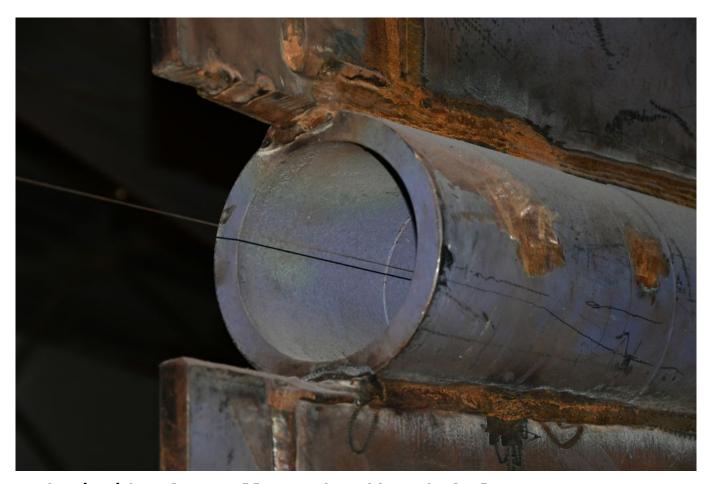
The inside of propeller and rudder shaft logs, are areas on steel vessels that often receive inadequate attention, once a vessel enters service. Rust in this location is virtually impossible to detect without shaft removal.

Another area of concern is the inside of propeller and rudder shaft logs on steel vessels. This area is typically thoroughly prepared, primed and painted when a vessel is new. However, once the vessel enters service, the area is rarely inspected or maintained, which in turn leads to rust and eventually a possible breach and leaks. Ideally, on an older (i.e. more than 10 years old) steel vessel, shafts and rudders should be removed, and these areas inspected.

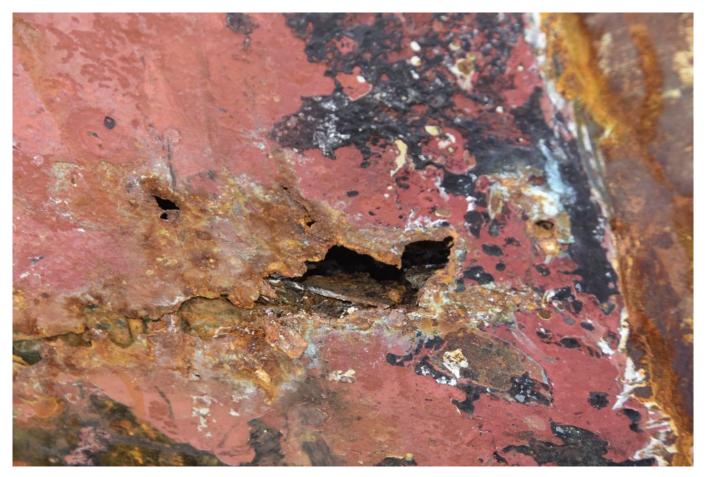
Proper maintenance of coatings is a critical, and ongoing aspect of steel vessel ownership.

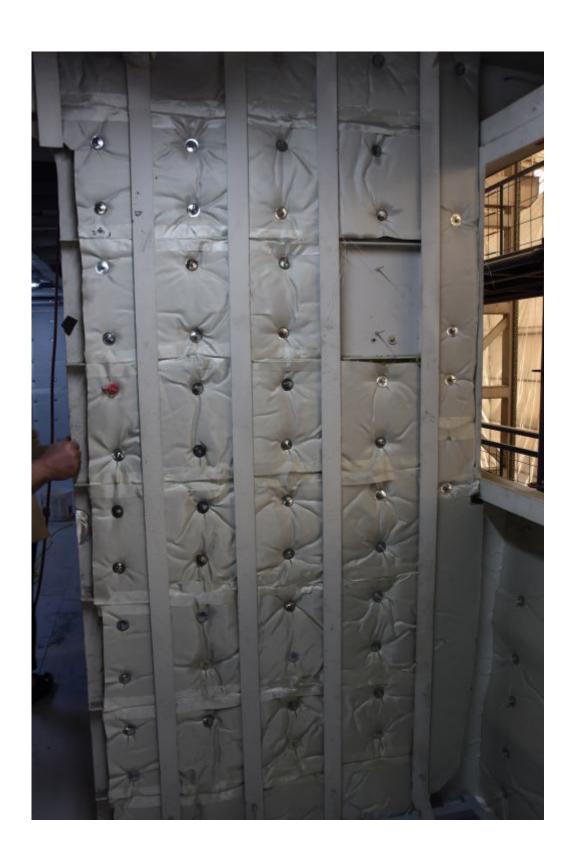
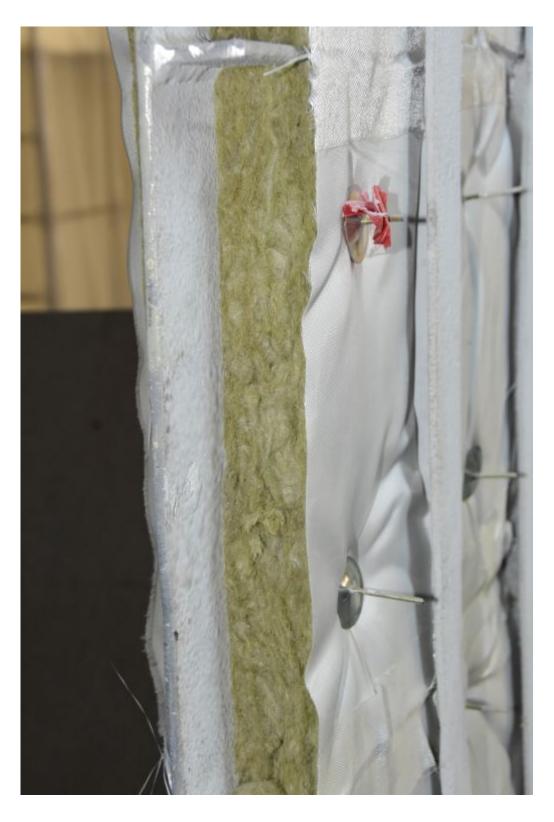
Different types of insulation are used on metal vessels. The batting style shown here can be relatively easily removed if welding becomes necessary.

Repairing and modifying steel is relatively easy for professional welders; these can be found in virtually every port. However, extreme caution must be taken when doing "hot work", as the heat generated by welding can cause nearby flammable materials, especially sprayed foam insulation, and timber joinerwork, to catch fire. Metal vessels have caught fire in boat yards, both while under construction, as well as when undergoing repairs. Metal vessels that use batting, often a mineral-based product, which is fire resistant, are more easily prepared for welding work.

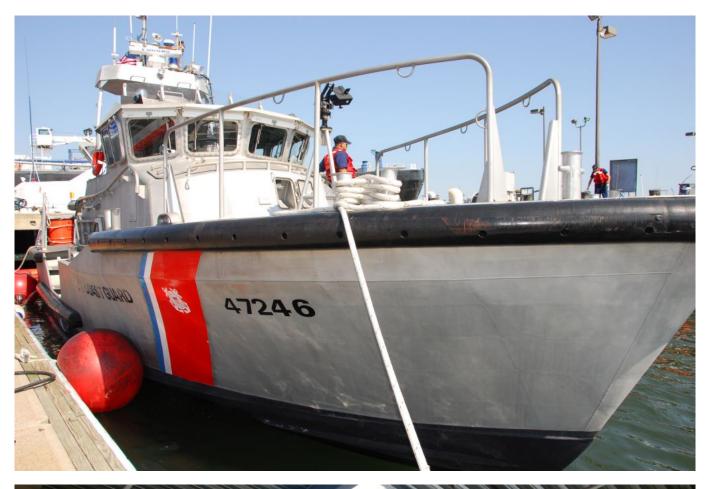
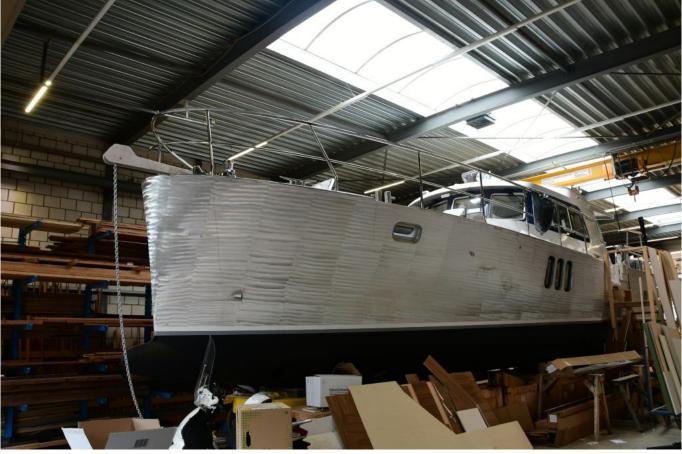
One of aluminum's attributes is its natural resistance to

simple corrosion; and as a result it does not require coating. In fact, coatings, when breached, trap water, which in turn fosters the formation of poultice corrosion.

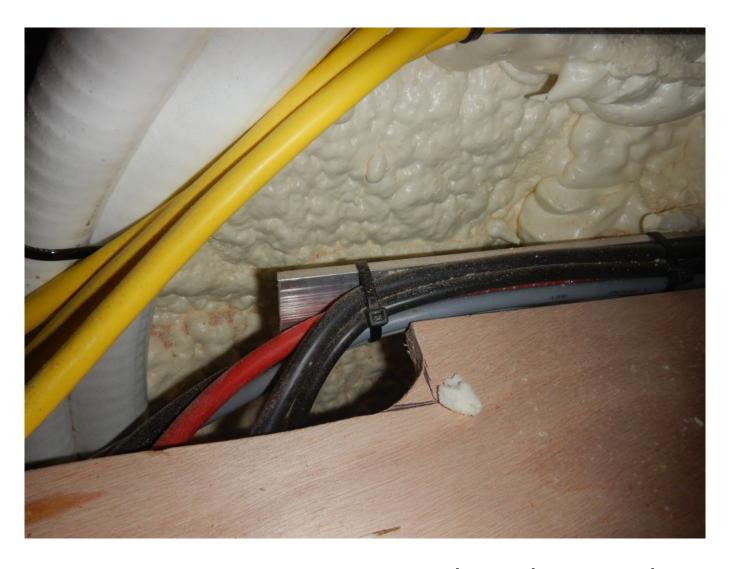
Sprayed polyurethane foam offers good insulating properties, and avoids water entrapment, however, it is more difficult to remove if welding becomes necessary.

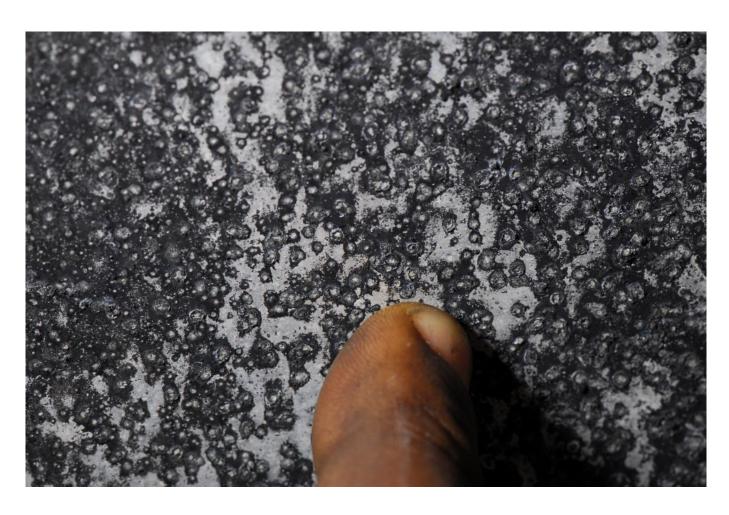
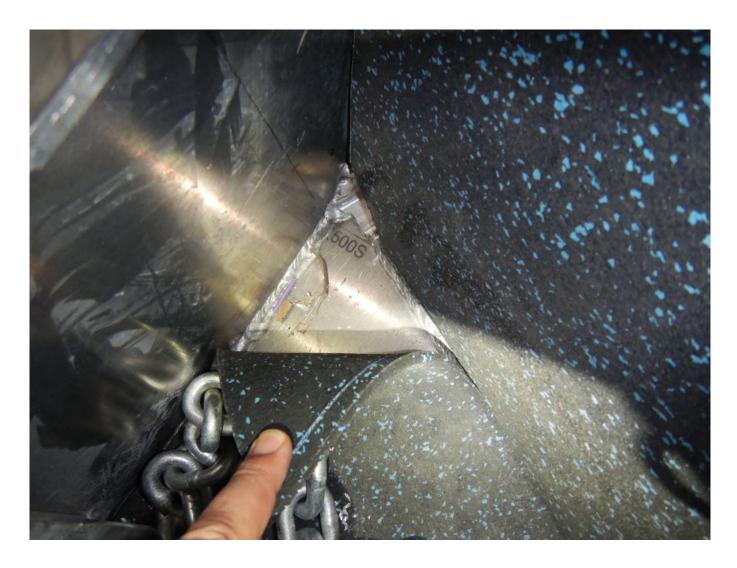
Aluminum is susceptible to poultice corrosion, which occurs when water is trapped, and becomes oxygen depleted. Without design and manufacturing care, there can be many areas on aluminum vessels where this may occur insidiously. Aluminum is susceptible to poultice corrosion, which occurs when water is trapped, and becomes oxygen depleted. Without design and manufacturing care, there can be many areas on aluminum vessels where this may occur insidiously.

Aluminum isn't subject to rust; however, it is susceptible to its own peculiar type of decay called poultice corrosion, which occurs when it is exposed to stagnant, oxygen depleted water. This can occur if wet fabric, insulation, bilge debris, or wood, or simply bilge water, remains in contact with aluminum, more on that subject here. It can, and often does, occur when aluminum is painted. If the paint is breached, even minutely, water can migrate through the void, giving poultice corrosion a toe hold, more on that subject here. While perhaps not as aesthetically attractive, this is why unpainted aluminum is far more desirable, maintenance is far lower and poultice corrosion is all but eliminated, at least on weather decks and hulls.

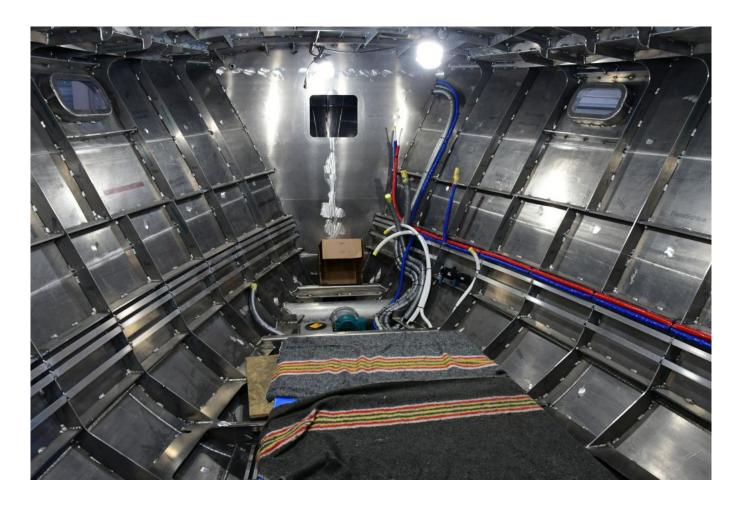
Like all metals, aluminum is subject to stray current corrosion, which often occurs rapidly and can cause severe damage, however, in the case of aluminum, it may be your hull rather than just your shaft, prop and through hulls that are corroding.

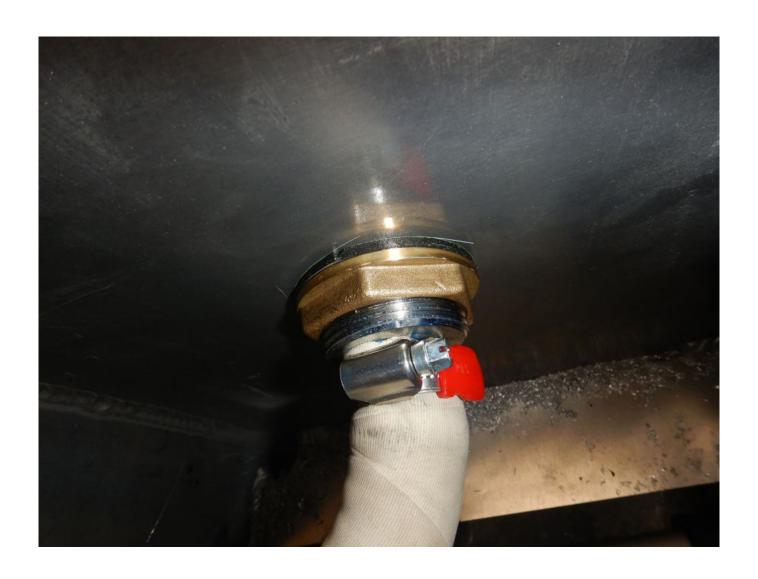
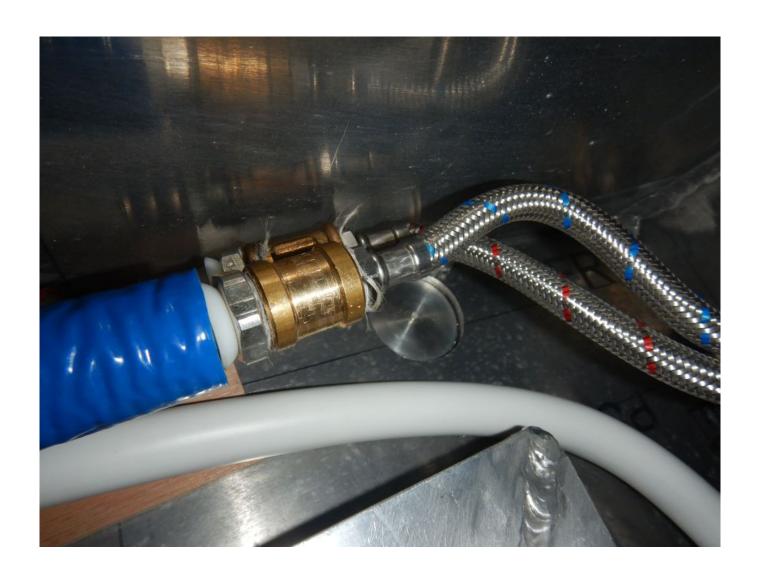
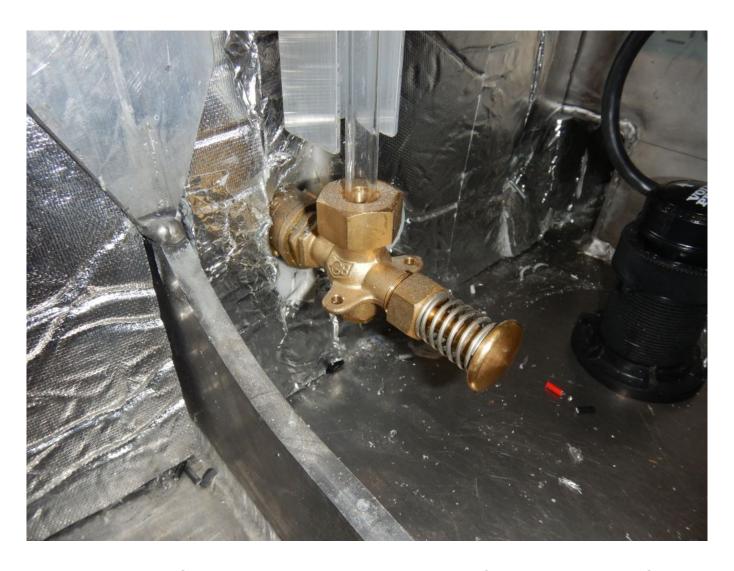
Where aluminum vessels are concerned, in order to avoid galvanic and deposit corrosion, care must be taken to avoid the use of copper and copper alloy plumbing. Where it must be used, it should be encapsulated.

Aluminum is subject to deposit corrosion. This can occur when water, fresh or salt, even condensation, drips from a copper alloy (copper, brass or bronze) pipe onto an aluminum surface. The water carries with it salts of copper, which over time will cause the aluminum to corrode.

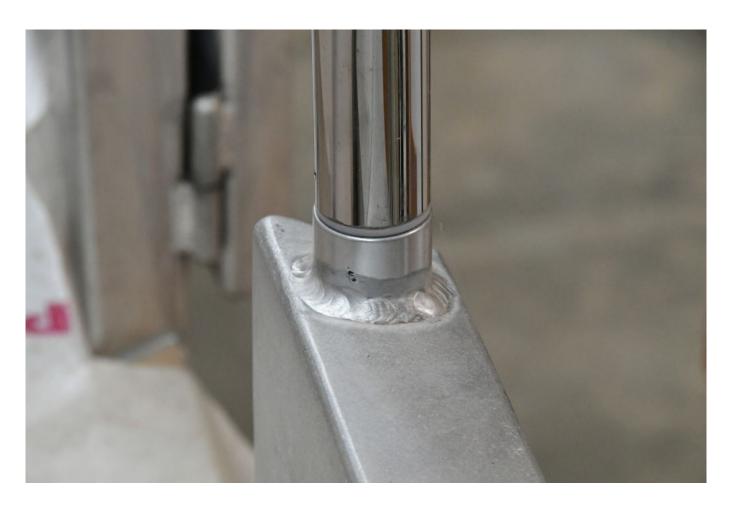
An insulating bushing is used between this stainless stanchion and its aluminum deck fitting. While this will prevent galvanic corrosion at this interface, if water becomes entrapped between the bushing and aluminum, it can lead to poultice corrosion.

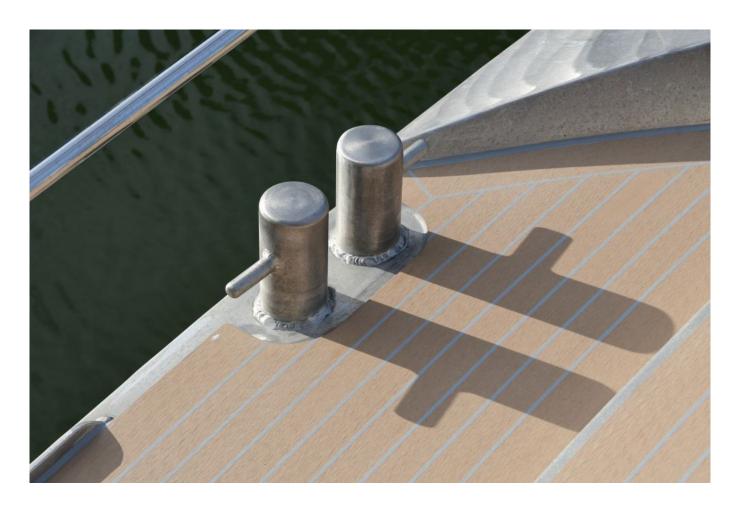
Because much if not all of the deck components (or brackets to which components can be bolted), can be welded directly to the deck, rather than through bolted, deck leaks are generally very rare on metal vessels.

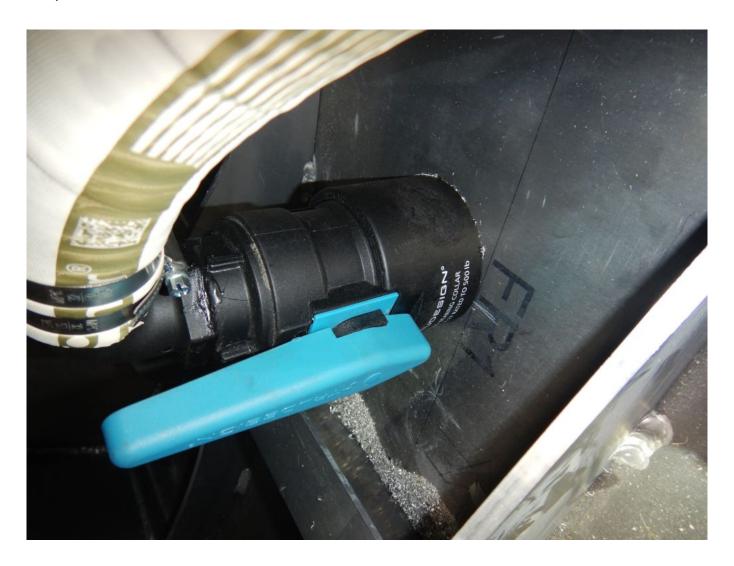
Non-metallic seacocks are frequently used on aluminum and steel vessels, as they avoid galvanic corrosion issues.

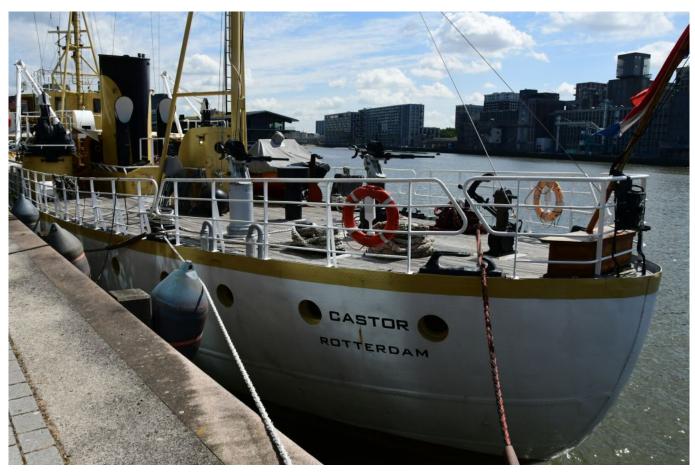
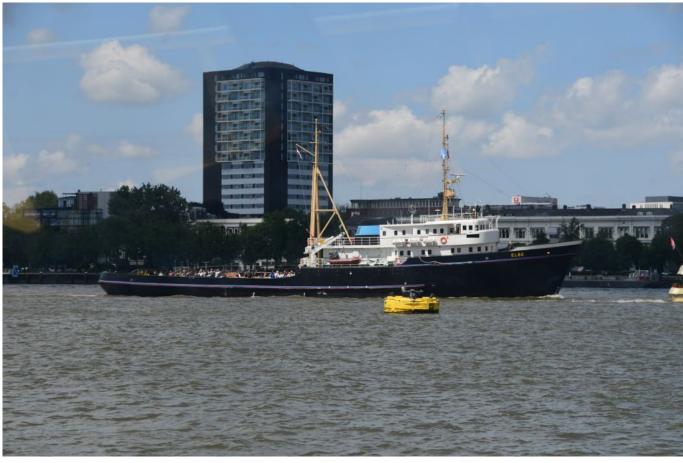
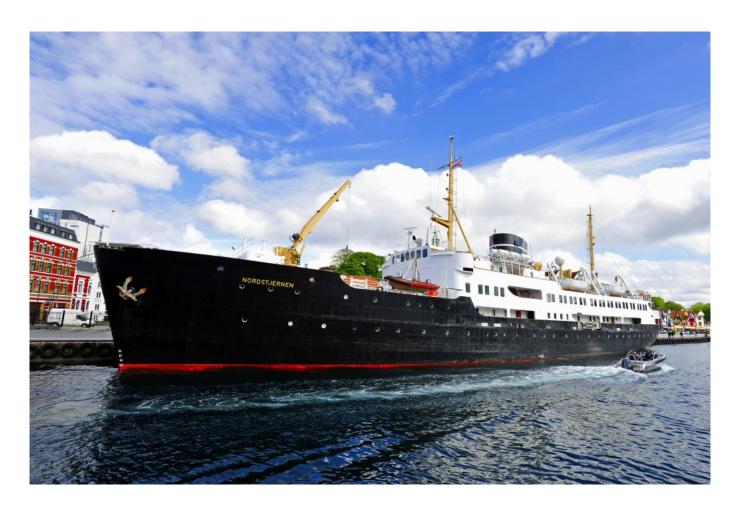
These vessels have been cruising for decades; when properly maintained, steel can be long-lasting and durable. Castor, built in 1950; Elbe, built in 1959; Nordstjernen, built in 1956.

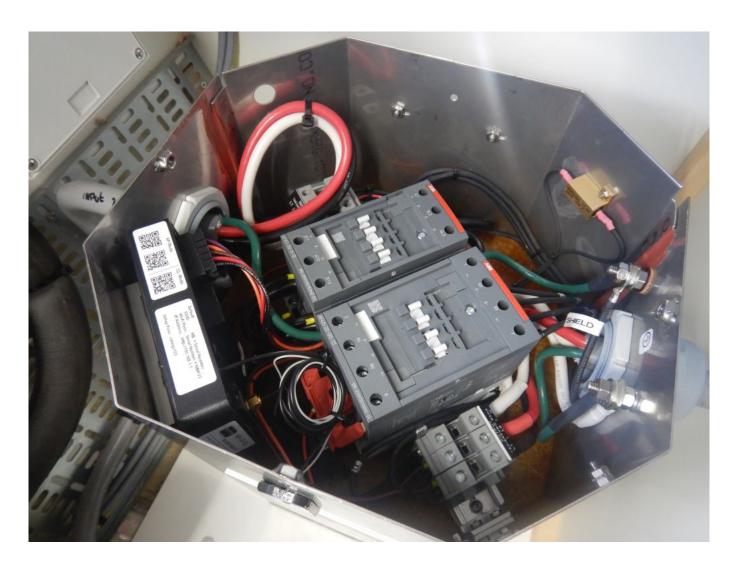
Isolation transformers are a veritable prerequisite for any metal vessel that is equipped with shore power.

Finally, shore power isolation transformers are, in my opinion, mandatory for aluminum and steel vessels. More on isolation transformers here and here.
