Feature: Risks of Undersized Bonding/Grounding Wires – Editorial: You Have Enemies?

Risks of Undersized Bonding/Grounding Wires

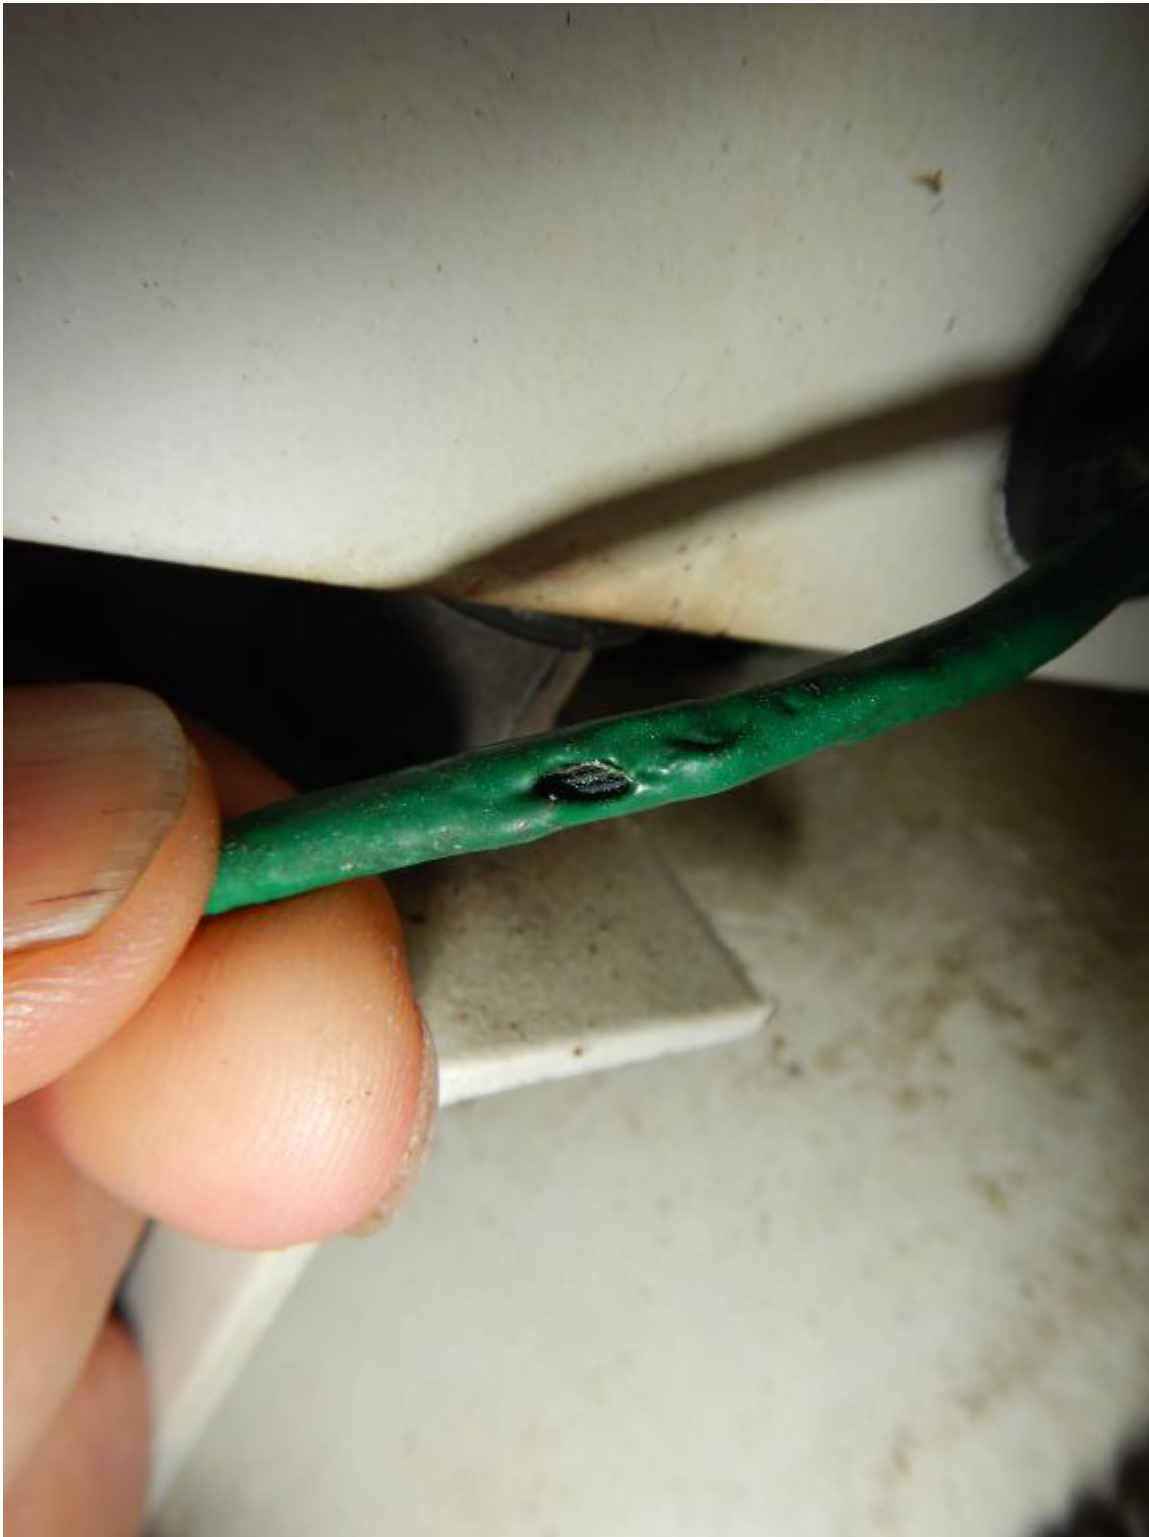
This DC grounding or bonding cable has been overloaded; it overheated, causing the insulation to melt. Under normal operating conditions, DC grounding and bonding conductors should not carry current, however, if they are called upon to do so, they must possess sufficient ampacity to avoid overheating.

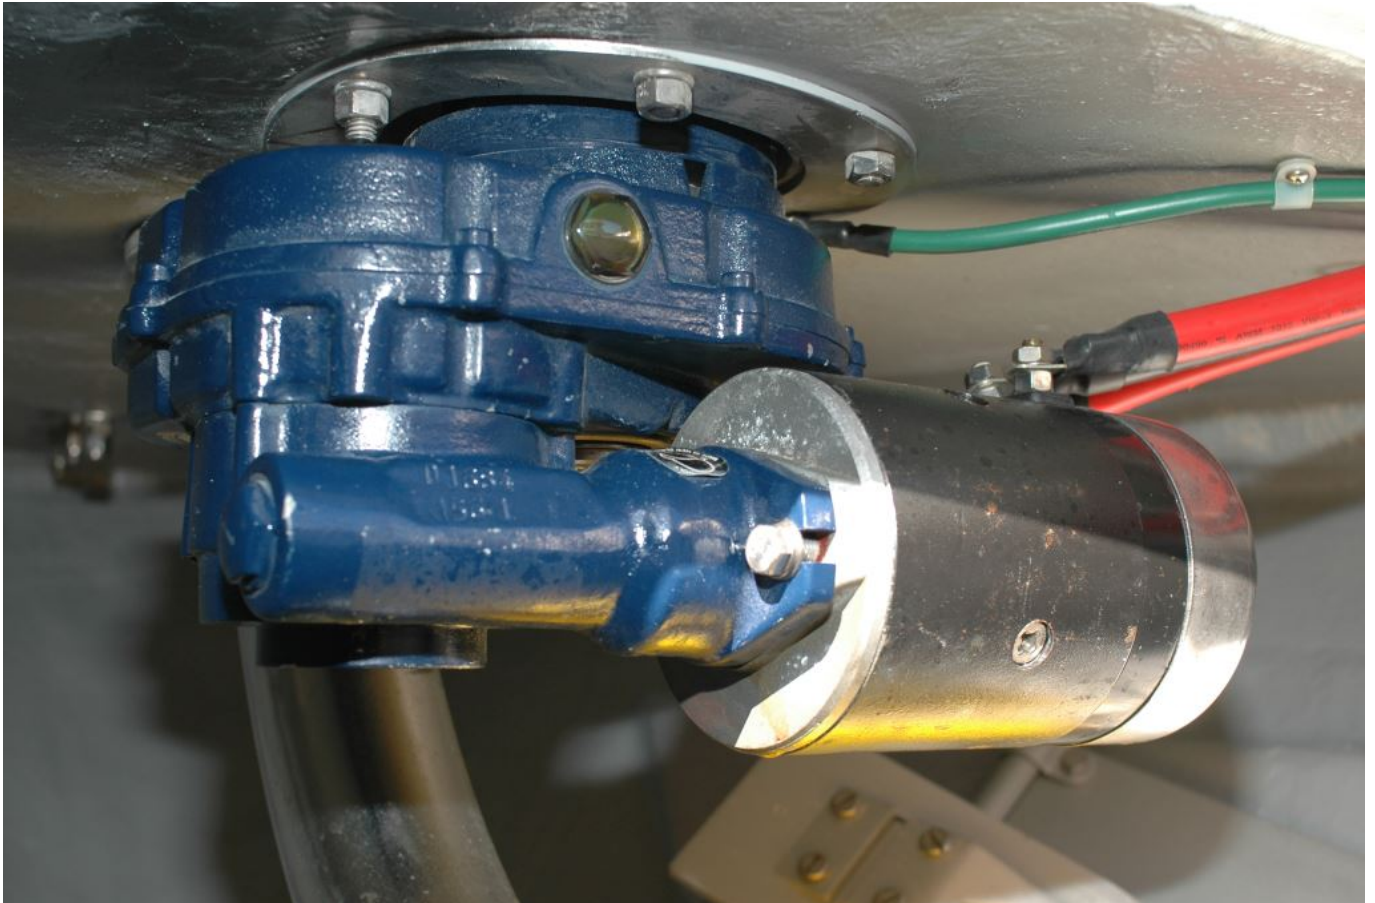
While optional, grounding deck equipment like windlasses is common. If that approach is taken, the grounding wire must be large enough to carry fault current from the windlasses' DC positive cable. This one is undersized.

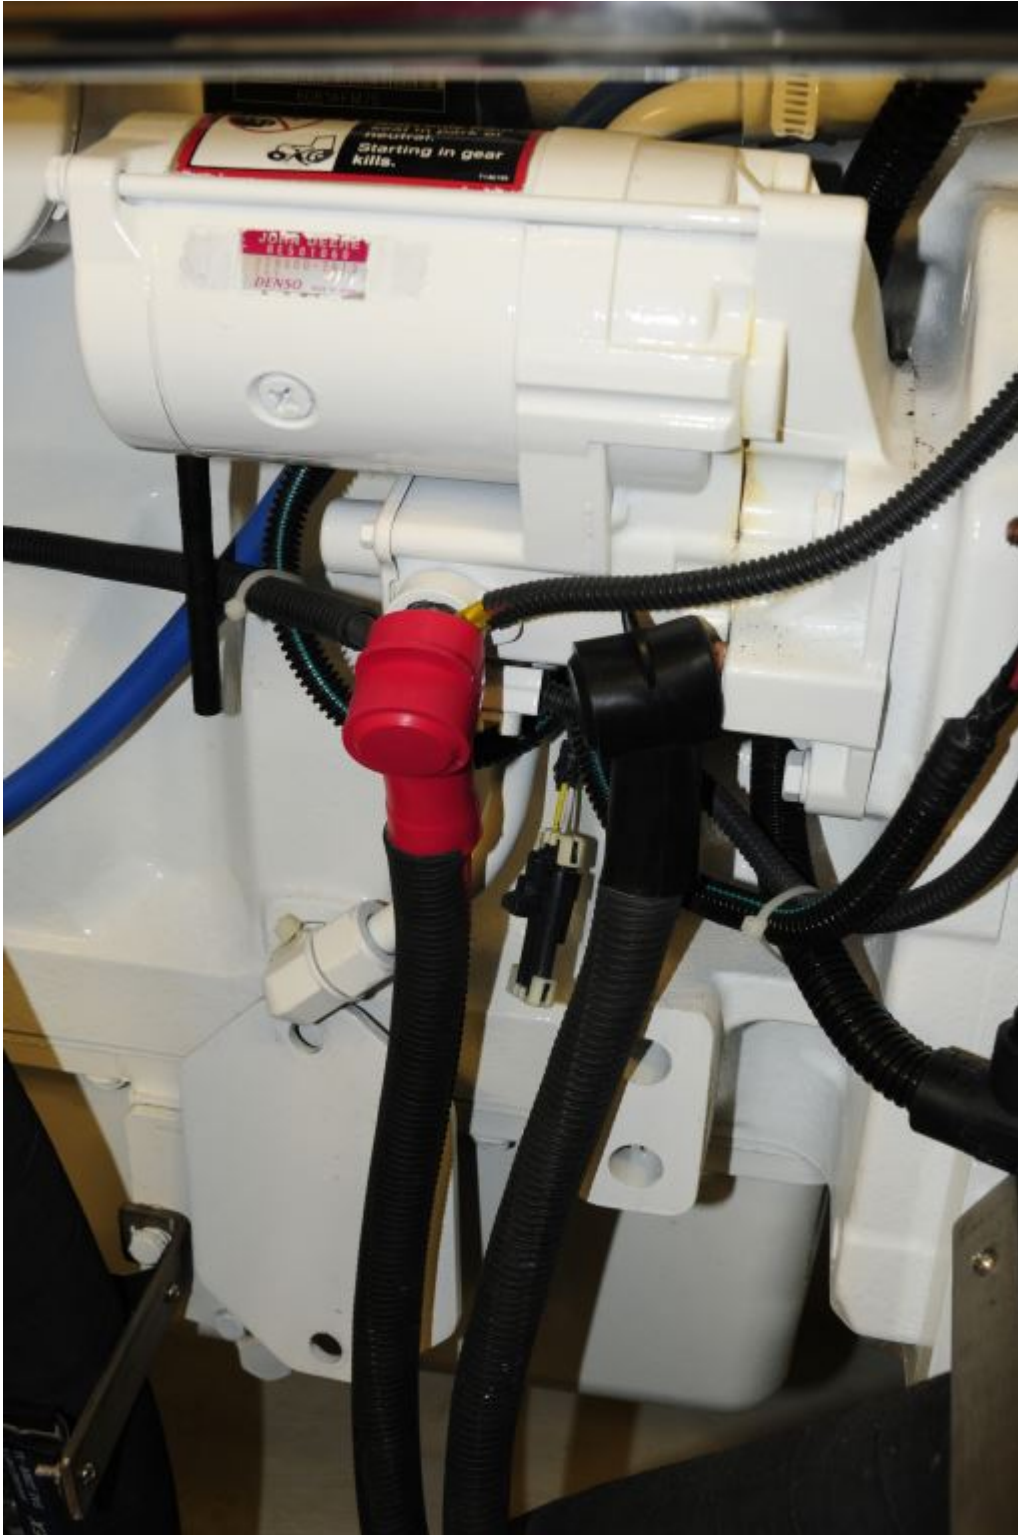
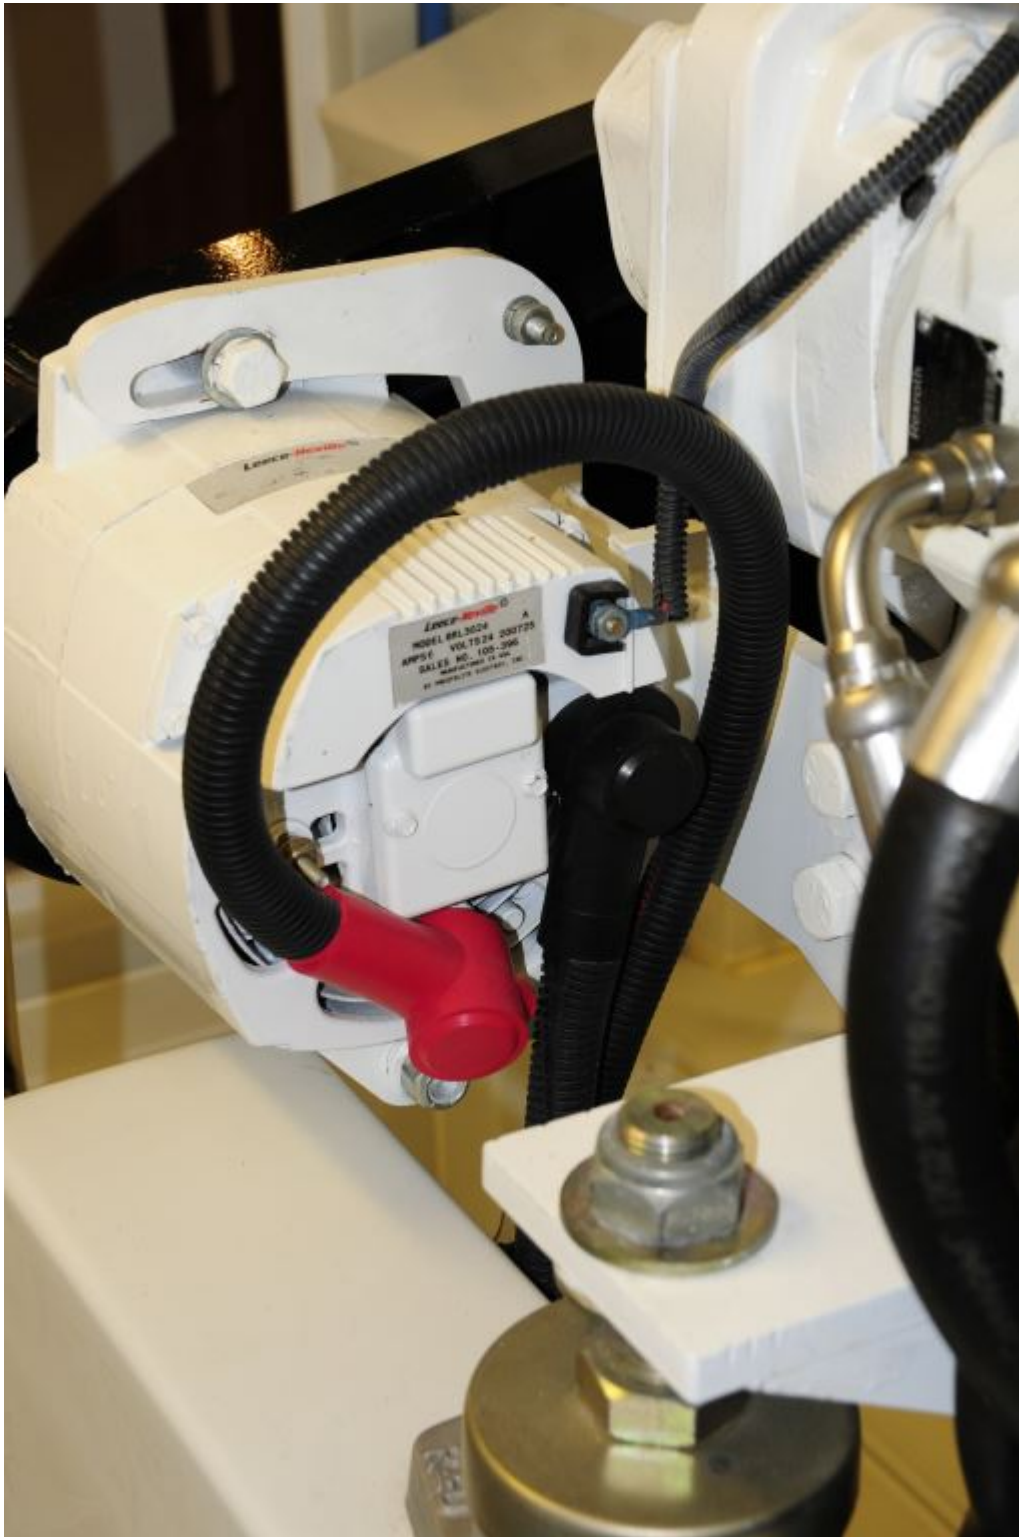
When isolated ground starters and alternators are used, the engine block is non-current-carrying, which means it can therefore be DC grounded. The grounding cable used must be large enough to carry full fault current from the largest DC positive conductor, which is usually the one supplying the starter, which is also typically not protected by over-current protection (a fuse); it is the only conductor which is exempt

from this ABYC rule, making the prospect of a short to the block even more dire.

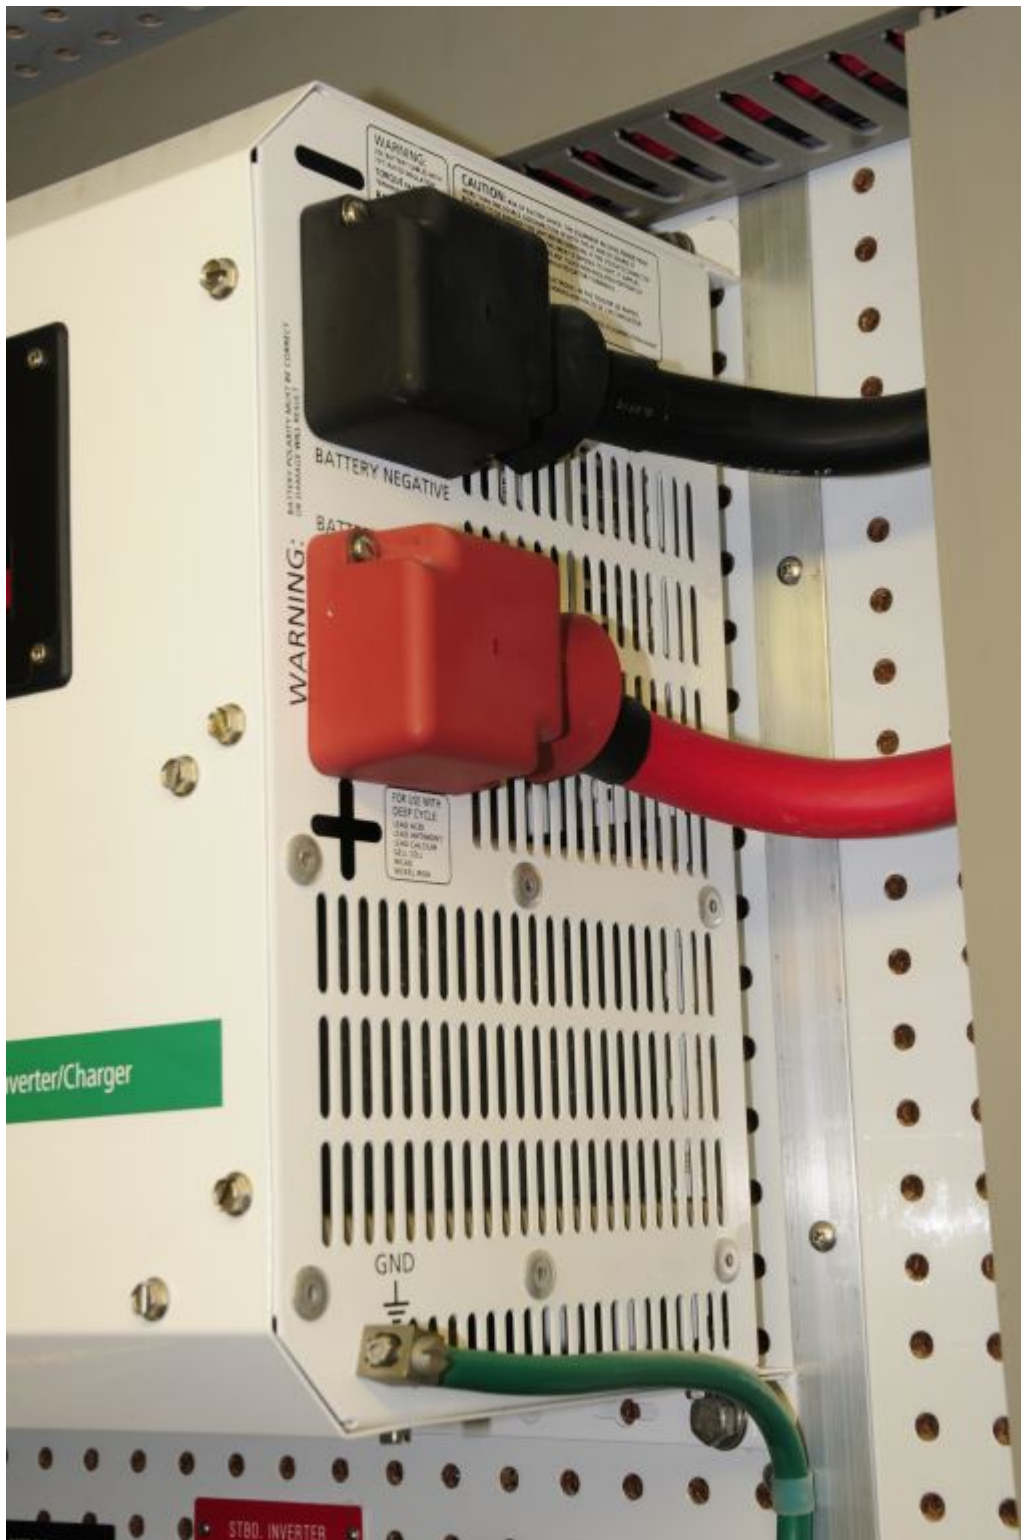
Inverter chassis grounding wires frequently violate the ampacity rule for these conductors. This undersized chassis grounding wire could not carry fault current from the DC positive supply cable, should it make contact with the enclosure. This grounding lug also uses a non-ABYC compliant direct-bearing fastener.

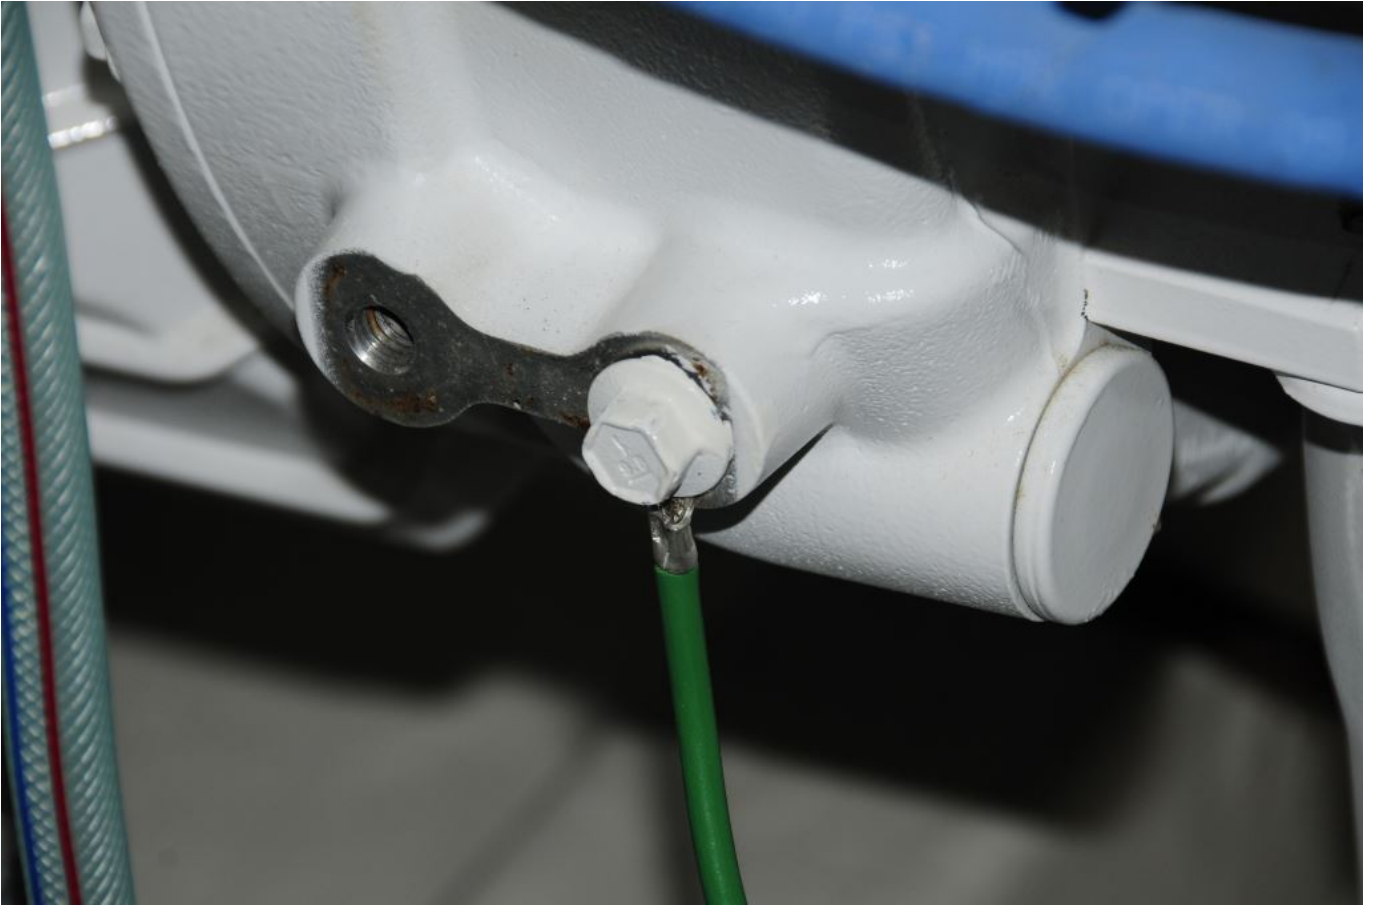
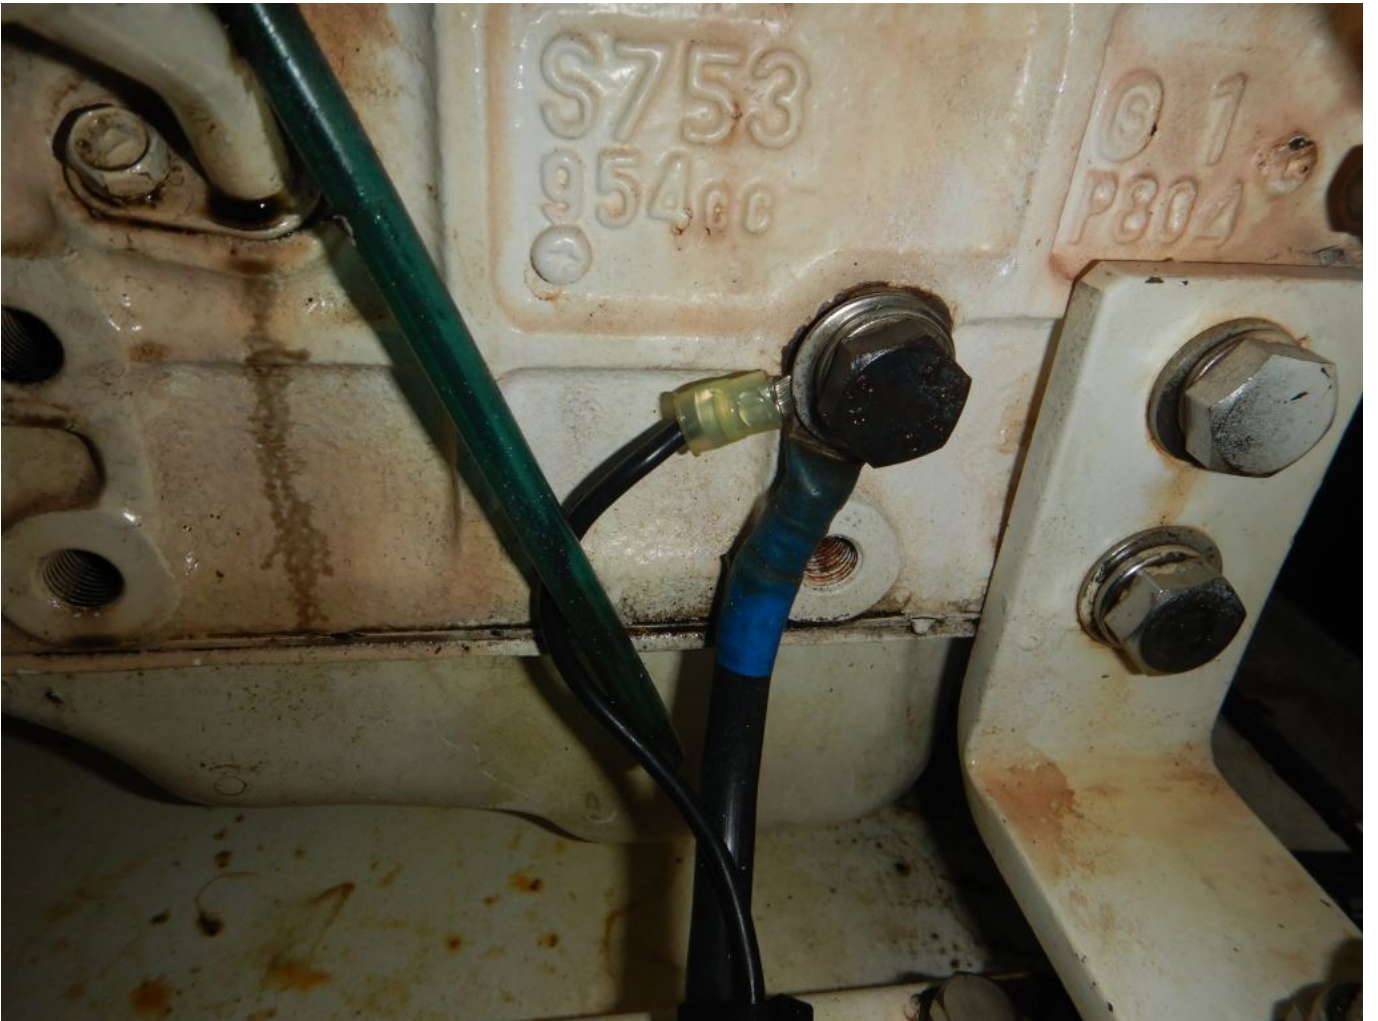
Small gauge wires used for engine block grounding are both incorrect and dangerous. If they are called upon to carry cranking, charging or fault current, they will overheat, which in turn could lead to a fire.

If the engine block is current carrying, i.e., the DC negative cable is connected to the block and the block is normally part of the circuit, If that primary DC negative cable becomes compromised, or it is somehow disconnected (I've seen this occur during battery replacement for instance), these small conductors can be called upon to carry cranking, charging, or fault, current, quickly causing them to become overloaded, and overheated, which can lead to a fire. Or, if the DC positive cable shorts against the block, these wires will carry at least some of the fault current, again potentially overheating.

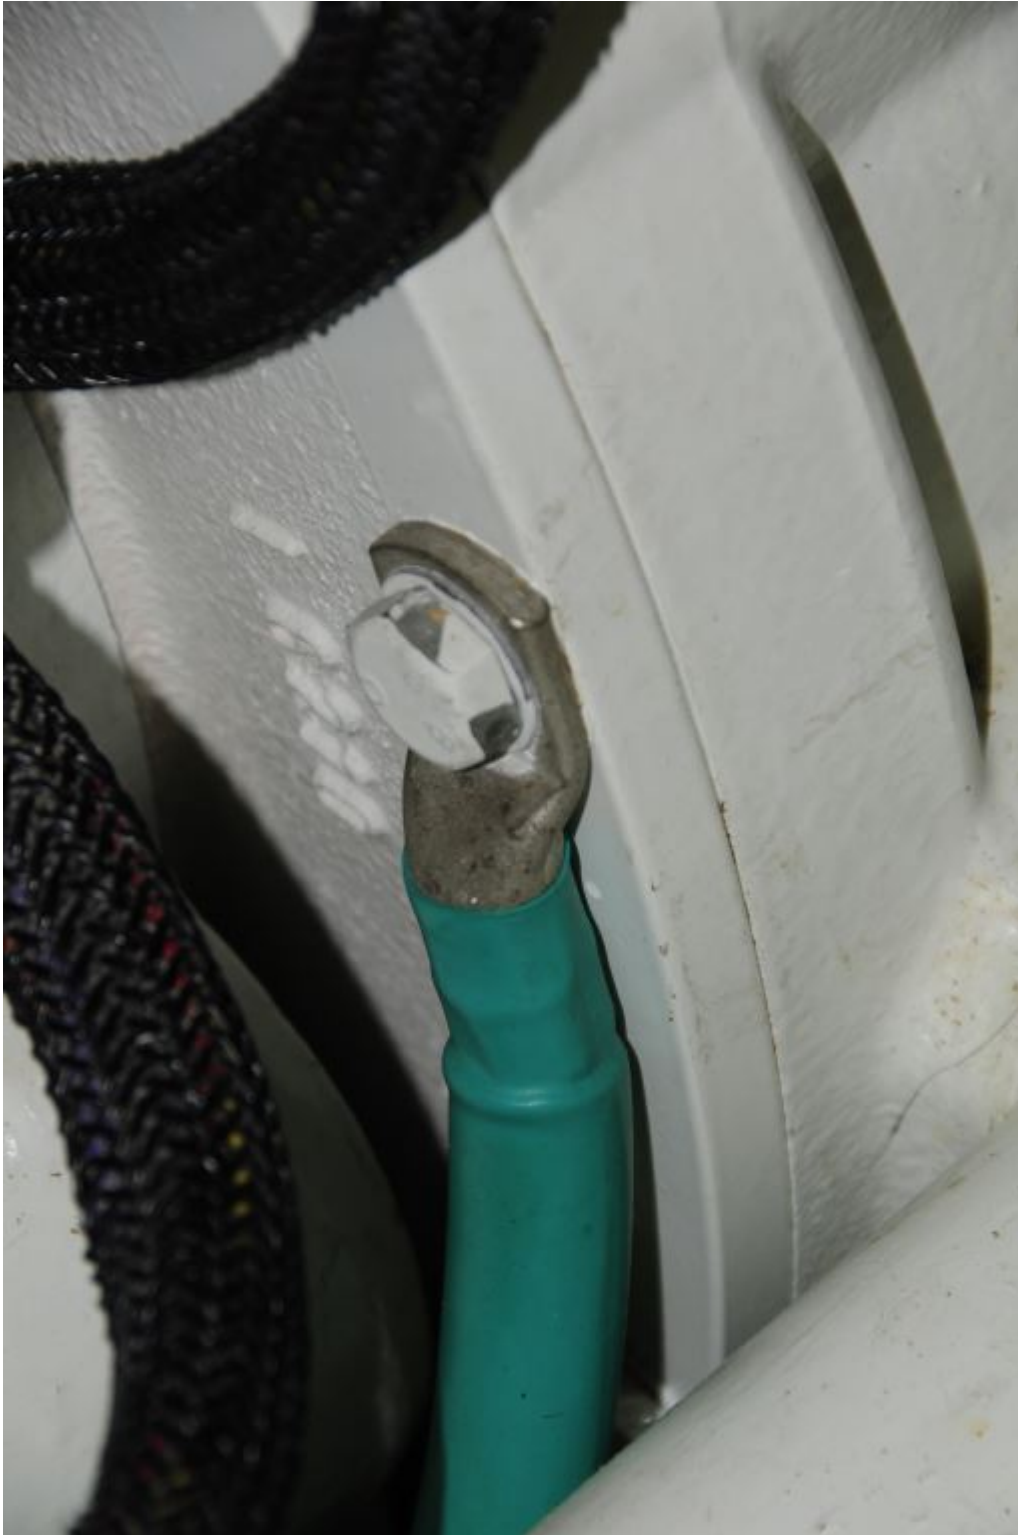
Grounding cables connected to engine blocks must be large enough to carry starter cable fault current, this one is appropriately sized (they should be installed over unpainted surfaces).

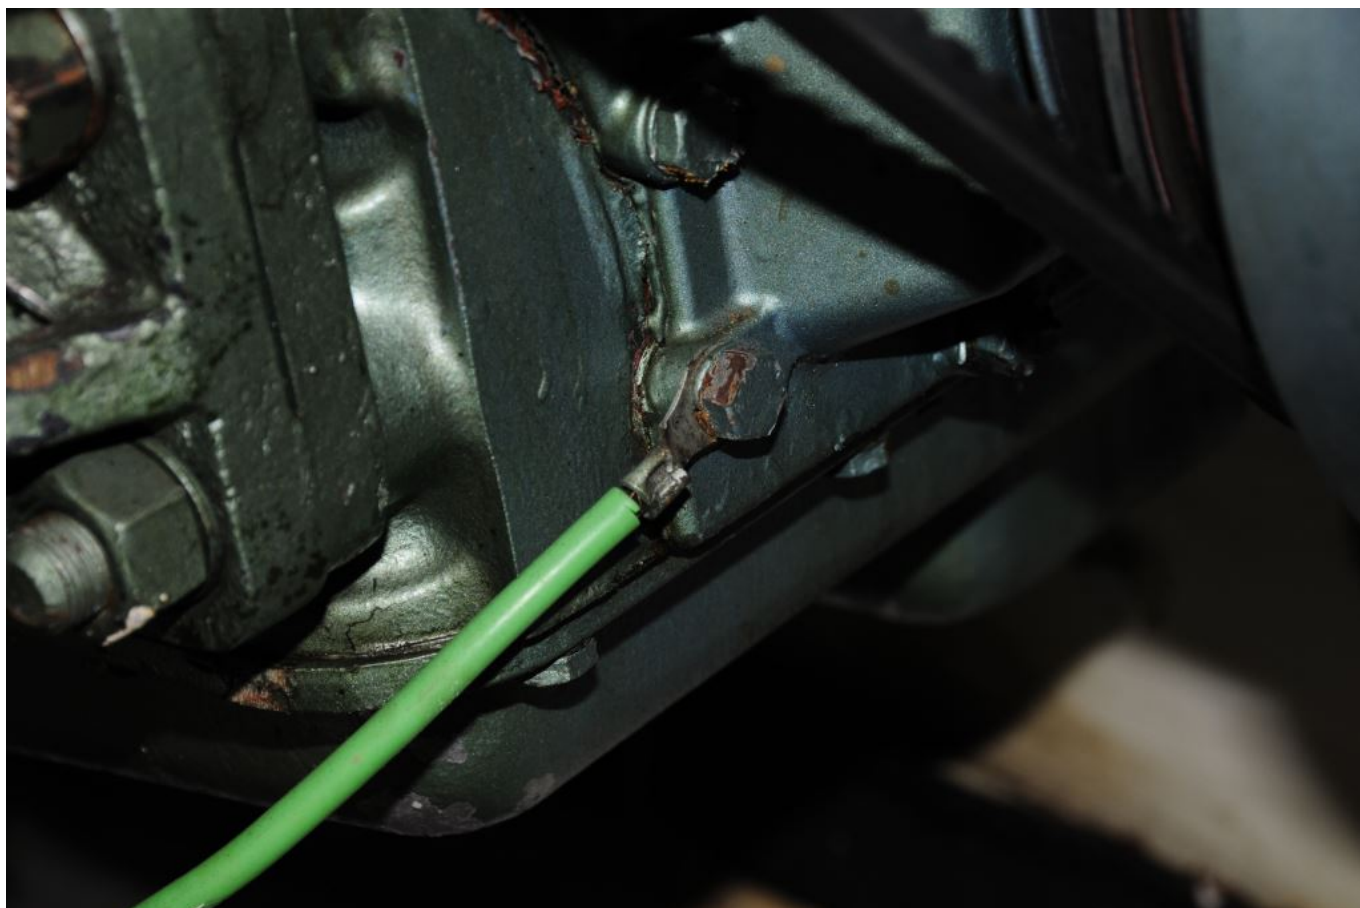
This engine block is grounded, and is therefore normally current-carrying; the starter and alternator use the block to complete the connection to DC negative. It should *not* have a grounding wire, and this one is undersized to boot.
